## Issues faced during the XFEL mass production

Walid KAABI- LAL/CNRS

CERN, June 27<sup>th</sup> 2017

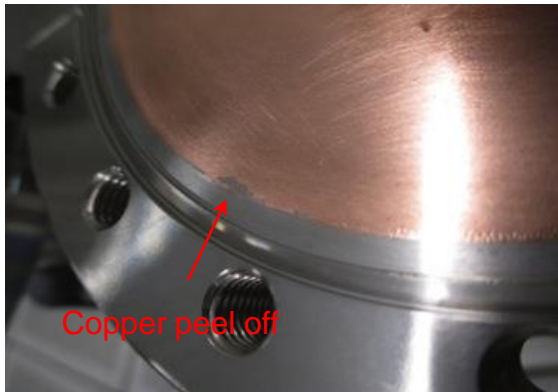
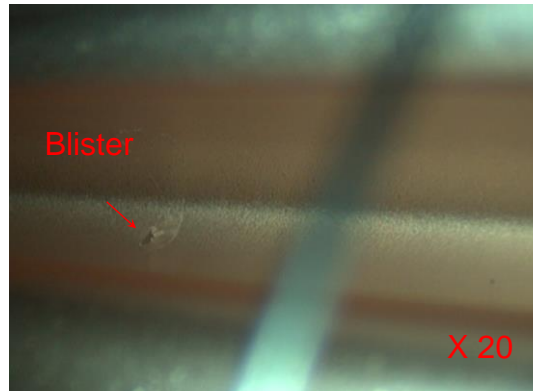
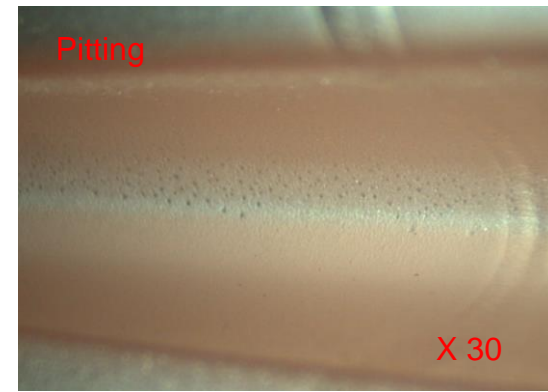
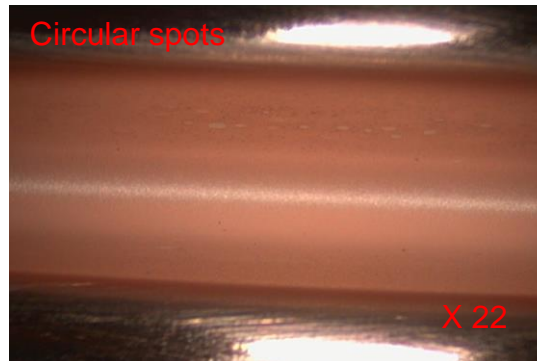
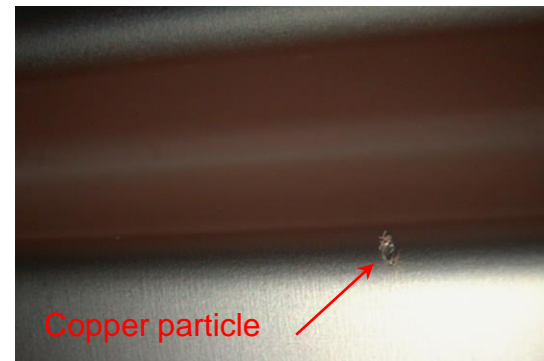
## Examples of observed copper defects:

→ Qualitative & quantitative acceptance criteria definition: defects classified per types, dimensions et number. Agreement on corrective actions and validation tests.

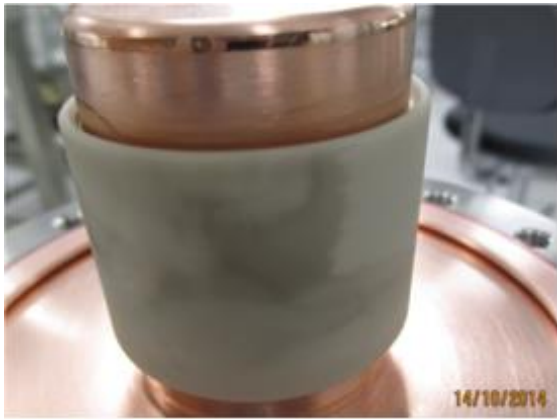
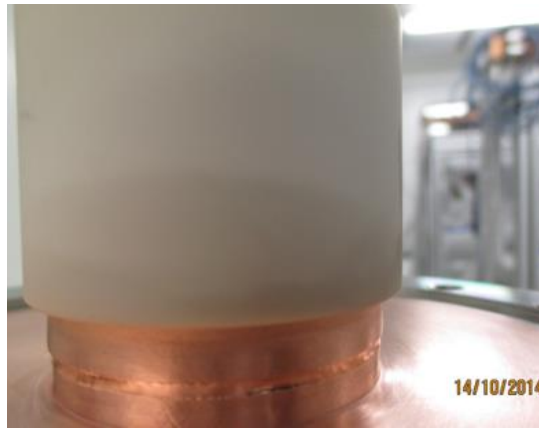
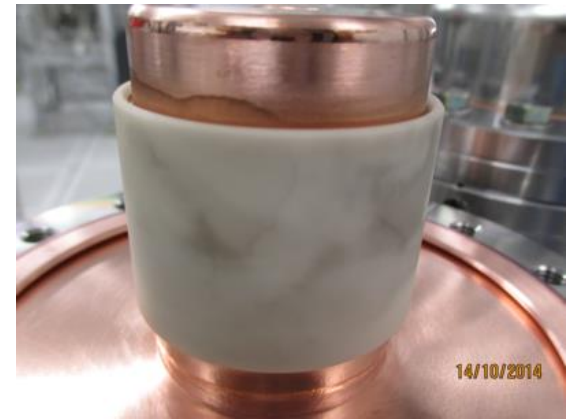
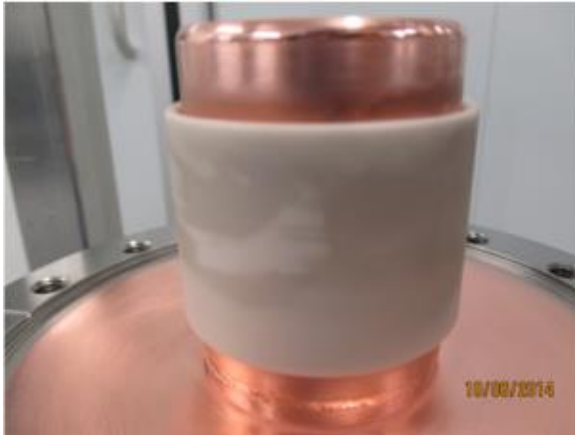
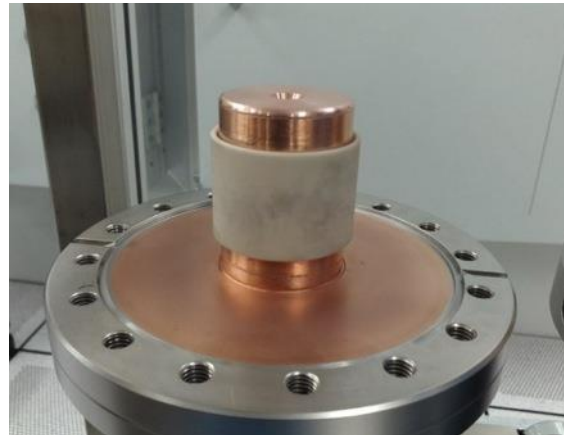
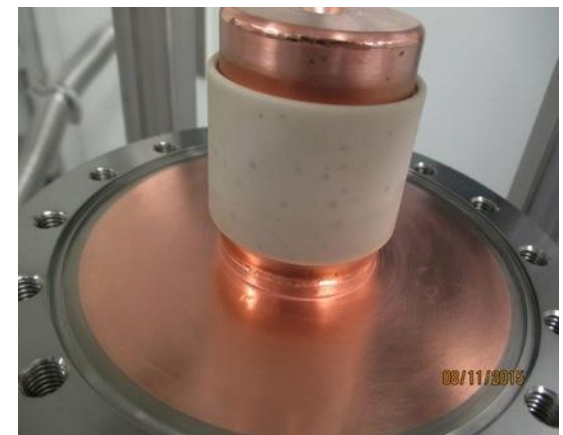
Main defect discovered during the final inspection: **Dark layer in cold ceramic window**

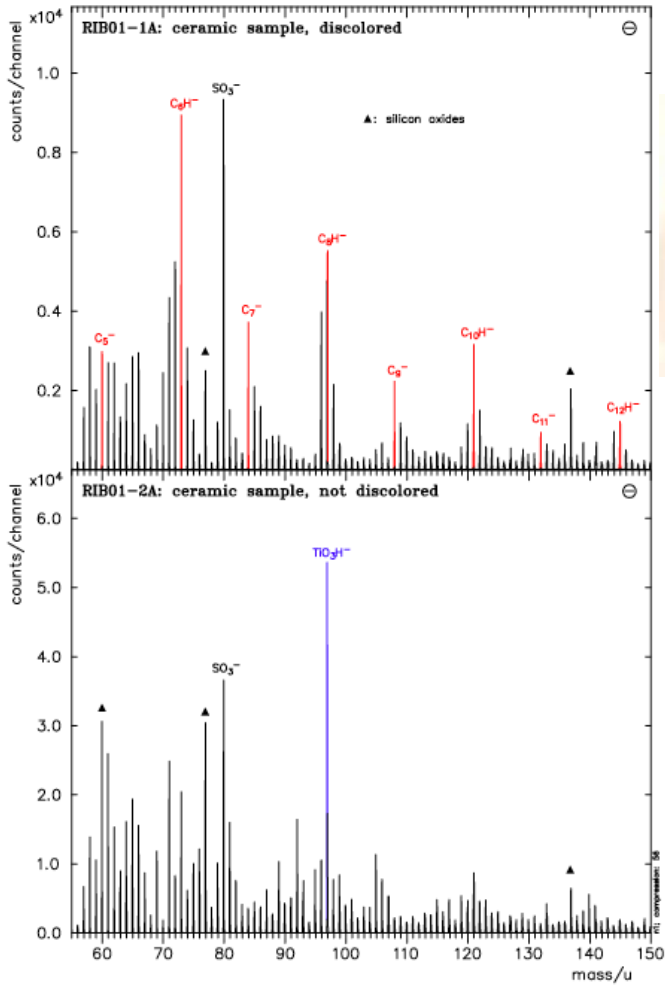
Figure 4: Details of the TOF-SIMS spectra of negative secondary ions

- In the spectra of sample 2 (not discolored) mass signals of **titanium**, **titanium oxides** and **silicon oxides** as well as mixed **silicon/titanium oxides** are distinctly observed (look at figures 4 and 5 on pages 8 and 9). Moreover **chlorine**, **higher fatty acids** (figure 5 on page 9) and the additive **4,4'-Bis(diethylamino)benzophenone** are detected with high signal intensities.
- In the spectra of both preparations **sodium**, **potassium**, **calcium** and **CN/CNO-** as well as **SO<sub>2</sub> anions** are identified with high signal intensities.
- Only in the spectra of the discolored sample 1 the lubricant **erucamide** (figure 5 on page 9) and **soot-like carbon anions** (C<sub>2</sub>H<sup>-</sup>, figure 4 on page 8) as well as **alkylsulfates** (figure 5 on page 9) are clearly detected.

While in the spectra of the not discolored sample the ceramic material is distinctly observed, particularly erucamide and soot-like carbon anions are detected in the spectra of the discolored surface. The former compound can probably be attributed to the plastic wrapping of this sample (→ as-received condition). However the soot-like carbon anions (→ carbon black) can possibly be associated with the observed discoloration.

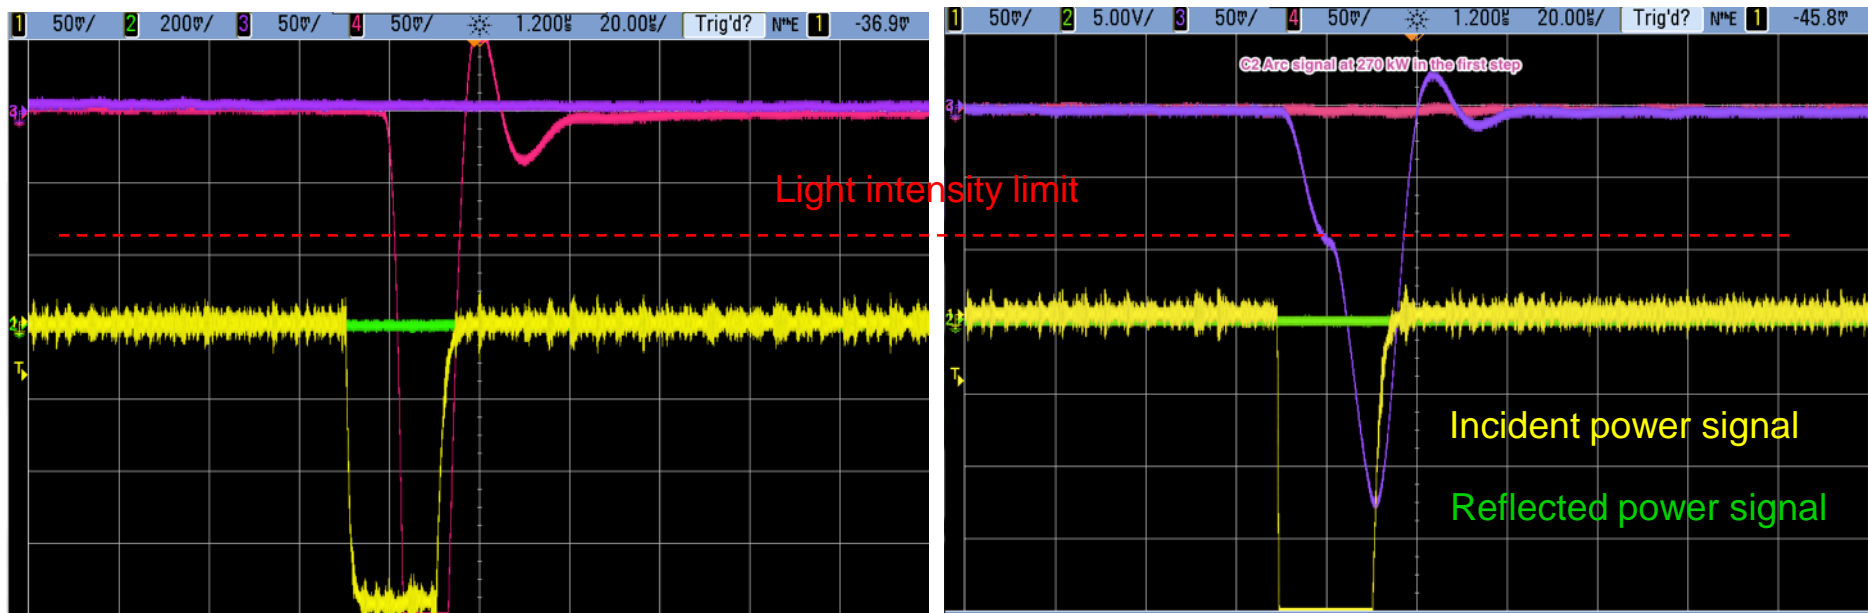
Sudden increase of the light intensity causing arc interlock: generally occurs at low power (under 250 kW) at the shortest pulse (20us) → impossible to go further: the pair is removed from the test stand.

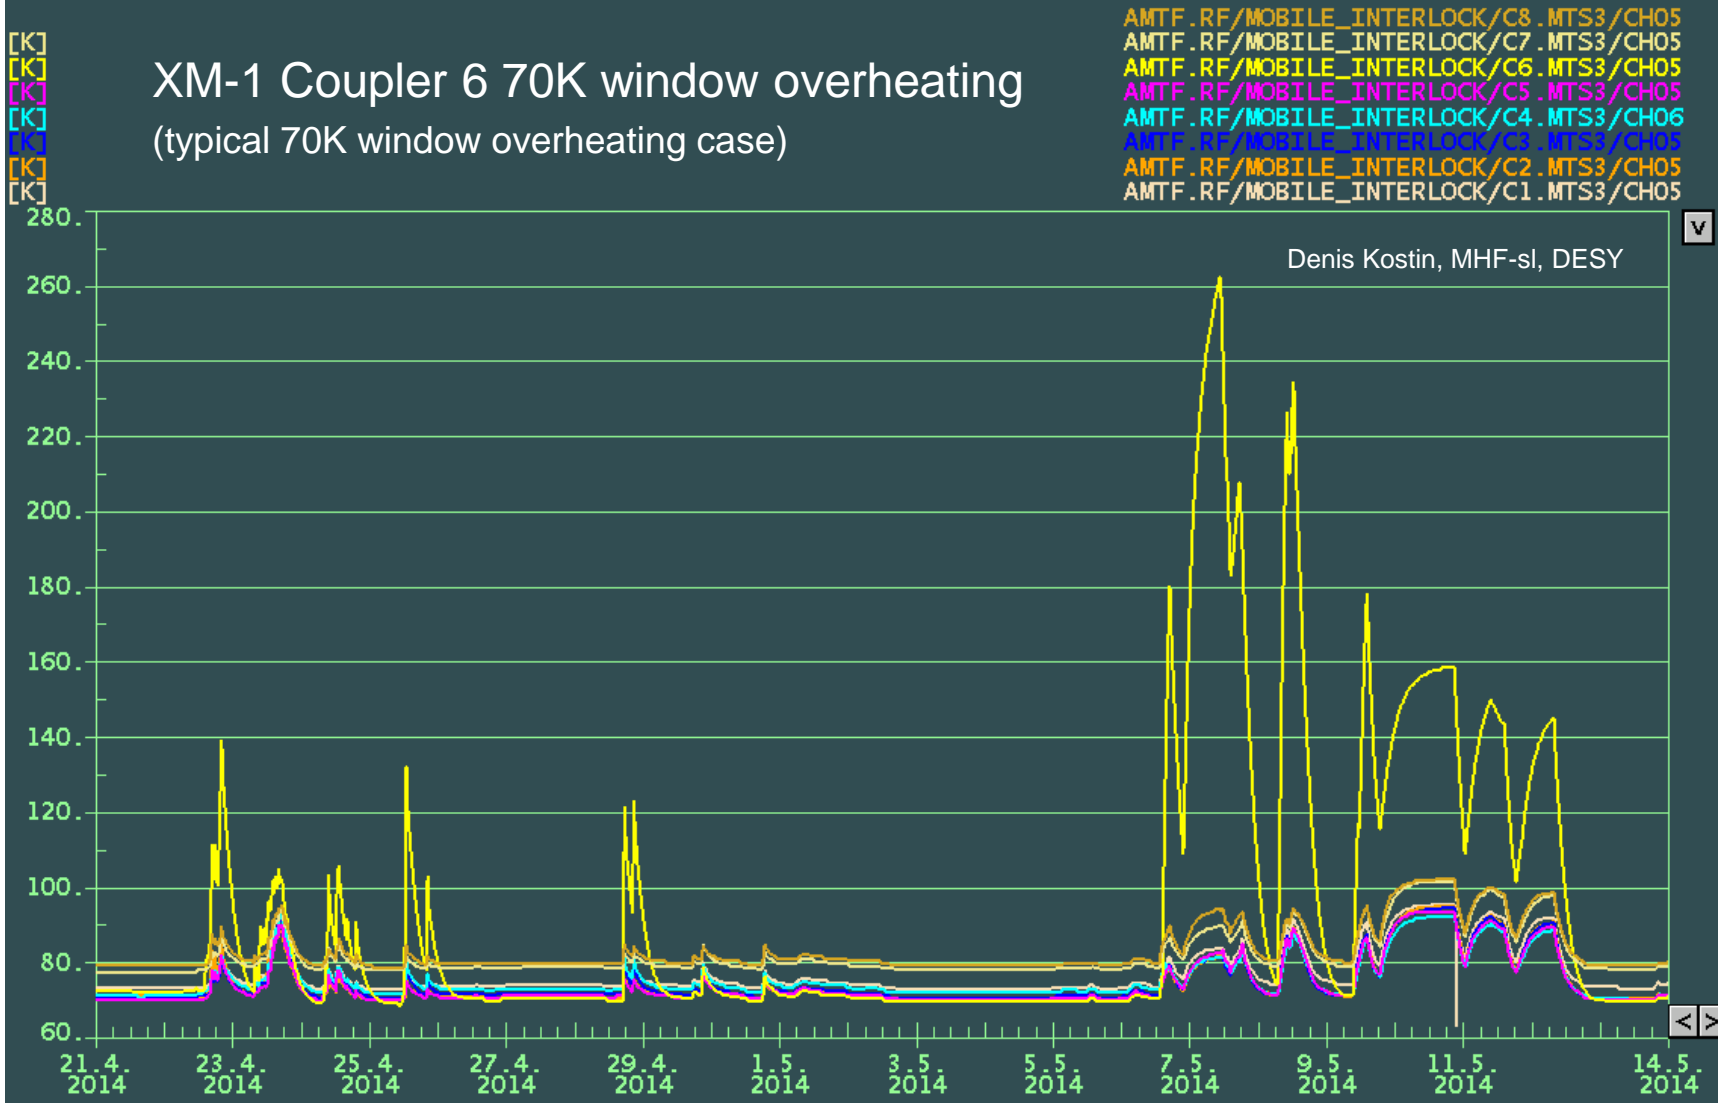
XM-1 Coupler 6 70K window overheating  
(typical 70K window overheating case)

Coupler 70K window overheating due to loose connection between the WIC and the CP. Cold part must be grinded and cleaned. The WP must be changed.

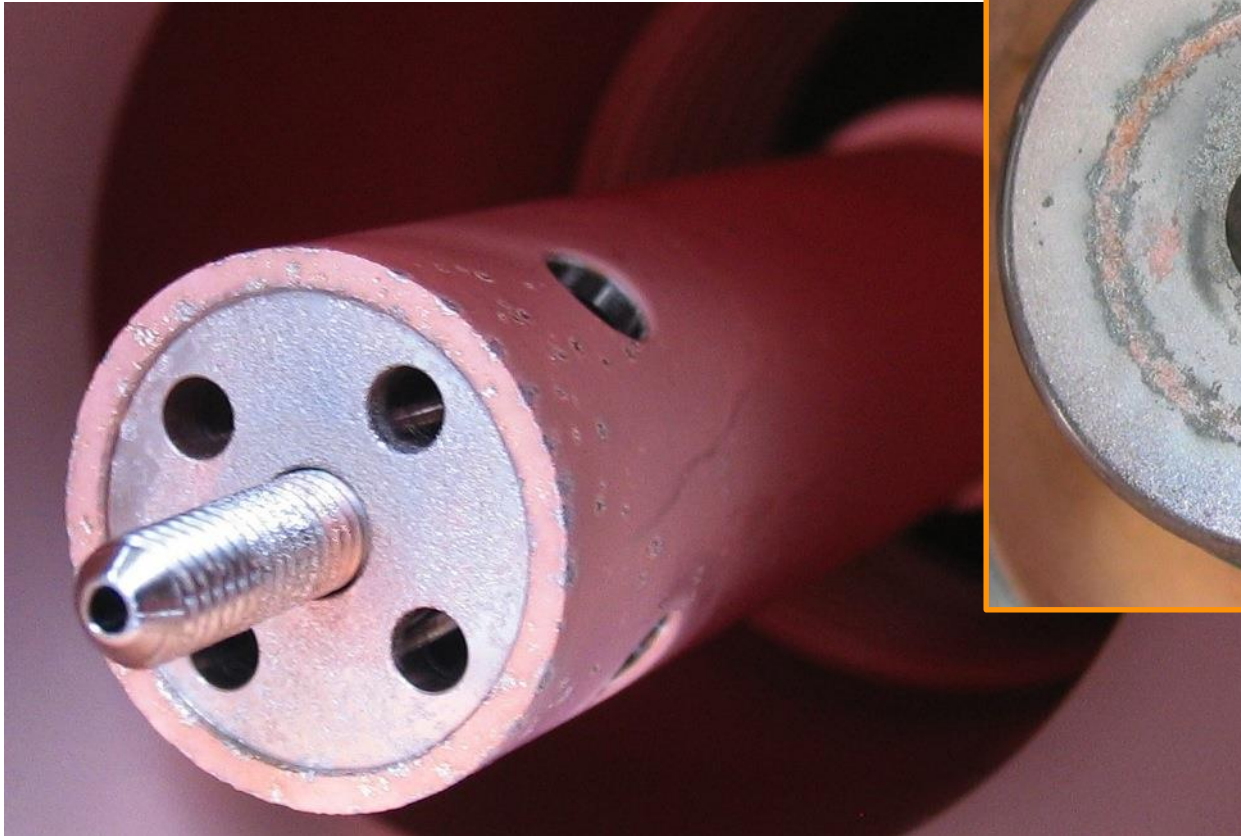
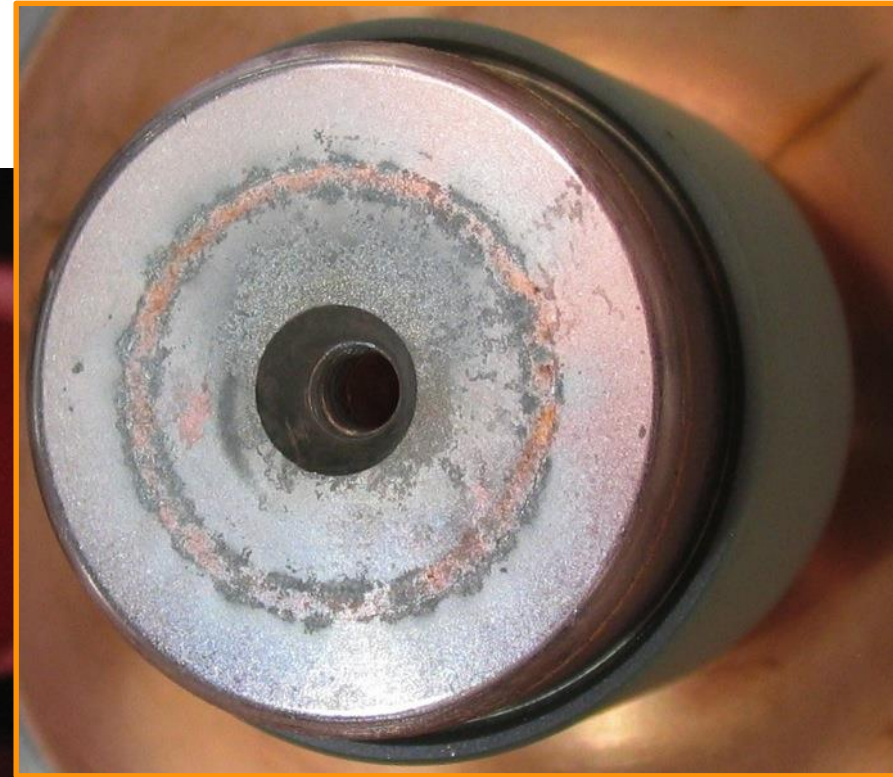
Re-conditioning takes long time: cleaning is difficult, no baking, no US-wash...

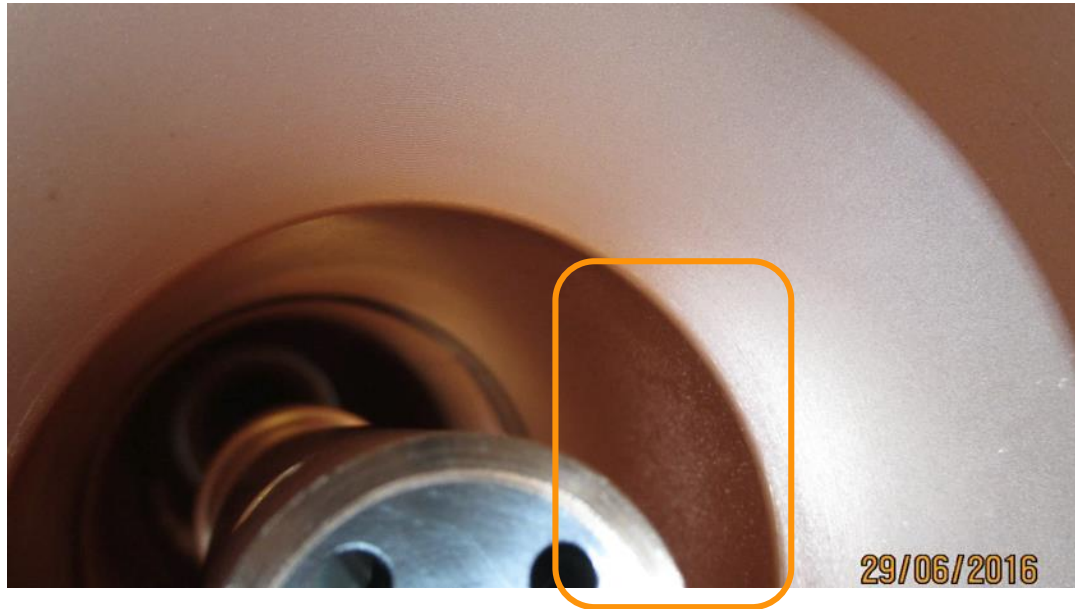
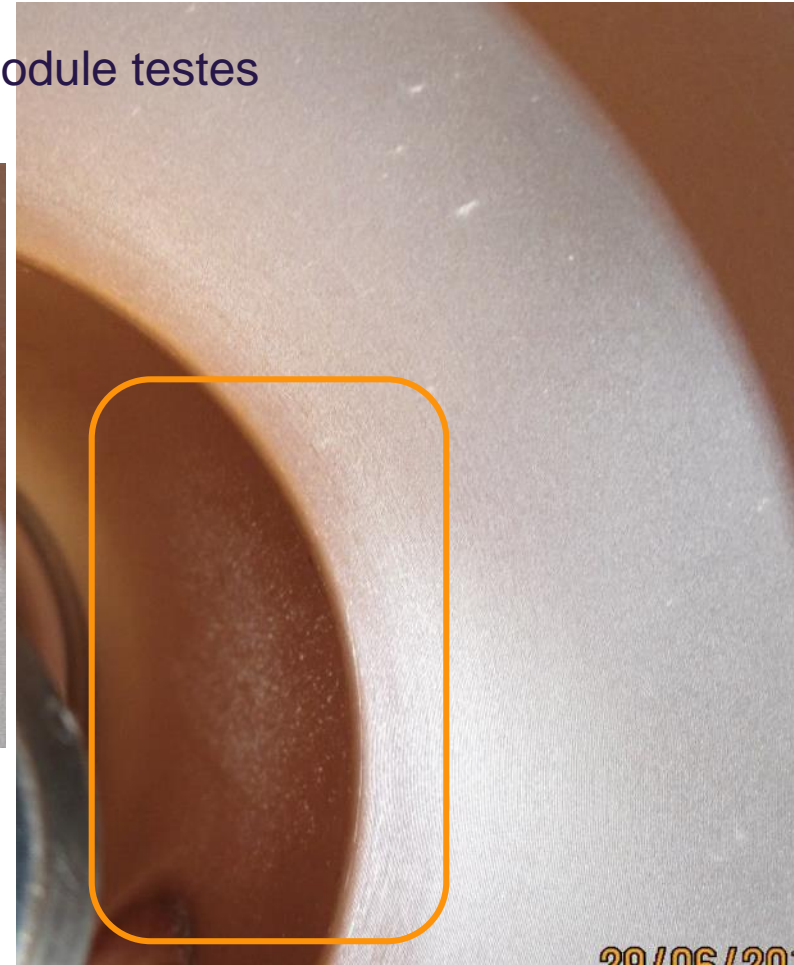
WPs inspection after observed Overheating in module testes

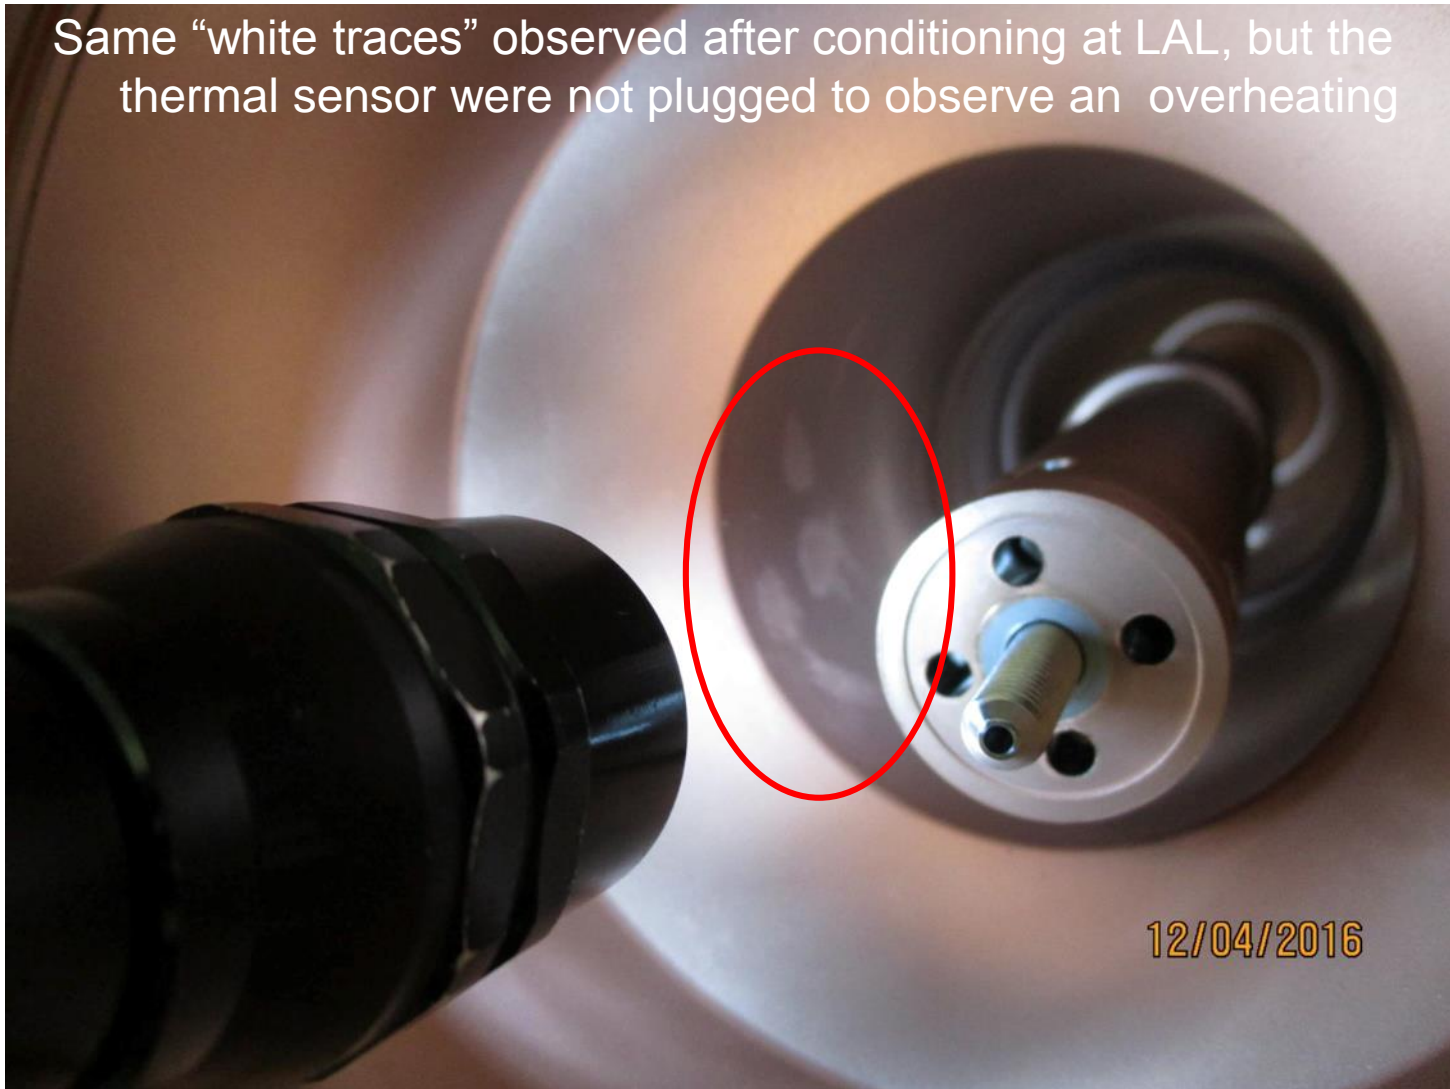
Same “white traces” observed after conditioning at LAL, but the thermal sensor were not plugged to observe an overheating

White circular spots  
Cu lack?

High pick-up signal le1C2 (near the warm window). Increasing during the time.

Vacuum level at the threshold limit

Power level blocked around 400 kW for hours (limiting vacuum) & even decrease.

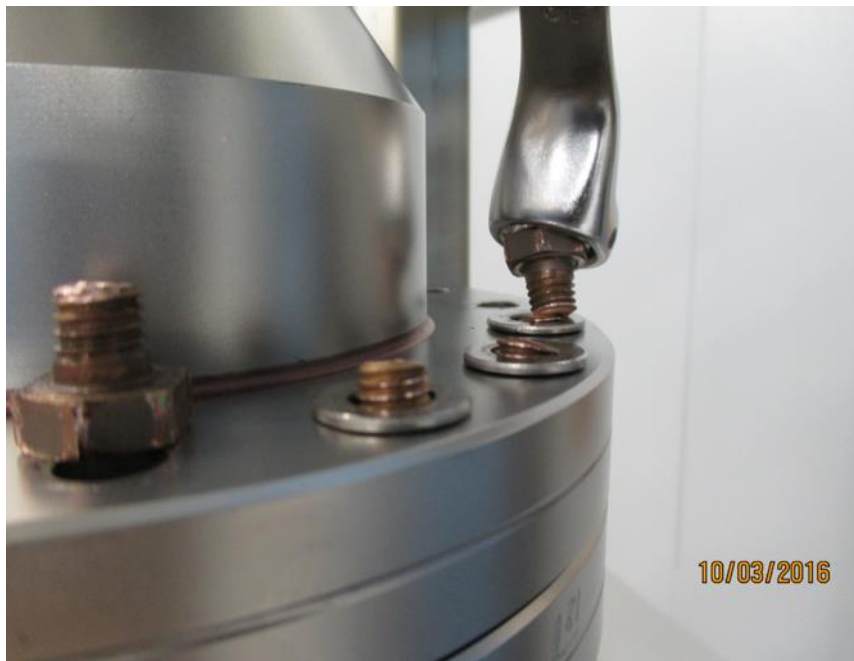
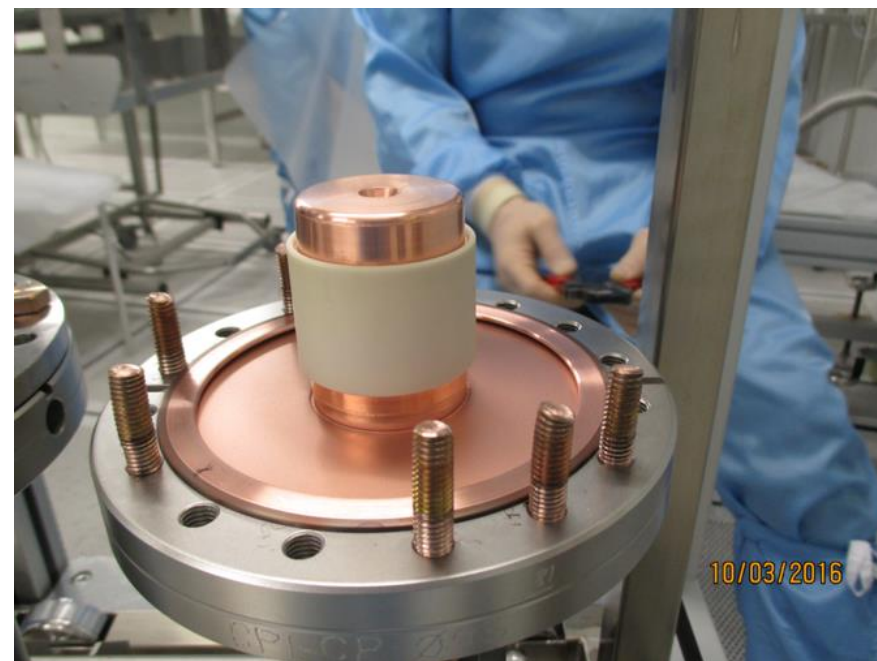
First, we faced difficulties to remove the WP because of the tilted threaded rods, blocked in the flange.

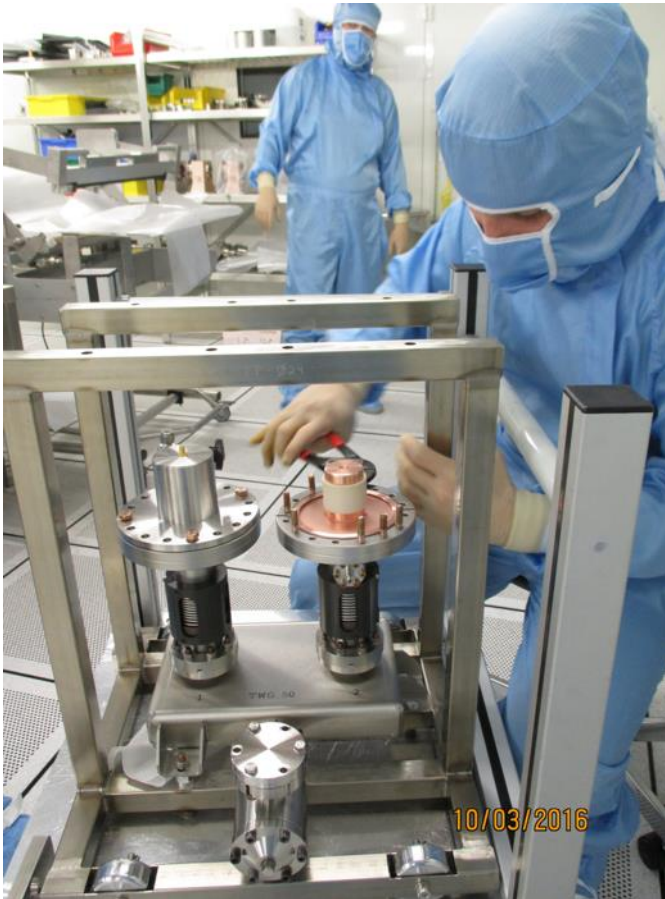
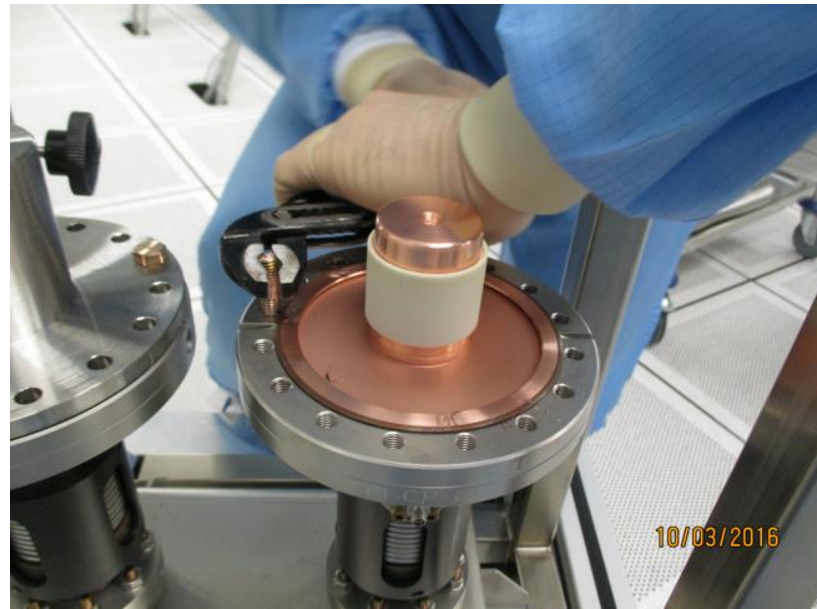
The 7 rods were then removed with a pliers, with the risk to heat the cold ceramic in case of bad handling, and to contaminate the parts with metallic particles.

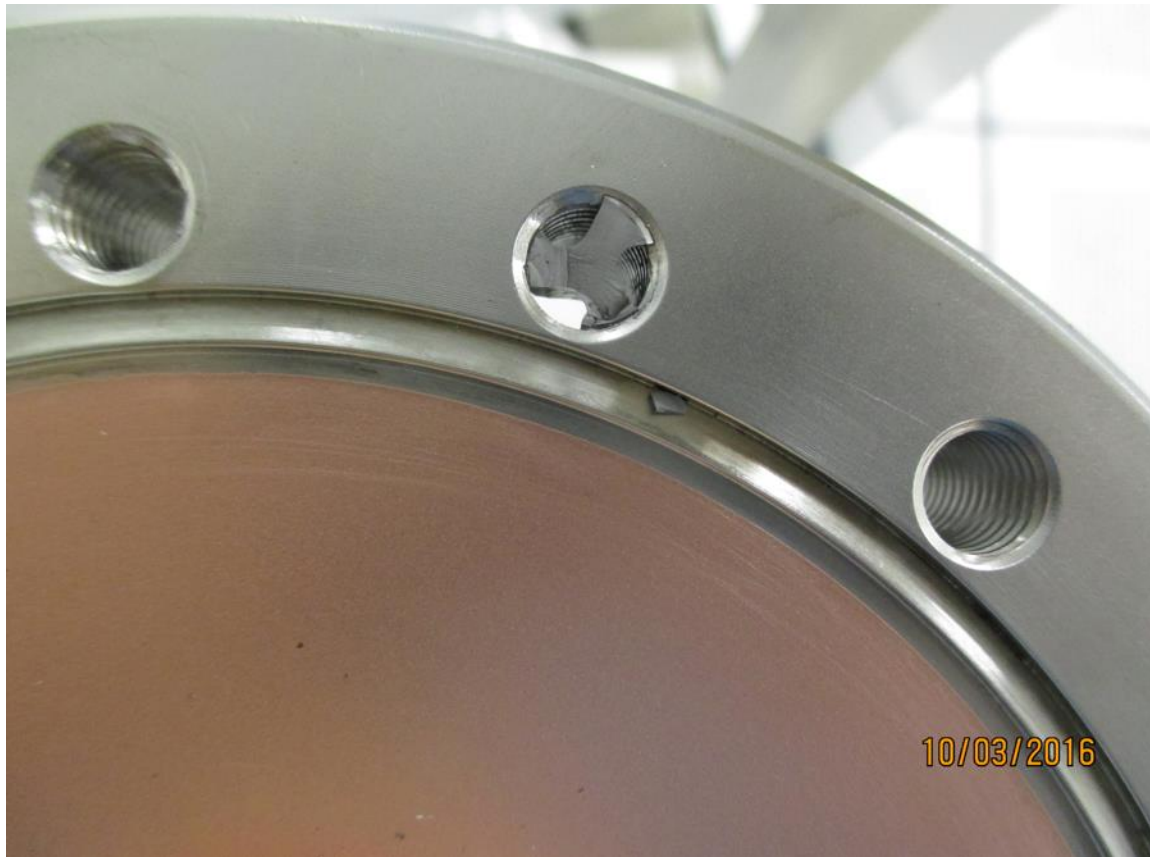
Once the rods removed, we started to rework the tapped holes. However, the quality of the original thread was so bad, that the tool was broken inside one hole.
