Disaster mitigation strategies for adobe houses: A case study of District Awaran, Balochistan, Pakistan

Mamoon U R Mengal, Waqas A Mahar

Department of Architecture, Balochistan University of Information Technology,
Engineering & Management Sciences (BUIEMS) Quetta.
e-mail: mamoonmengal@gmail.com, architectwaqas@hotmail.com.

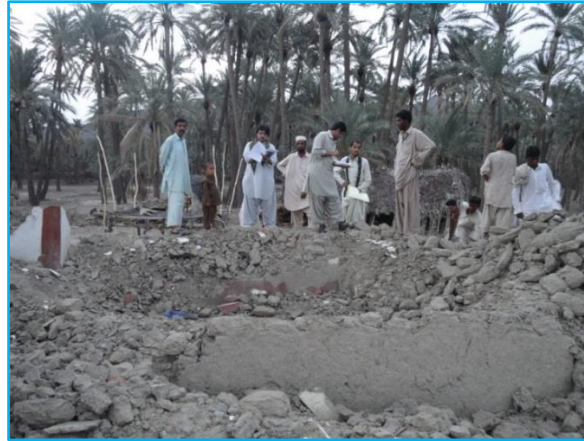
The team first arrived at Mangoli and it was then when they realized the scale of destruction. The village of Mangoli was completely razed to the ground except a few adobe huts. The villagers were using some of the tents provided by the earthquake relief as temporary shelters. They set up the tents along with the remains of their houses. The destruction at Mangoli can be seen in figure 3, survey team members are also busy in data collection.

Figure 3. Destruction at Mangoli

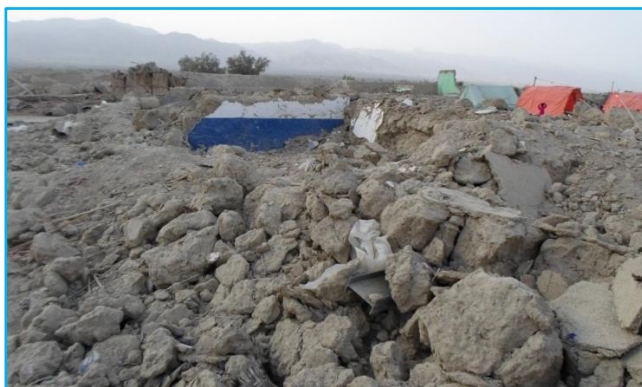
Figure 4(a). Damages at Gajjar town

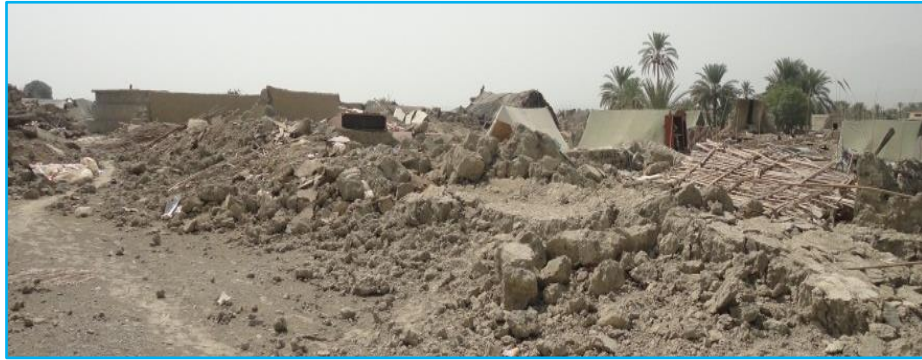
Figure 5. Earthquake damages at Nok Jo

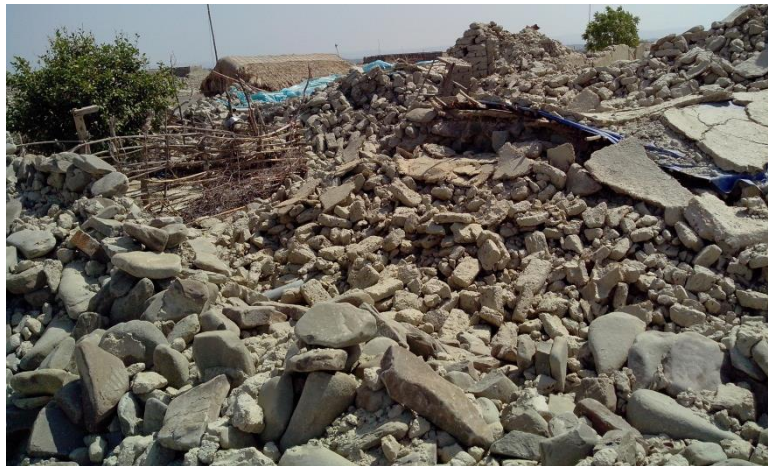
Figure 6. Destruction at Malaar
(stone boulders used in wall construction can be seen in the picture)

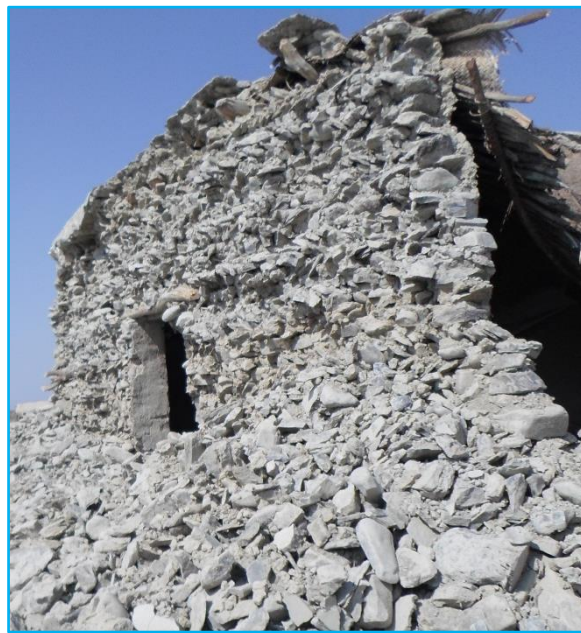
The use of stone boulders for the construction of walls was mainly seen in the south, such as in Gishkore and Dandaar areas. The stones were mainly round and of improper shapes or bounding,

excessive mud plaster was used for the construction of such walls. The walls have the same width as of other walls, i.e. 18" (45.7 cm) and constructed without using any stiffeners, figure 9(c).

Figure 9(c). Stone boulder walls

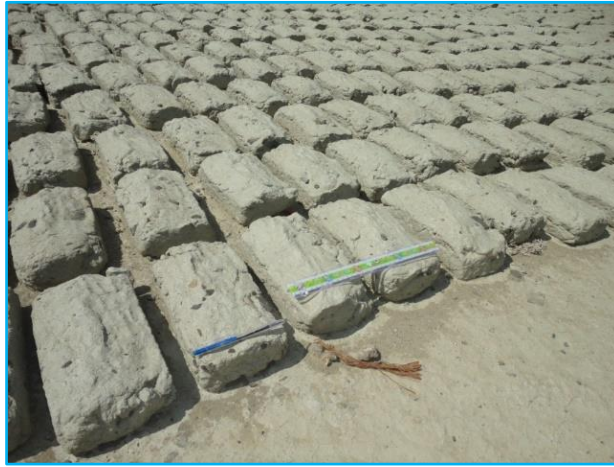
The mud bricks made locally and used for the construction of houses were of improper shape and form with round surfaces and uneven edges making it essential to use extra mortar during the construction of walls, figure 11. The material mix used for the brick making was not up to the standard as it contained boulders and organic materials, such as reed stalks etc.

Figure 11: Bricks placed for drying

It is necessary to make the brick of proper and even size. The soil should be first passed through the sieve to separate the gravels and small stones before formation of the mix. The proper moulds should be used to mould the bricks and then moulded bricks must be placed on even ground or surface to let it dry, figure 17(a) and 17(b).

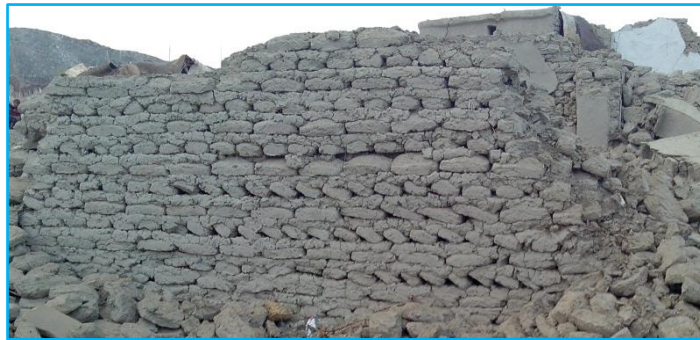
During the construction of a wall, the brick courses were placed without following any proper bond pattern, see Figure 12. Some bricks were placed slanted while some were placed vertically. Whatever, was the reasons for using bricks in such manner, it made the walls vulnerable to even a slight jolt.

Figure 12: A wall with the lack of bond

As mentioned in section 4.2 that the improper brick bond was also a cause of damages. The bricks should be properly bounded to strengthen the bond. The corner can be strengthened by using bamboos as reinforcement on the corner which is shown in figure 21.

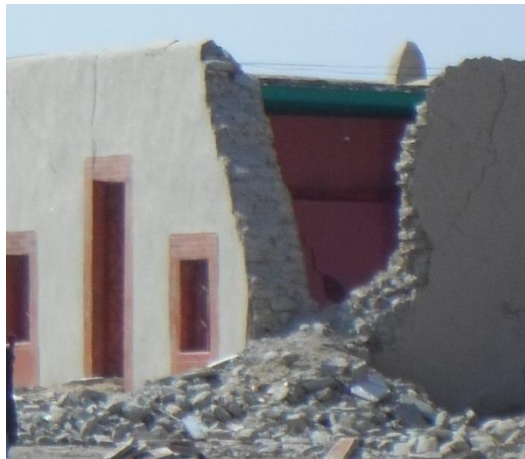
It was observed that in most of the construction, the corners were not strengthened and as a result they gave in easily when the walls started shaking, as shown in Figure 13, the wall is damaged at the corner.

Figure 13. Wall damaged due to weak corner

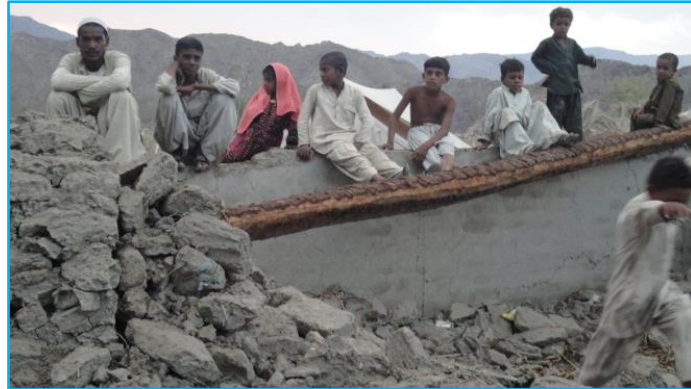
Heavy girders were used in majority of the houses without having any mechanism for the distribution of loads, see figure 14. As a result, the concentrated load from the heavy girder was applied to only a few bricks which failed easily. The heavy girders caused more structural damage and may also been responsible for any loss of life that occurred.

Figure 14. Heavy girders caused damage

Several buildings fail in the earthquake as the unevenly distributed weight of heavy roof pushes the walls in one direction. Light roofs reduce stress on walls in earthquakes. Lighter walls with a light weight roof can survive even severe quake vibrations with little reinforcement better than heavy walls and roofs. The adobe house shown in Figure 22(a) can hold up a light-weight roof. It must consist a special base and plastic mesh to reinforce the walls. The same size house shown in Figure 22(b) with a heavy-weight roof should have heavy earth piers at all corners to help brace the walls against the weight of the roof moving in an earthquake.

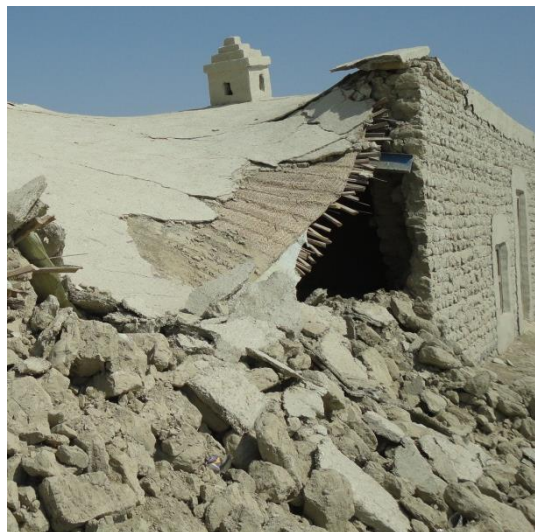
The roofs were placed on the walls, as shown in Figure 15, such that there were no projections on any side. As a result, when the walls even slightly moved, the roof came down pushing the walls further while doing so. As a result, the entire houses collapsed.

Figure 15. Lack of projections

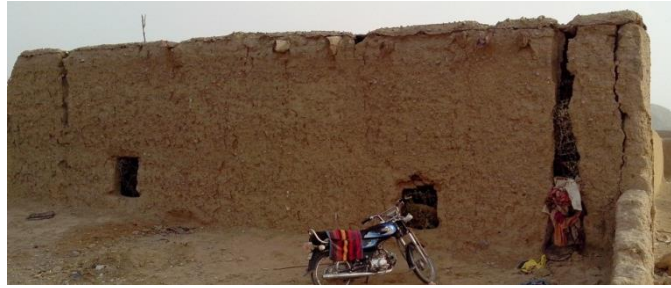
Most of the mud and mud brick walls were already weakened by the rainwater mainly due to spouts and not having the required projections to stop the rainwater penetration into the walls, as shown in Figure 16. This had made the walls weak and thus vulnerable.

Figure16. Damage caused by water spouts

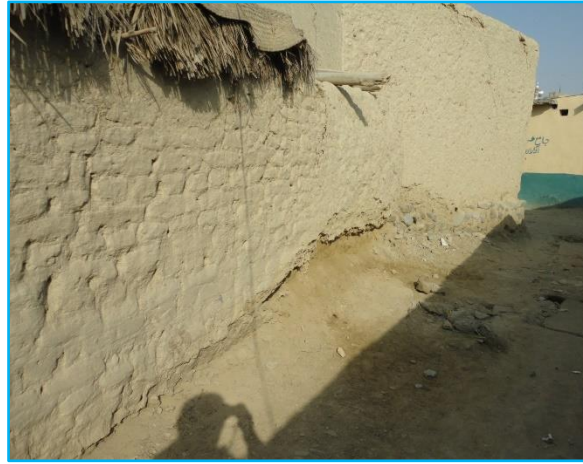
Figure 35. Plinth decay

As water makes the foundation soil weak. In an area that experiences rainfall or snowfall, it is recommended to use a waterproofing layer at the plinth level before starting the construction of wall above the plinth and provide an apron and drain around the house to prevent runoff water that might wet walls or enter the foundation. In 2007, Awaran was highly affected by flooding which caused 20 deaths and more than 1800 houses were entirely collapsed (PDI, 2007). Figure 35 shows the effect of plinth decay due to water.
