**BLM SYSTEM:
SIGNAL DROP AT IP3 ON 23/05/2017**

Christos Zamantzas on behalf of the BLM team.

09/06/2017

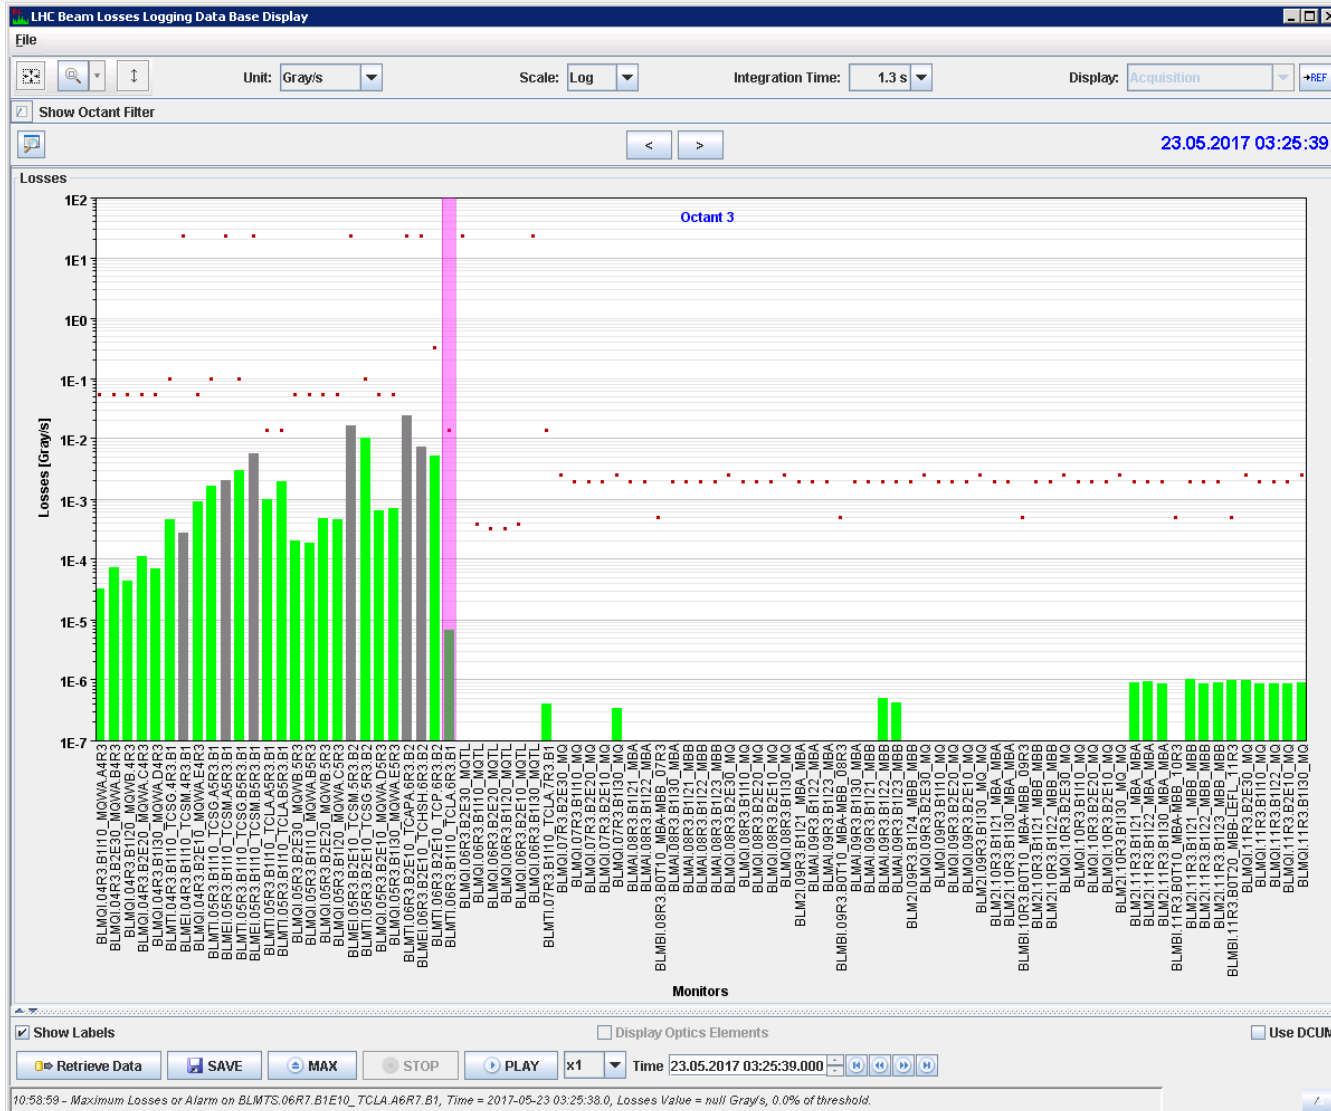
Issue: channels 6R3 – 10R3

- During the Loss Maps Validation several BLM signals drop to zero at DS of R3
- The issue has been reported twice in Run 2:
 - [BIBML-990](#) on 2015/05/05
 - [BIBML-1344](#) on 2017/05/23
- Issue known since Run 1:
 - Several investigations and actions
 - Cabling is not the same as in all other locations
 - Cause never really understood

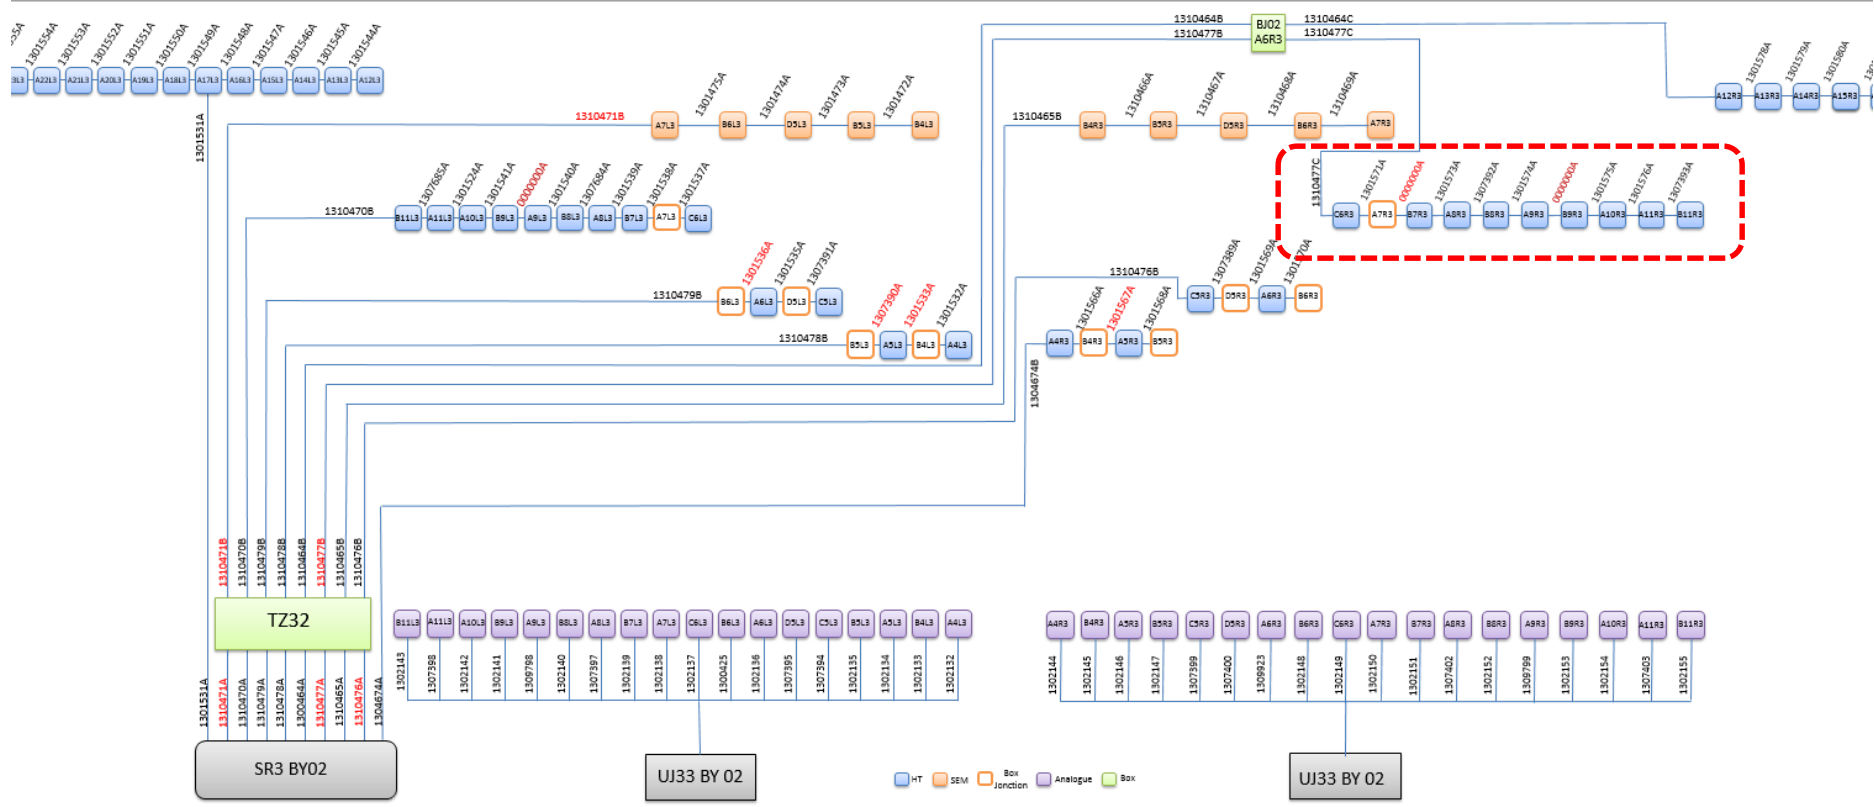
Installation

- Specificities of the location
 - HV cable is ~ 3km (all other locations < 200m)
 - Very long signal cables (~ 800m)

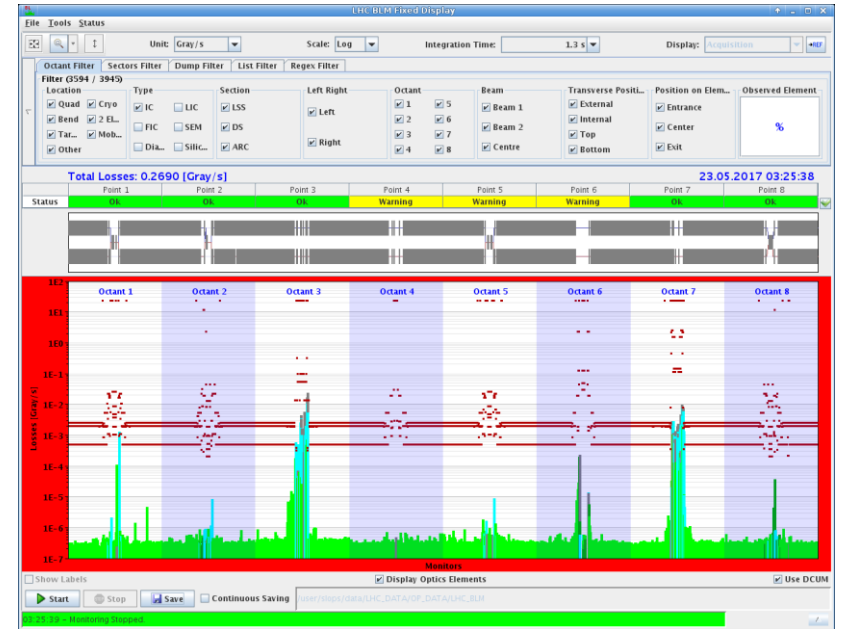
Protection

- Due to the Loss Maps all MASKABLE BLM channels were masked
- Otherwise a beam dump would have been issued from two other points already
