MPP Meeting

# ***FMCM Commissioning and first operational experience with new converters***

# RD34.LR3 Issue

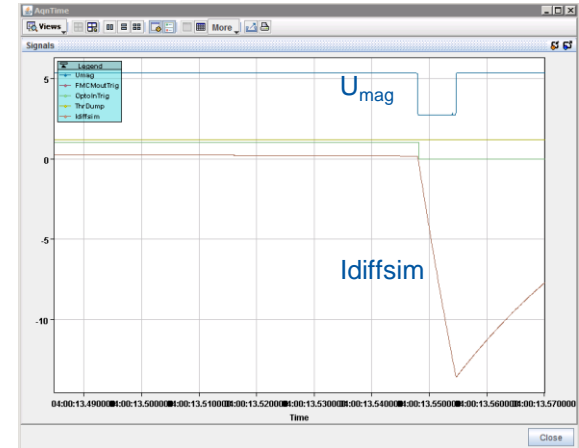
- FMCM of RD34.LR3 **tripped 4 times** on 29/04/2017 after the successful commissioning (in appearance) of the FMCMs.
- FMCM was **masked** during the weekend.
- The intervention on 01/05/2017 pointed out a **badly crimped connector of one HV cable**.
- After exchange of the HV cable, the HV divider had to be **multiplied by 2** in order to remove the saturation of the isolation amplifier !

FMCM  $U_{mag}$  &  $I_{diffsim}$

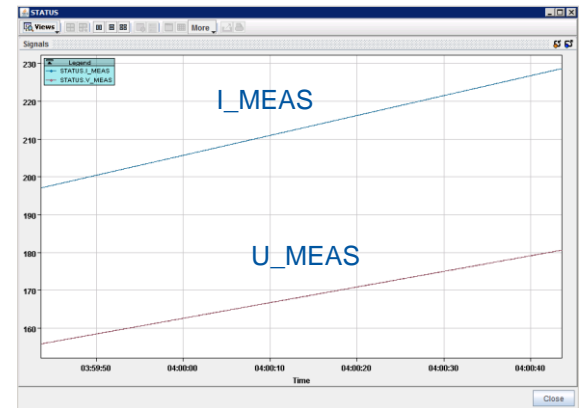
Power converter U & I

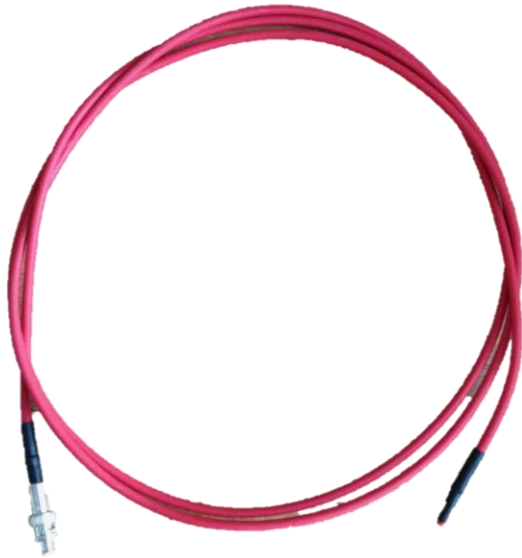
HV cable to connect  
the output of the Power  
converter to the FMCM  
HV box

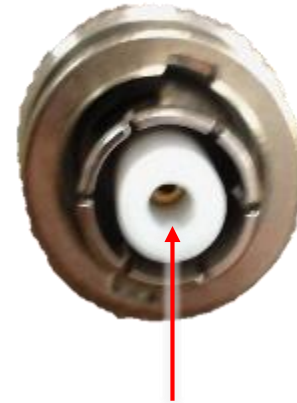
Bad crimping = cable core retracted

- Very successful RD1/RD34 power converters replacement by EPC as there was no interlock from FMCM on these power converters in 2017.
- Commissioning and initial operation revealed problem on the HV boxes of the FMCM
  - Bad crimping on HV connectors leading to missing half the measurement circuit and causes 4 beam dump.
  - Analysis of all circuits made.
  - Two circuits have been corrected (RD34.LR3 & RD34.LR7)
  - One remaining circuit foreseen to be corrected in TS1.

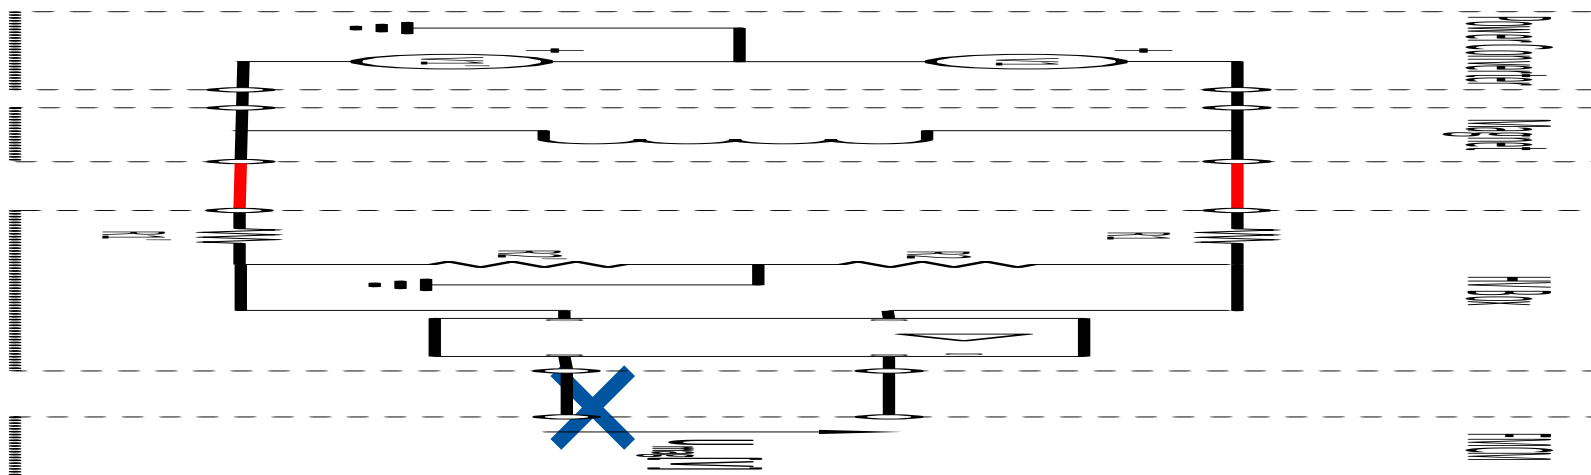
$U_{mag}$  originally calculated as  $U_{mag} = \cancel{2} \times V_1 \times \frac{R_2}{R_1 + R_2}$

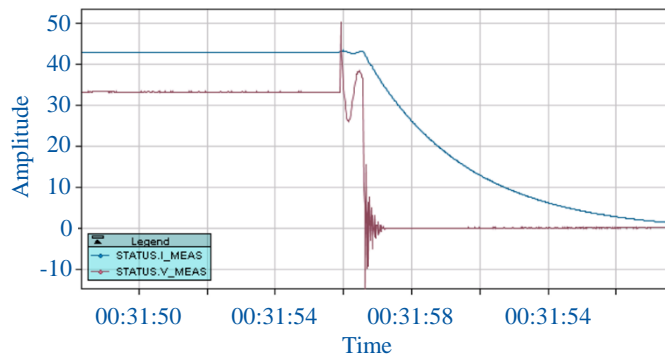
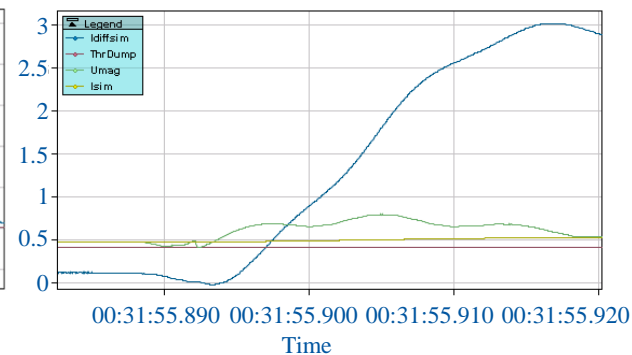
- On 12th October 2016, RD1.LR5 triggered a beam dump because of an electrical perturbation of  $\sim 8.5\%$  with a duration of 100 ms.

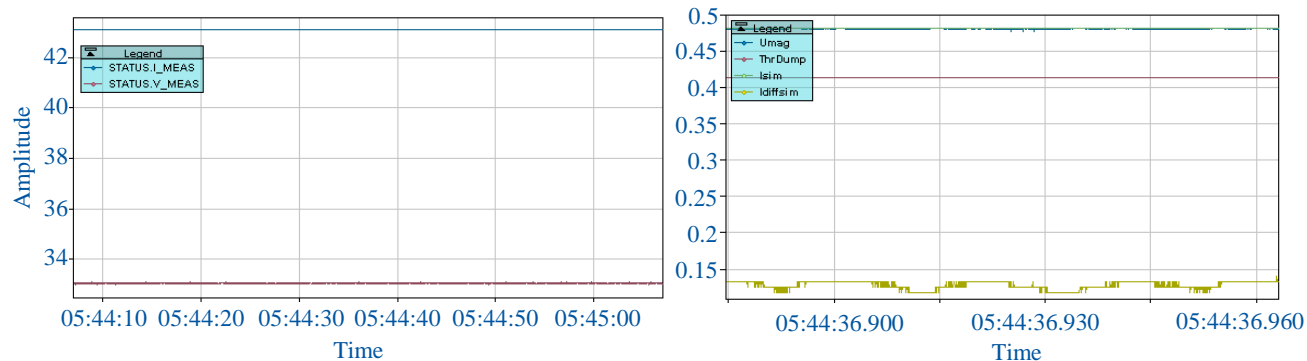
- On 31th May 2017, a comparable perturbation of 2016 triggered a beam dump by the FMCM RMSDB1.
- RD1.LR5 converter rejected successfully the electrical perturbation.
