# The LHC Main Magnet Electrical Interconnections:

the Subtle Size of Superconductivity

Lucio Rossi

**CERN**

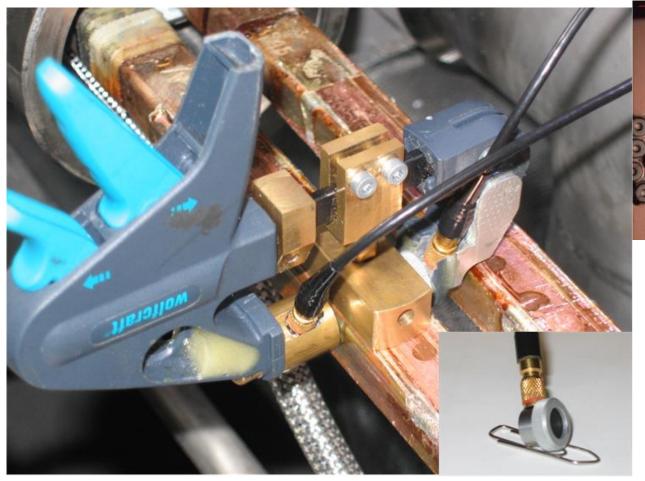
**Good Junction**

Bad Junction still with good electrical and mechanical properties: 3 tonnes

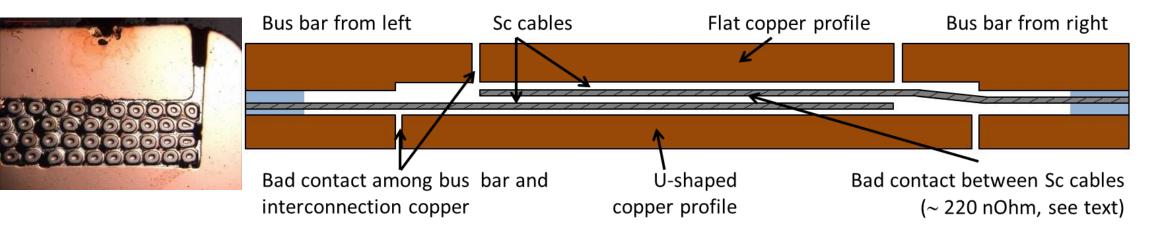
### A resistive joint of about 220 $n\Omega$ with no contacts with the stabilizer

The value of 200  $n\Omega$  was find from electrical model (set up later) and independently confirmed by HeII calorimetry (see later)

Extensive measurements on various type of defects later on confirmed that a joint badly done is less than 10 n $\Omega$  (even without solder). The faulty joint was not heated. The joint melted away generating a low voltage high power arc fed by the magenta c energy stored in the magnets.

The lack of continuity in the stabilizer of course **left the bad joint unprotected**: during IC works was noticed gaps between bus bar and flat copper profile 1-5 mm, filed when >1-2 mm; **however nobody thought of possible voids inside bus bar.**

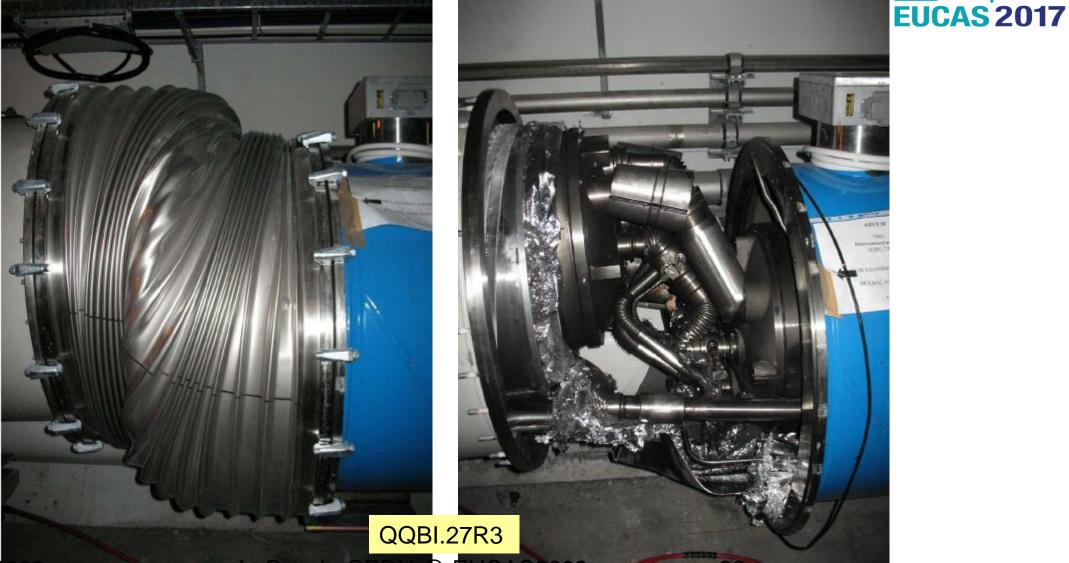
## Collateral damage: magnet displacements with further arcs

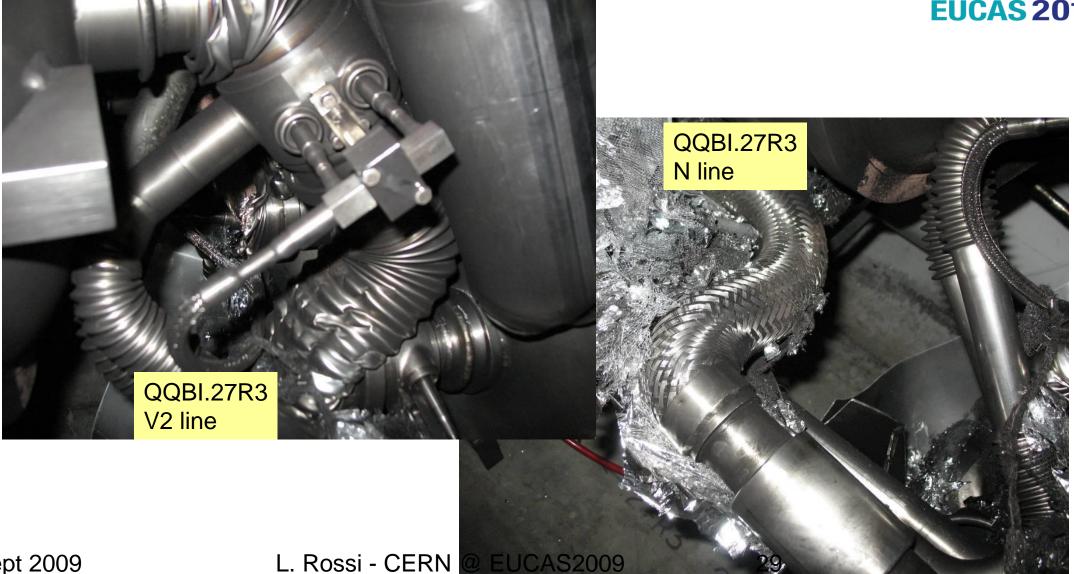
#### Collateral damage: magnet displacements and mechanical damage

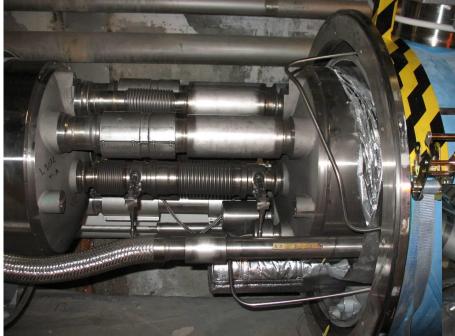
QBQI.27R3 Bellows torn open **EUCAS 2017**

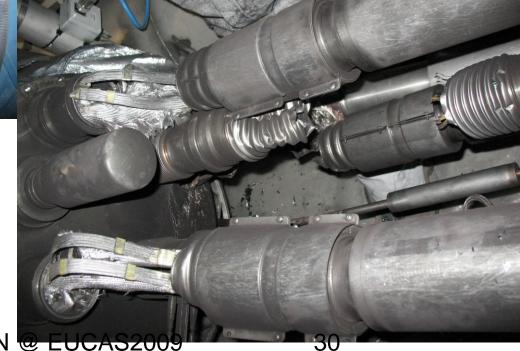
QBBI.B31R3 Extension by 73 mm

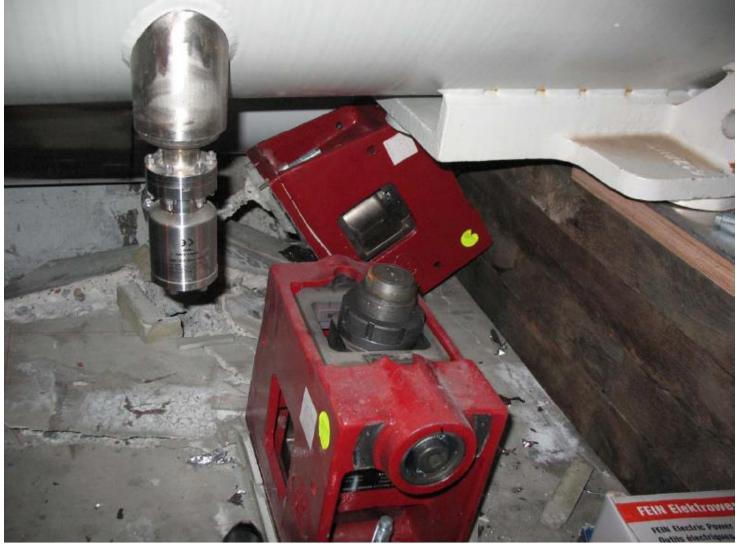
## Collateral damage: ground supports not enough robust

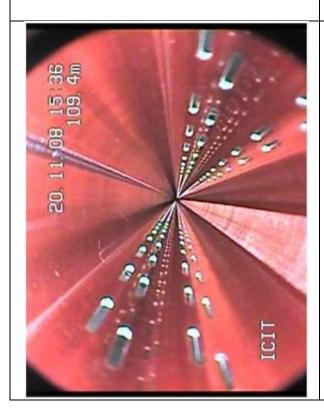
Beam Screen (BS): The red color is characteristic of a clean copper surface

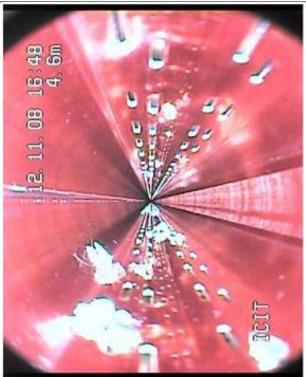
BS with some contamination by super-isolation (MLI multi layer insulation)

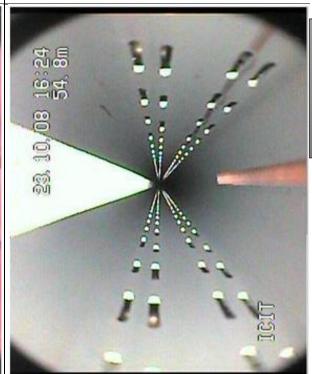
BS with soot contamination. The grey color varies depending on the thickness of the soot, from grey to dark.

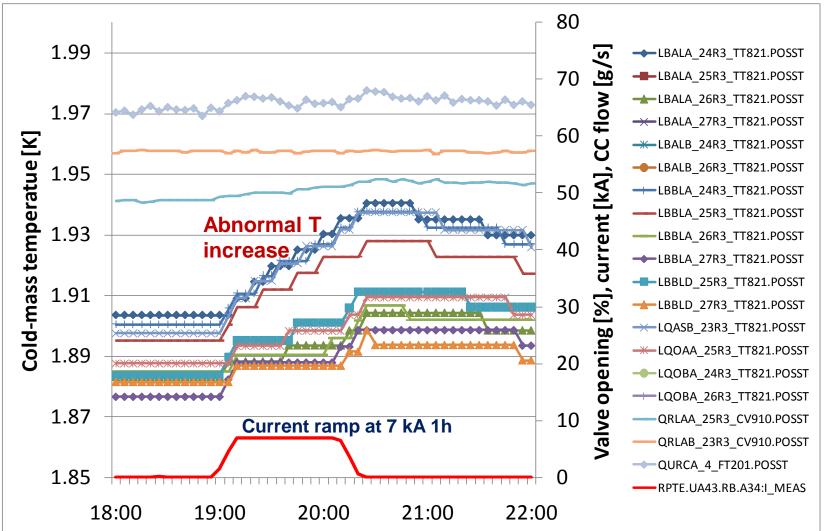
## Bad electrical diagnostic: but we ignored cryogenic signals (installed for other scope...)

Precursor (a posteriori): temperature drift @ 7 kA current flat top (15.09.08) In the bad subsector the ΔT increase was 40 mK, double than normal

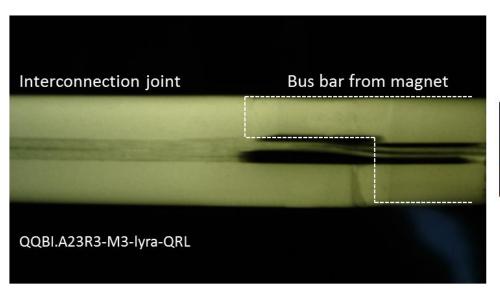
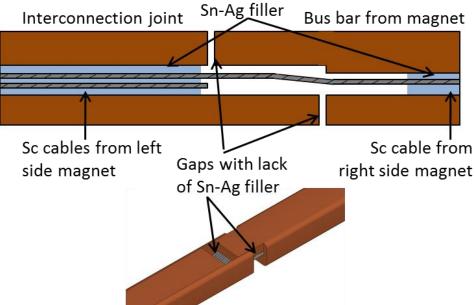
- Splice SC-SC can be good (or acceptable, < few  $n\Omega$ ), however the stabilizer may be not continous and not in contact with the cable.
- (Enhancing) Voiding bus bars solder due to excessive heating durign (good) joint

#### Defective interconnetion-bus bar transition γ-ray picture (left) and scheme (right)

## This failure mode is more frequent for under- or overheating during melting

After the incident, simple Copper Stabilzing Resistance Measurement introduced: very effective. Most attention shifted from the  $n\Omega$  of SC splice to Cu  $\mu\Omega$
