EUCAS 2017 3L04-04
20/Sep. /2017

Protection against the ground fault for 275 kV HTS cable and experiment

T. Takagi, M. Yagi, H. Fukushima, S. Mukoyama
(Furukawa Electric)

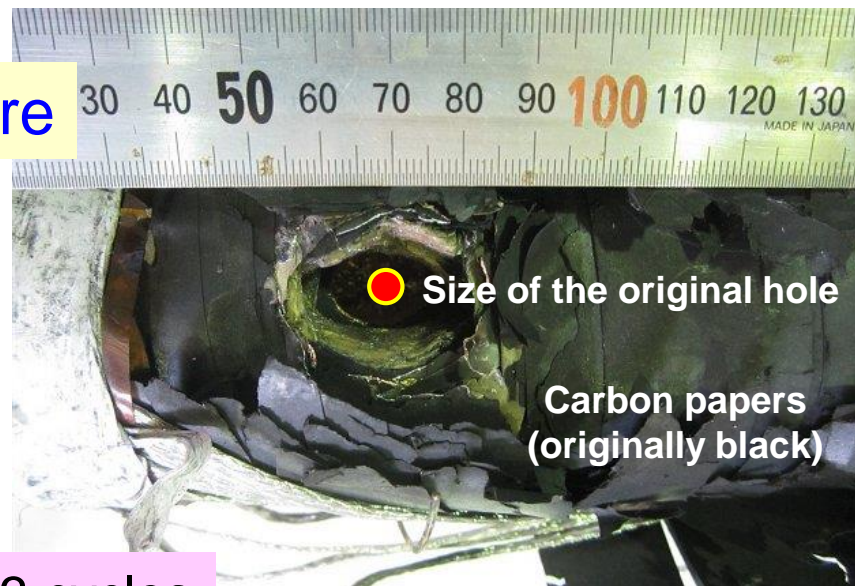
Core

AC 10 kA – 3 cycles

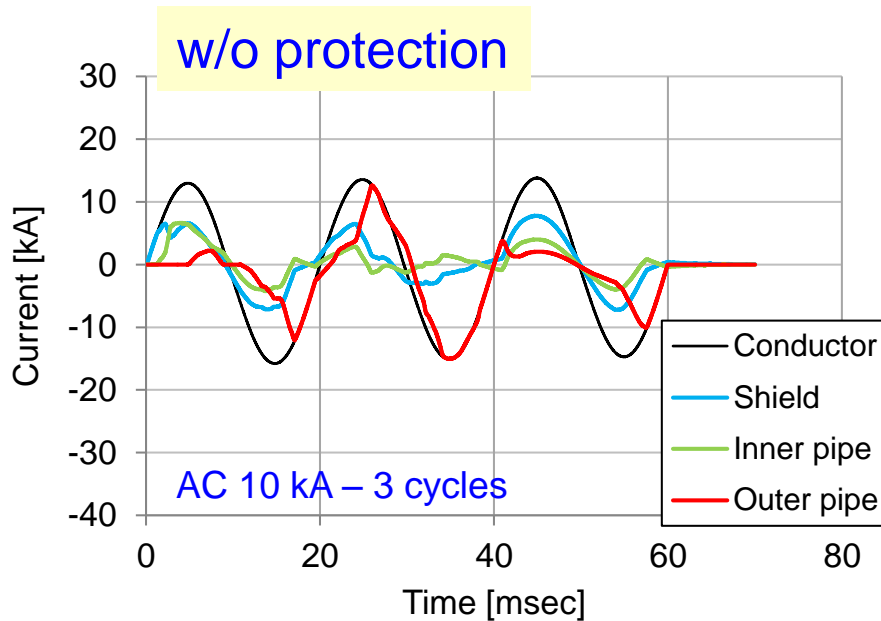
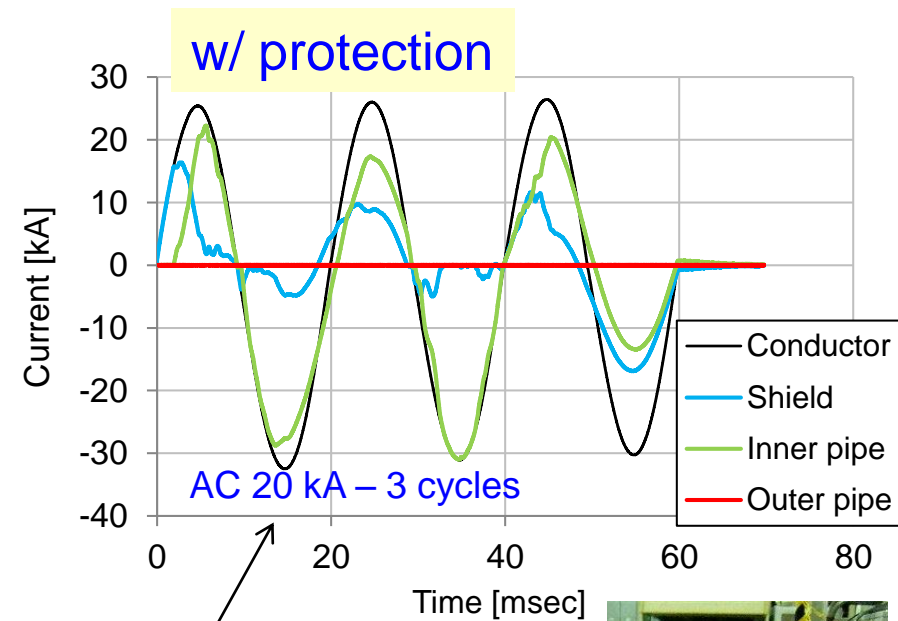
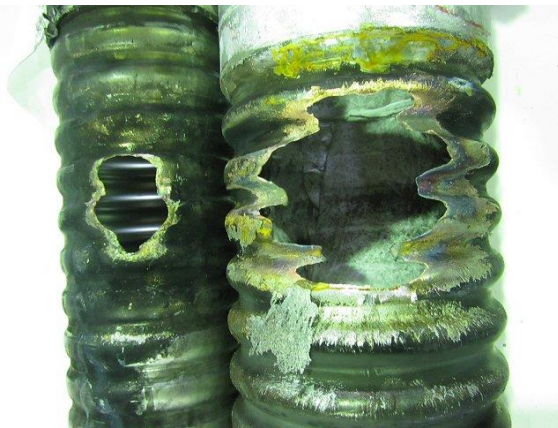
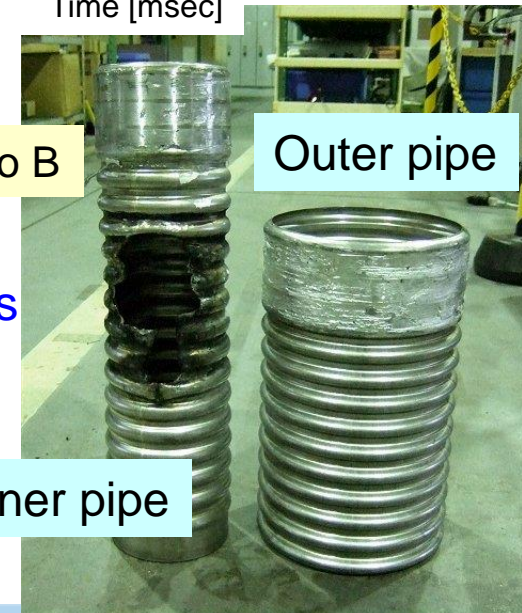
Sample A, similar to B

Outer pipe kept its soundness
NOT reached by arc discharge

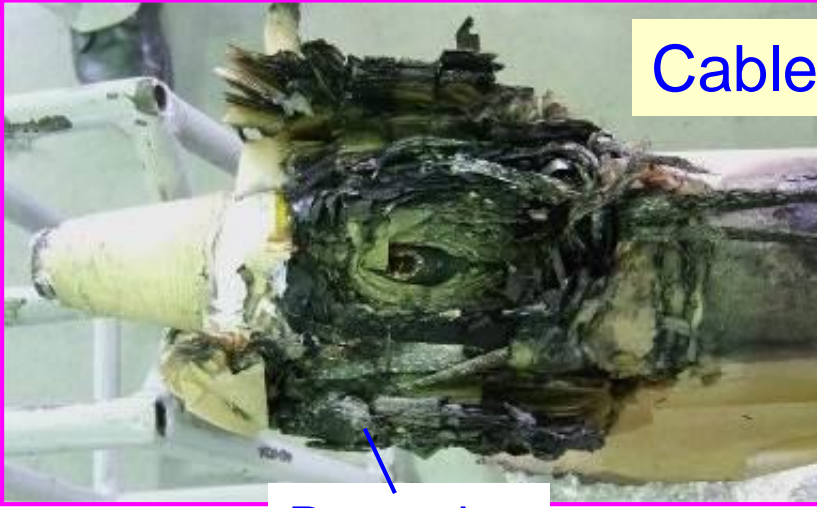
Cable core

The protection on the core was severely damaged, as well as the core itself.

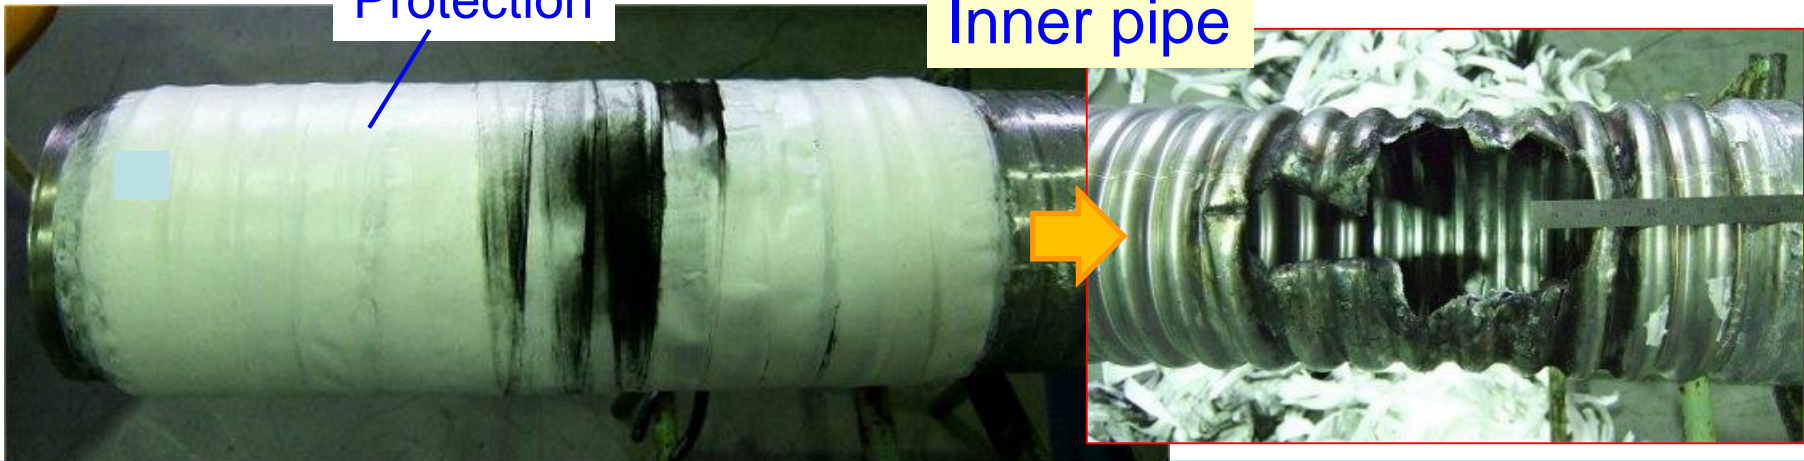
Inner pipe

The protection on the inner pipe was damaged thermally, in spite of its outer soundness. (common to sample A and B)
