# SEM BLMs removed around TDE

N.Magnin – MPP 01.09.2017

# Dump BLMs: Overview

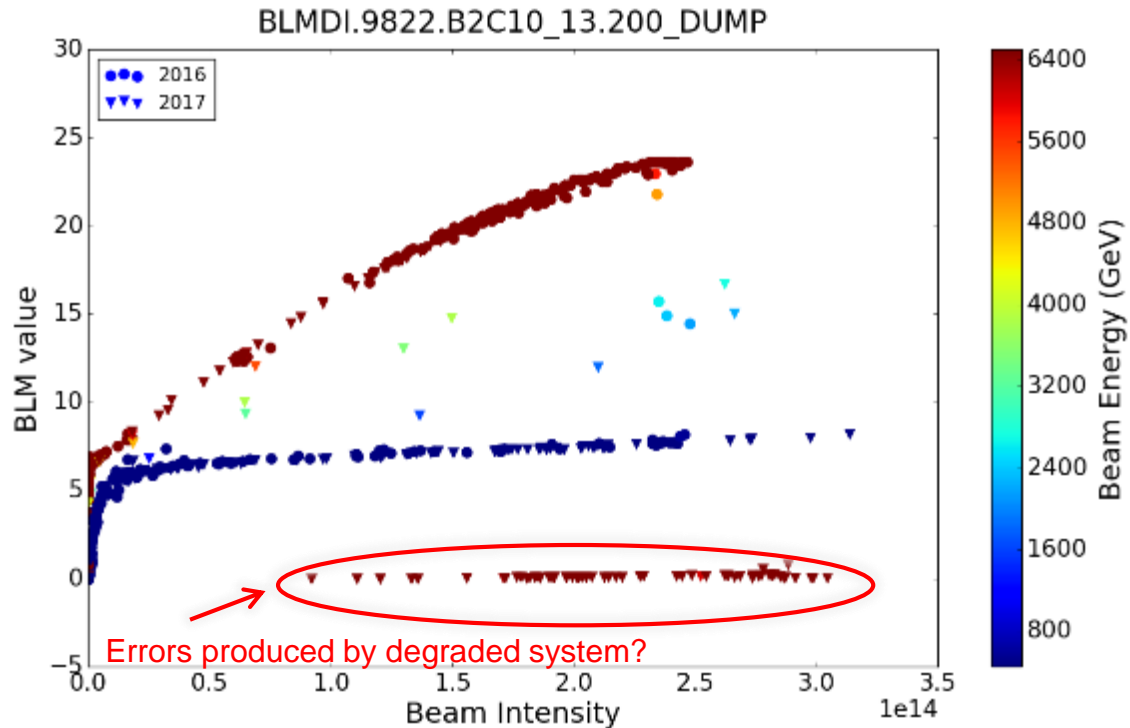
# Dump BLM: IC – B2 – problems

- Good intensity/energy correlation for all B1 monitors, some SEMs show larger spread of correlation, in particular the failing one.
- Very nice correlation for the IC, saturated above  $2e14$  at 6.5 TeV; this requires a small filter.
- B2 shows degradation of int/energy correlation with losses during 2017 for all monitors, SEMs inside shielding and IC outside shielding; all daisy chained, suspect cable issue due to radiation.

- Keep all SEMs disconnected as already done
- Install filter (factor 20) on existing IC - next TS (mid-Sept)
- Use available channels to install LICs outside the shielding -YETS
- Back up present IC with LIC to get direct reference - YETS
- Until new monitors are installed, don't establish XPOC thresholds on existing ICs; this would often fail for B2

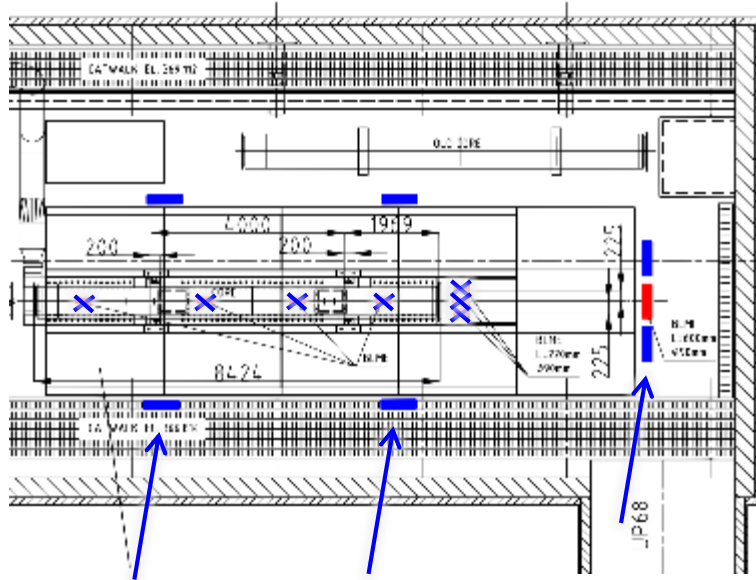
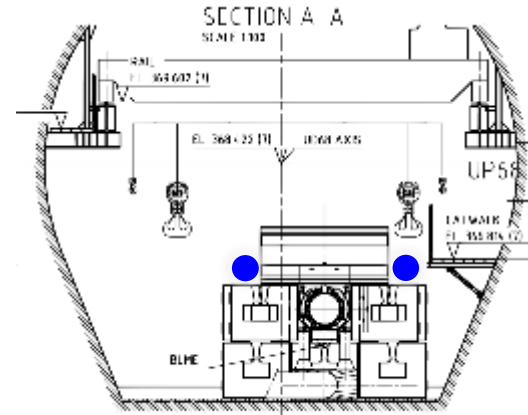
Proposing 6 new BLM: LIC and/or IC with small filter (factor 20)

2 BLM on each side (right/left) 2 additional BLM behind dump

Priority is to re-establish redundancy. Exact positions are being discussed with BI. Independently, BI is planning to replace cabling.
