Beam dump due to BEM problem

N.Magnin - MPP 01.09.2017

Dump due to LBDS

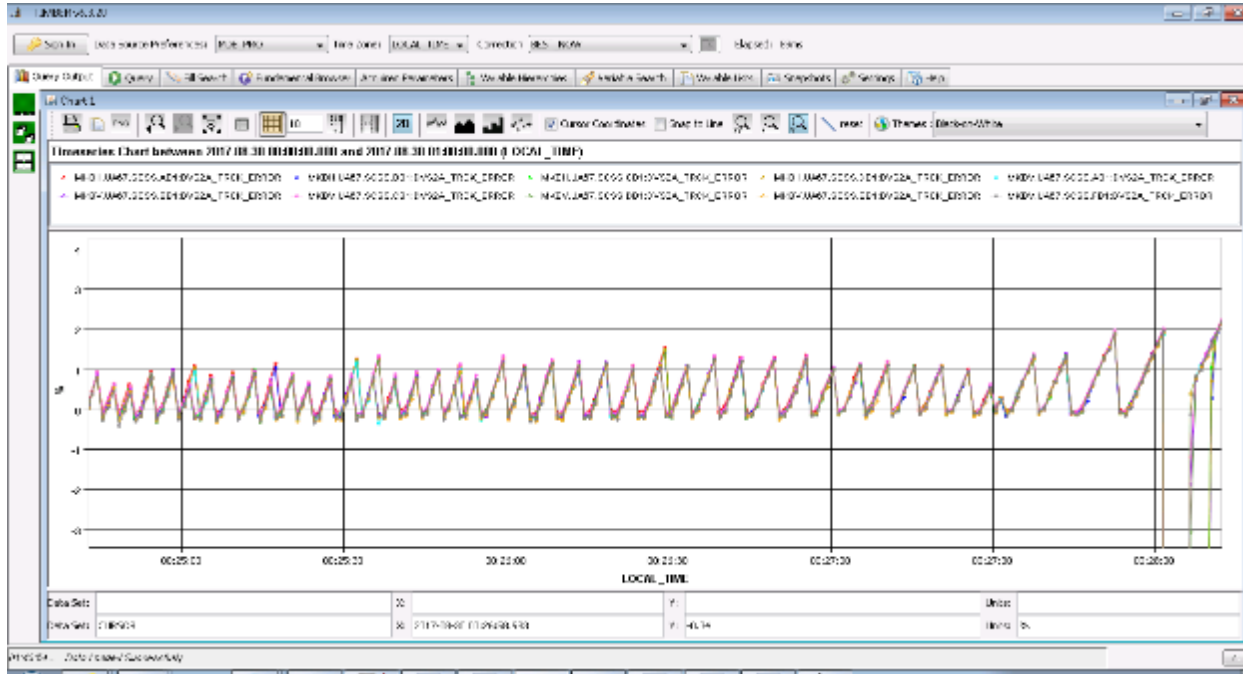
SCSS tracking error

ALL MKD and MKB generator showed big 'saw shape' tracking error during ramp

Dump after 2% error:
3 MKB gen interlocked

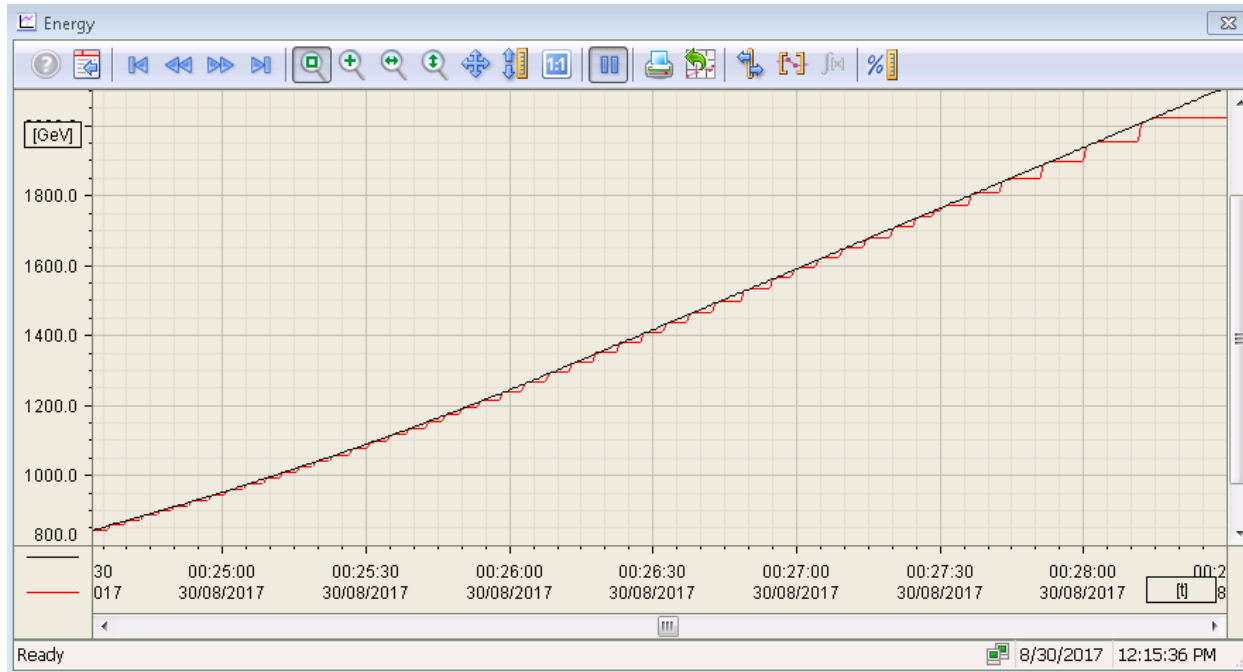
SCSS energy Reference/Interlock

Reference energy OK

Interlock energy
'frozen' for increasing
time up to minutes !

⇒ Communication
problem with the
BEM-Interlock card

- Dump due to AnyBus communication problem between BEM-Interlock and SCSS
- This is a known failure mode, taken into account in design
- System protections worked properly
- Beam dumped synchronously, clean dump
- AnyBus communication diagnosis problem identified.
 - Could be fixed with a new firmware deployed during YETS.
 - Validation during reliability run with local BIS loops.
