WorldFIP RadTest CNGS Repeater 1 : look at results

20 August 2009

Julien Palluel BE/CO/FE

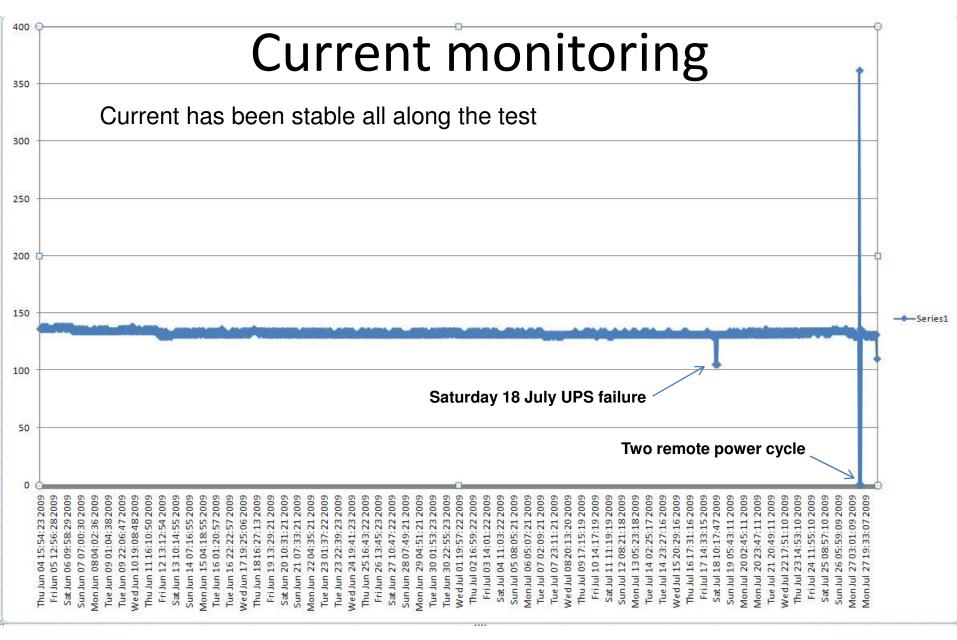
- Despite 2 remote power cycle, there is still many errors
- In Louvain radiation test, once testing was completed, after 5 minutes of rest, the module was working normally. Possible reason : the supply current has drained the trapped charges in MOS thresholds and allowed them to re-operate properly
- During the shutdown, we quickly tried to restart the communication, but the return channel of the repeater seemed to not working anymore (FIELDRIVE??).
