# SYSTEM'S PERFORMANCES IN BI

V. Schramm, William Viganò, C. Zamantzas, CERN, Geneva, Switzerland

In this talk, the dependability of CERN's Beam Instrumentation (BI) in 2017 is presented. All faults which contributed to LHC downtime are analysed, categorised and compared to previous years to isolate recurrent failures and evaluate trends. Special attention is given to the Beam Loss Monitoring system and its System Sanity Checks which was the highest contribution to the BI downtime in 2017. Finally, actions taken to remedy the situation as well as on-going reliability analysis and upgrade efforts to improve the overall performance in the future are discussed.

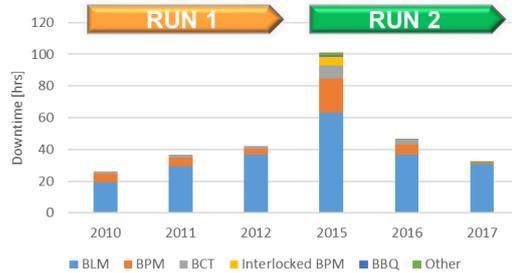
AFT tracks faults of the LHC systems, since 2010, which influence the operation mainly in terms of availability. With the start of the second LHC Run, the procedure to record and assign the faults have been streamlined and provides consistent data. Observing this period only, the absolute yearly downtime of all BI systems significantly decreased year to year (see Figure 1). Nevertheless, when the data are normalised per day of operation, it can be seen the decrease of the downtime remains true but the step is smaller (see Figure 2).

Figure 1: Raw Fault Time by System.

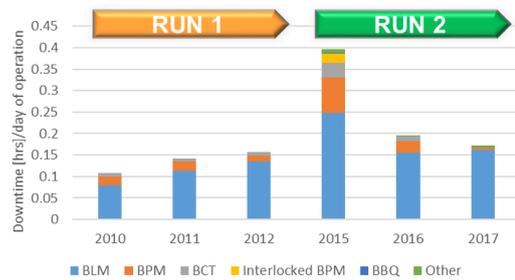
During 2017, the BLM system maintained the same availability level as in 2016. Because of the Extended Year-End Technical Stop, the LHC lacked 50 days of operation compared to 2016. An operational day is herein defined as a day where the storage ring was filled.

Figure 2: Normalized Raw Fault Time by System.

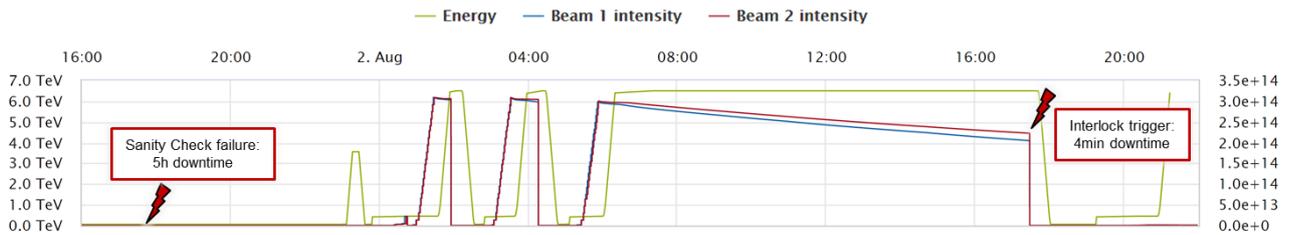
Figure 3: AFT extract of the 02.08.2017. Two distinct BLM failures with different availability and luminosity impact.

To illustrate the different impact Figure 3 displays two BLM system faults within 30 hours of operation in August 2017. The first was a problem with the dump block SEMs and caused 5h of LHC downtime. The issue was discovered while performing the Sanity Checks before a new fill and prevented this fault to happen during physics operation and therefore avoided to unnecessarily fill the machine in a fault state. The second fault is an interlock, which triggered due to incorrect BLM system voltage values. It accounts for 4 minutes of downtime, but happened during the flat top and dumped the beam. For this example, this clear contradiction between availability loss and associated luminosity loss requires special attention when drawing conclusions for future improvements. It is hard to quantify precisely the lost luminosity related to a false beam dump because of many parameters, which vary depending on different operational scenarios. This can be the time of the dump at either injection or at a specific time on the flat top, the optimum fill length, the energy, degraded operation and many more to name only a few. Nevertheless, future efforts need to aim at reducing the amount of false dumps by reliably discovering fault states of the system before injecting the beams. This increases the luminosity production when furthermore the availability impact of these fault states is mitigated.
