## MQXS inner layer quench heaters

S. Izquierdo Bermudez, J. Ferradas Troitino, P. Ferracin, J. C. Perez, F-O. Pincot, G. Vallone, S. Florence Gayot, S. Tavares, G. Maury, N. Bourcey

# Our problem – MQXFS3

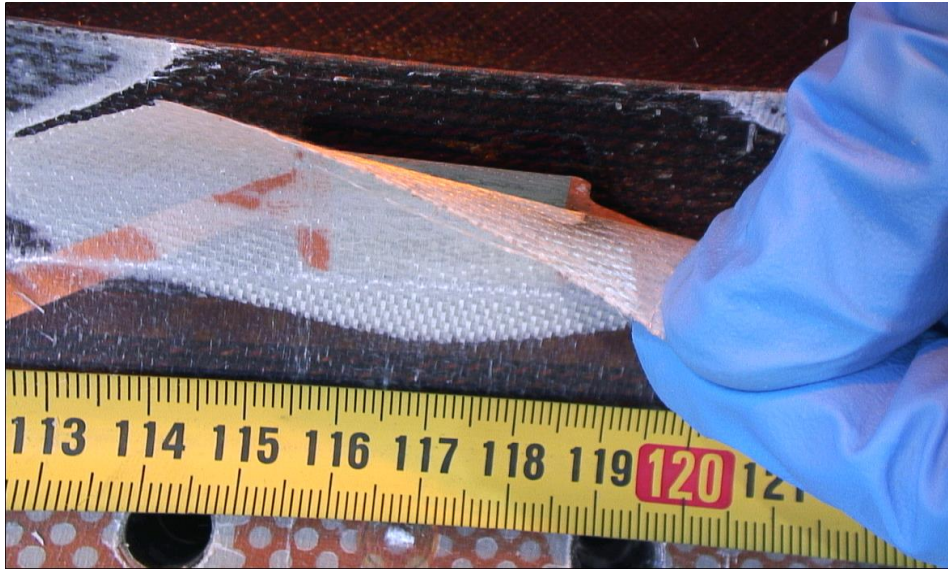
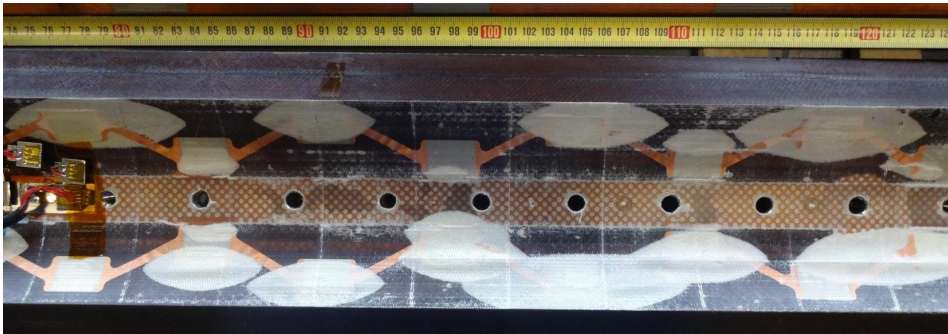
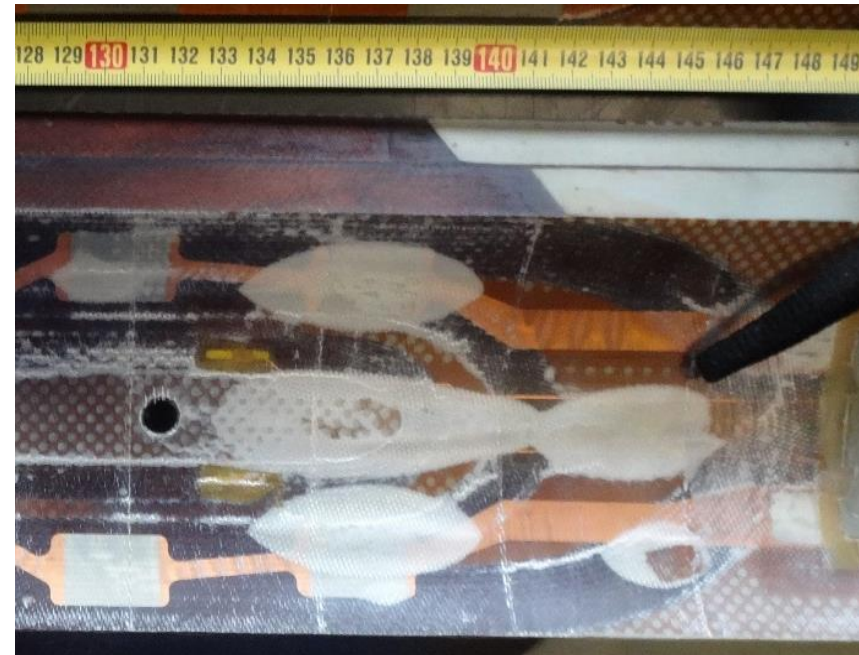
- After cold magnet test (inner layer heaters were powered), delaminations observed in the coil inner diameter.
- The bubbles issue is a problem of adherence glass to stainless steel (or copper).

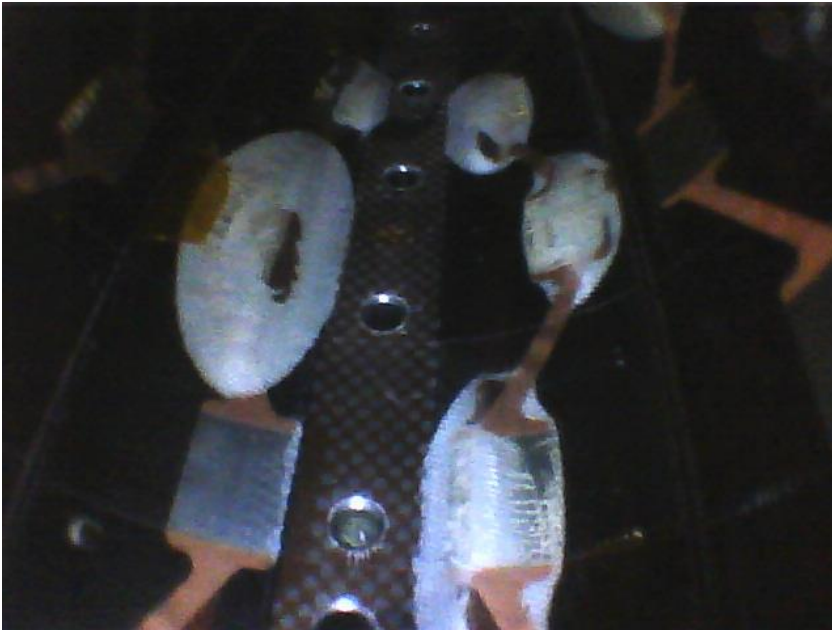
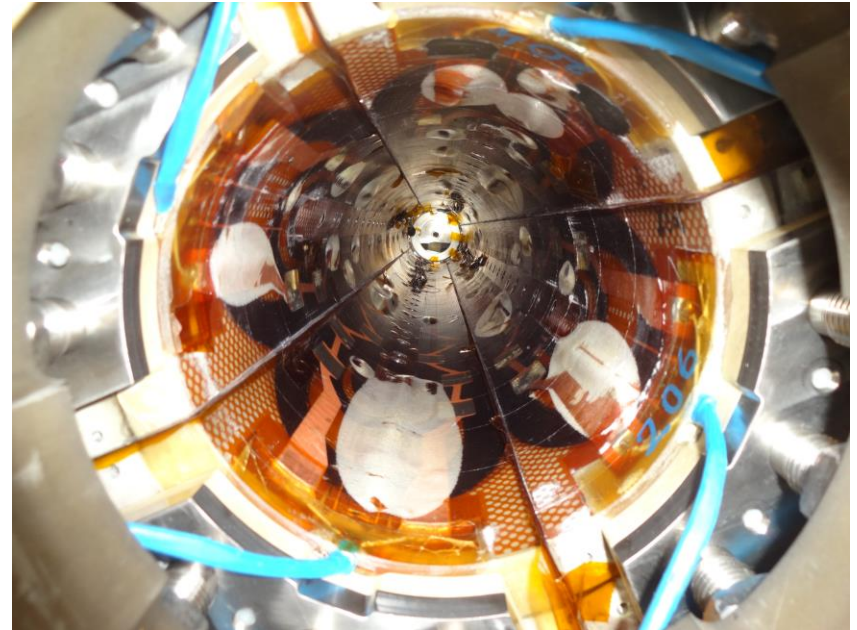
- Inner layer **heaters** were **not powered** during the first and second thermal cycle, to study the heater degradation due to cool down and magnet powering.
- Large bubbles observed even if heaters were never powered!
  - **The source of the problem is the magnet quench and not the heater powering.**

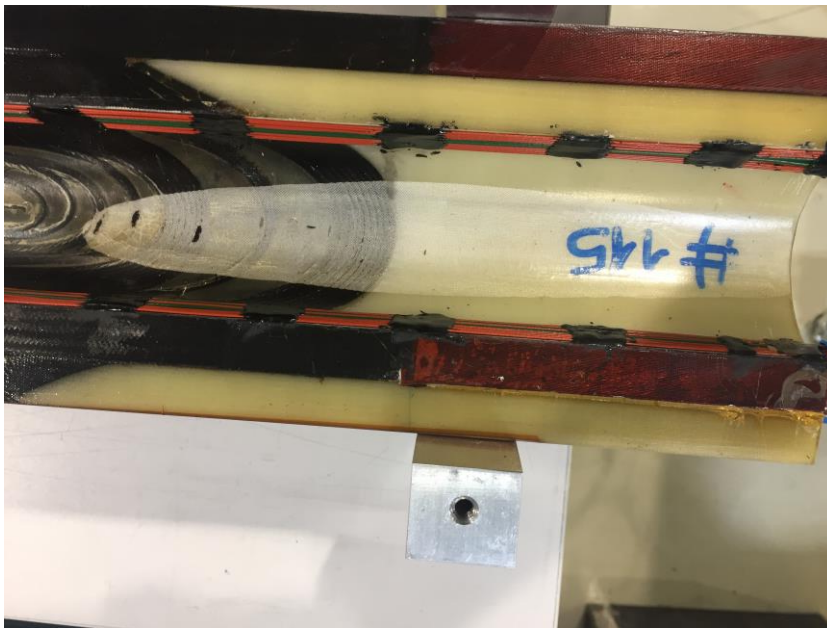
## Coil 115

0 quenches on the IL lead end

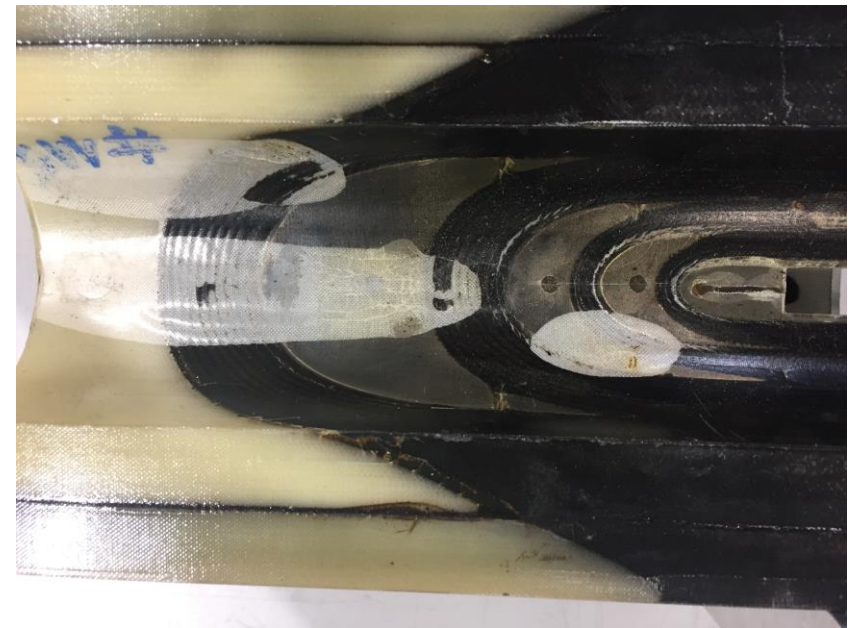
## Coil 115

1 quench on the IL return end

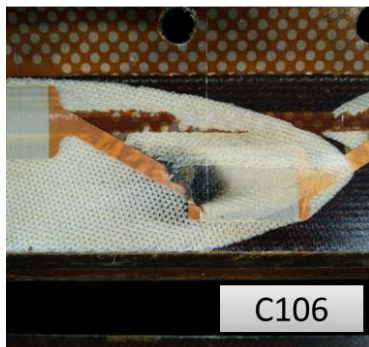
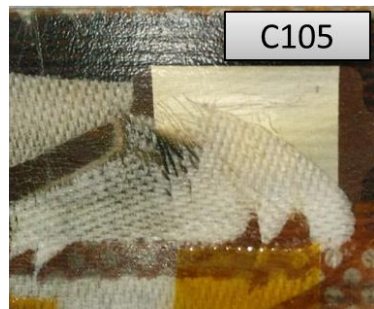
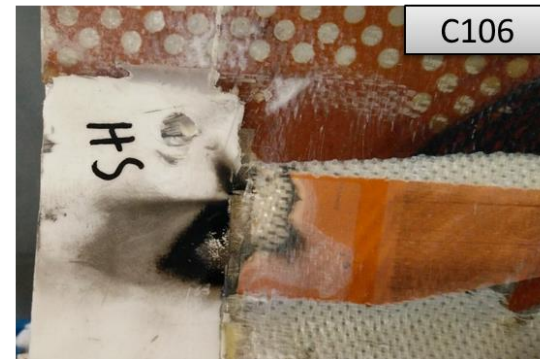
- 2 out of 8 IL strips were lost during MQXFS3a training:
  - Inner layer strip of coil 105, right, failed after the second training quench during a trip at 4 kA (a.002)
  - Inner layer strip of coil 106, left, failed after the fourth training quench during a trip at 6 kA (a.018)
- In MQXFS3b, one additional heater strip was lost:
  - Inner layer strip of coil 106, right, failed after OL+IL quench integral study at nominal current (hh051)
- These are the only locations where burnt areas were found during coil inspection
- Several voltage taps on the inner layer of coil 105 and 106 we also lost.

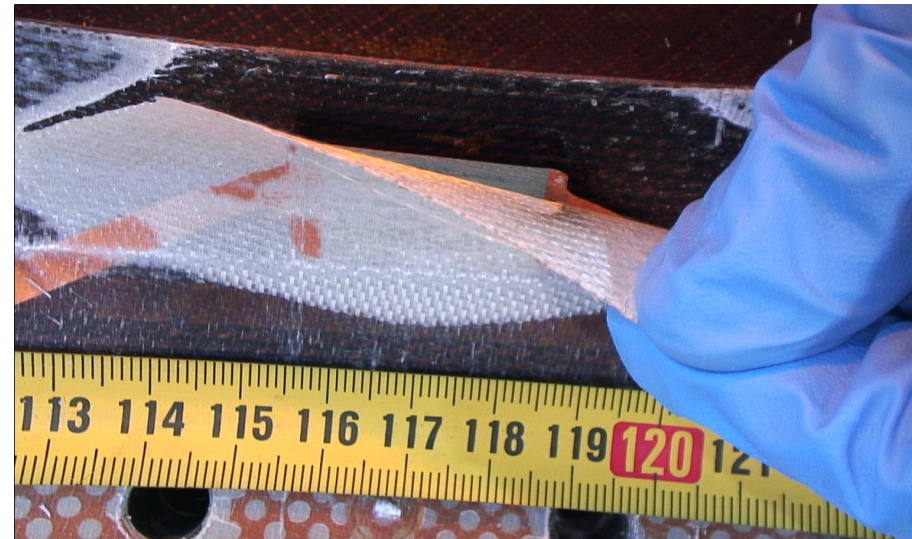
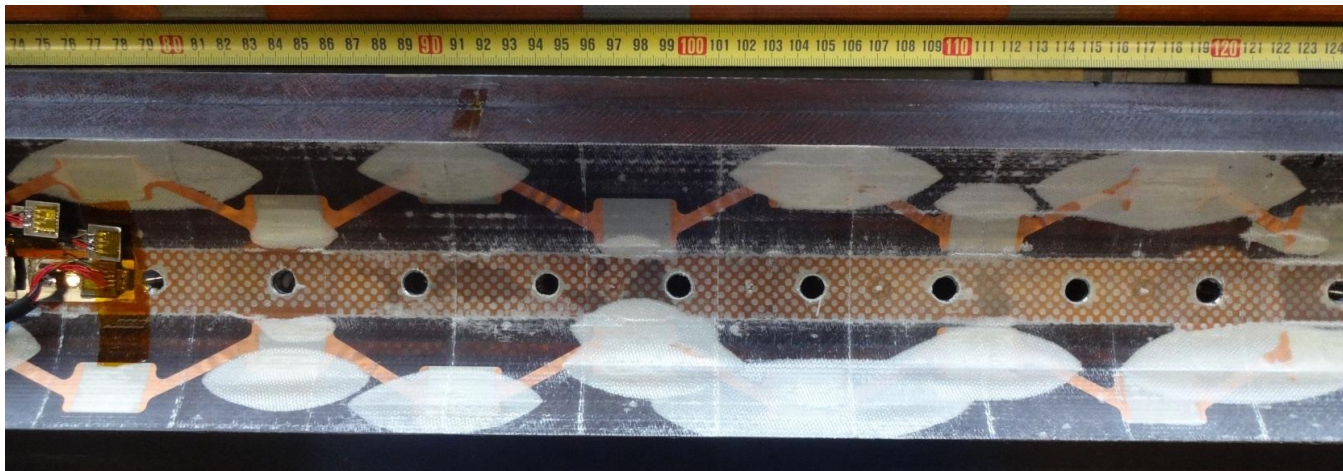
- The bubbles issue is a problem of adherence glass to stainless steel (or copper).
- It was verified and confirmed through peel off test in specific samples with different types of fibers.
  - No significant difference found in between JPS 26781 and HEXCEL 4522.

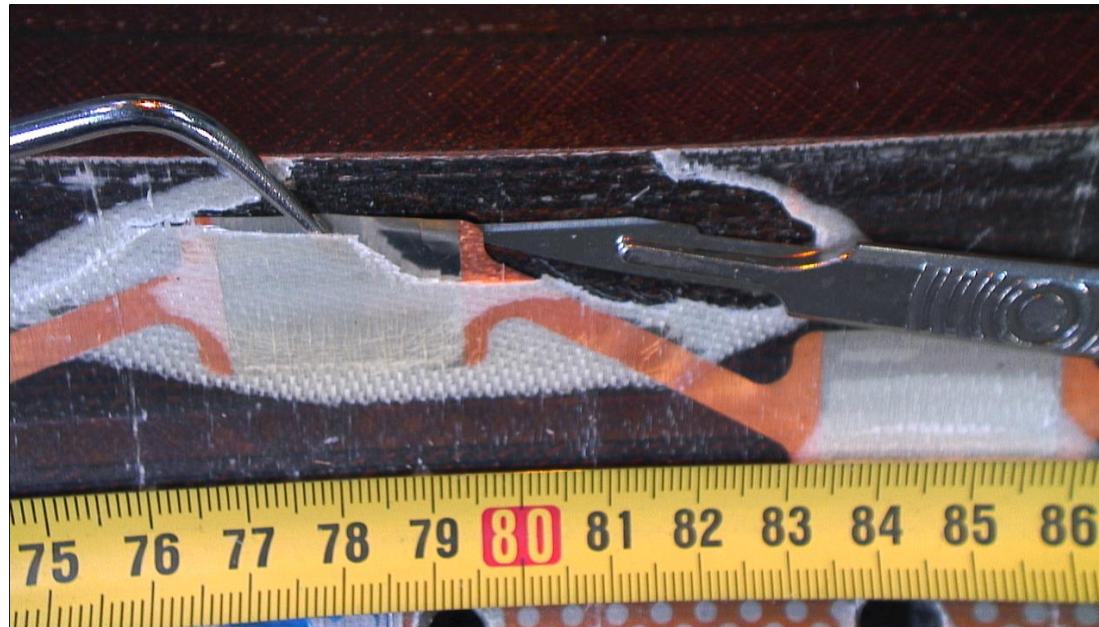
- Only in 3 out of the 38 heater stations we observed stainless steel to polyamide delamination.

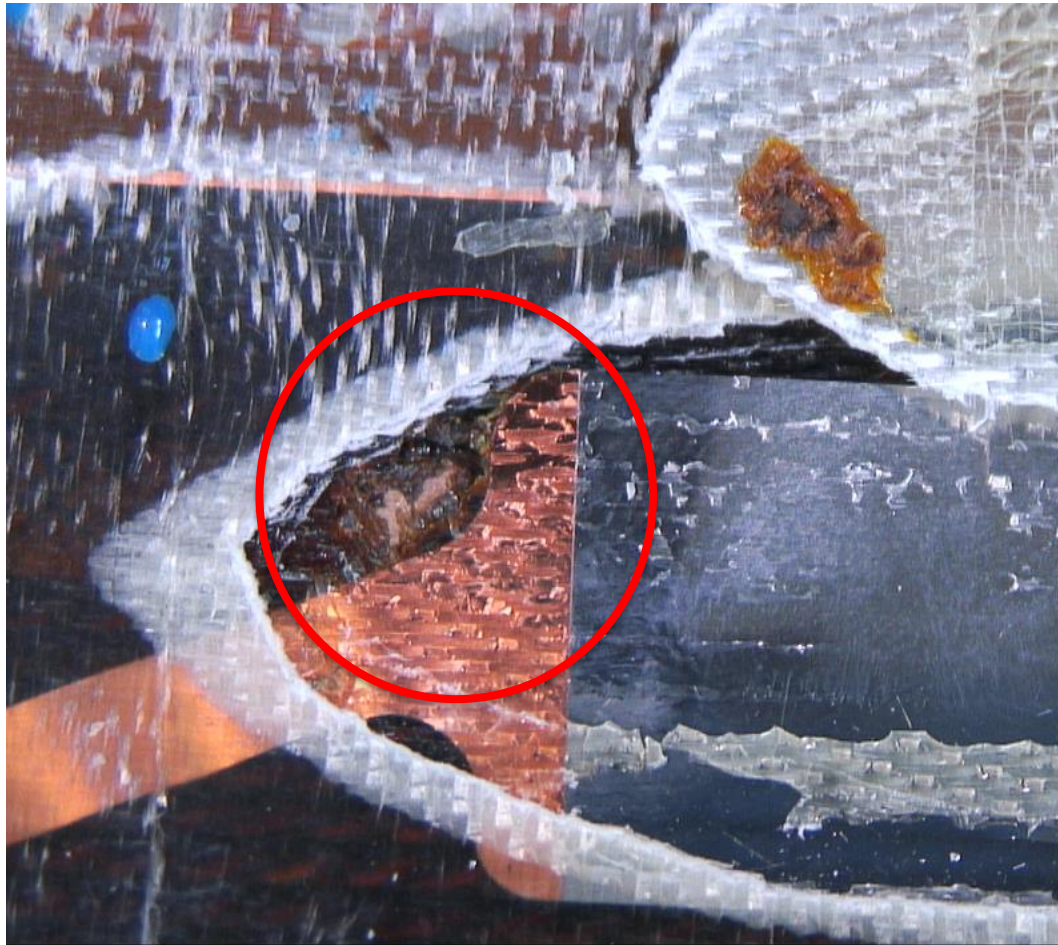
- The bubbles are dangerous, since they can remove the conductor and wedge insulation

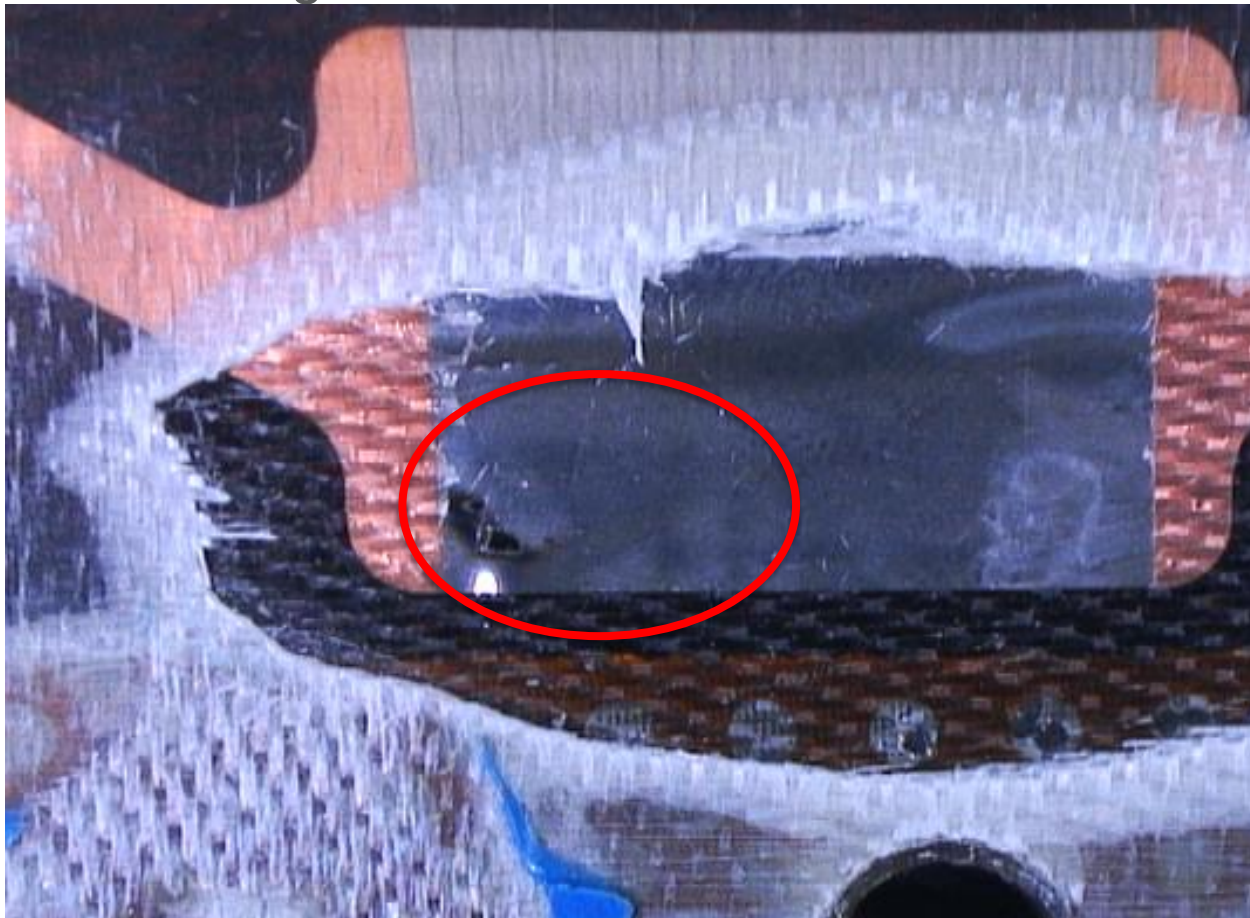
- Heater was locally burnt in one spot.
  - When did it happen? The defect was there from manufacturing or it was a bubble-related issue

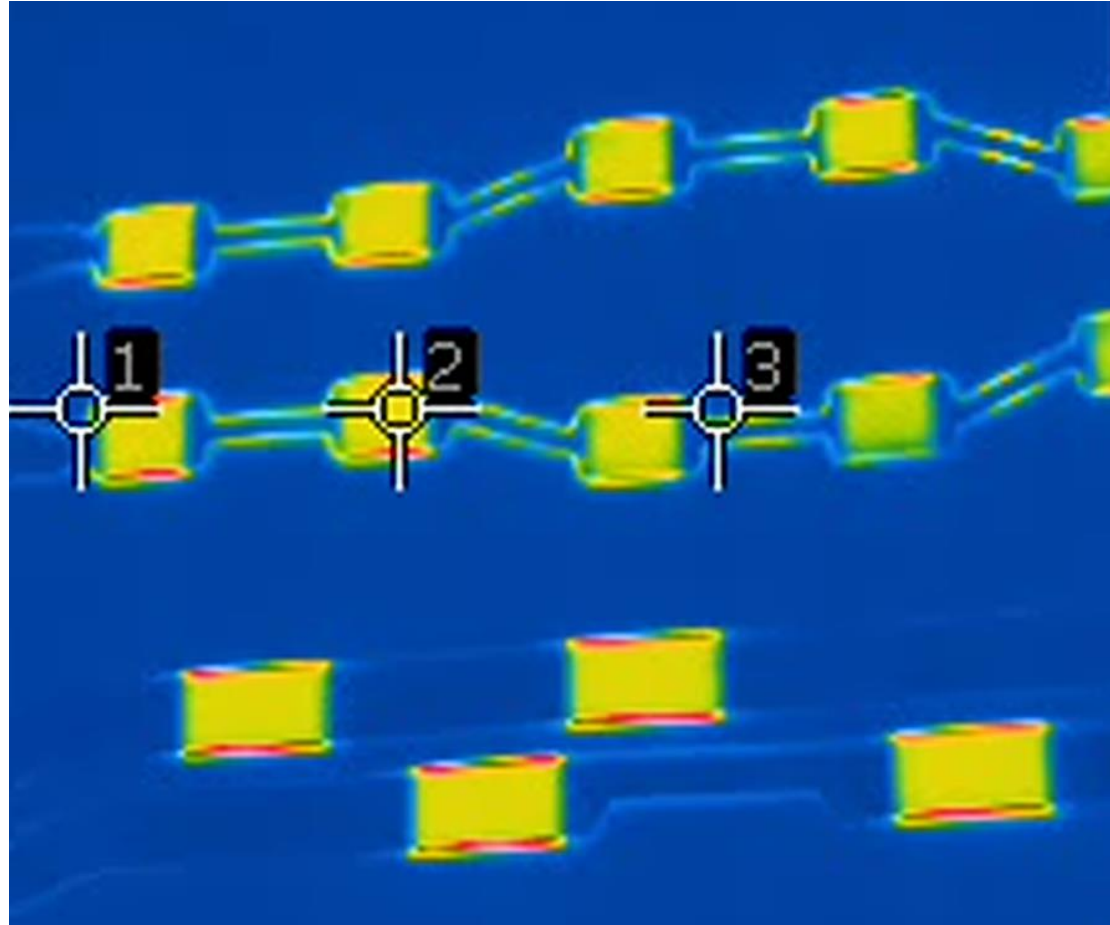
- We tried to burn one old set of heaters, applying 80 A/380 V/500 J, to verify if the copper plating was behaving as expected
  - Behavior OK, not over-heating in the copper-stainless transition.

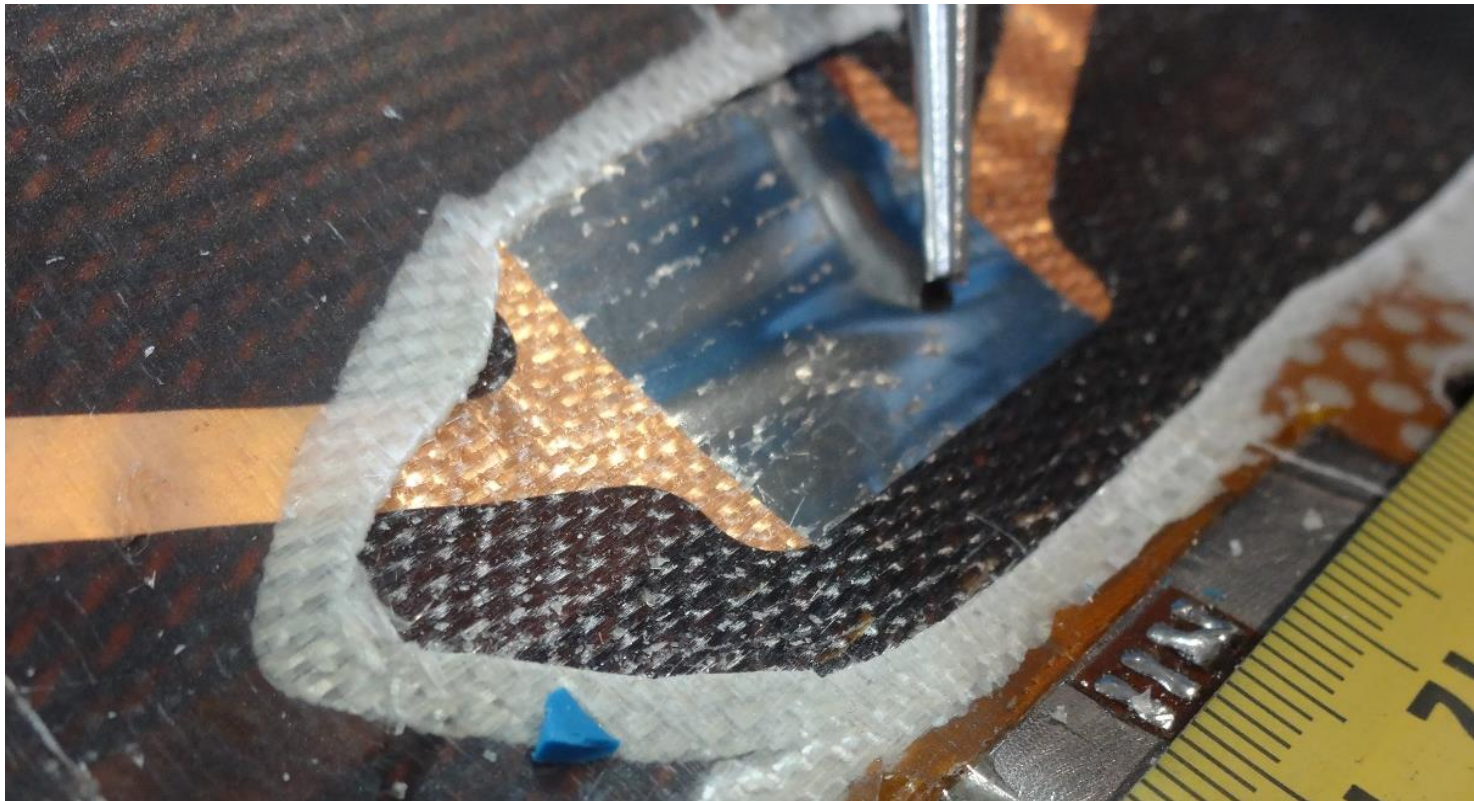
- In some locations, heaters are folded (gas bellow)
  - Second order problem

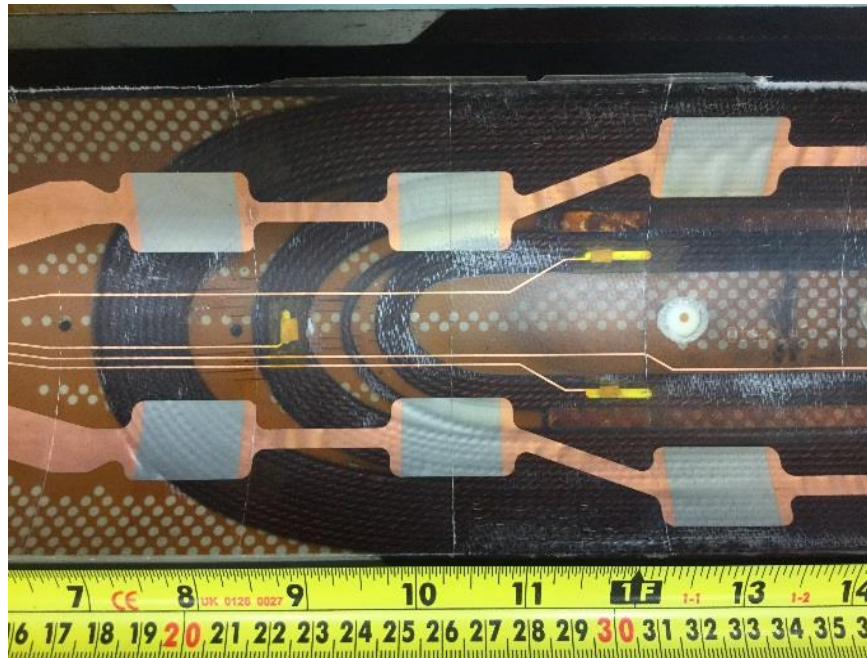
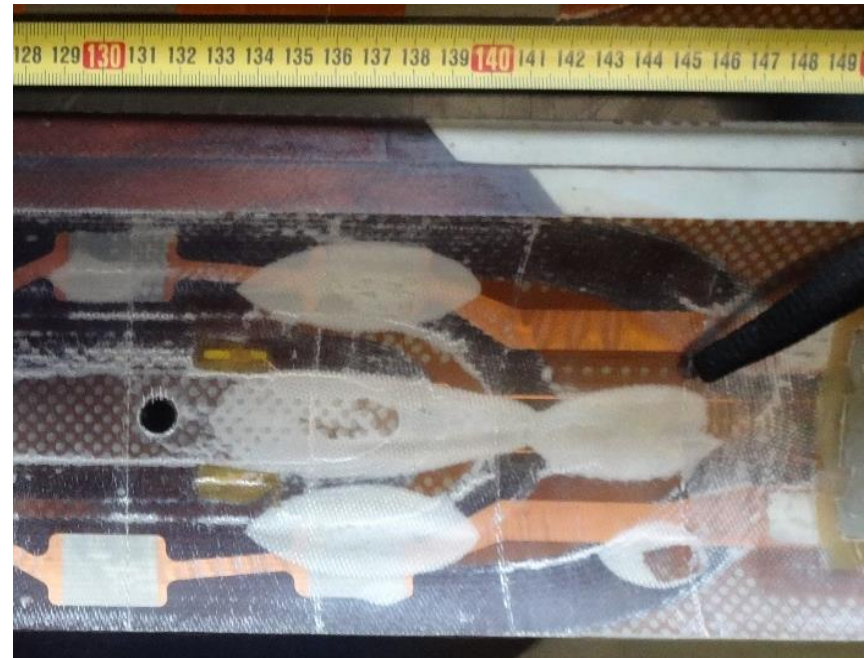
- Even if we remove the heaters, we will still have an issue of adherence to the pole and the end spacers.
- LP 7 before cold test
- LP 7 after cold test

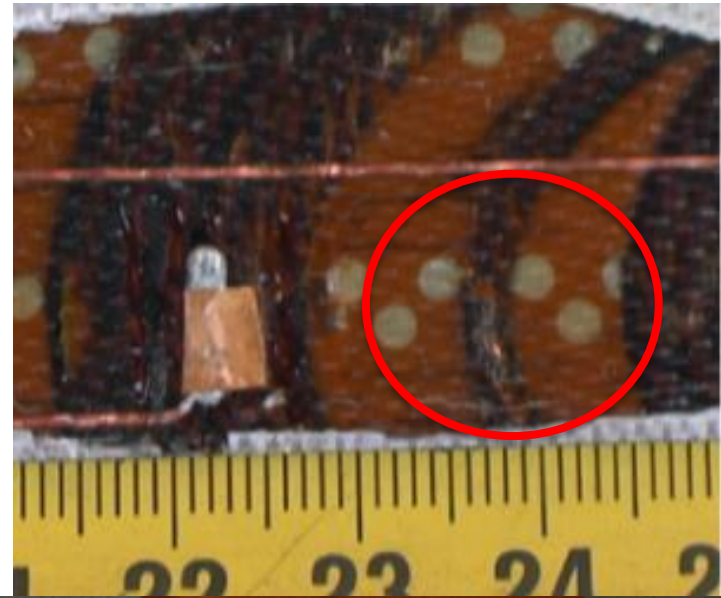
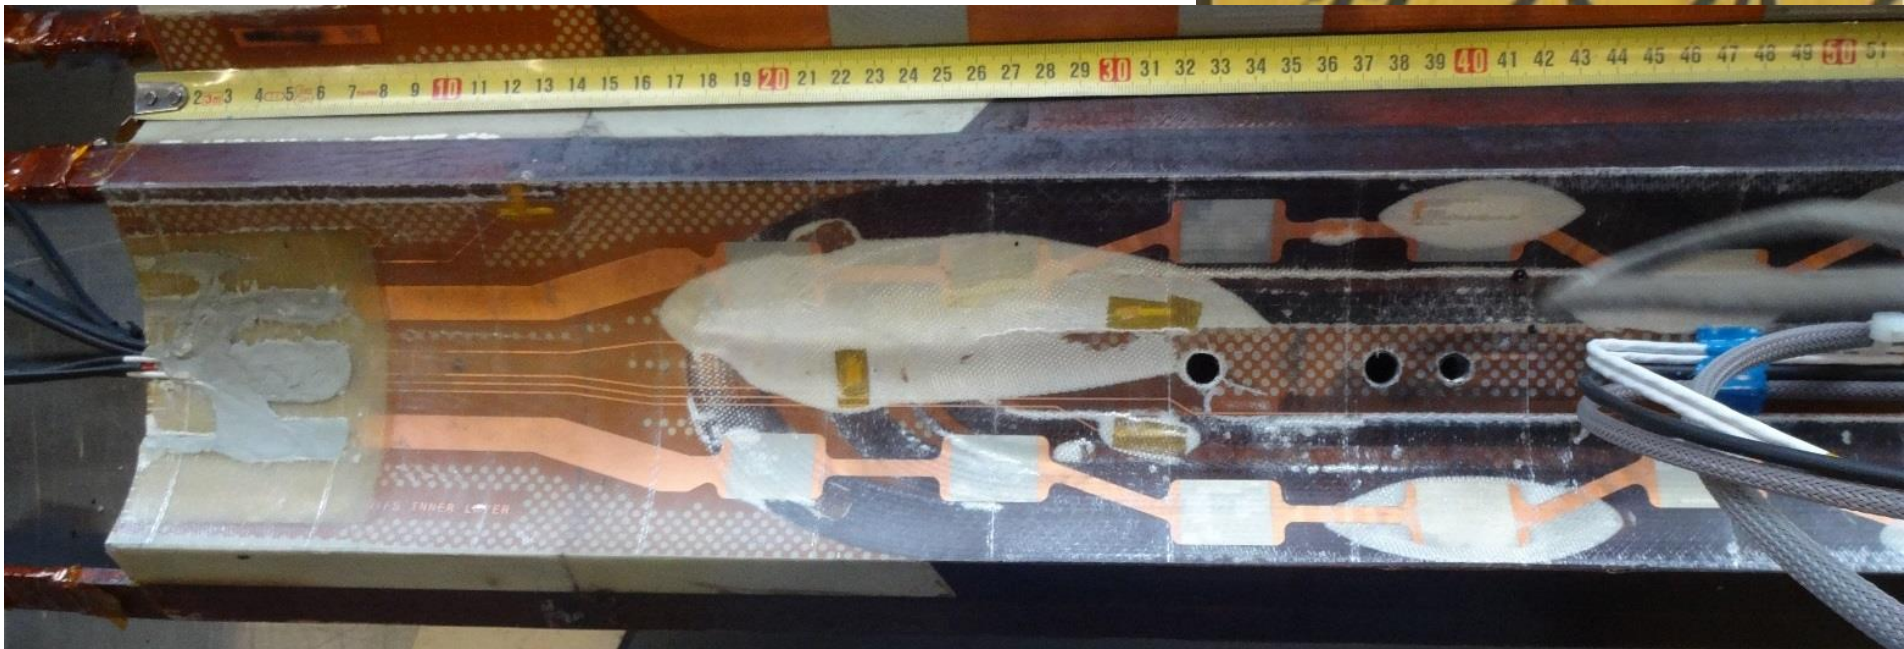
- The bubble in the lead end was able to remove the conductor insulation.
- Discharge test up to 4.5 kV did not show any weakness.
- This coil quenched a lot in that region, so the situation is probably a bit less dramatic.

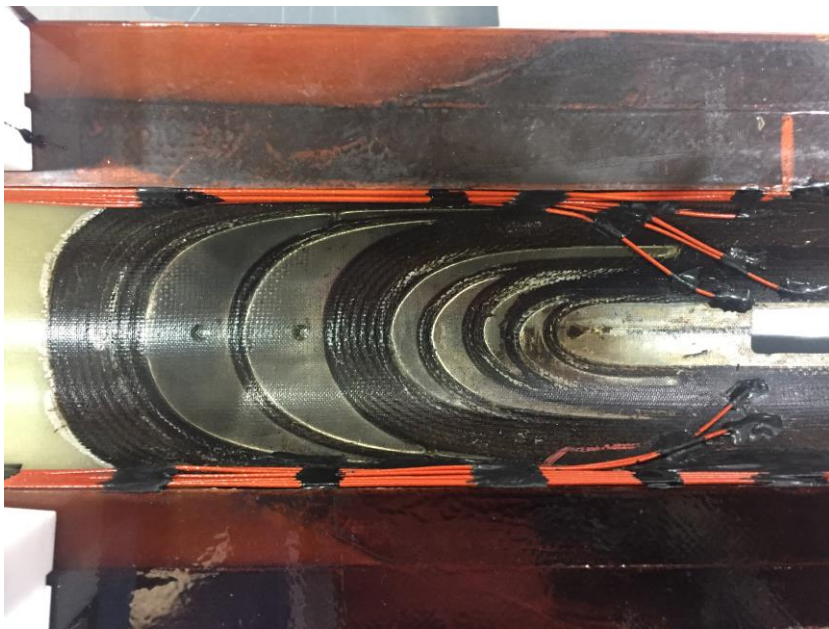
## Coil 109

0 quenches on the IL lead end

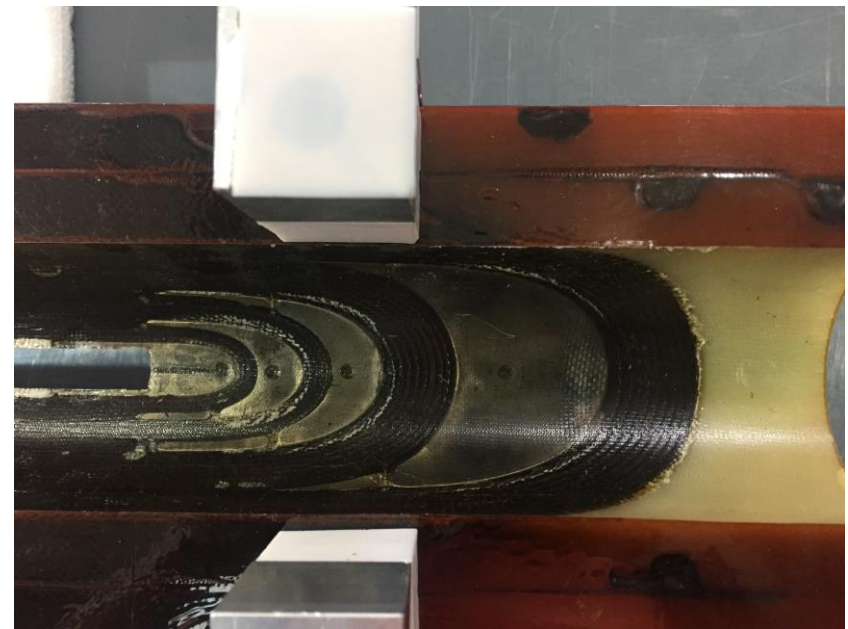
## Coil 109

1 quenches on the IL return end

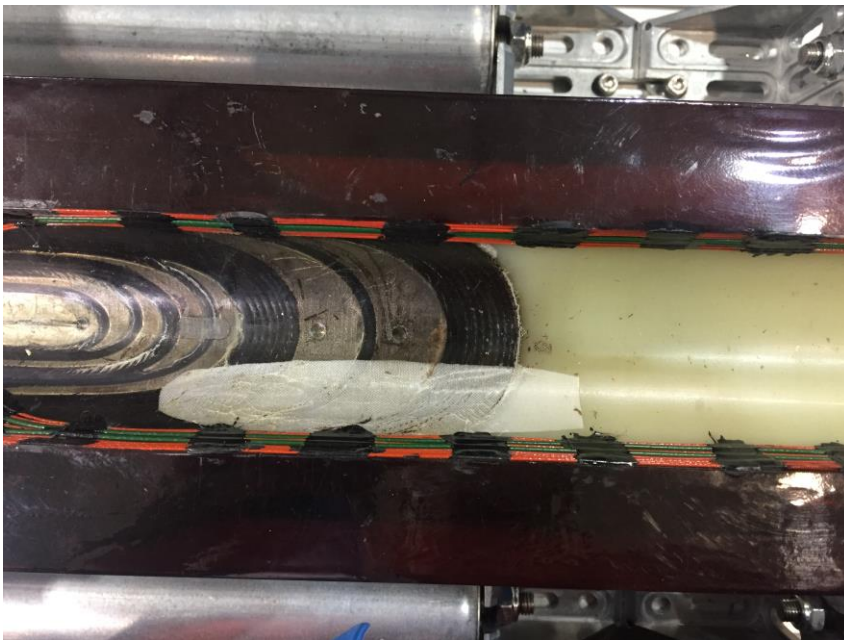
**Coil 112**

**1 quenches on the IL lead end**

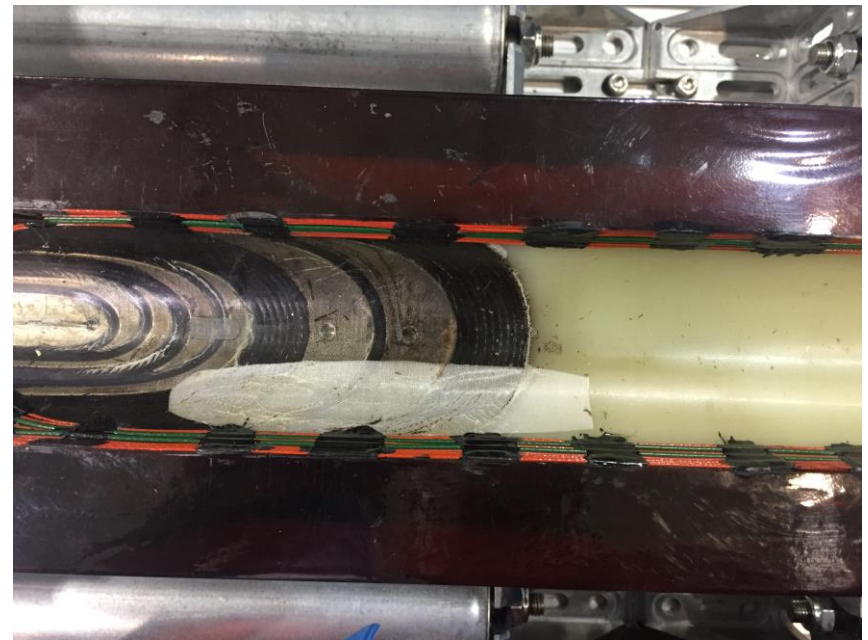
**Coil 112**

**0 quenches on the IL return end**

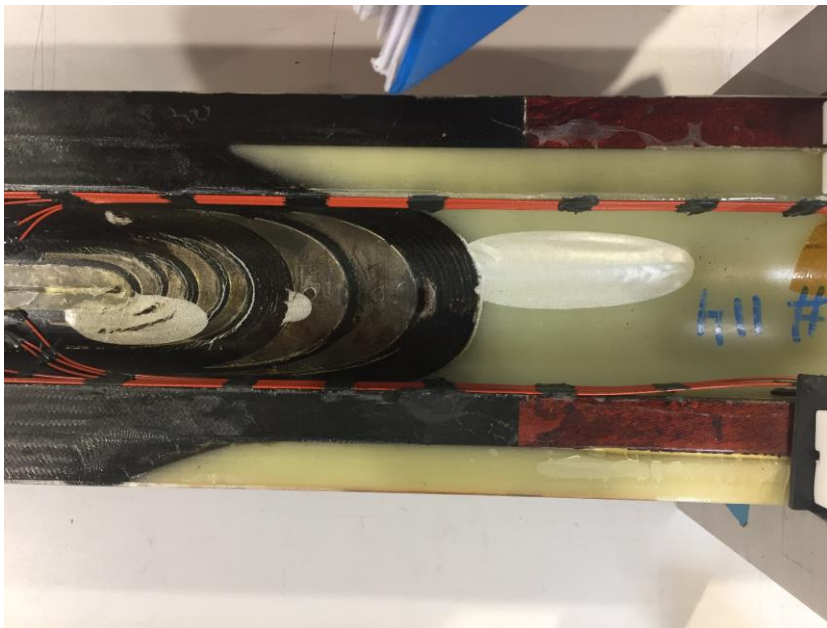
**Coil 114**

**0 quenches on the IL lead end**

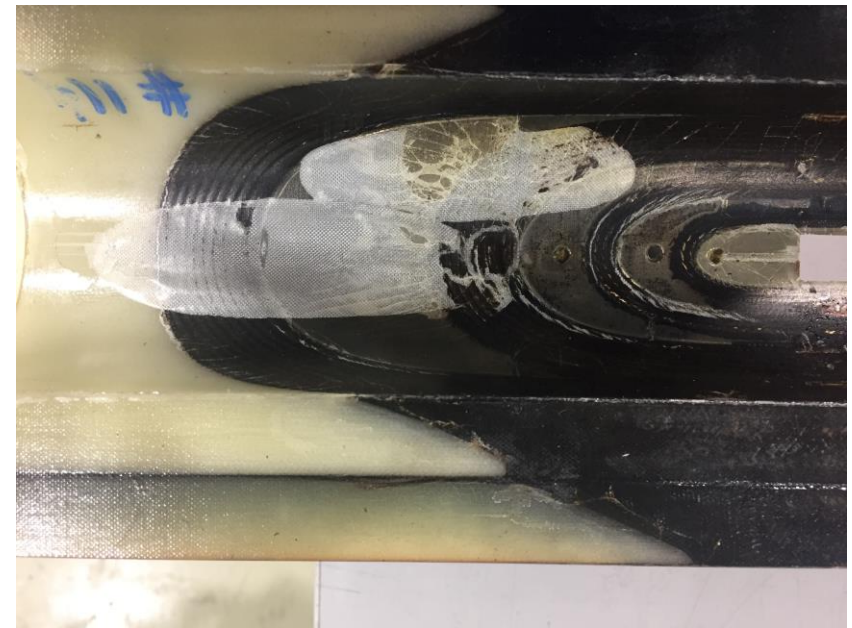
**Coil 114**

**0 quenches on the IL return end**

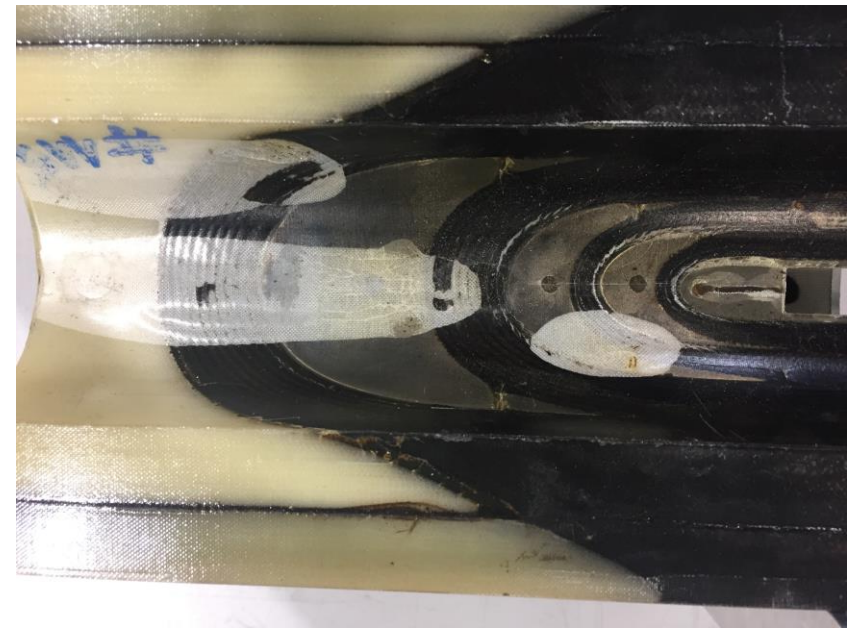
## Coil 115

1 quench on the IL return end

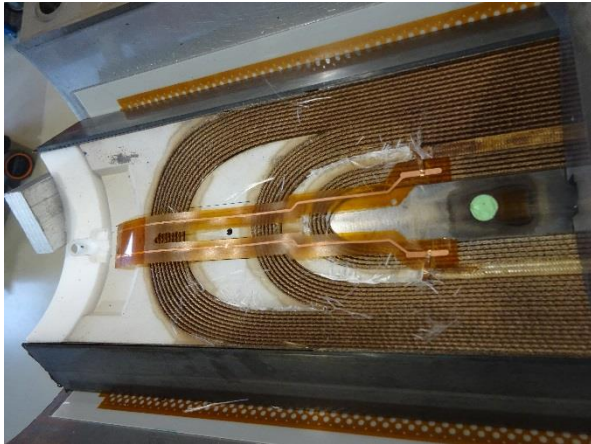
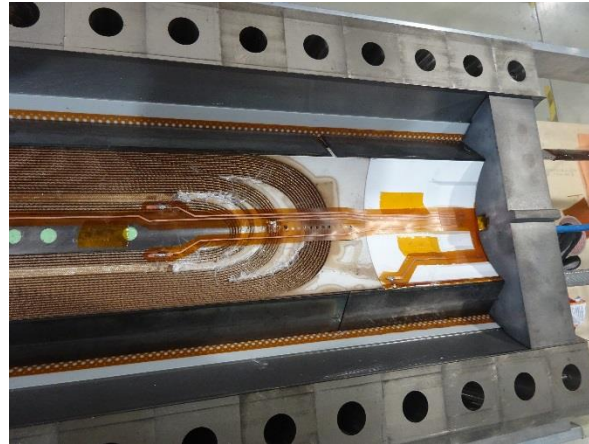
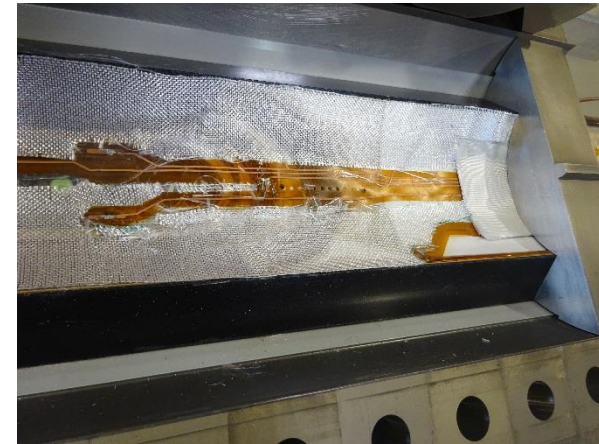
# Coil 207

The quench heaters of IL have not been installed: i.e. the trace has been cut, and only the parts containing the circuits of vtaps have been installed.

S2 glass inner layer: 2 layers Hexcel 4522 (1 layer in correspondence of the vtaps)
