Study of delamination between inner layer trace and inner impregnation layer after quench training of MQXFS coils

EDMS n° 1842073

May-Aug 2017

TE-MSC-MDT

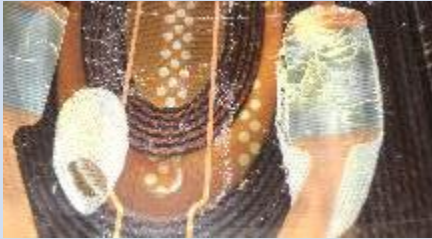
Coil ref.	Inner layer fabric	Aspect of inner layer after quench training		
CERN COILS	Coil #103 (1 st gen)	Tissu de verre S-2 493 (Tisstech, FR)

- Blistering and delamination of glass fibre layer at quench heater location
- Several levels of delamination depending on coils

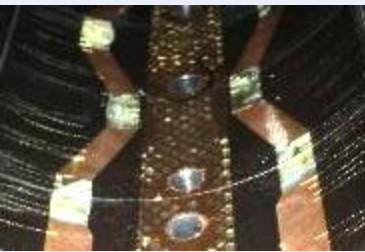
Coil #05	JPS 26781 933HTS (JPS, USA)

Less blistering with JPS fibre ?

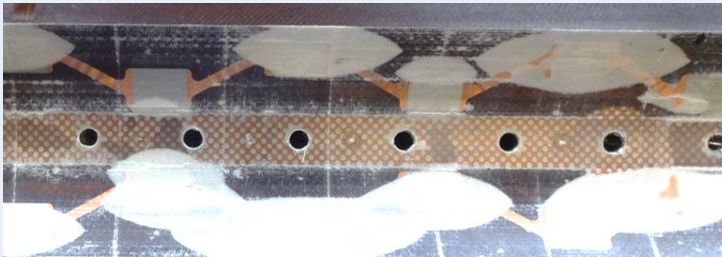
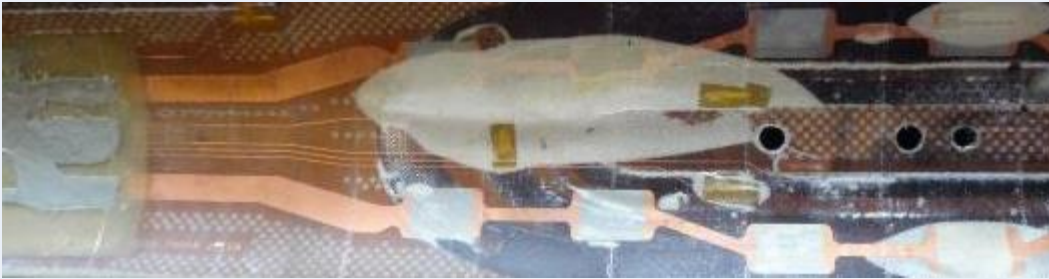
Coil 106 (1 st gen)	Tissu de verre S-2 493 (Tisstech, FR)	
	Coil 107 (1 st gen)	Tissu de verre S-2 493 (Tisstech, FR)	
LARP COILS	Coil #007	JPS 26781 933HTS (JPS, USA)

More delamination on LARP coil, impregnated with JPS fibre !

LARP suggestion: change inner layer fabric again, in CERN and LARP coils

- Exact opposite situation as for MQXFS1
- Switch to Hexcel 4522 F81
- “more open” fibre weave → easier escape for helium bubbles during quenches ?

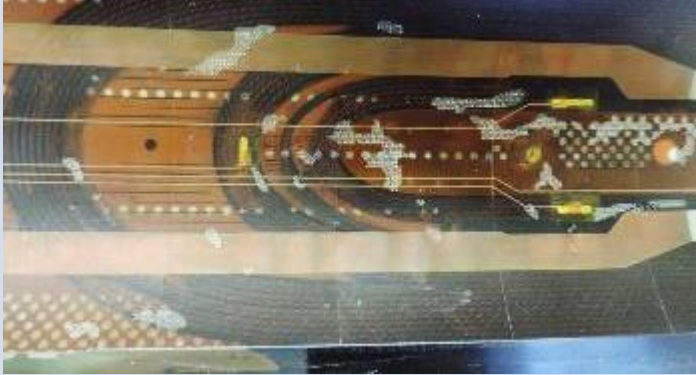
After impregnation

Dry zones

The resin looks blurred, which is not usual
→ contamination by release agent ? → might explain the dry zones
→ poor quality of the photos ?

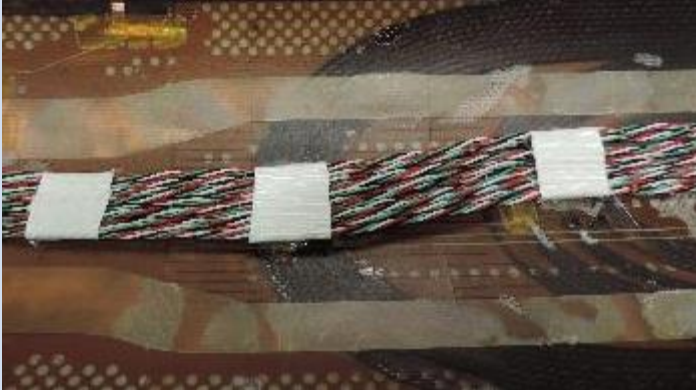
After cold powering

Blisters only at QH location

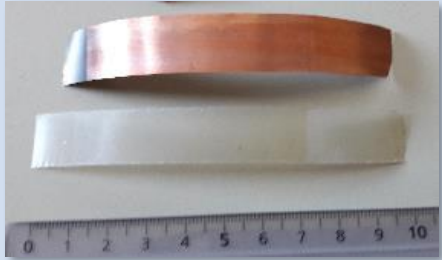
SAMPLE TYPE	TEST	LOAD (N)	ASPECT AFTER TEST	COMMENT
Metal/ impregnated fibre	90°	0.58

NO ADHESION between metal from trace (copper or inox) and impregnated JPS fibre
Polyimide/ impregnated fibre	90°	>21.5 Polyimide broke

Delamination occurs at **metal/epoxy resin interface**, due to very bad adhesion of epoxy on metals

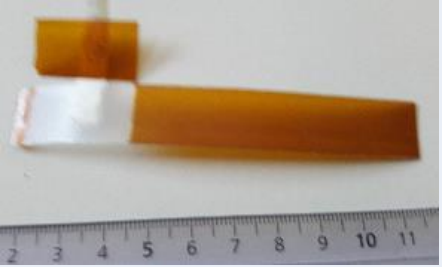
VERY GOOD ADHESION between polyimide from trace and impregnated JPS fibre
Polyimide/ impregnated fibre	180°	>20.2 Polyimide broke

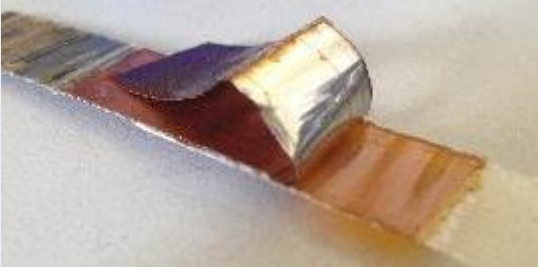
SAMPLE TYPE	TEST	LOAD (N)	ASPECT AFTER TEST	COMMENT
Polyimide/ impregnated fibre	90°	15.4 Polyimide broke	<i>similar to tests 1 and 2</i>	
Simulation of encapsulated metal/ impregnated fibre <i>(repeated 2 times)</i>	90°	29.8* Polyimide broke

<p>VERY GOOD ADHESION</p> <p>between polyimide- “encapsulated” metal and resin</p> <p>Polyimide separated from metal and then ripped before being separated from resin !</p>

Encapsulating next MQXFS traces by adding a thin layer of polyimide on top
