3x1x1 operations: Problems found and possible explanations

Laura Manenti & Laura Molina Bueno

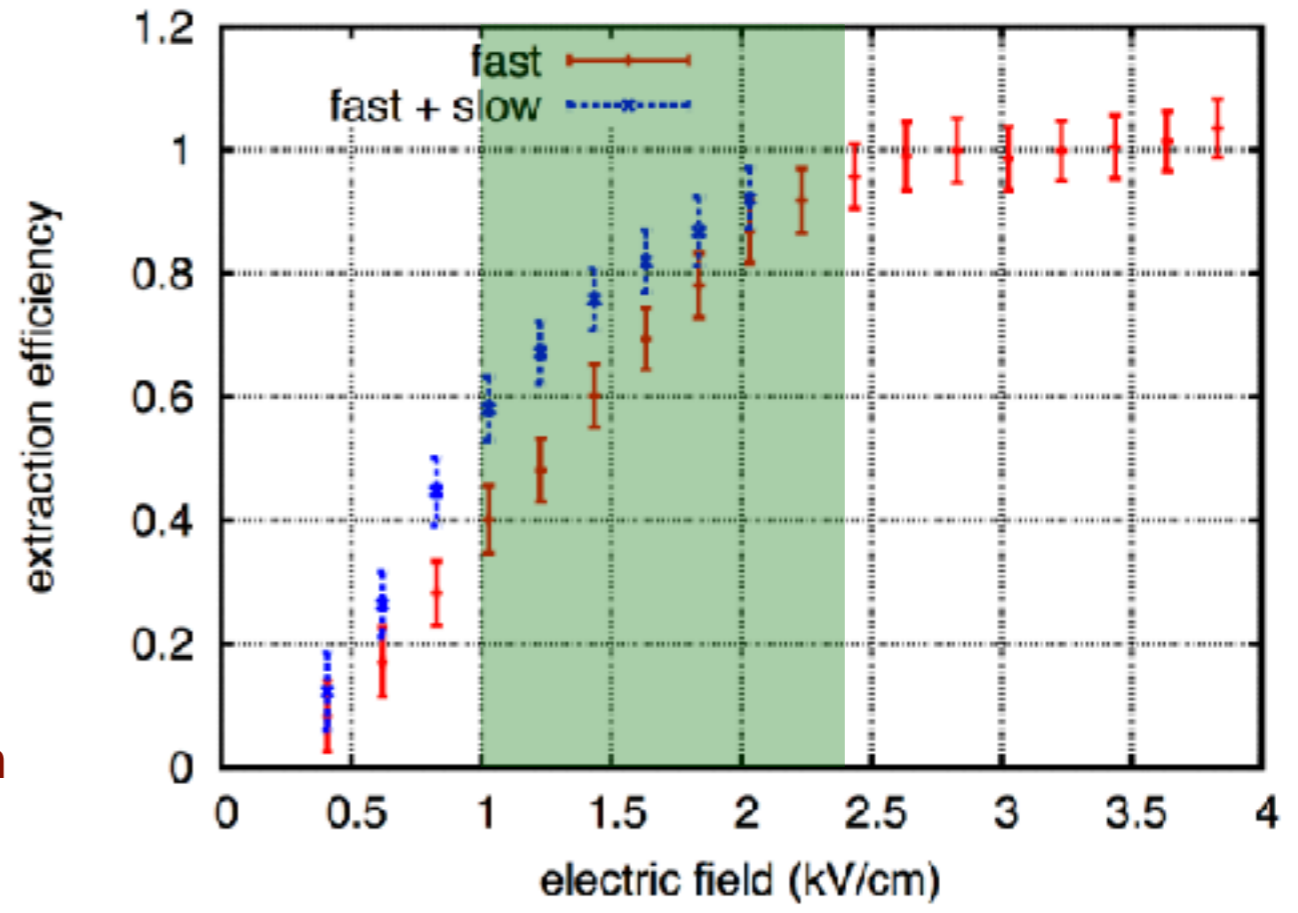
- Reached values**
- LEM field: 28-29 kV/cm
 - Extraction field in liquid: 1-2.3 kV/cm
 - Drift field 500V/cm up to 700V/cm,
 - Induction field: 1-1.5 kV/cm

- During operations we have always stayed below the nominal operating voltages as the extraction grid trips before reaching its nominal value.
- This limits the extraction efficiency, the induction field and the field across the LEMs.
- This also limits the scan of LEM and induction field.

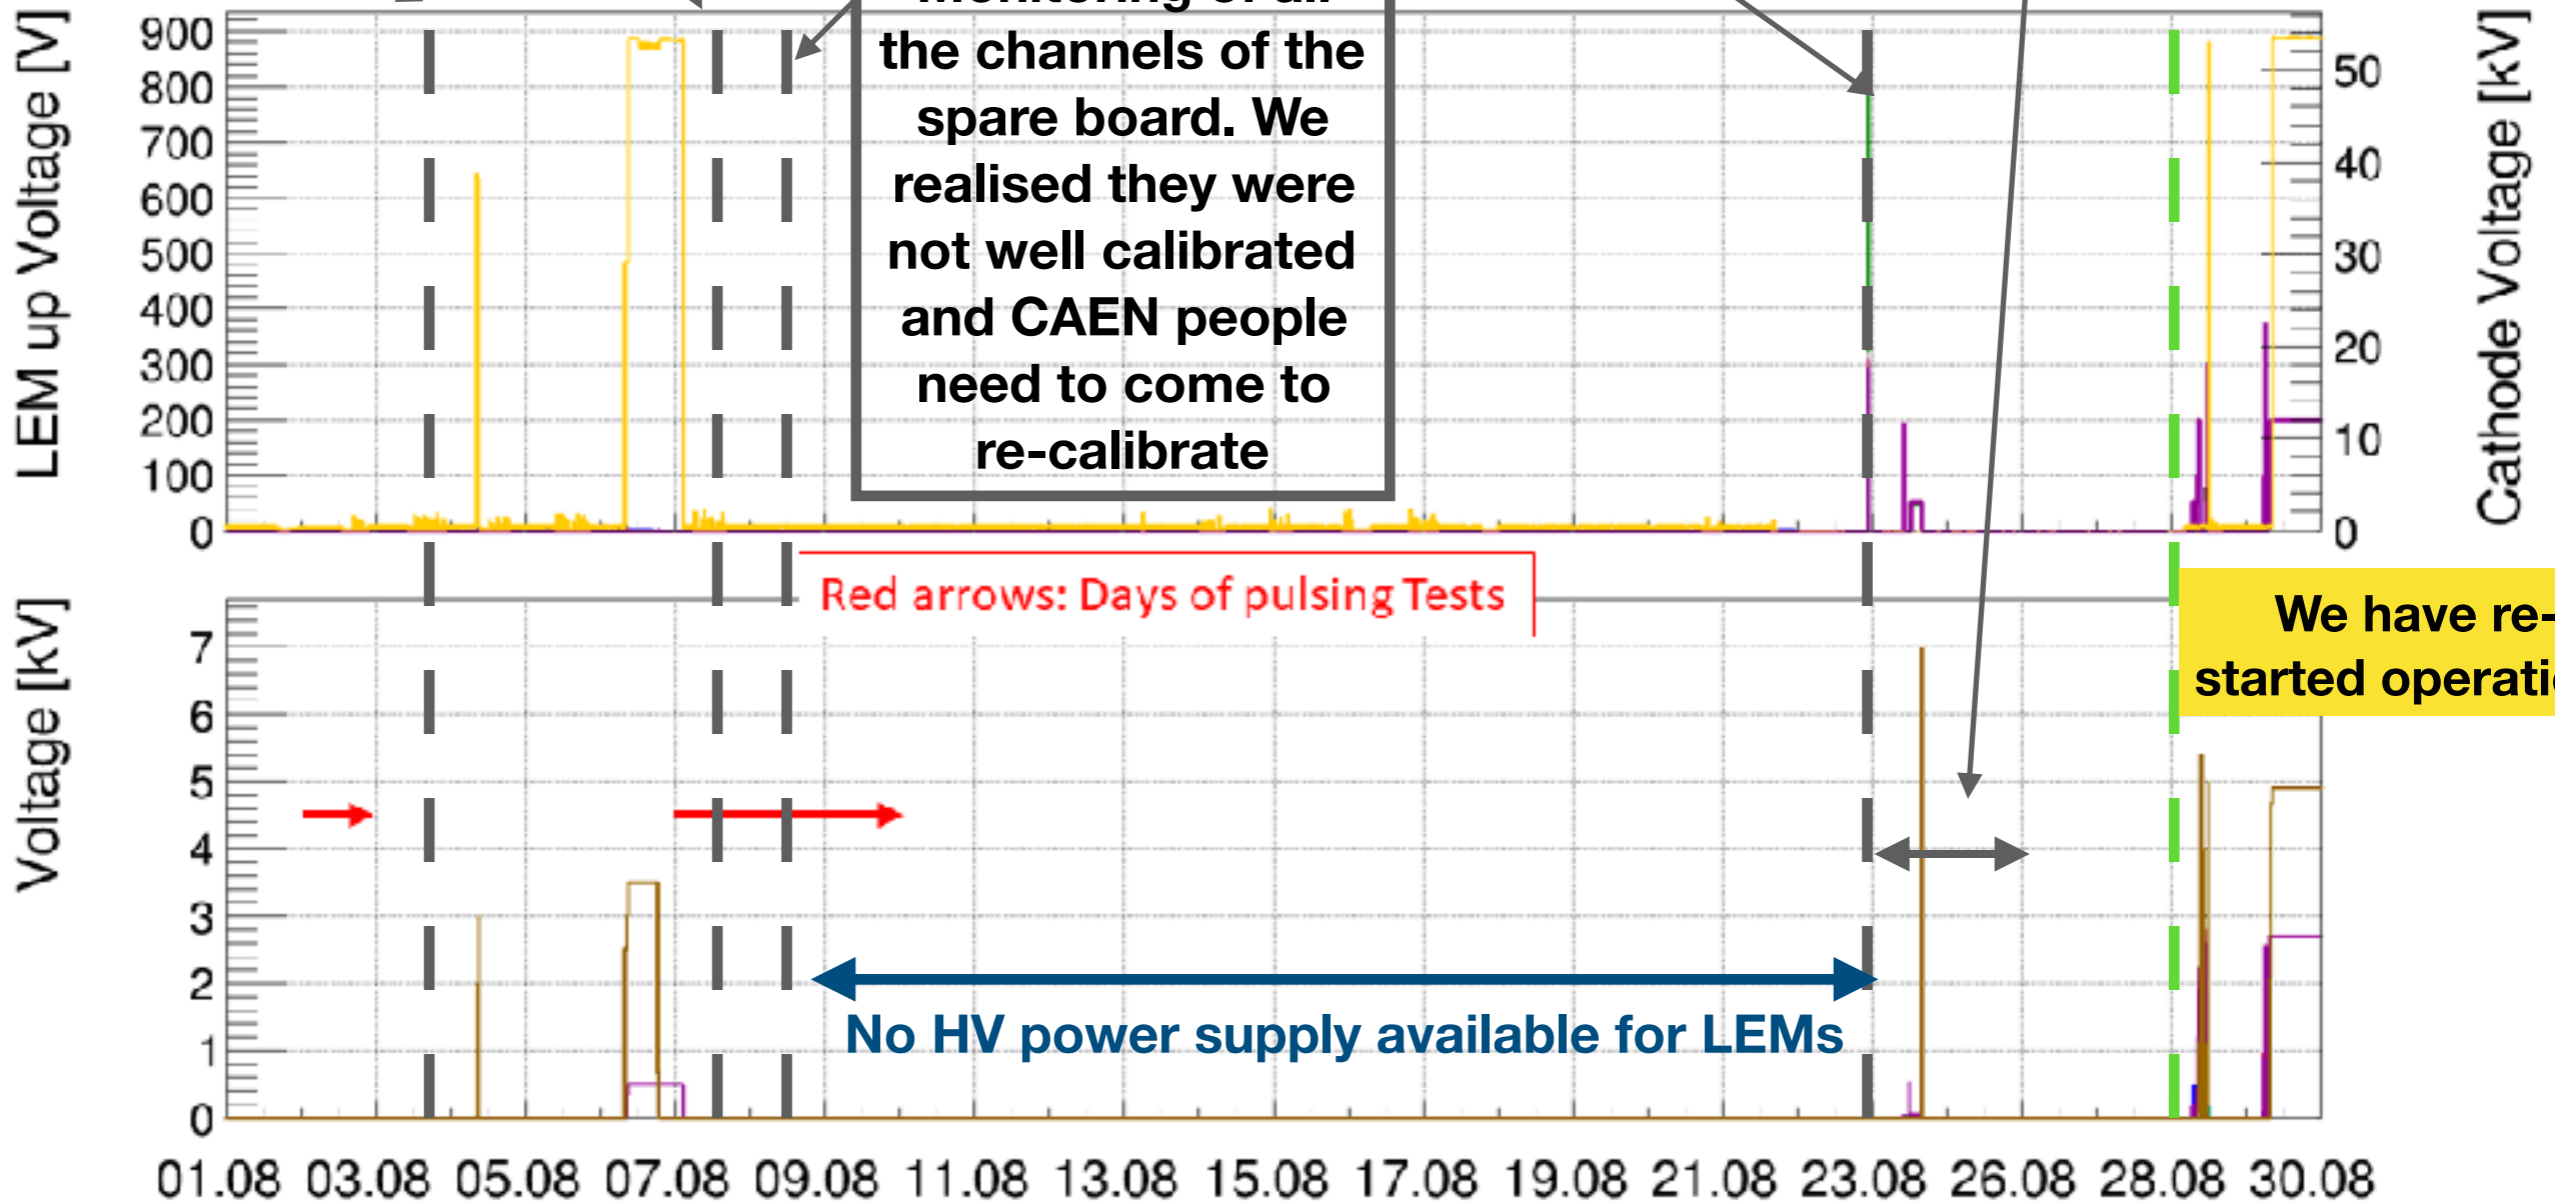
Problem with CAEN power supply

CAEN suggested to change the board

CAEN re-calibrate the boards and repaired the one with a faulty channel

Monitoring of all the channels to verify they are all ok

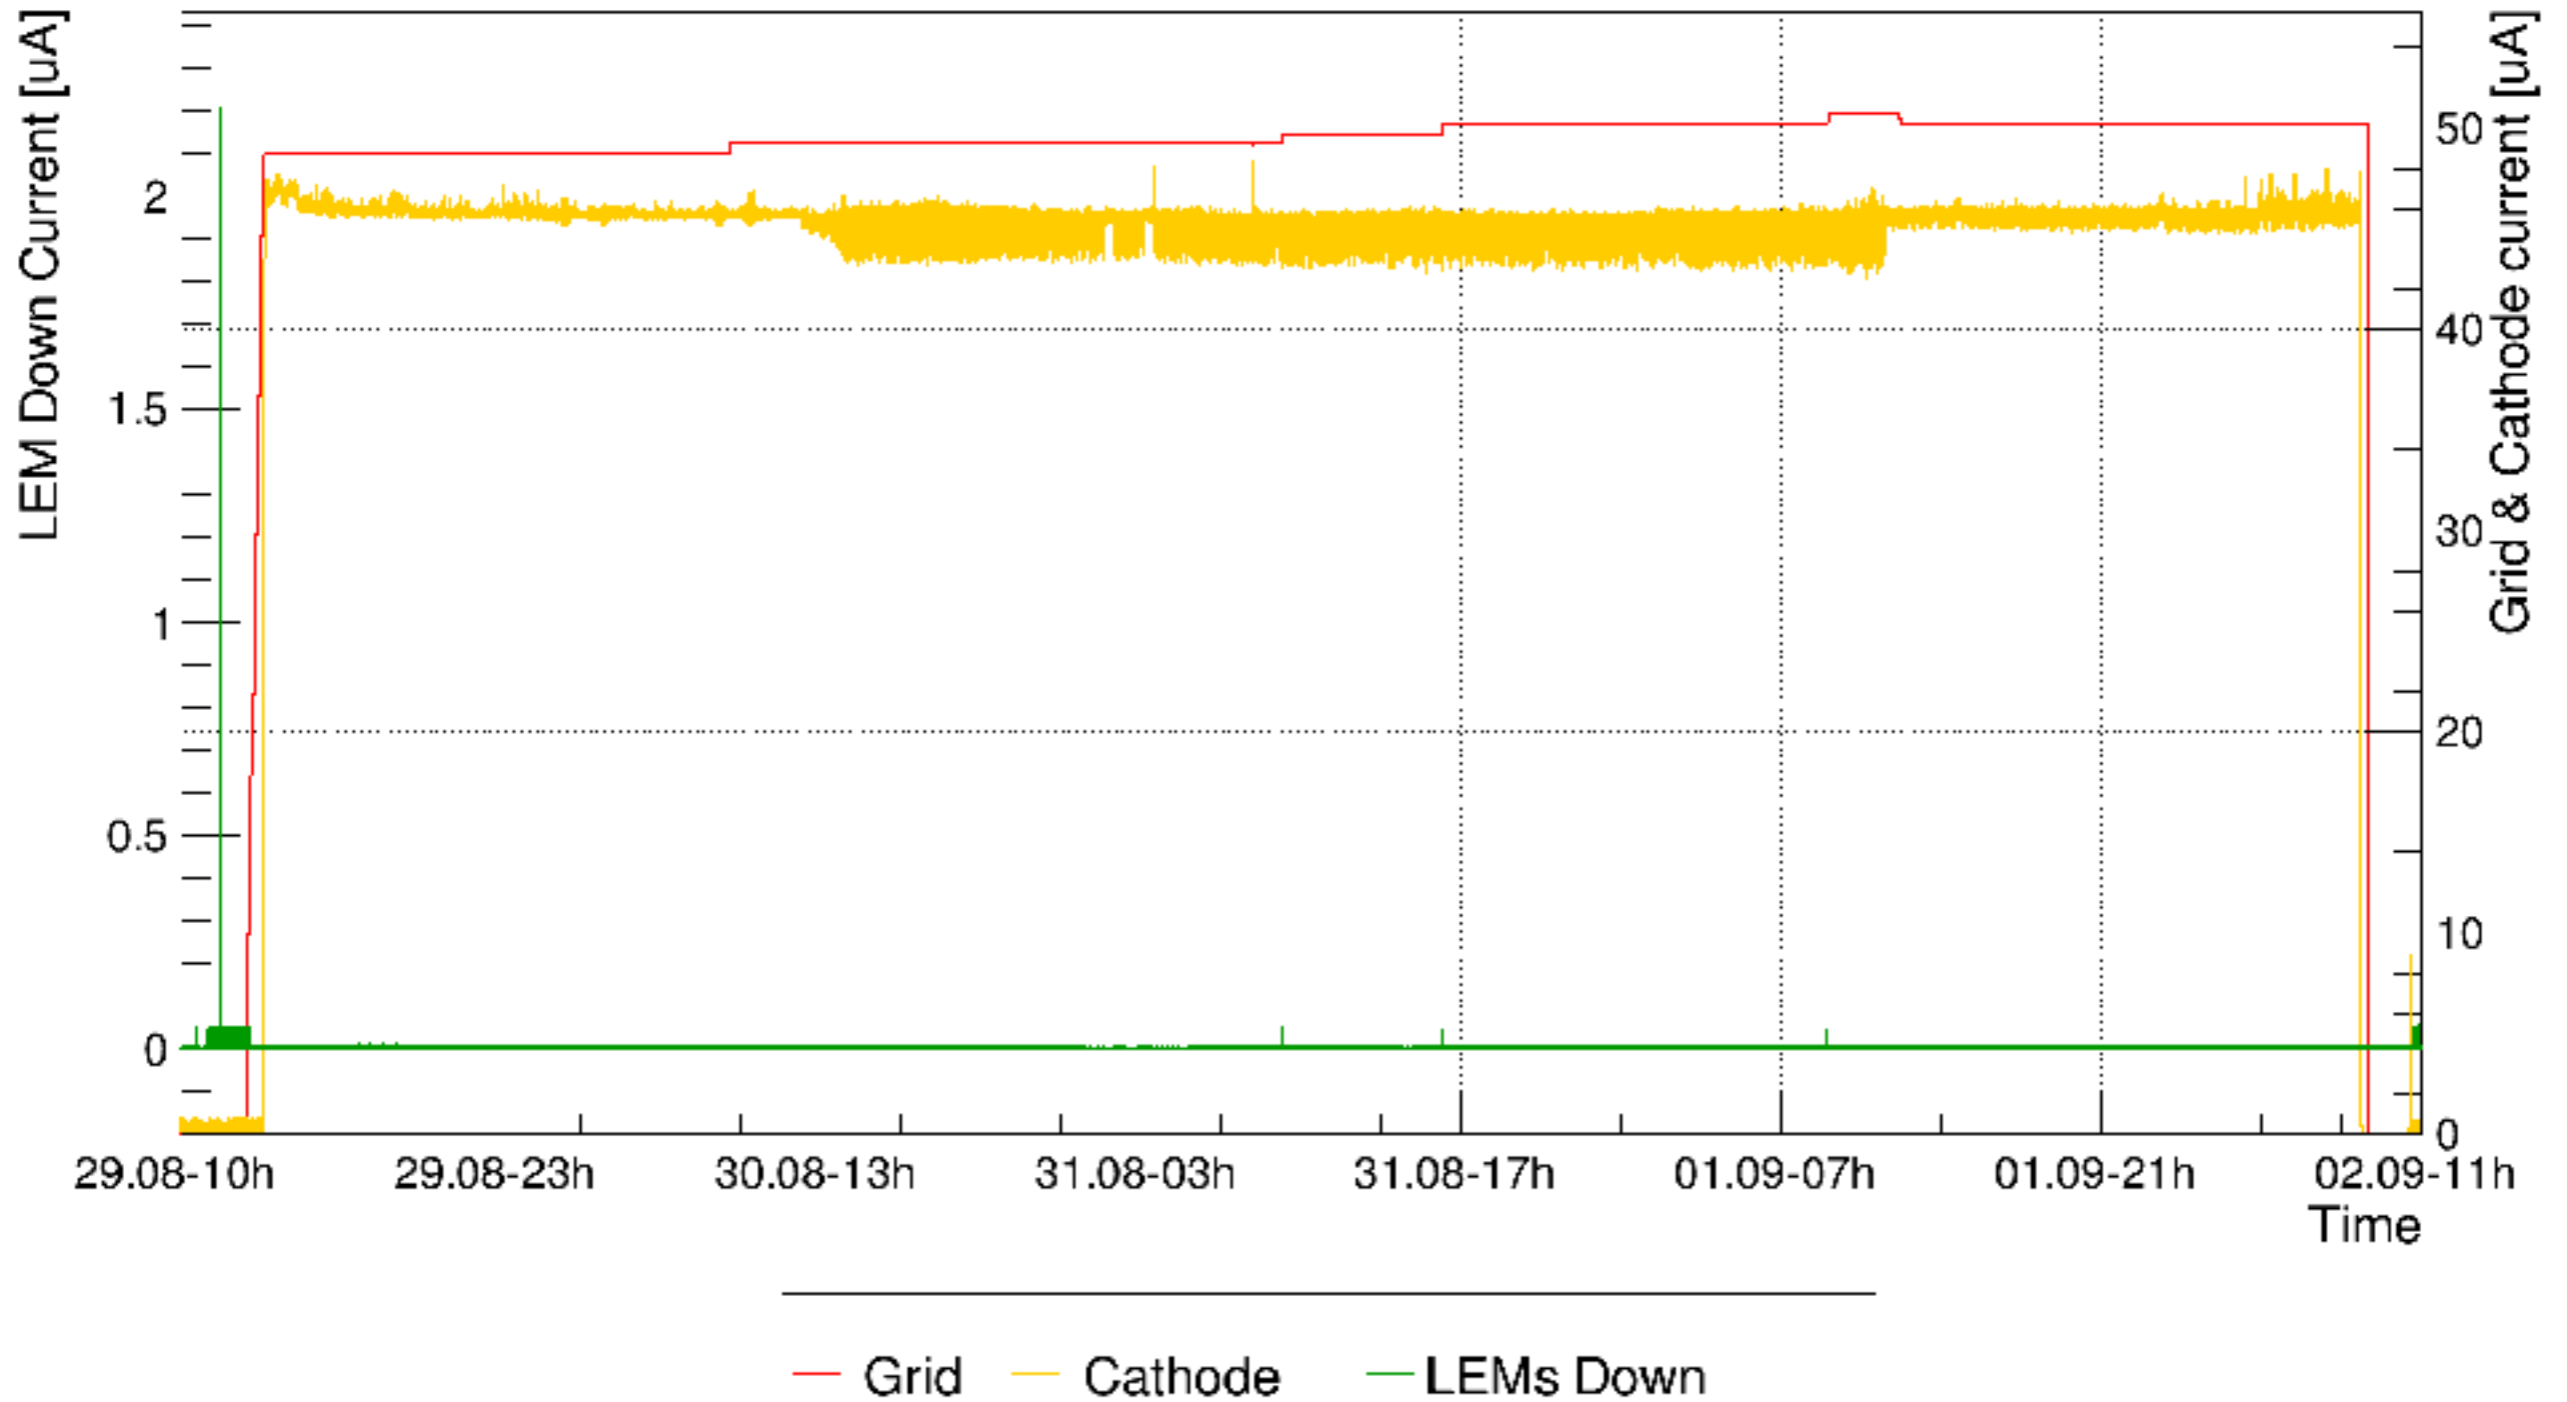
The performance was limited by the sparks of the grid from 4 kV (nominal is 6.5 kV). Possible causes which can explain this issue:

- 1. Non-planarity of the CRP.**
- 2. Liquid level value and stability.**
- 3. Sparks of the grid towards the field cage.**
- 4. Contact between the extraction grid and the LEM: for example, due to a broken/un-tensed wire.**
- 5. HV grid connection:**
 - I. It could be a problem with the HV kapton cable inside
 - II. The HV connector itself inside
 - III. The SHV connector of the HV flange.

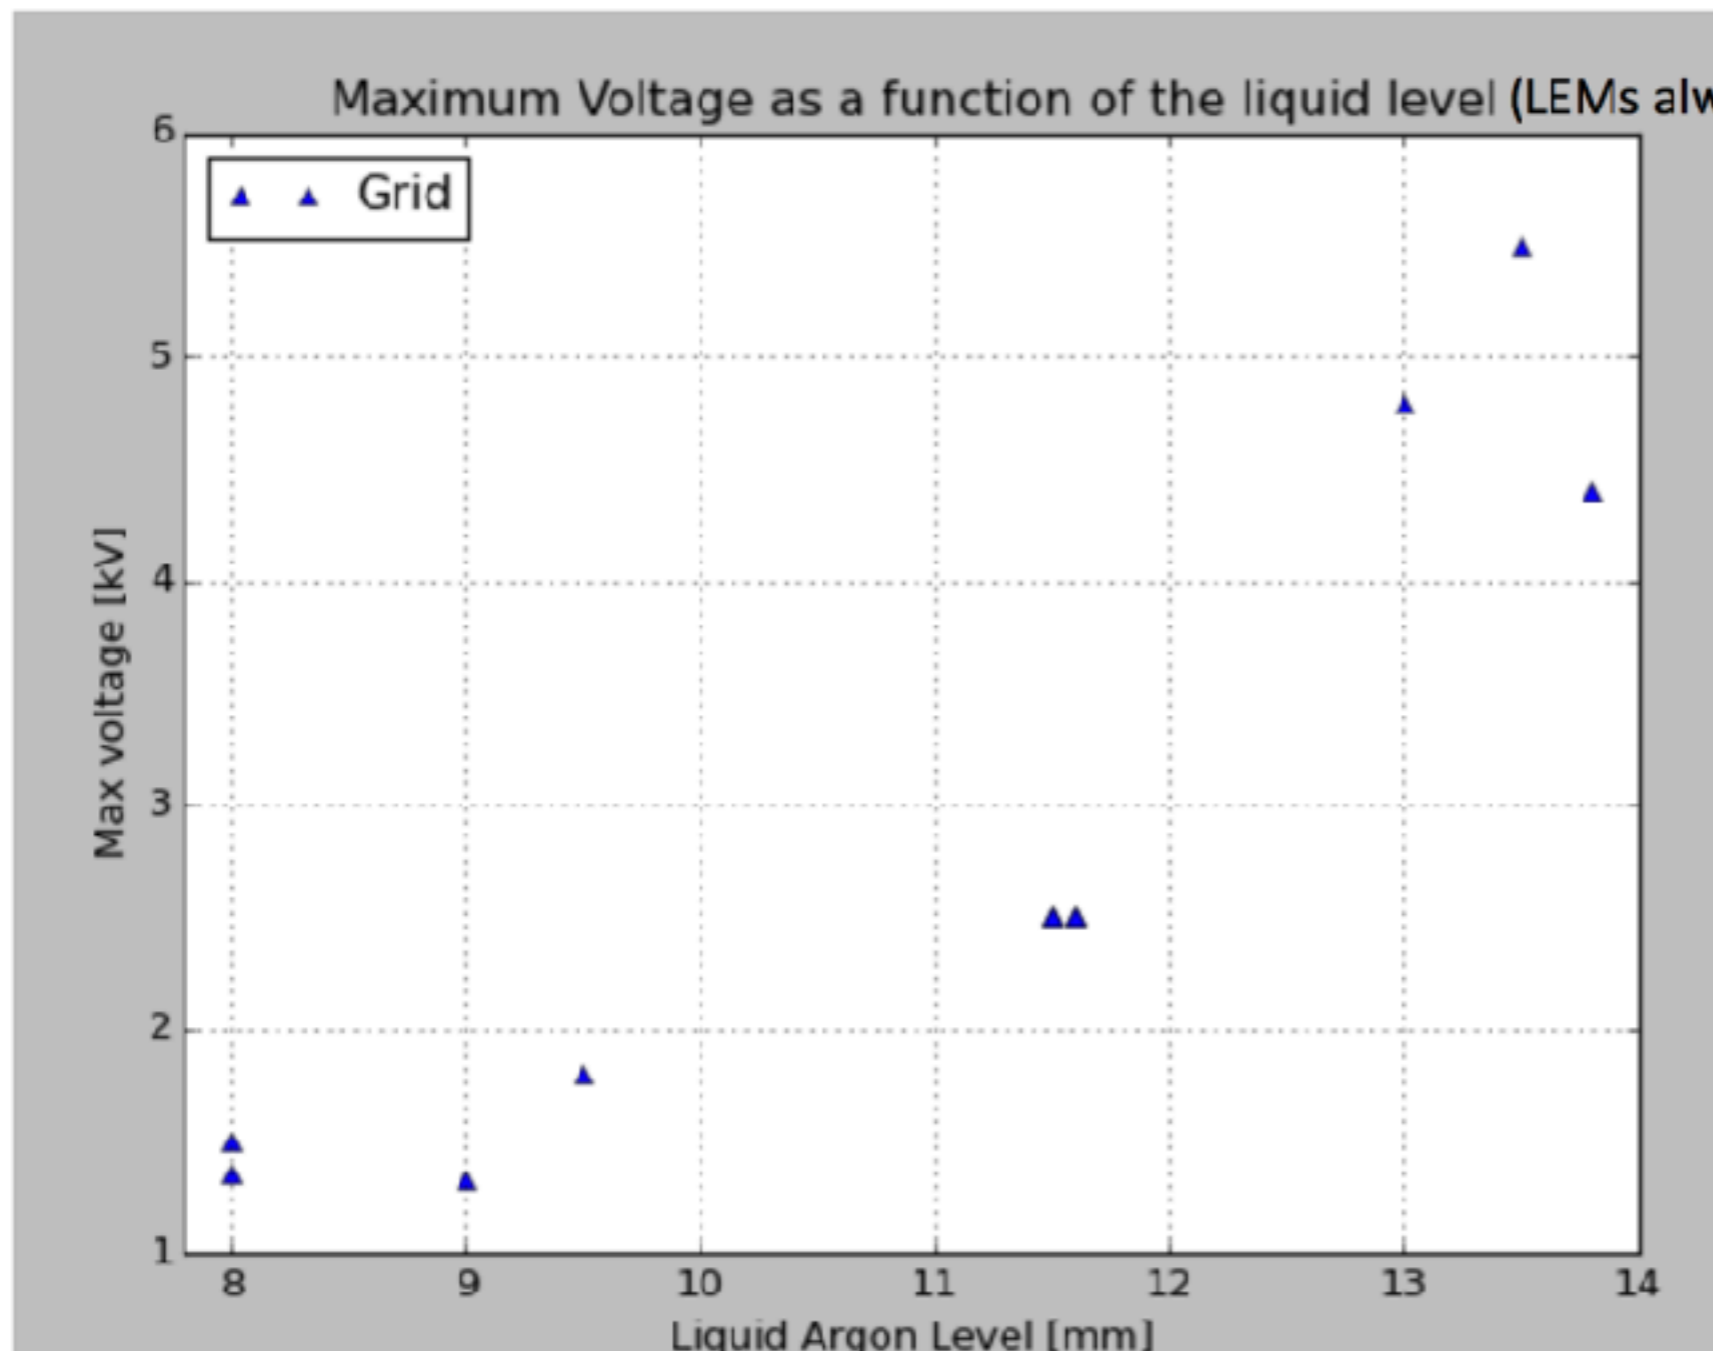
The maximum voltage reachable on the grid depends on the liquid level.

We need to have at least 5 mm of liquid above the grid to reach voltages larger than 4 kV.

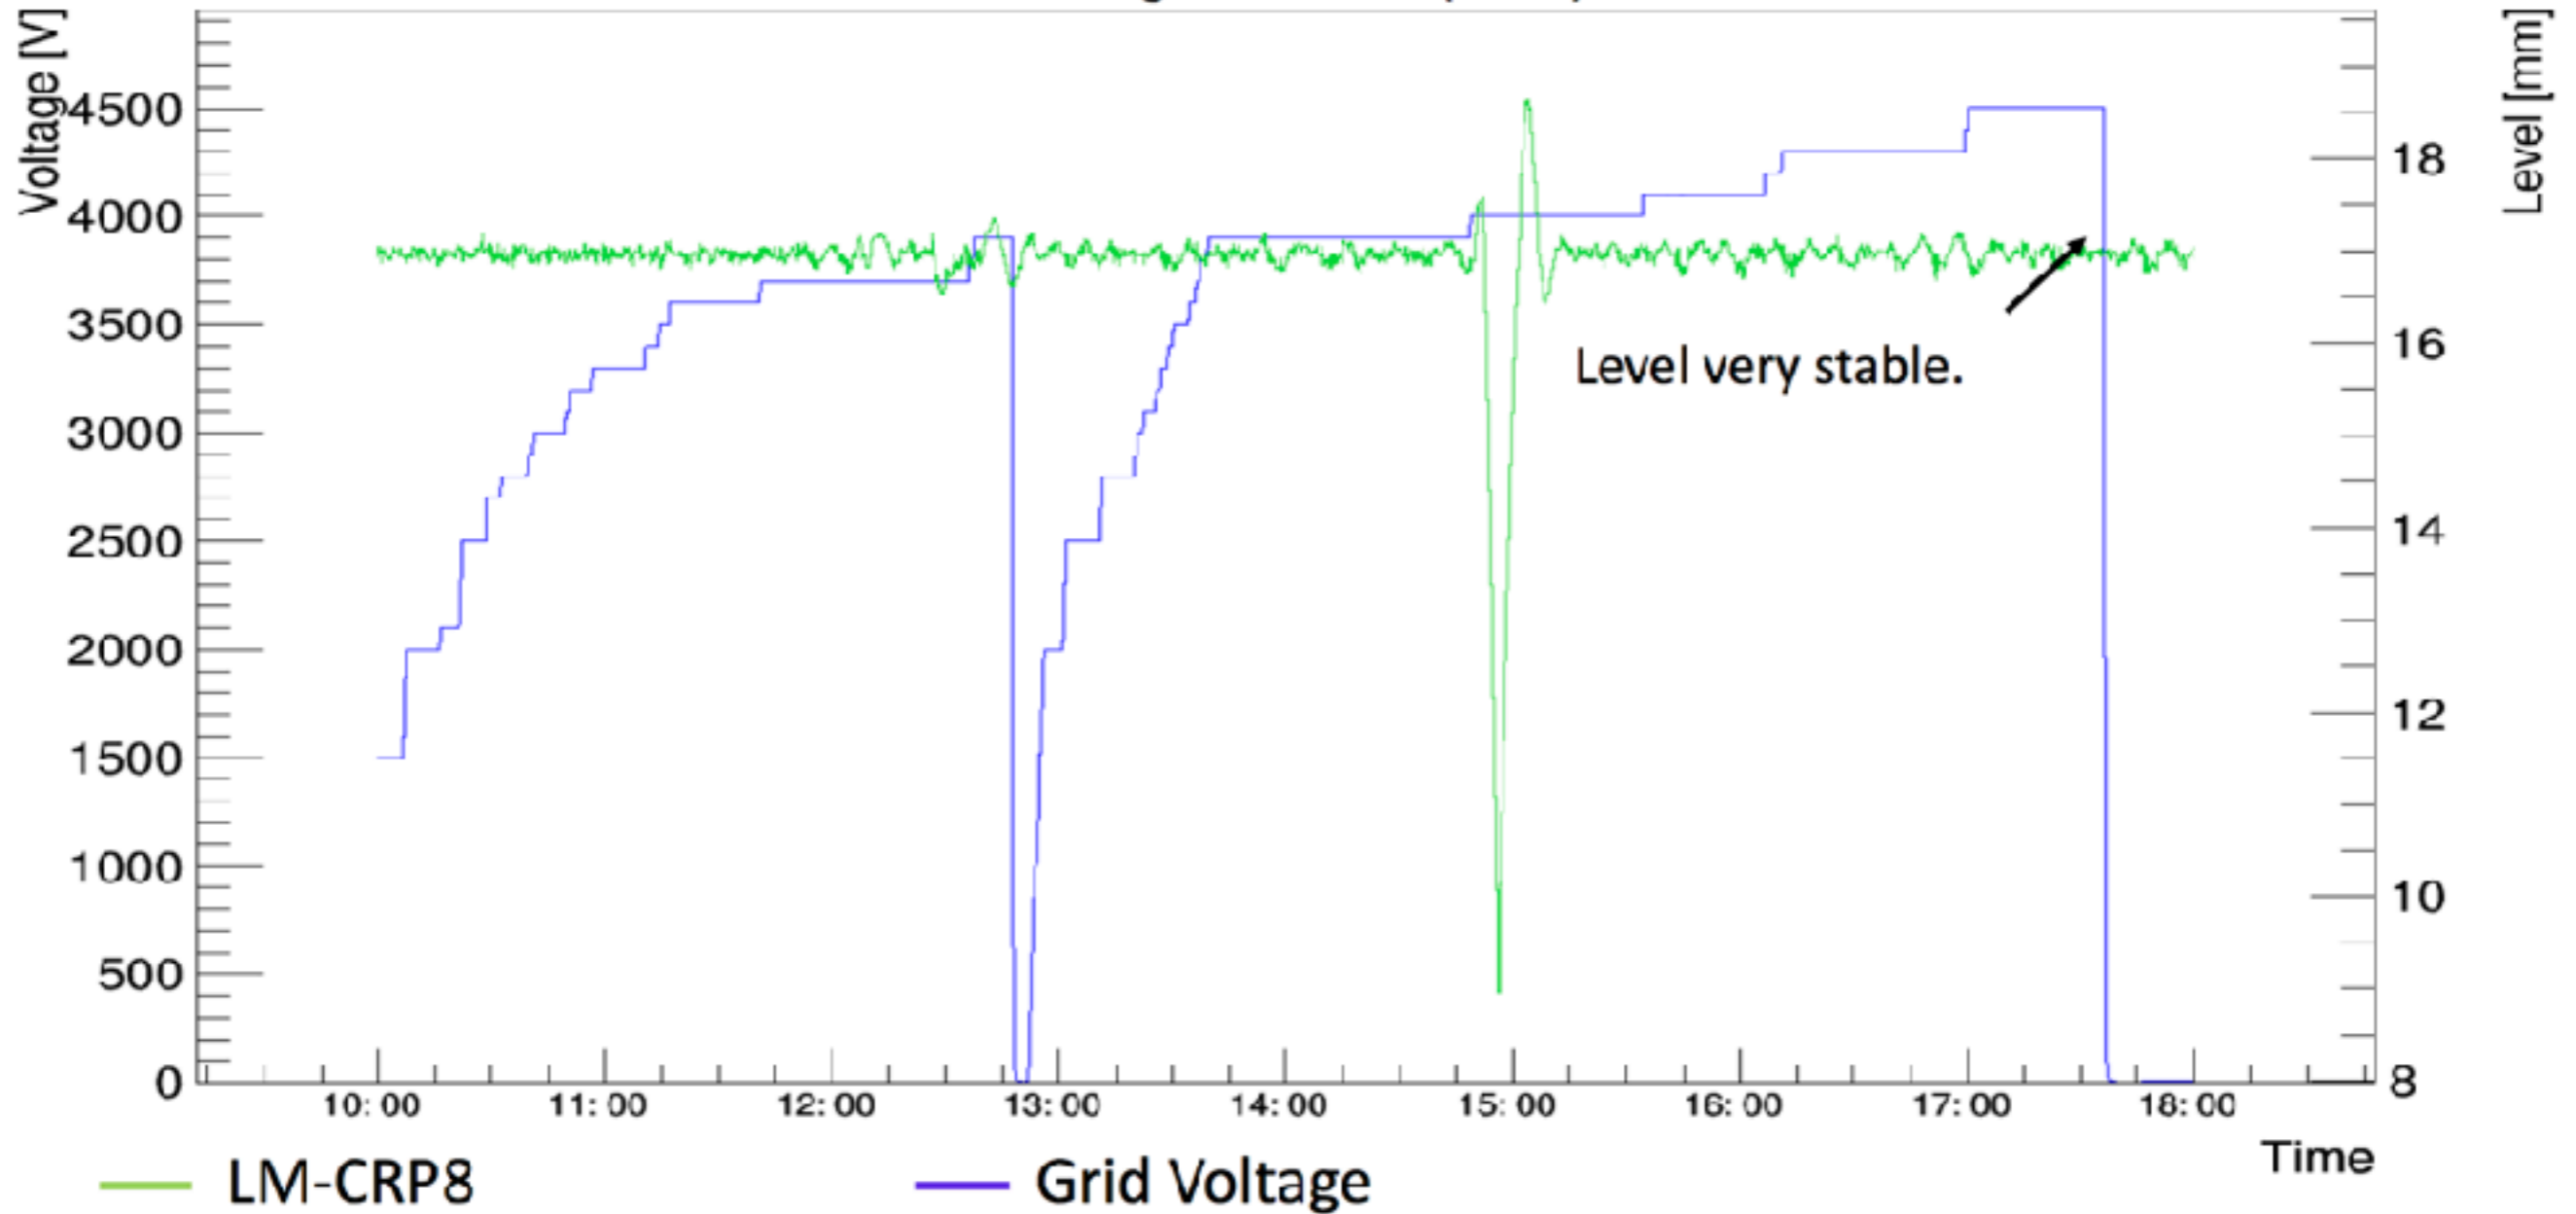
Extraction grid and Level (29.06)

3. No obvious correlation between trips and short-time variations of the level, as soon as the grid is immersed.

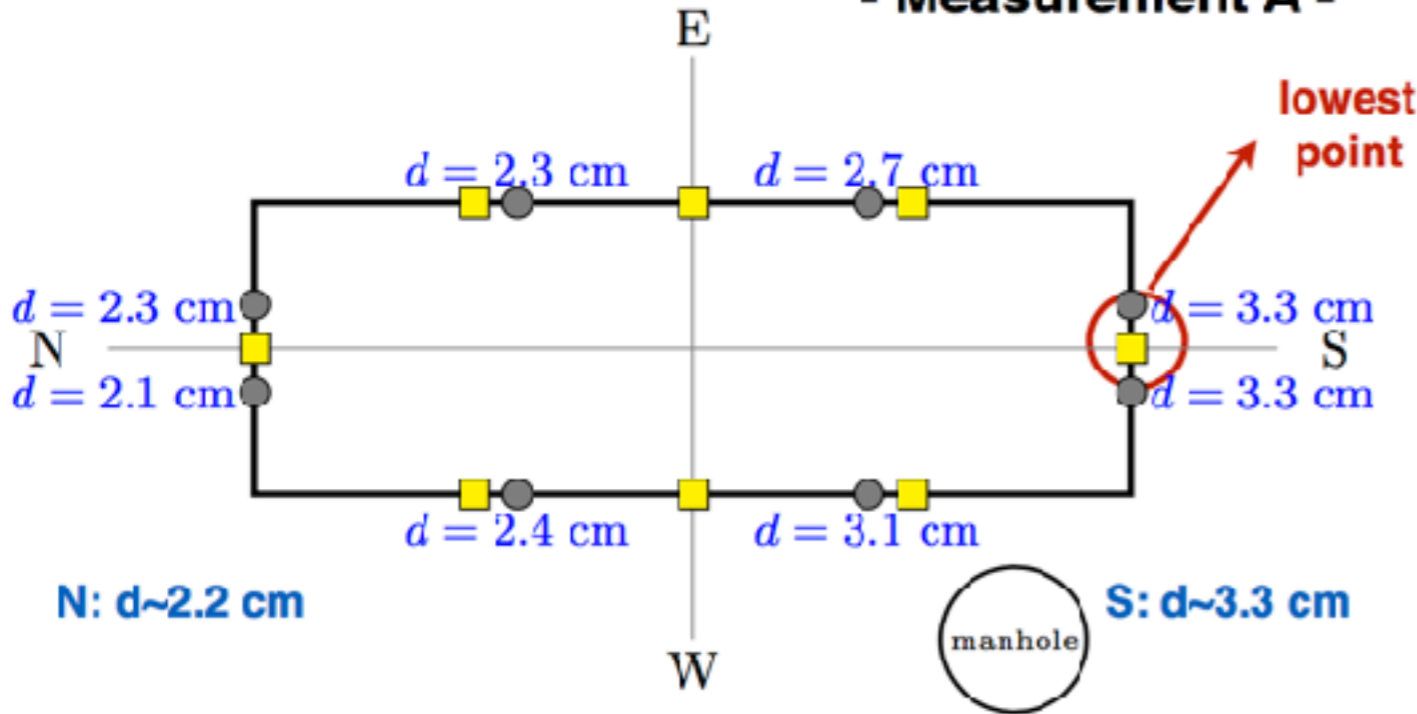
Tilt CRP-DC: use distance FFS to extr. grid
6 measurements corresponding to FR4 pillars
- Measurement A -

Considering tilt N-S axis only.
Tilt on E-W axis negligible.

→ Now CRP is aligned with the liquid
Drift cage and CRP have a relative tilt of 4 mrad

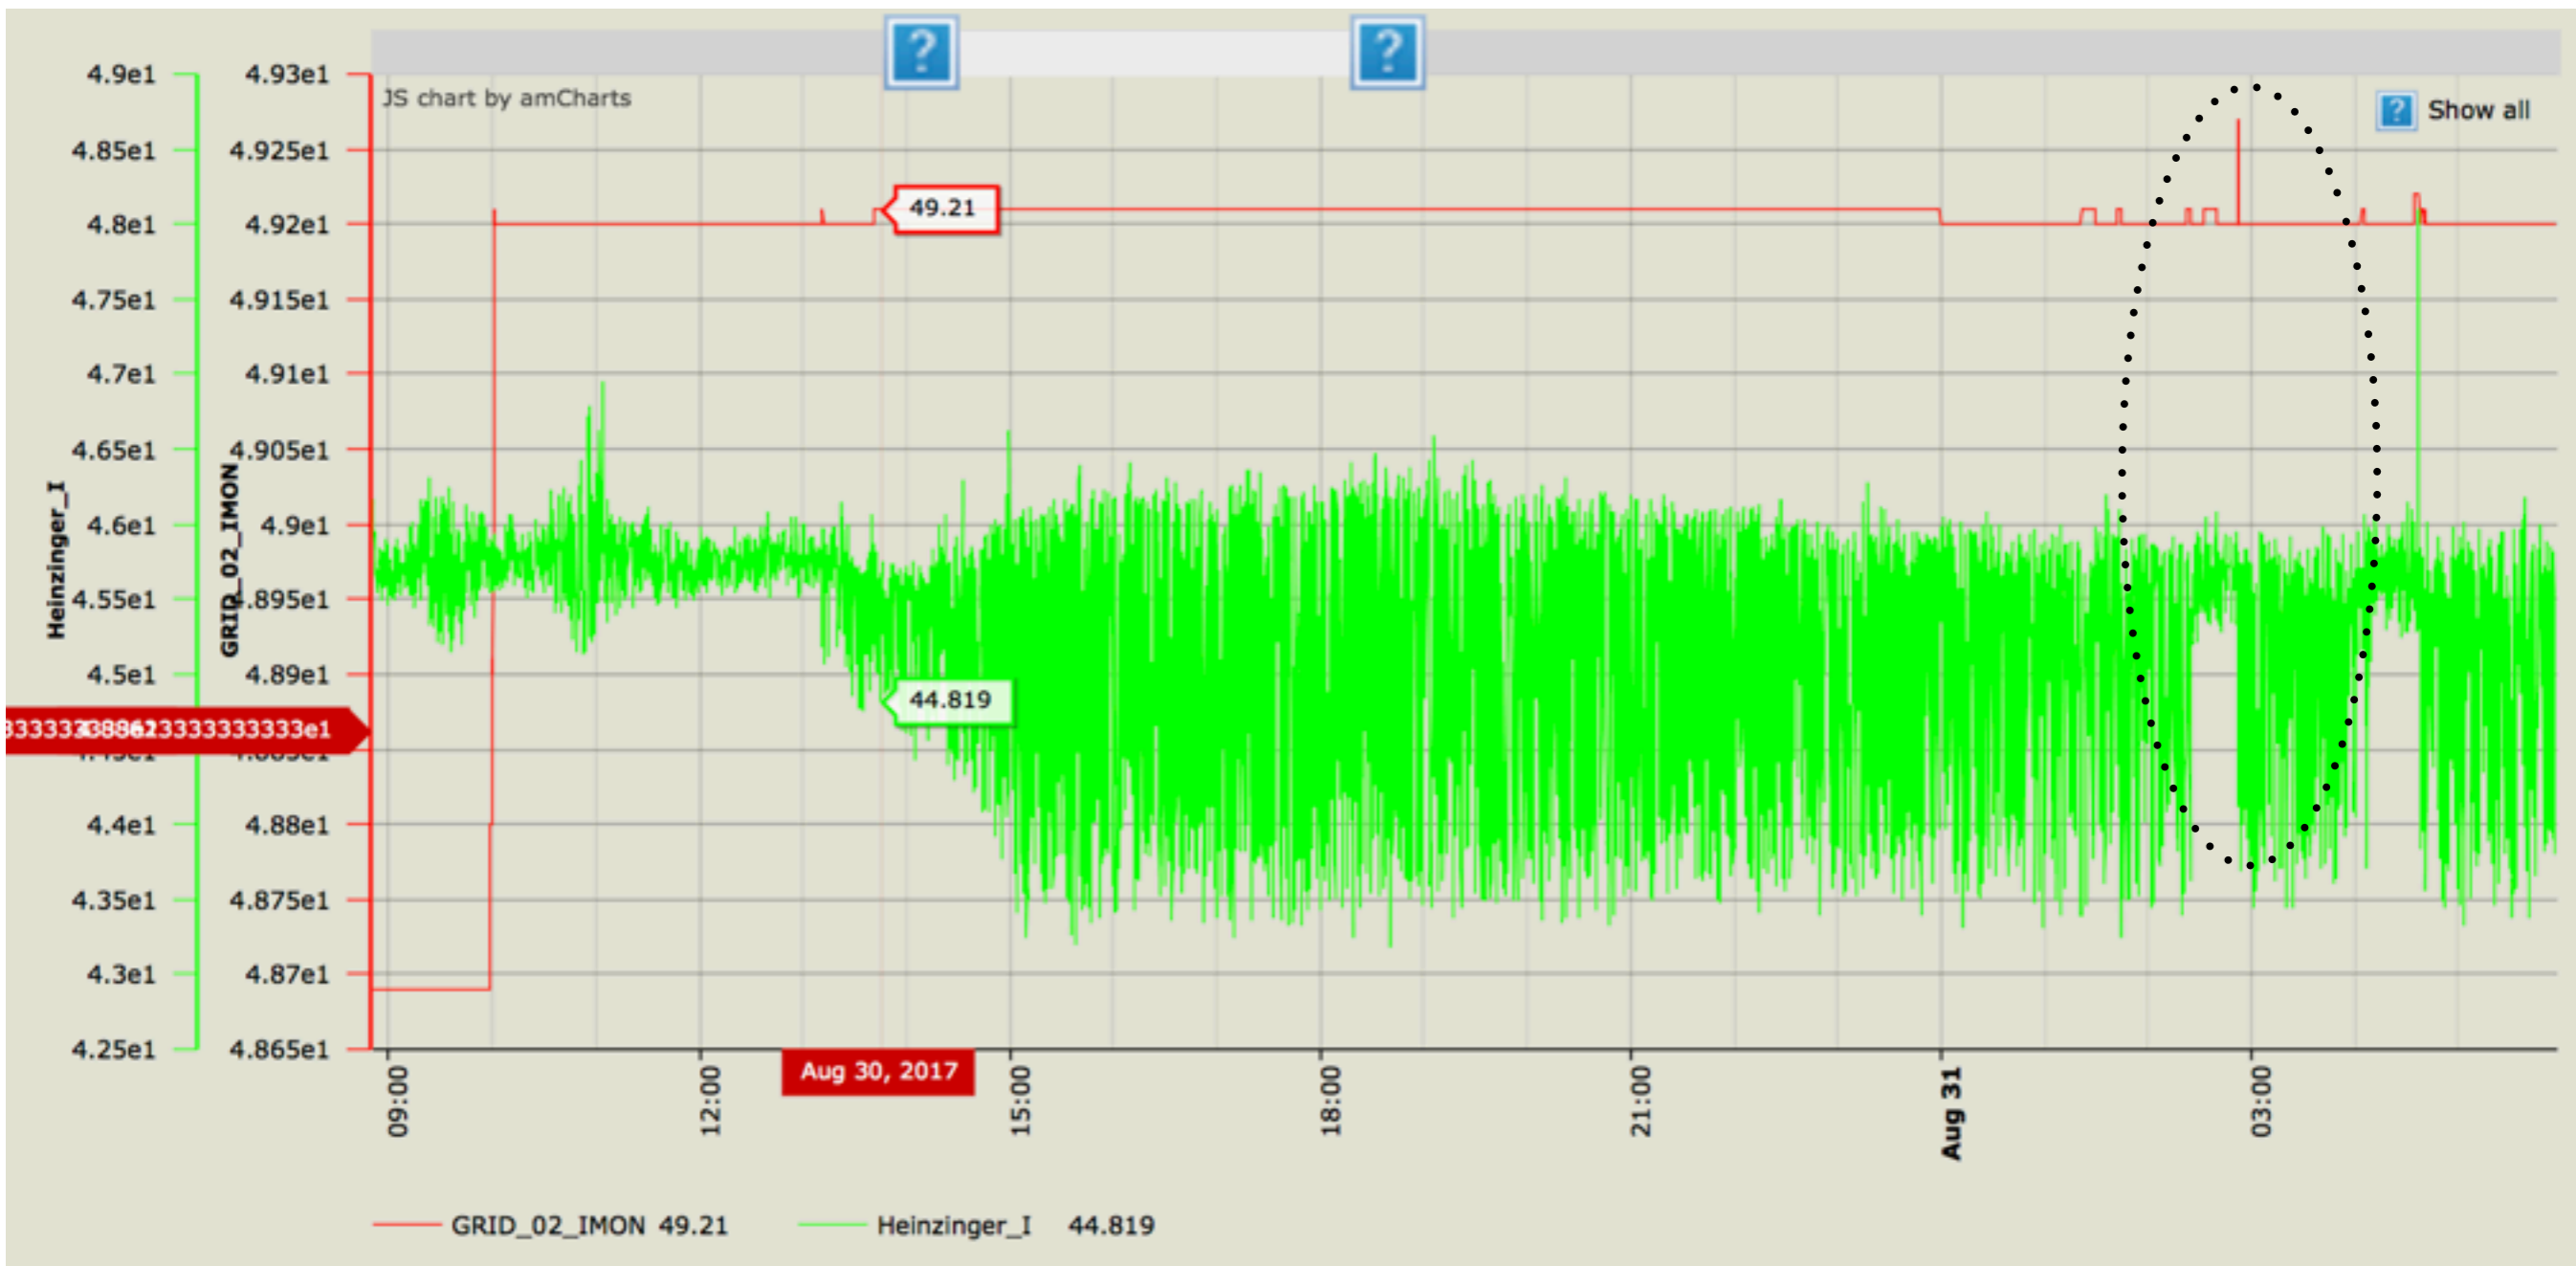
Possible evidence of contact between the field cage and the grid

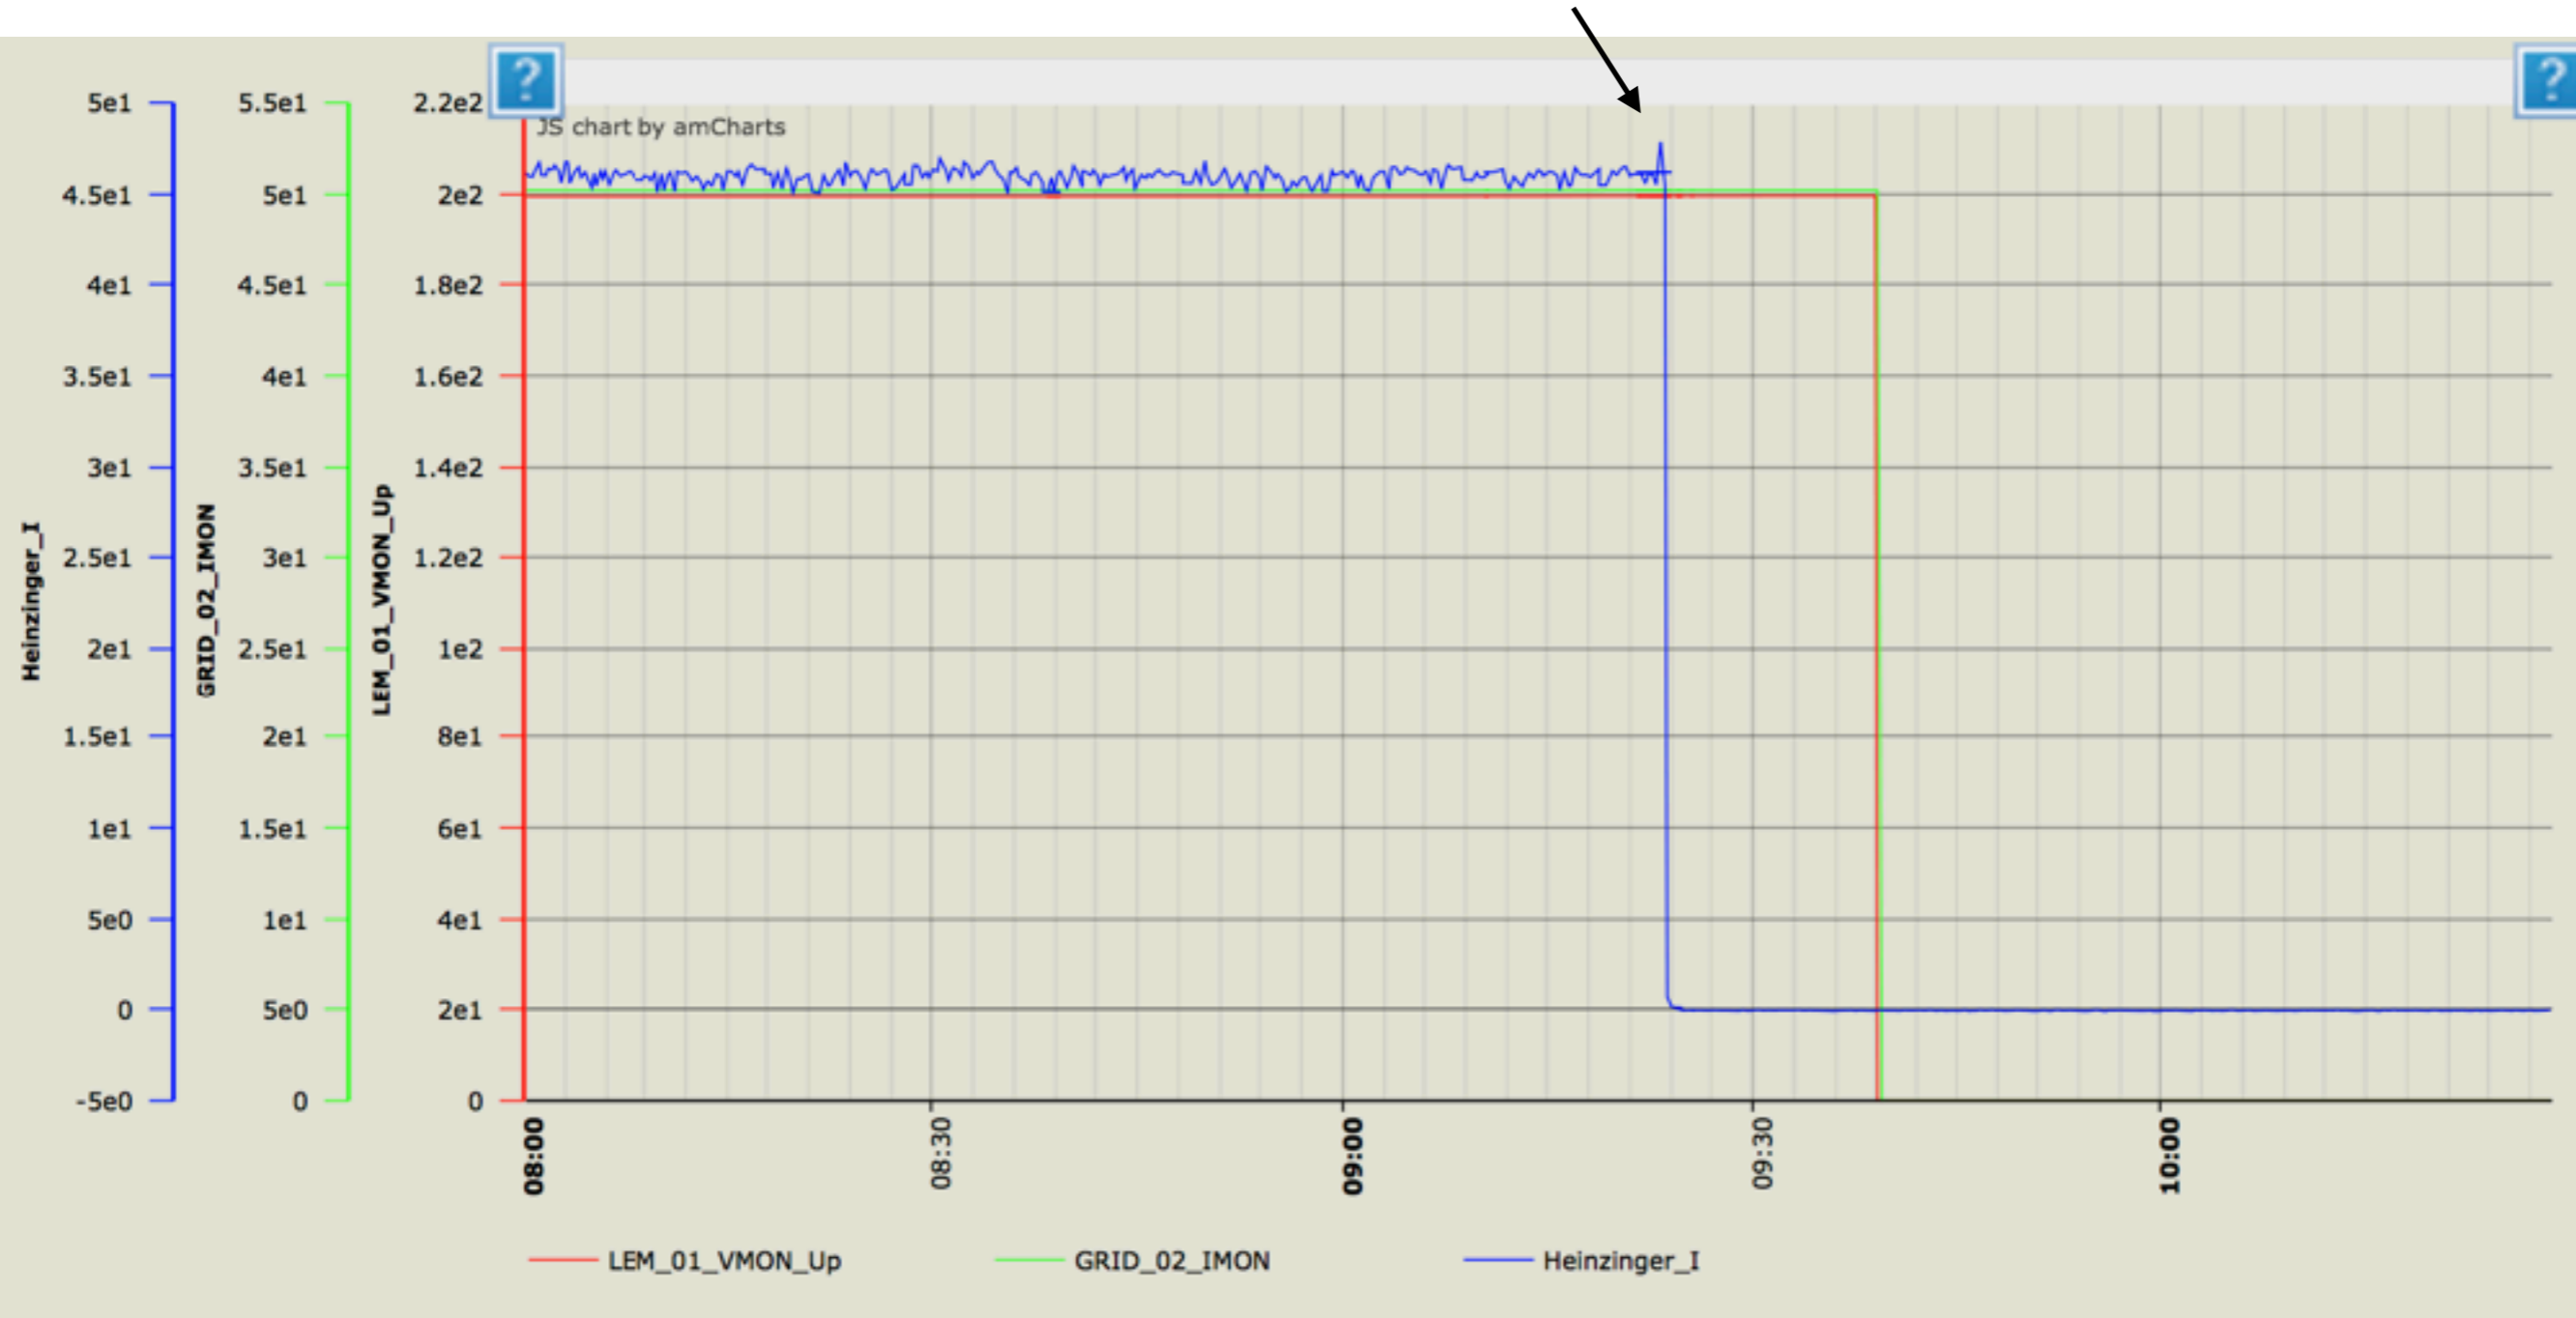
The cathode tripped
