3x1x1 operations: Problems found and possible explanations

Laura Manenti & Laura Molina Bueno

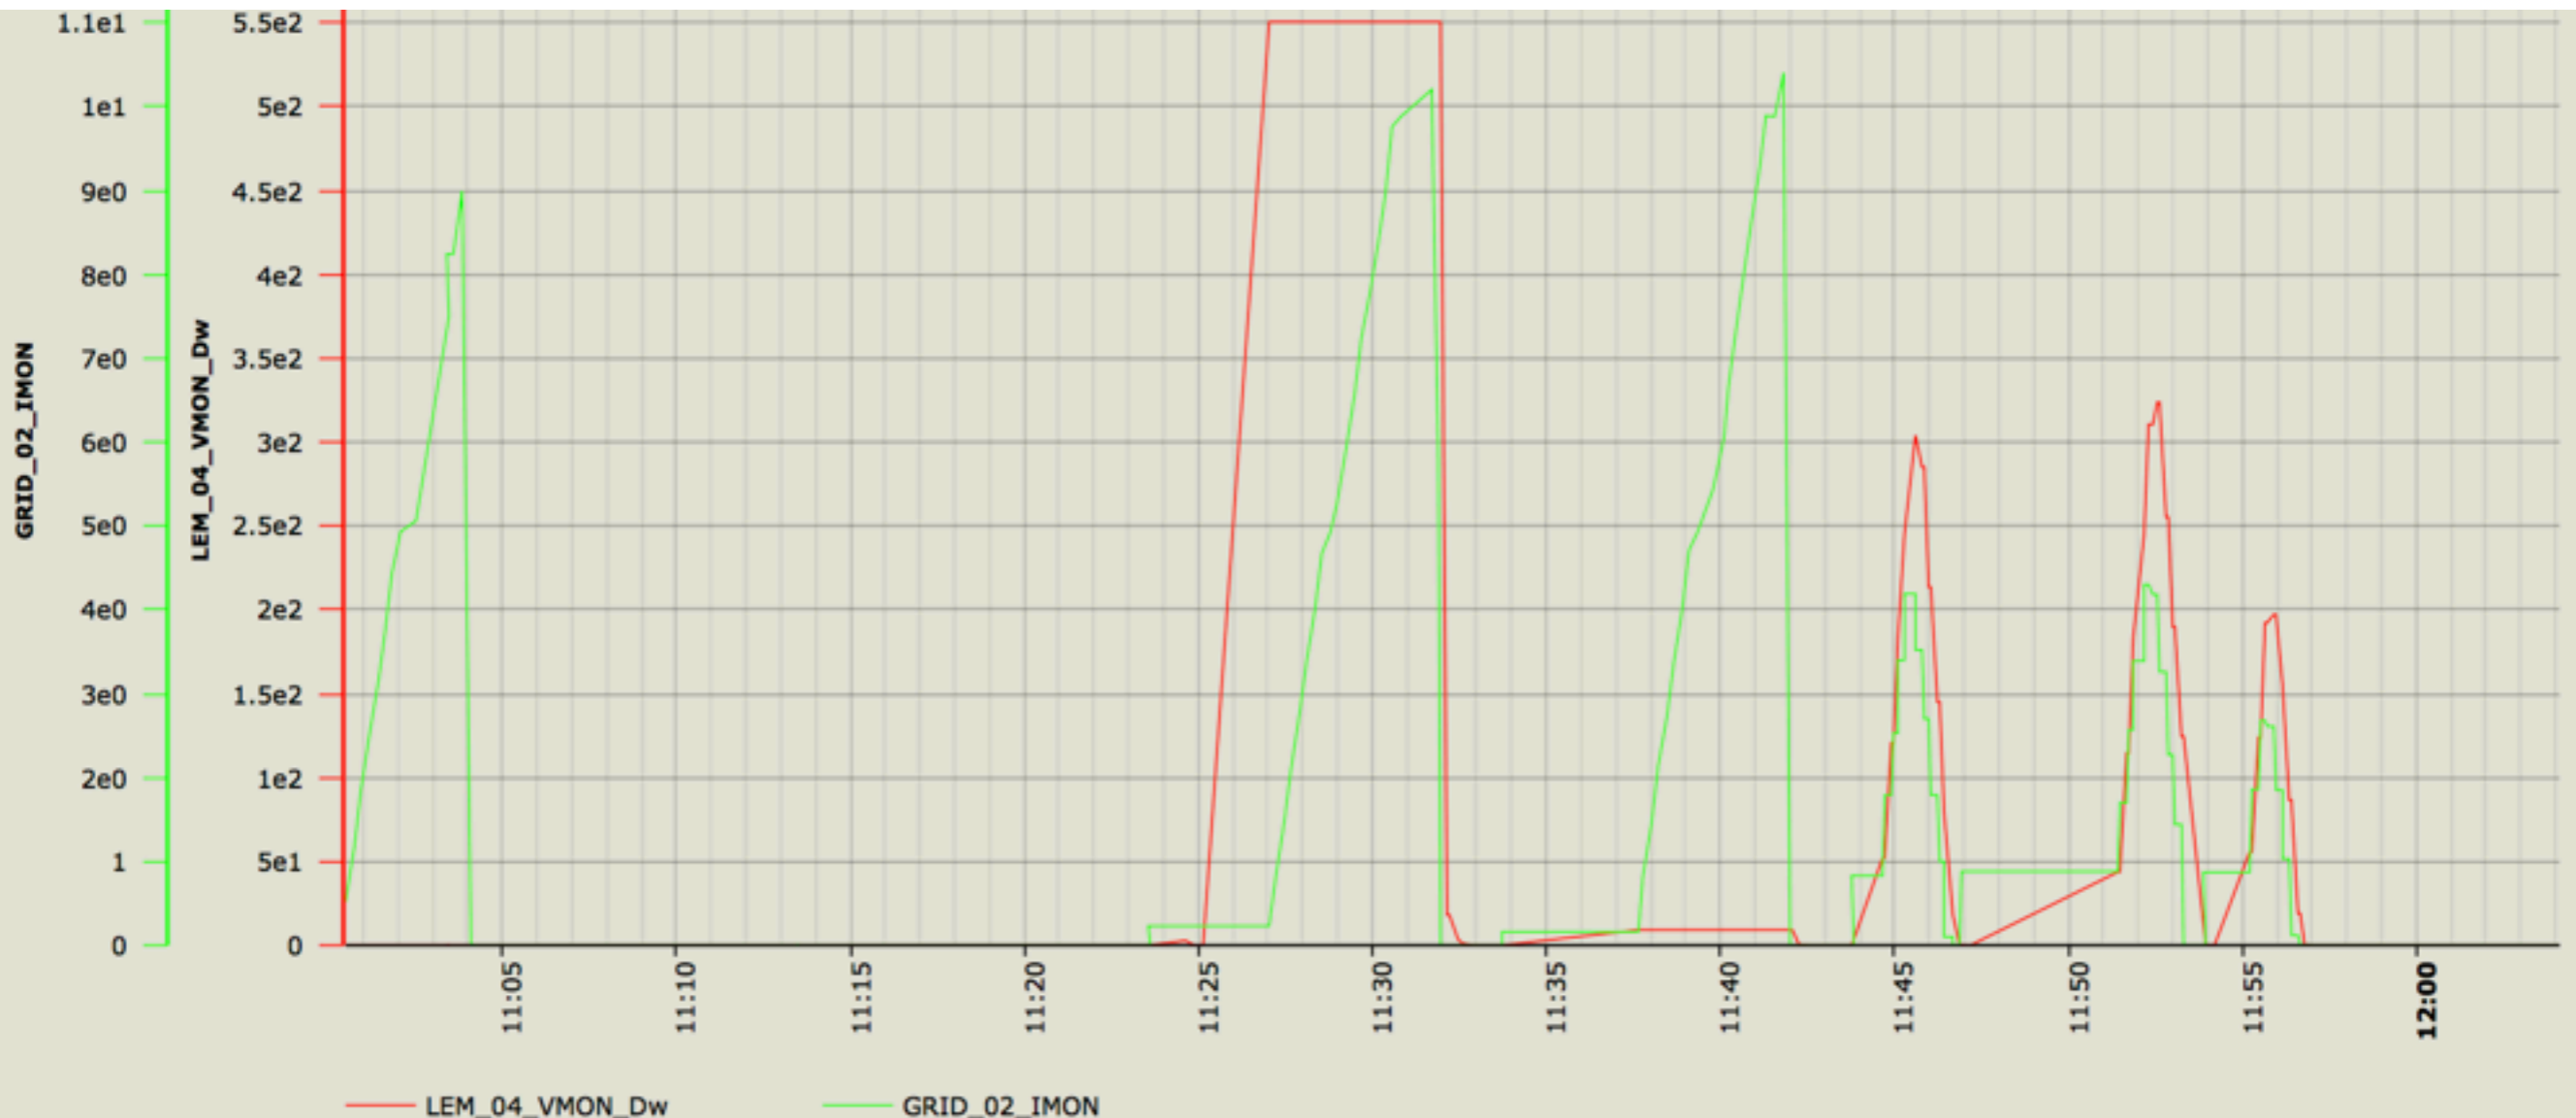
On **September 13th**, we raised the level 2 mm more. Then, we ramp up the voltages and we were not able to ramp up the grid above 1 kV.

- 1) We tripped first LEM 2 up and then the grid at 1000V. We repeat the test 3 times recording movies with and without the LEDs ON.
- 2) We disconnect LEM 2 and we reconnect LEMs 3 and 4. The grid tripped at the same voltage LEM 3 and 4 as yesterday.
- 3) Finally, we left all the LEMs OFF which means they are at 0V floating, and we powered the grid. As you can see from the plot there is a clear connection between the grid and the LEM4 down, as you power the grid and immediately you see almost the same voltage on LEM down.

4) We measured the **capacitance between the LEMs and the grid** after filling the tank with an additional 2 mm of LAr. The capacitances were measured through the LEM/grid connections on the SCFTs. They were measured through a standard BNC cable, connected to the grid on the north flange and a custom LEMO connector with a simple copper wire, connected to the LEM HV connections.

The average capacitance between LEM down and the grid increased from 214 pF to 242 pF after the first filling and then to 318 pF after the second filling. The capacitance measurement between LEM 4 and the grid gave a negative measurement, characteristic of an electrical short between the two.

Indeed, measuring the resistance, a value of 16.6 Ohm was obtained, confirming that one of the grid wires is touching LEM 4. The capacitance between the grid and LEM 4 up was measured to be 8.61 nF which is the capacitance between LEM up and LEM down, which is in agreement the previous values.

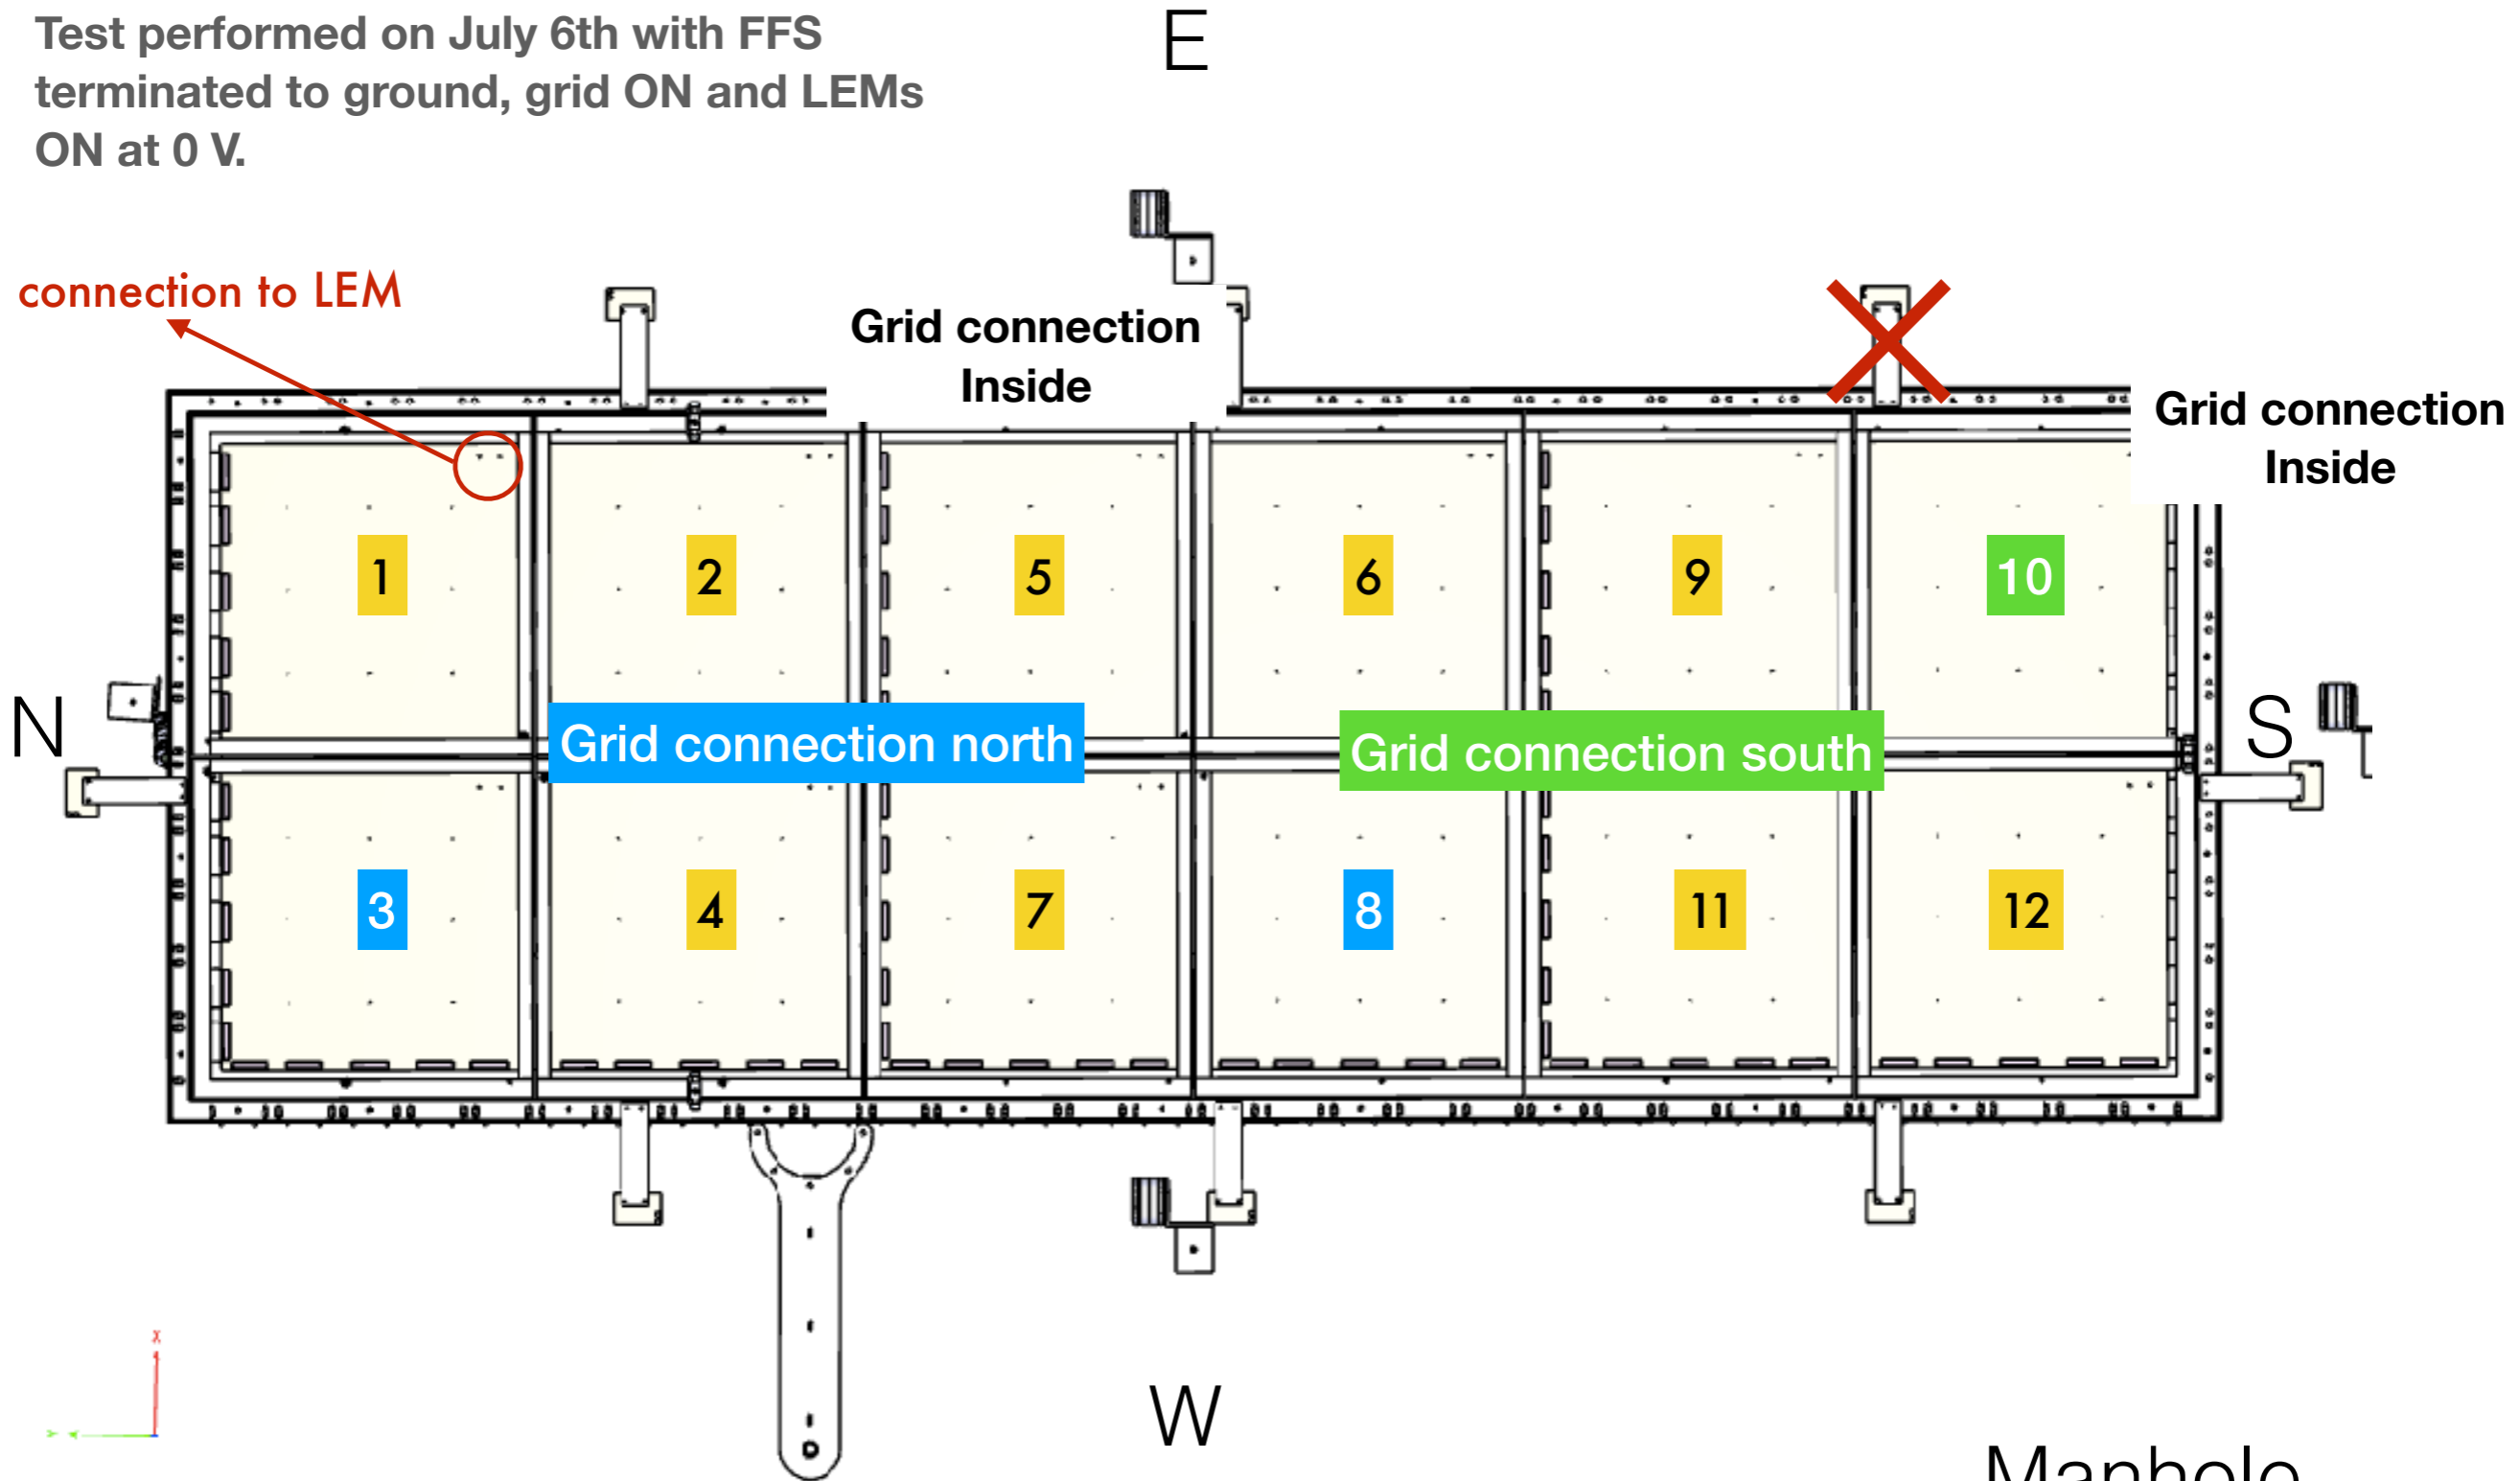
Test performed on July 6th with FFS terminated to ground, grid ON and LEMs ON at 0 V.

The grid tripped ramping up to 4,8kV Tripped between 3,8 and 4kV corner Manhole

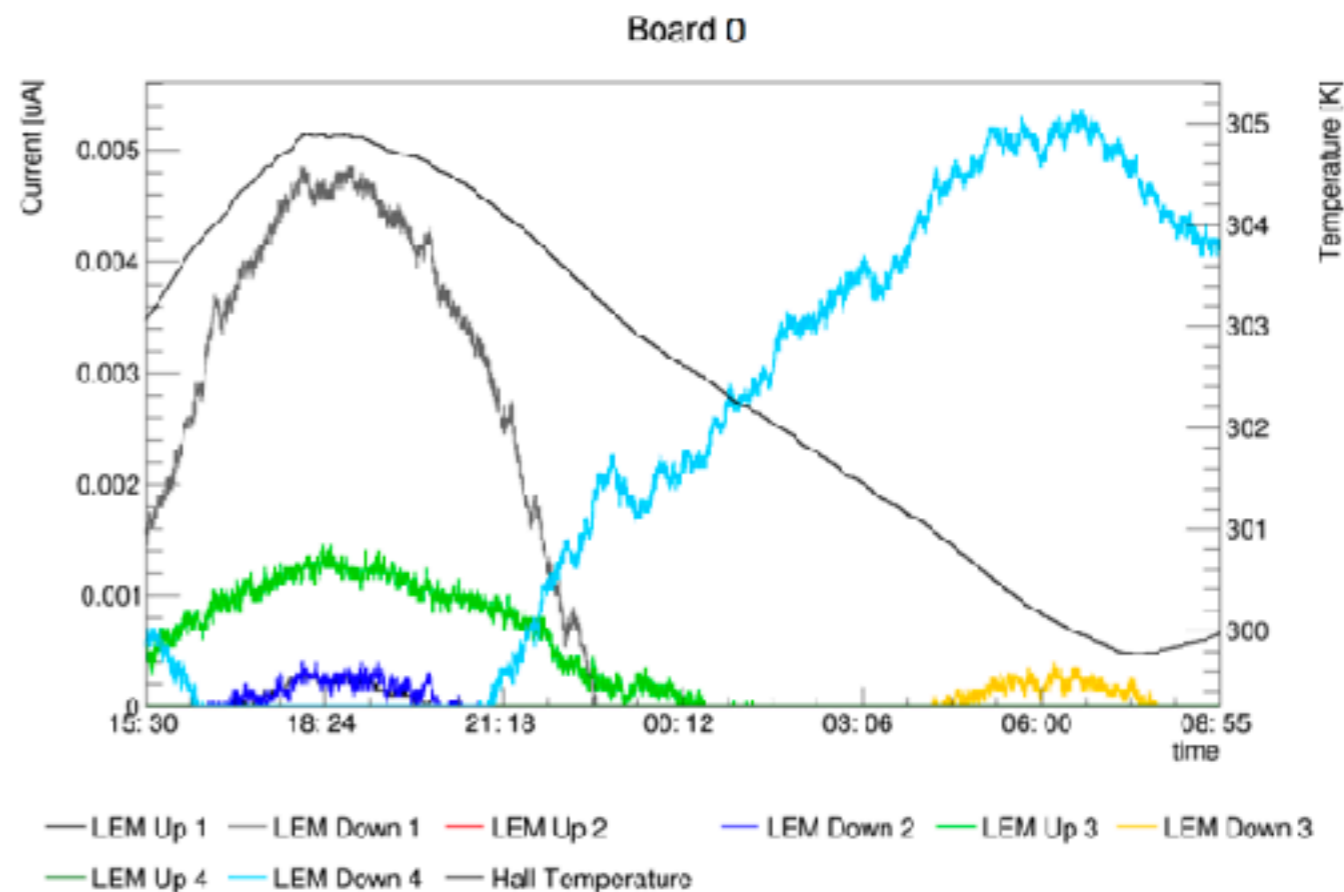
Affected LEMs: LEM 1,3, 7,8,12 up and down LEM 2, 4, 6 down

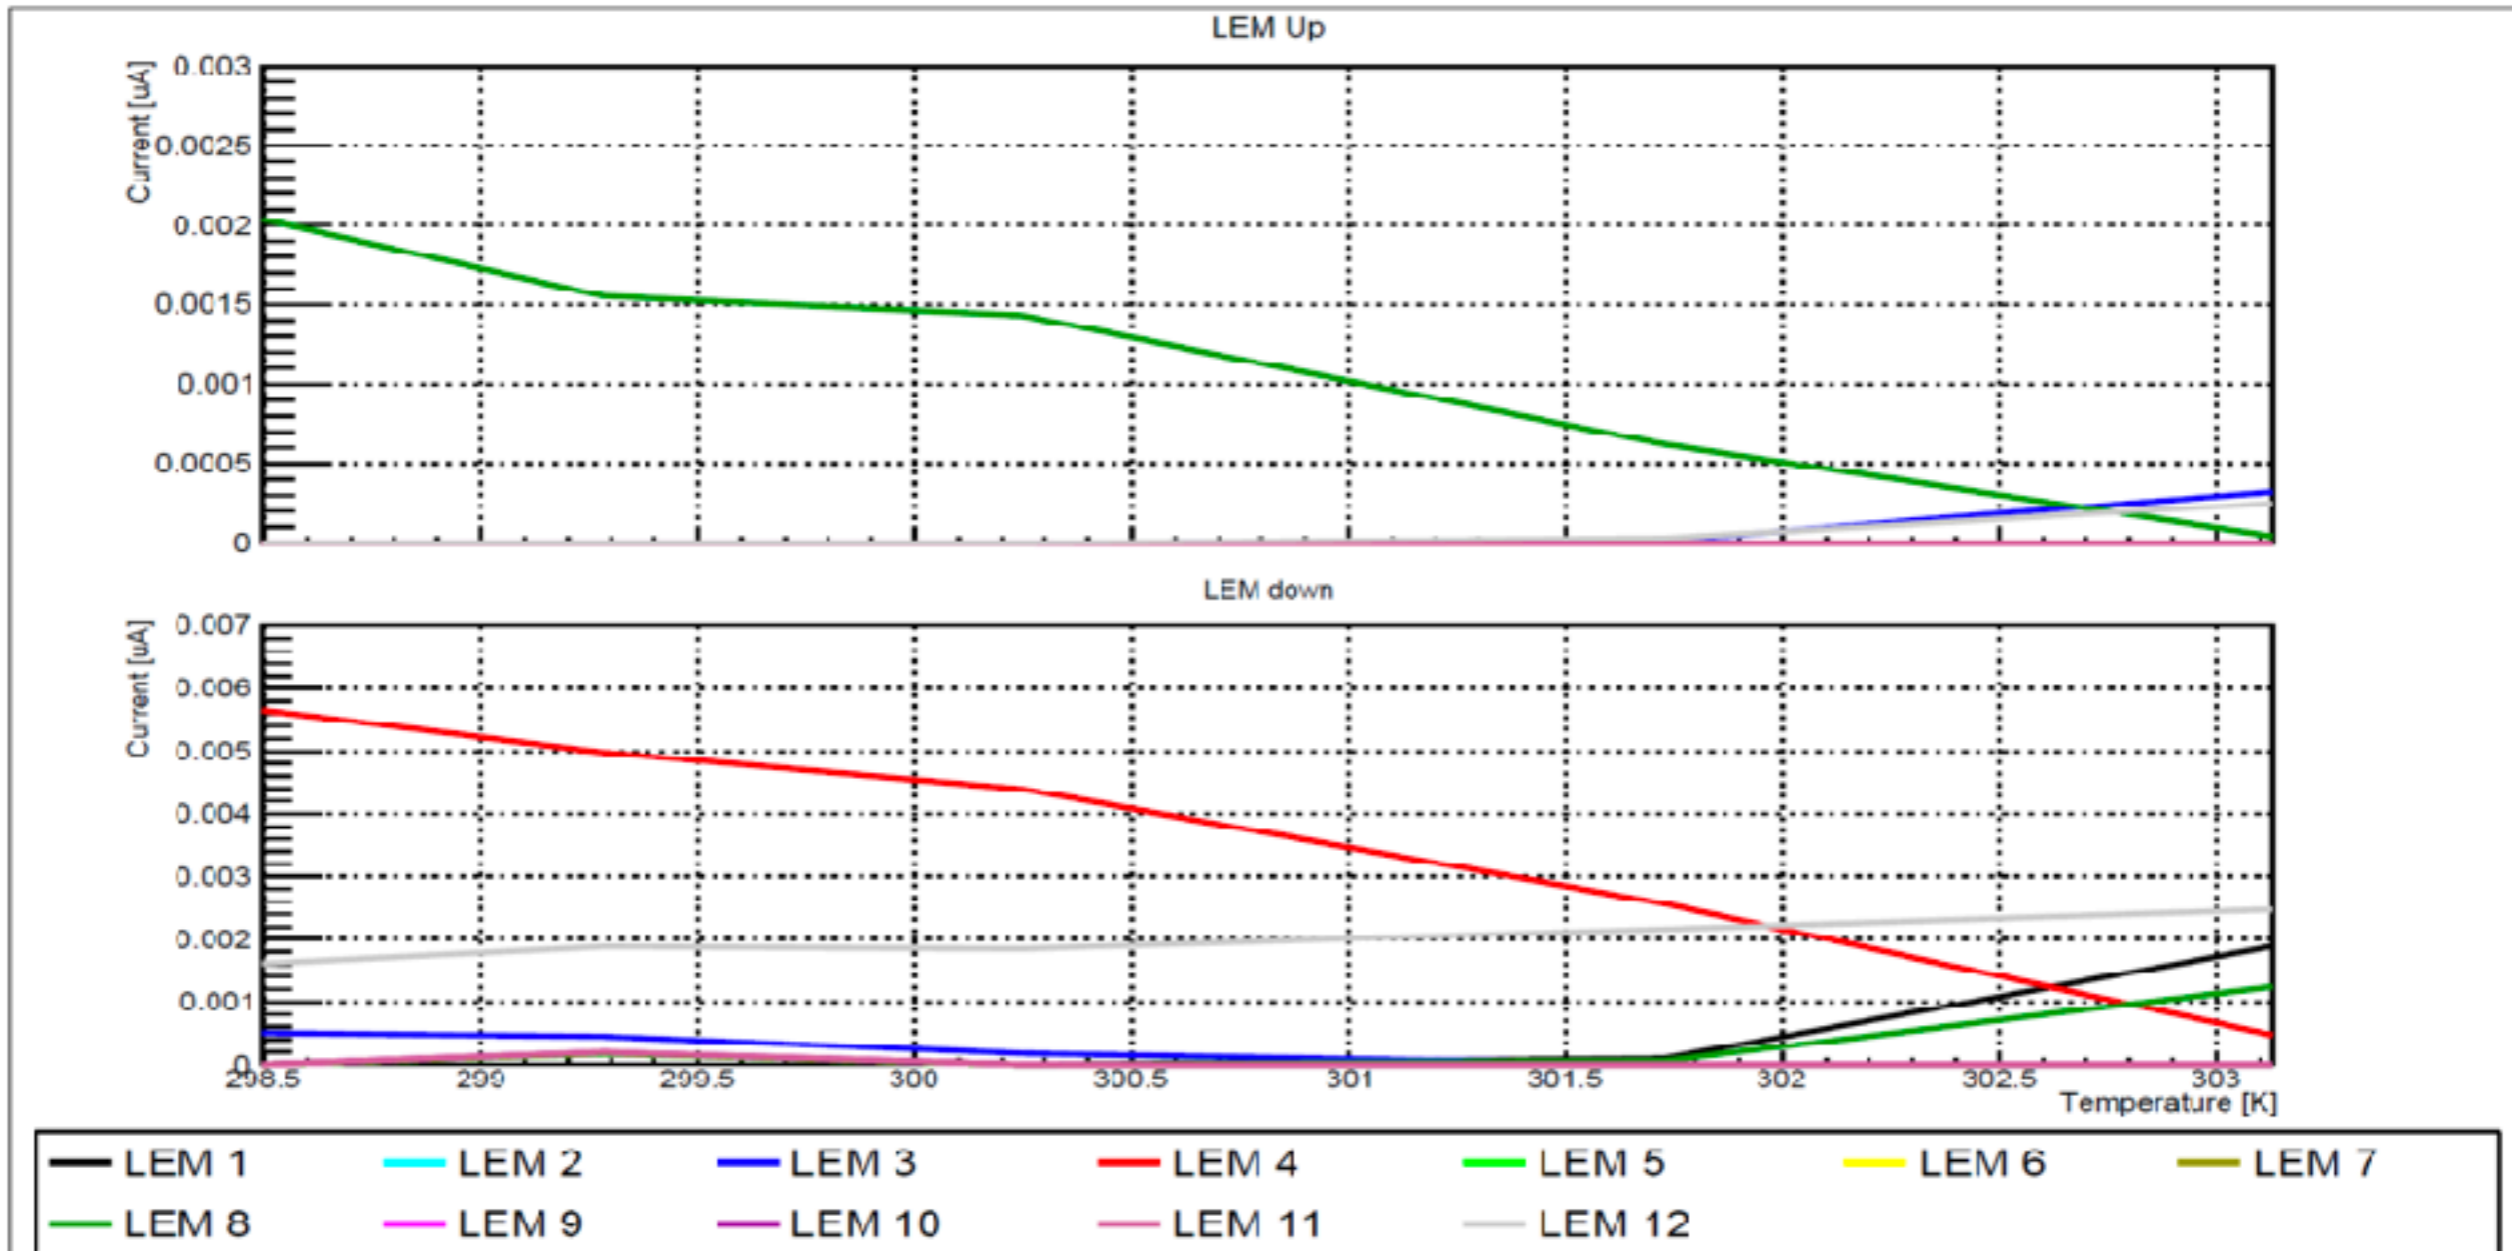
1) The current is (anti-)correlated to the hall temperature. (plot for the period of 07.07.2017 – 09.07.2017)

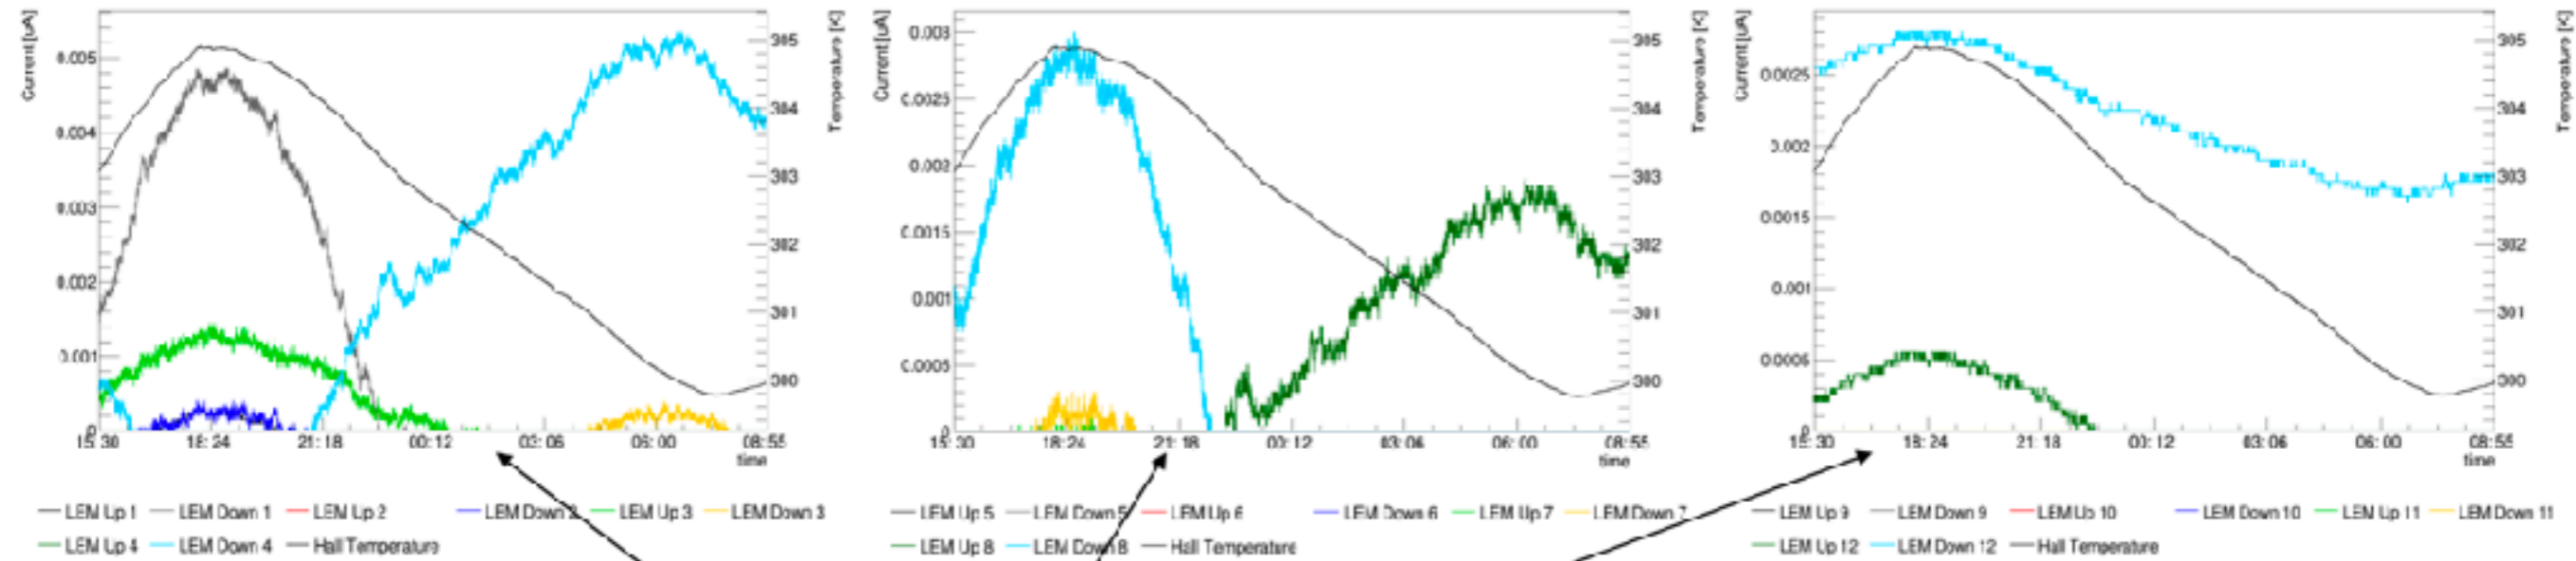
2) The current is higher on some LEM (see table) and the current drops from Board 0 to Board 2.

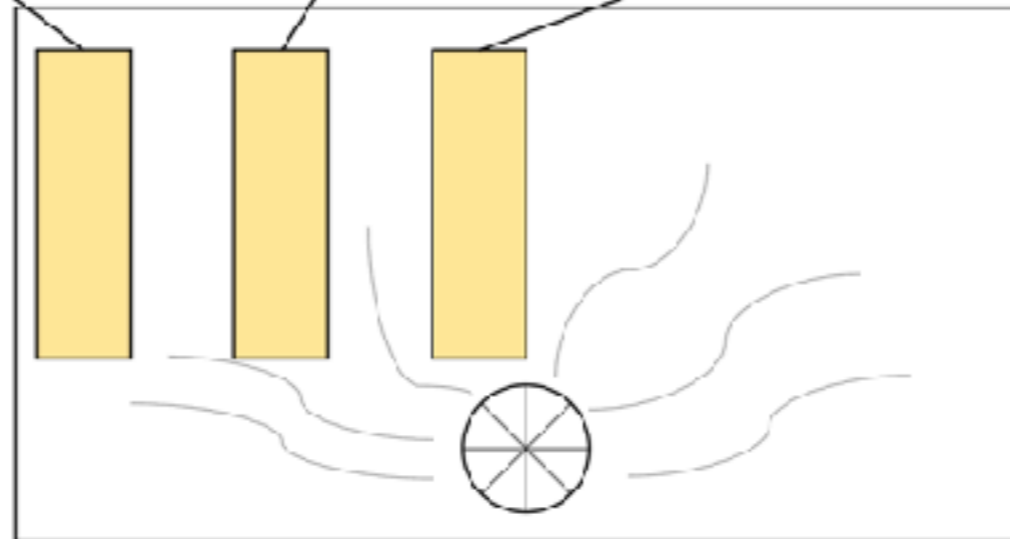
Fan providing a uniform air flow

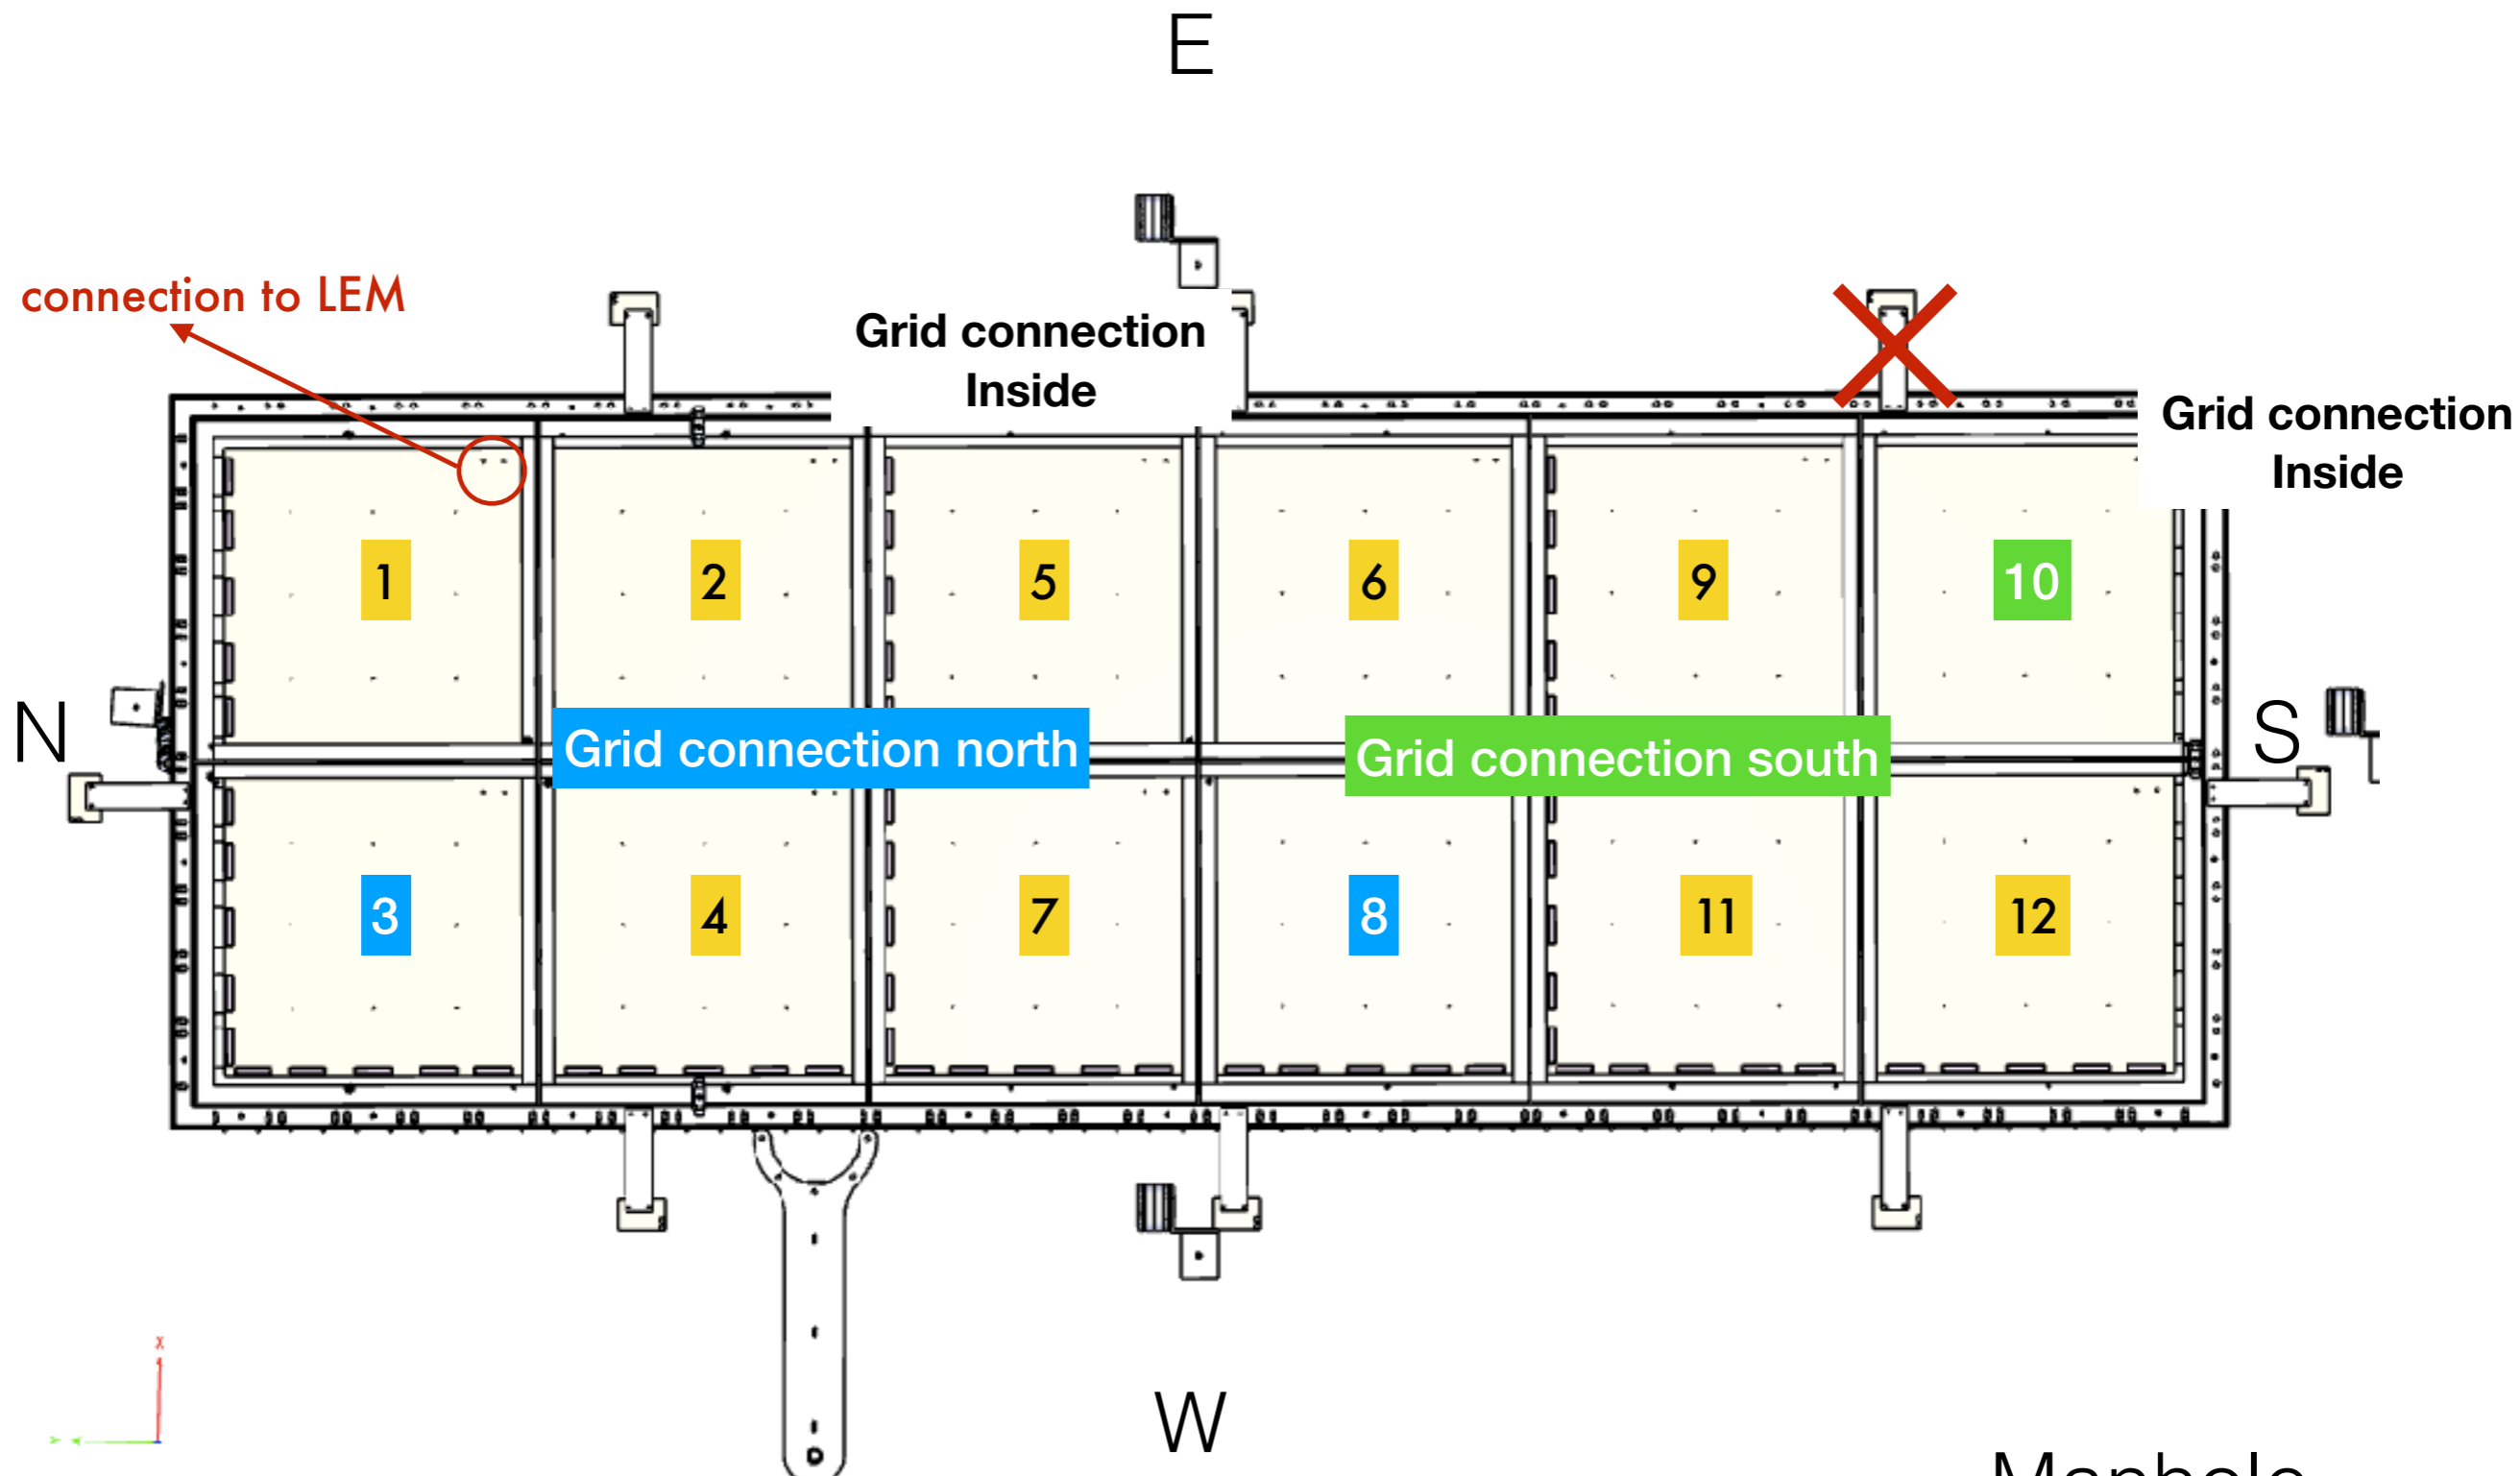
The grid tripped ramping up to 4,8kV Tripped between 3,8 and 4kV corner

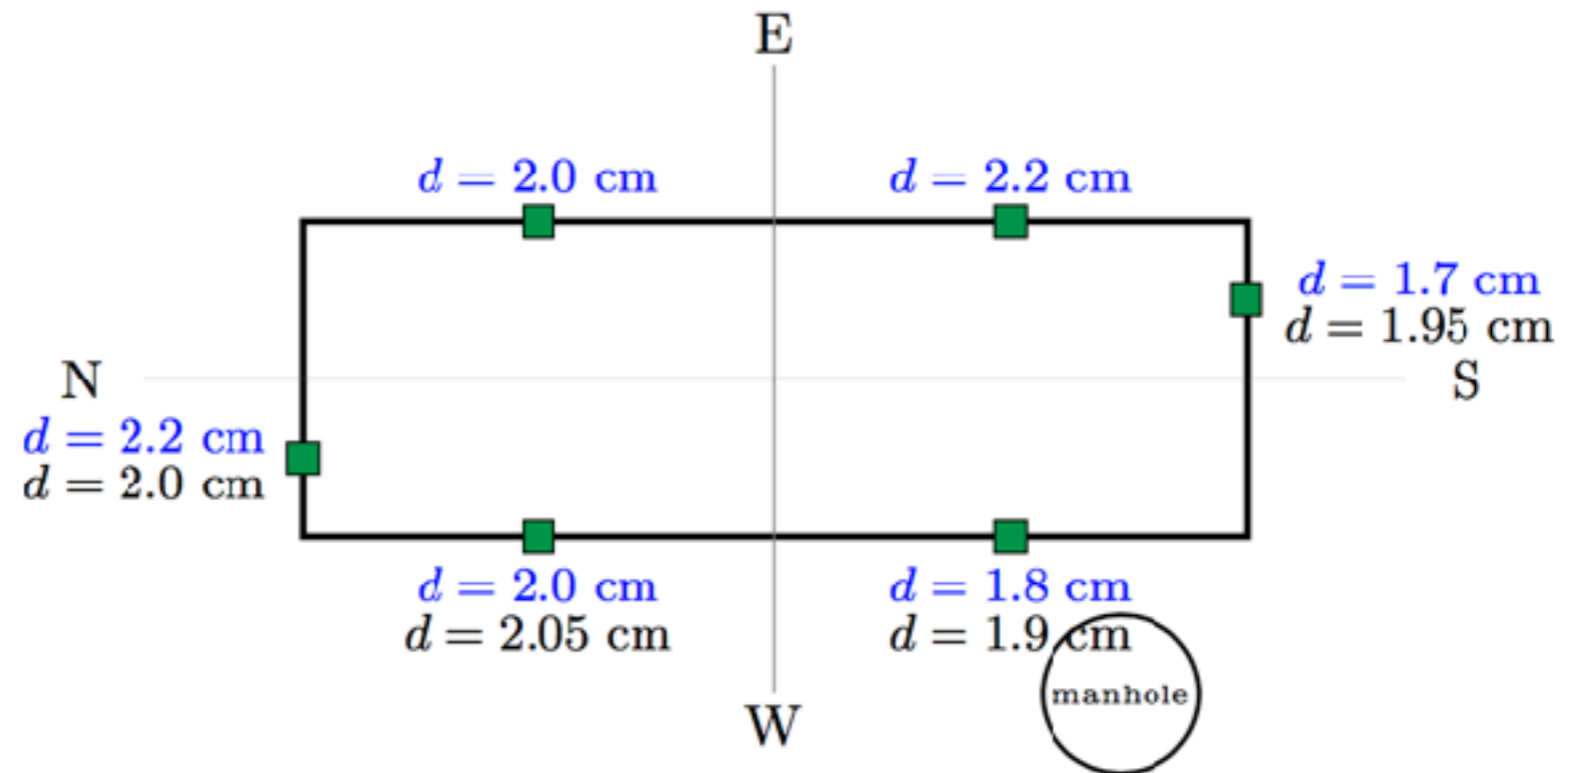
All d should be = **2.05 cm** (i.e. LM-DC aligned with DC).
They are not. Also DC is tilted (as seen before).
Because of misalignment and tilt :
⇒ **sensor on the N side [LM-DC1] is the highest**
⇒ **sensor on the S side [LM-DC4] is the lowest**
↳ cf elog#219, LM-DC4 was the first one to see LAr

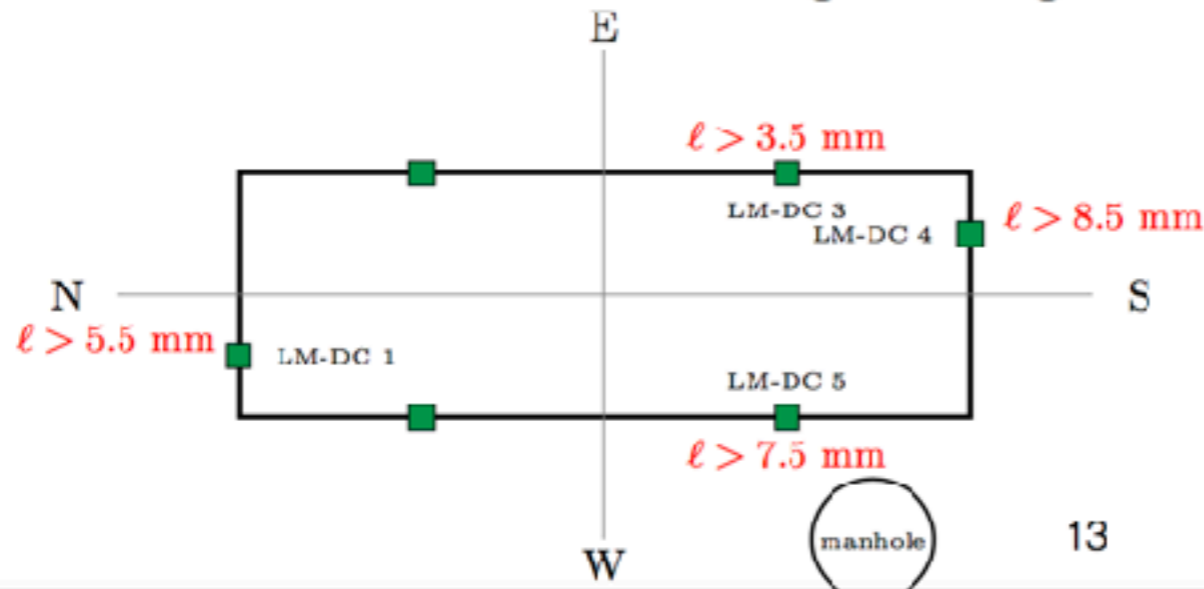
As DC is tilted :
 critical for LM-DC 1.
 LM-DC 3, 4 and 5 should be fine

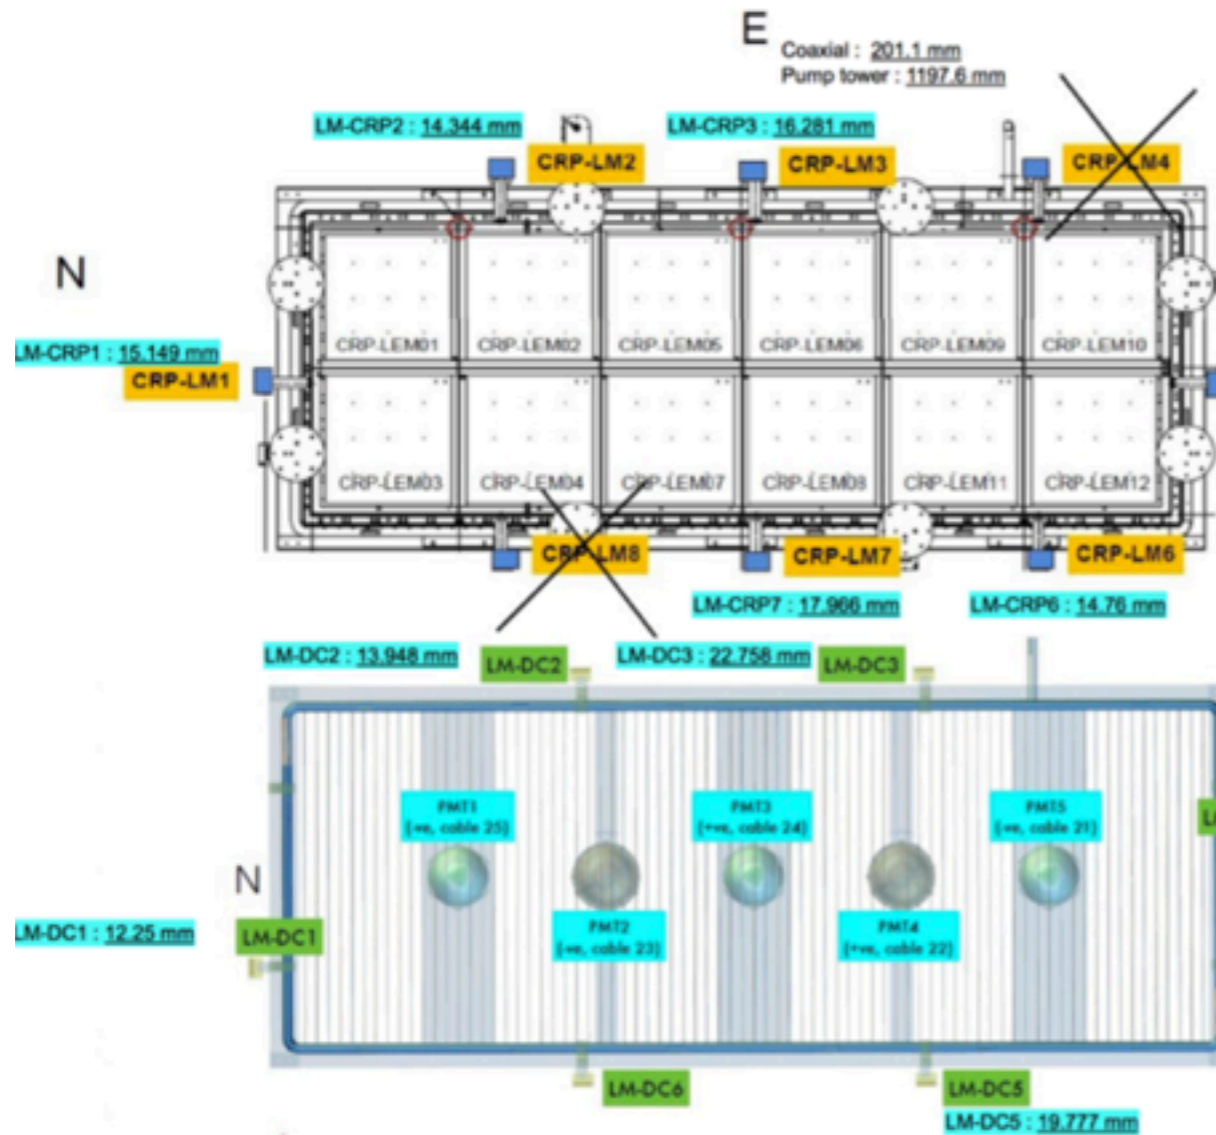
↳ Central part of the CRP is more immersed ?

↳ Consistent with 4 mrad tilt
 $\text{asin}(12/3000) \sim 4 \text{ e-3 rad}$
