CT-PPS Experience during Intensity Ramp-Up; Recent Auto-Retraction

**MPP Meeting
22 September 2017**

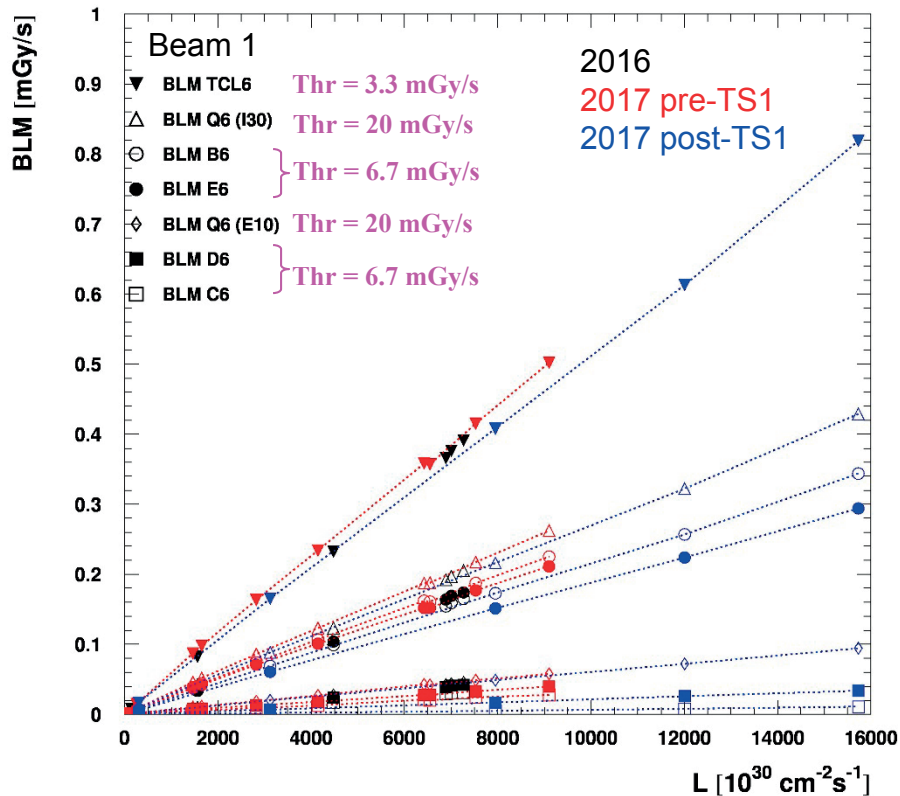
BLMs

- Up to the highest LHC luminosity: $L = 1.6 \times 10^{34} \text{ cm}^{-2} \text{ s}^{-1}$
- 2 ramp-up periods: before and after TS1
- without any problems (except 1 interlock problem \rightarrow later)
 - BLM signals in line with 2016 (at least factor 3 below thresholds)
 - very good vacuum levels
 - benign temperatures
 - no impedance problems

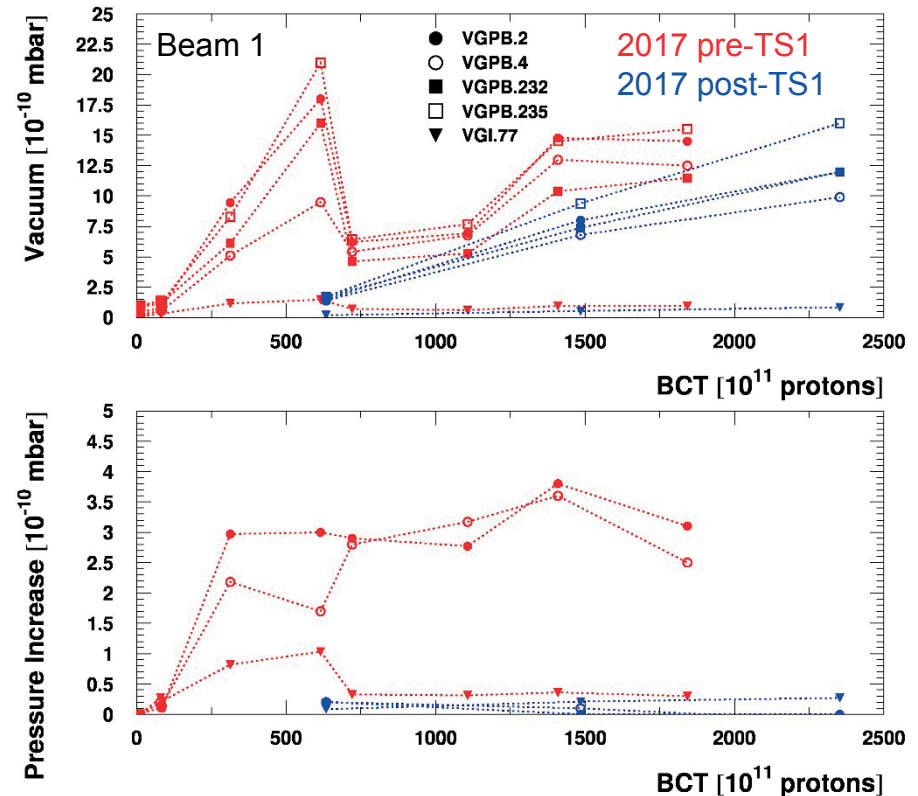
Vacuum dominated by other systematics, not primarily by beam current.

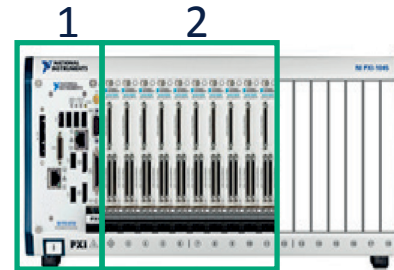
24 June: spurious dump by movement interlock,
TIMBER logging time resolution not fine enough → no malfunction found
→ Implementation of an LVDT filter and a post-mortem diagnostic system
(see MPP 07.07.2017)

- Real time part (1):
- Generation of a post mortem file after an interlock generation (1s before and 1s after).
- FPGA part (2):
- **Interlock Generation if conditions are valid during three consecutive loop iterations of 10 ms each** (same as AFP and ALFA)

i.e. only if the dump threshold was crossed!
Crossing the warning threshold does not trigger a post-mortem file. **To be improved.**
