# Xilinx 9500/9500XL CPLD Testing CNGS 2009 Update 3.09

TE/MPE/MI

Radiation Working Group

3<sup>rd</sup> September 2009

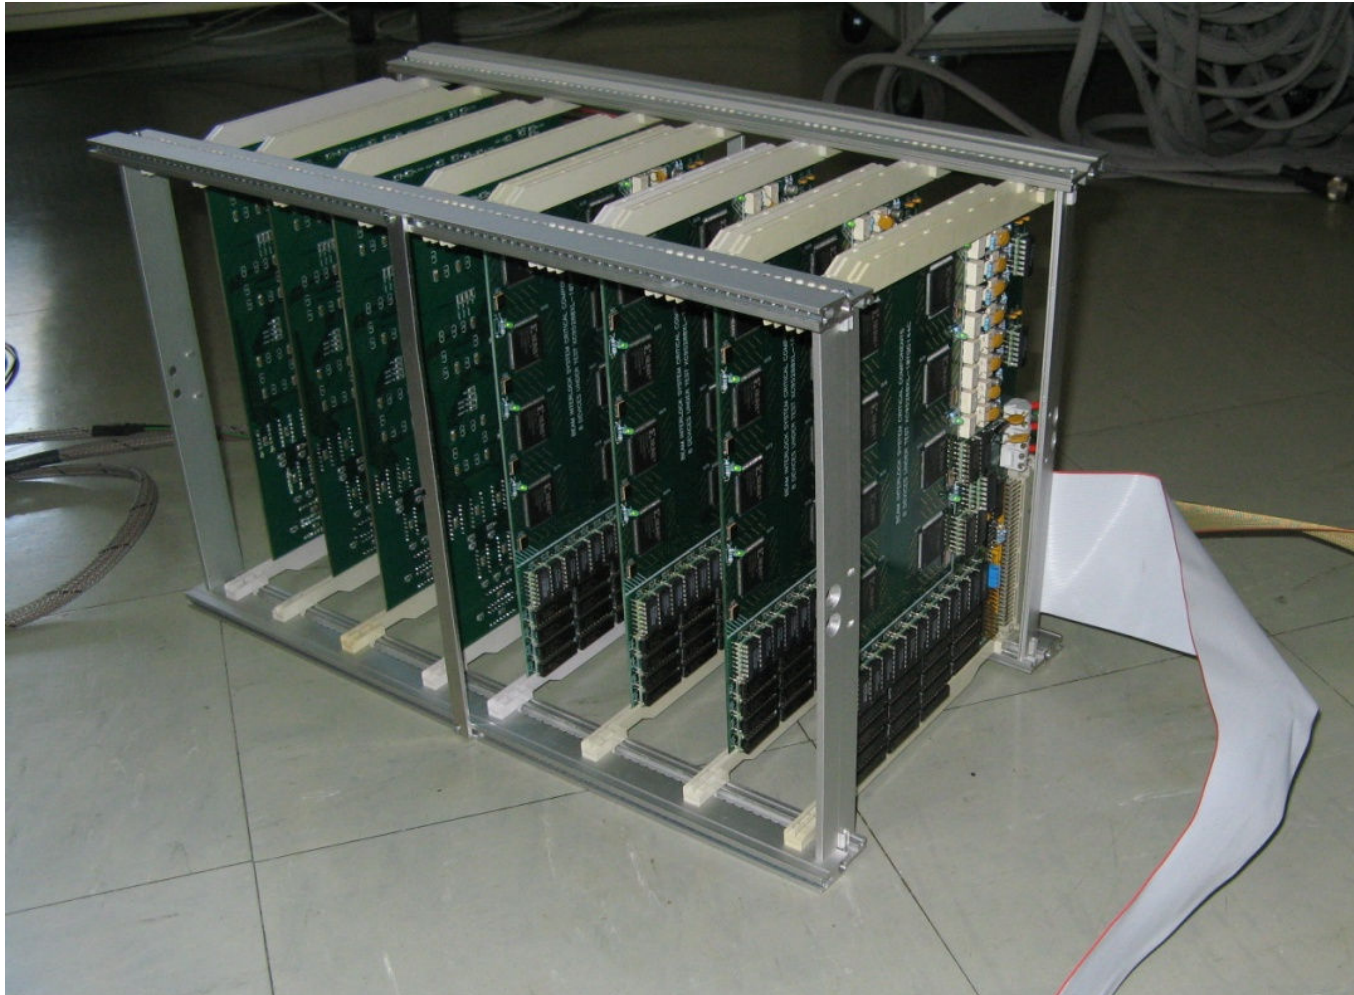
**32 x XC9500 (5V)**

**9 glitches**

**15/08/2009 03:12:08.0289 – Beam ON**

**16/08/2009 15:33:13.7339 – Beam ON**

**17/08/2009 18:35:46.0737 – Beam ON/OFF**

**20/08/2009 05:55:53.3168 – Beam ON**

**22/08/2009 00:40:03.1329 – Beam ON**

**23/08/2009 05:17:16.3159 – Beam ON**

**01/09/2009 08:11:19.3216 – Beam ON**

**01/09/2009 11:15:13.6641 – Beam ON**

**02/09/2009 08:27:47.7136 – Beam ON**

one event doubtful there was beam – will have to look at logging shot-by-shot  
Could be EMC...

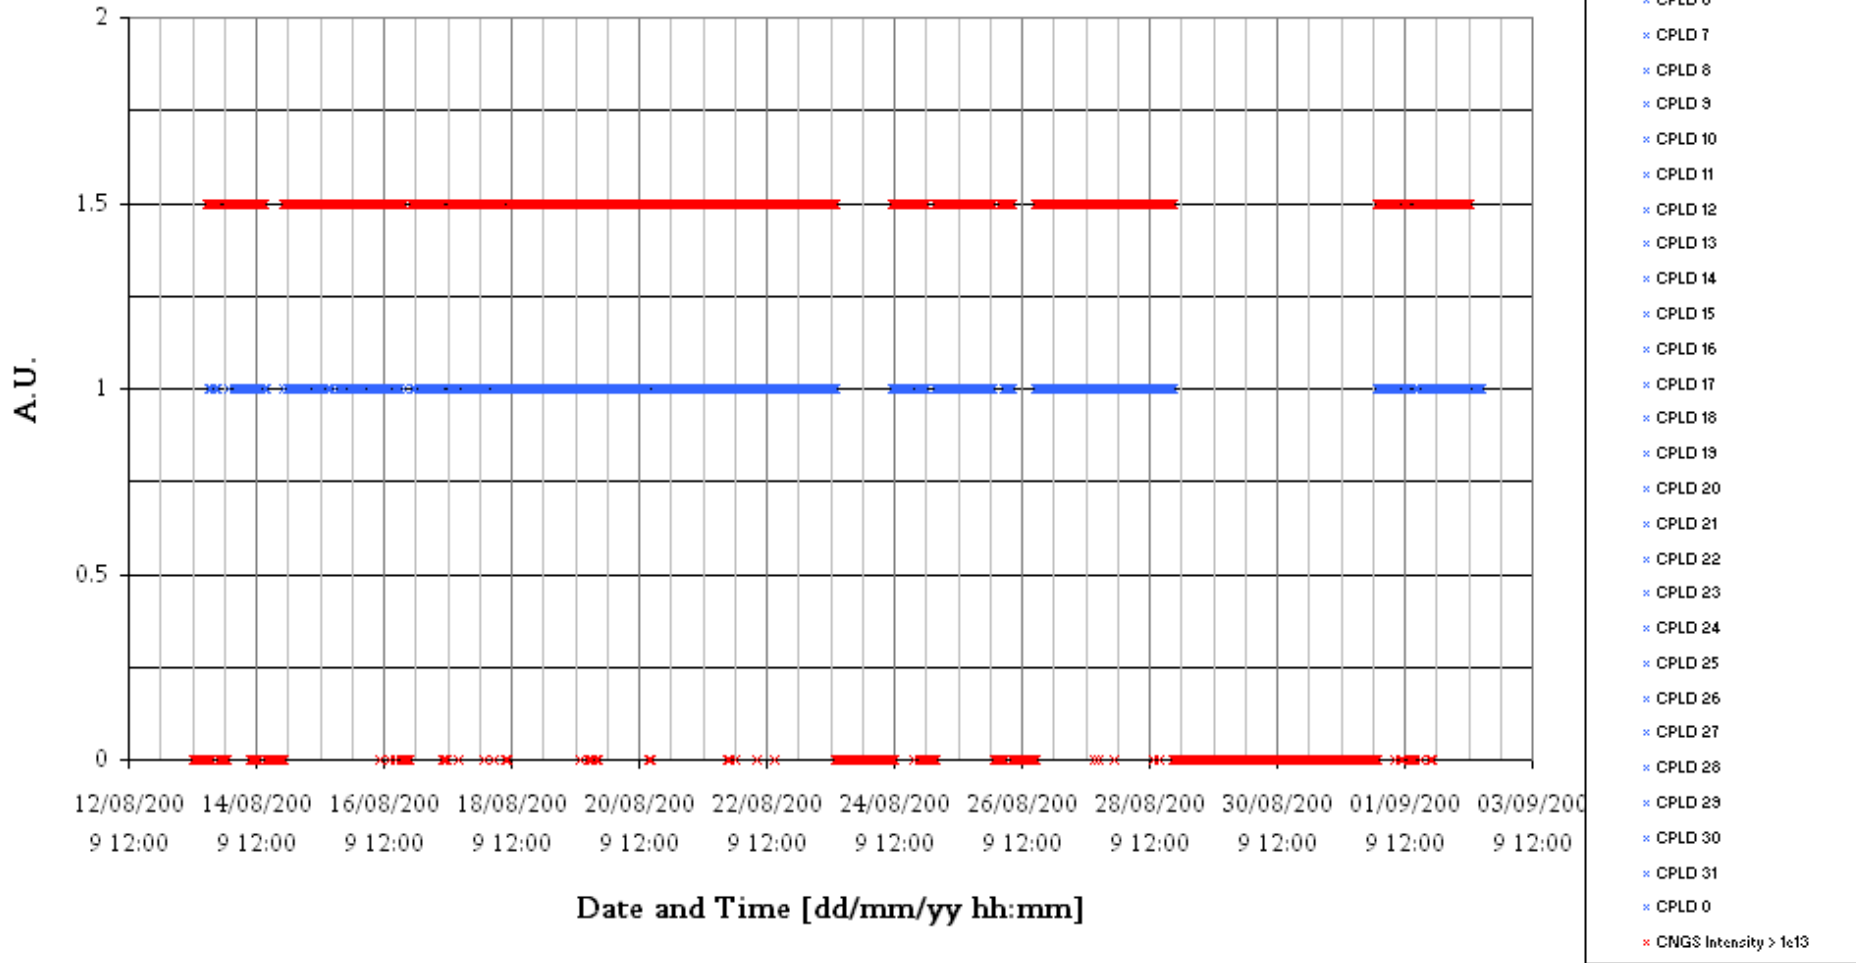
## Single Event Upsets Observed in the CIRB Test Bench with Fluence on CNGS Target

47 (Gy) Total Dose

No failed devices yet.

1.13e12 1MeV equivalent Hadrons

5e-9 Events per Particle

7.8e11 >20MeV Neutrons

8e-9 Events per Particle

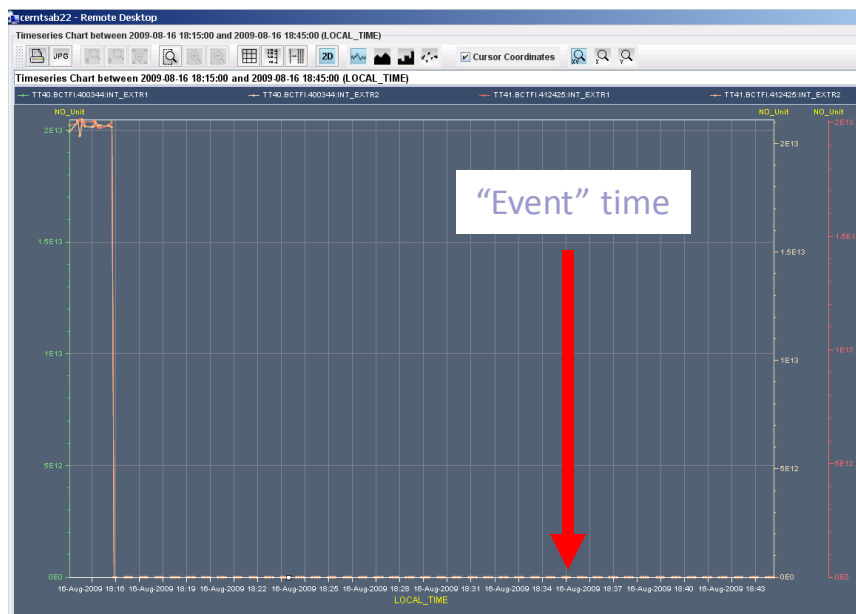
- Have seen constant events in the log-file since 15:00 on day of installation
- False Beam Dumps
- Missed Beam Dumps
- Periods without beam in SPS = no errors...
