# Update: Stave 7

WILLIAM HEIDORN  
IOWA STATE UNIVERSITY  
ISU WEEKLY STAVE QA MEETING  
MAY 29, 2018

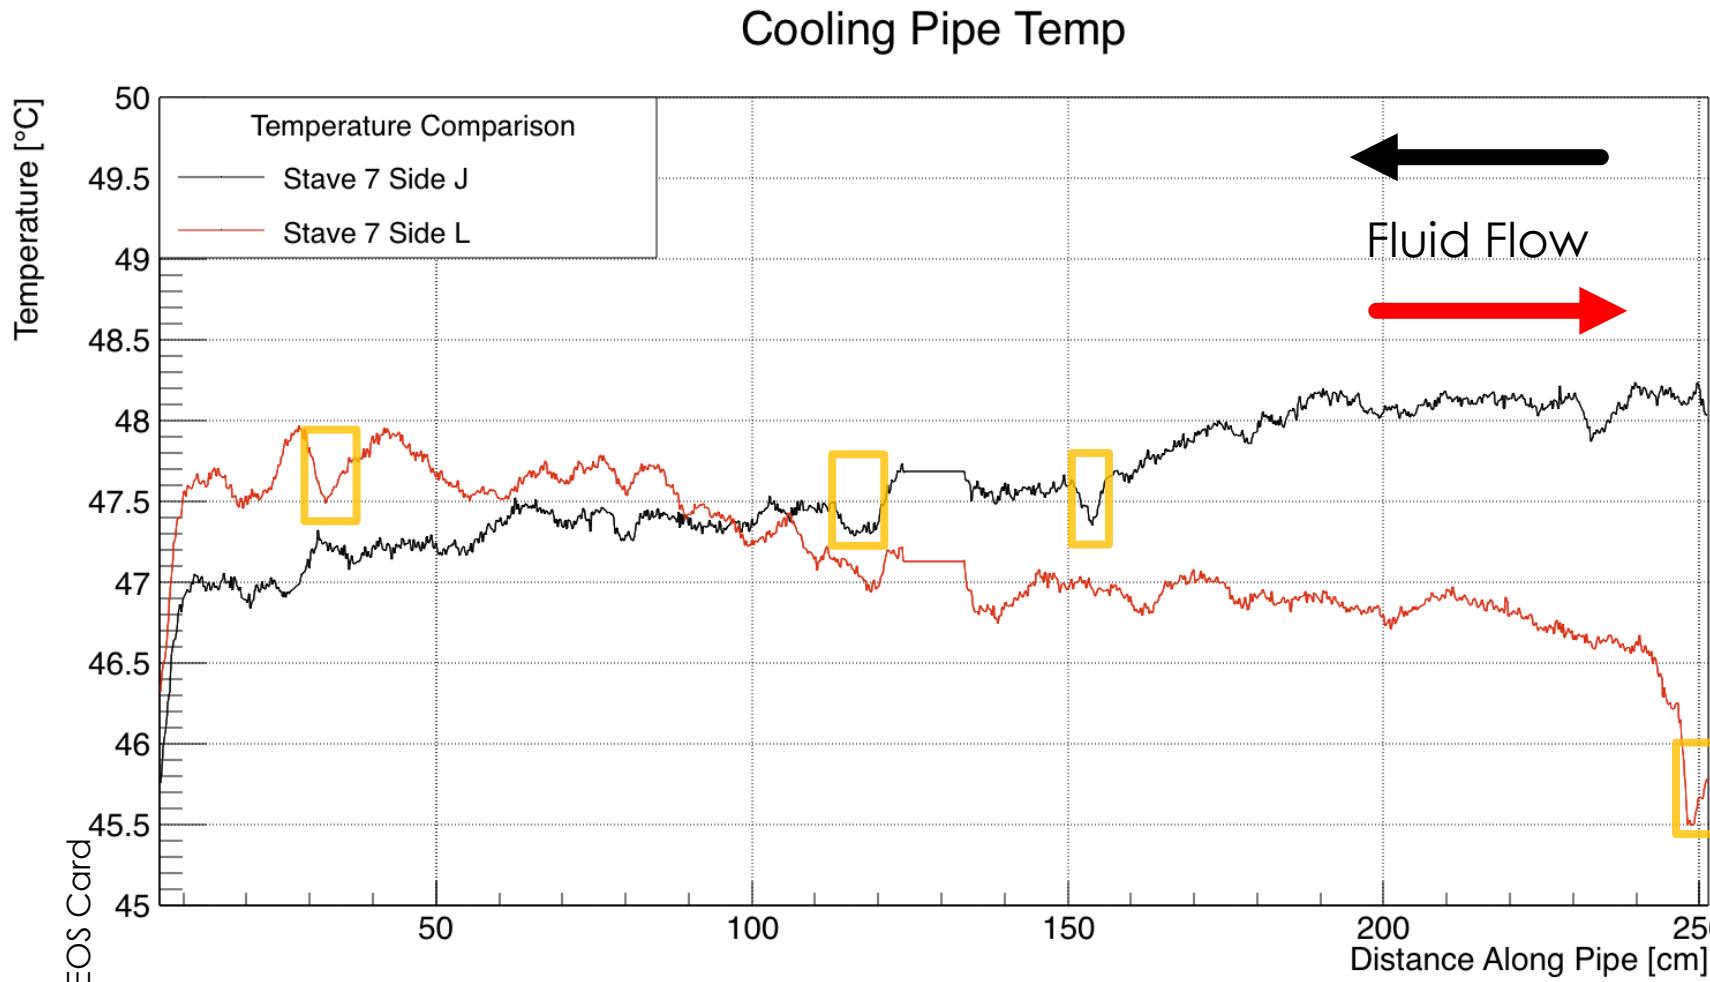
# Stave 7: Thermal Measurement Hot

- Thermal measurements were taken on both sides of the stave with 50 C fluid flowing into the stave core
- The defect finder found 4 possible defects. Only the side L defects are reproduced in the cold thermal profile
- Linear Fit RMS was found (Stave 6 Results also given for comparison)
  - J Side: 0.13 C (0.12 C)
  - L Side: 0.21 C (0.09 C)

- ▶ Flaws were found by the defect finding algorithm in the hot thermal profiles, but not in the cold profiles. Similar features are still found in the cold profile for side L. This would indicate that there could be a few unimplemented flaws on this stave.

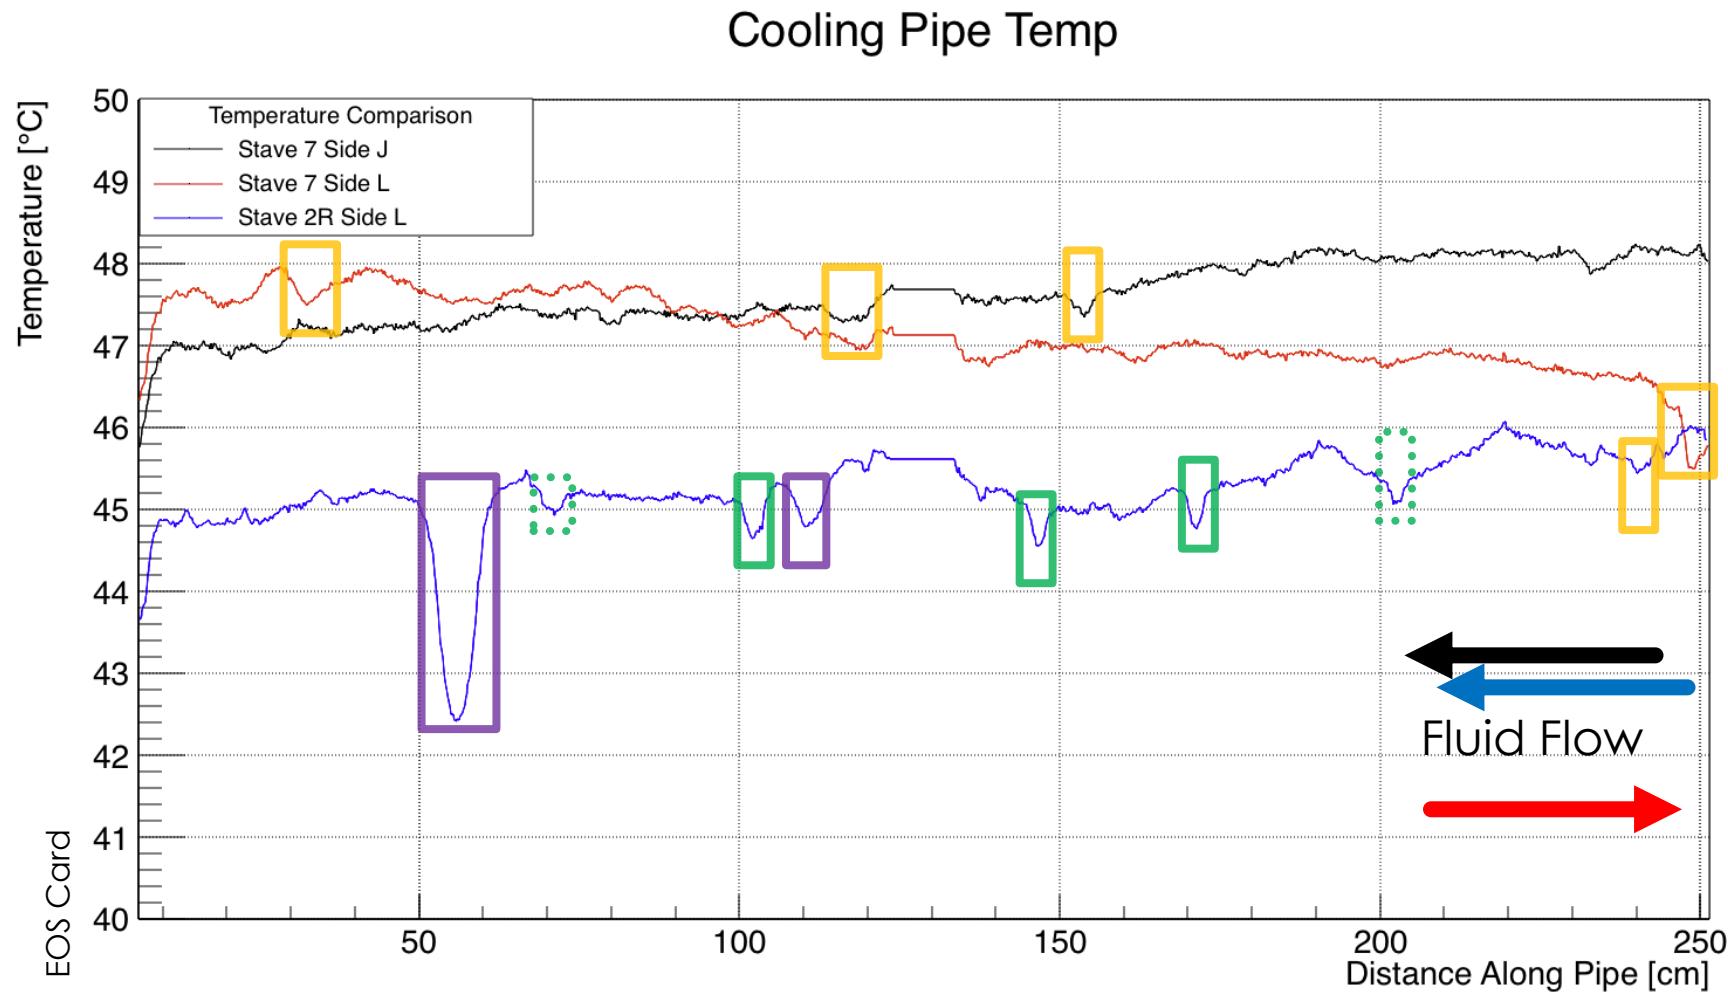
# Stave 7 Comparison with Stave 2R Hot

- ▶ This is a comparison between stave 6 and 2R with +50C fluid flowing
- ▶ The defects found are boxed on the 2R profile
  - ▶ **Purple:** Pipe-Foam
  - ▶ **Green:** Foam-Facing
  - ▶ **Green Dotted:** Partial Foam-Facing
  - ▶ **Orange:** Unimplemented

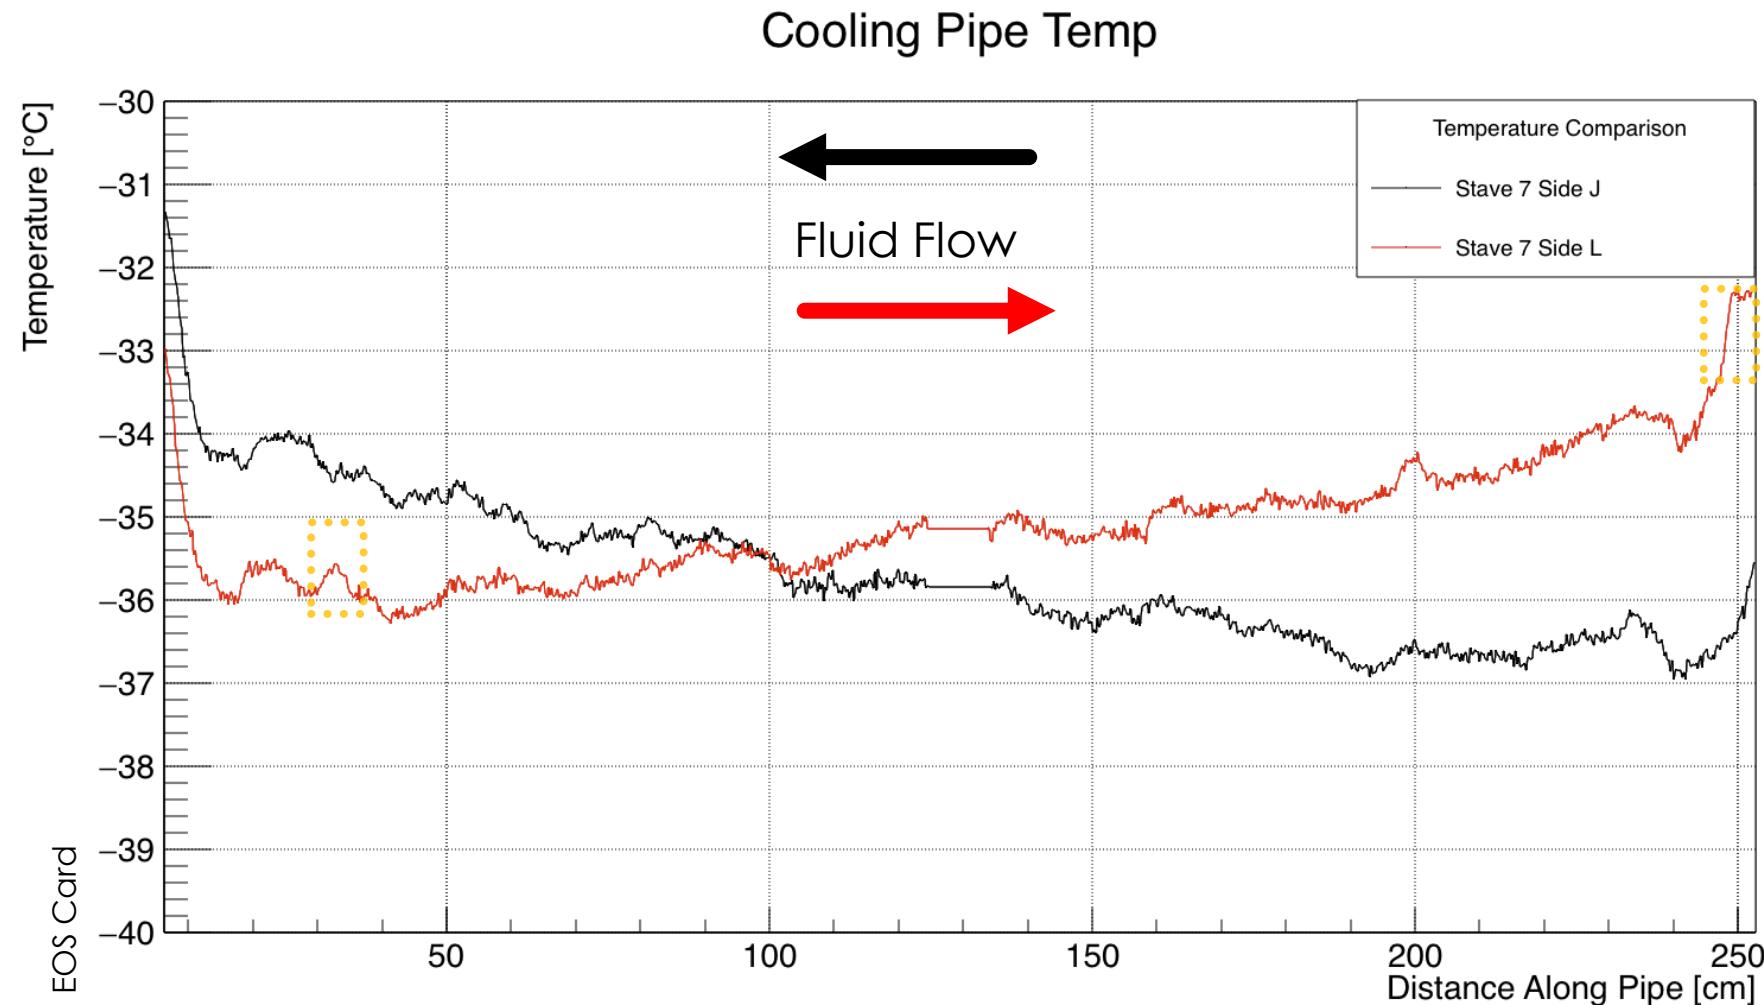
# Stave 7: Thermal Measurement Cold

- ▶ Thermal measurements were taken on both sides of the stave with -40C fluid flowing into the stave core
- ▶ Dry nitrogen was turned off at least 10 minutes before measurements were taken
- ▶ The defect finder found no flaws
- ▶ The yellow boxes show the repeated flaws from the hot measurements
- ▶ Linear Fit RMS was found (Stave 6 Results also given for comparison)
  - ▶ J Side: 0.3 C (0.6 C)
  - ▶ L Side: 0.3 C (0.6 C)

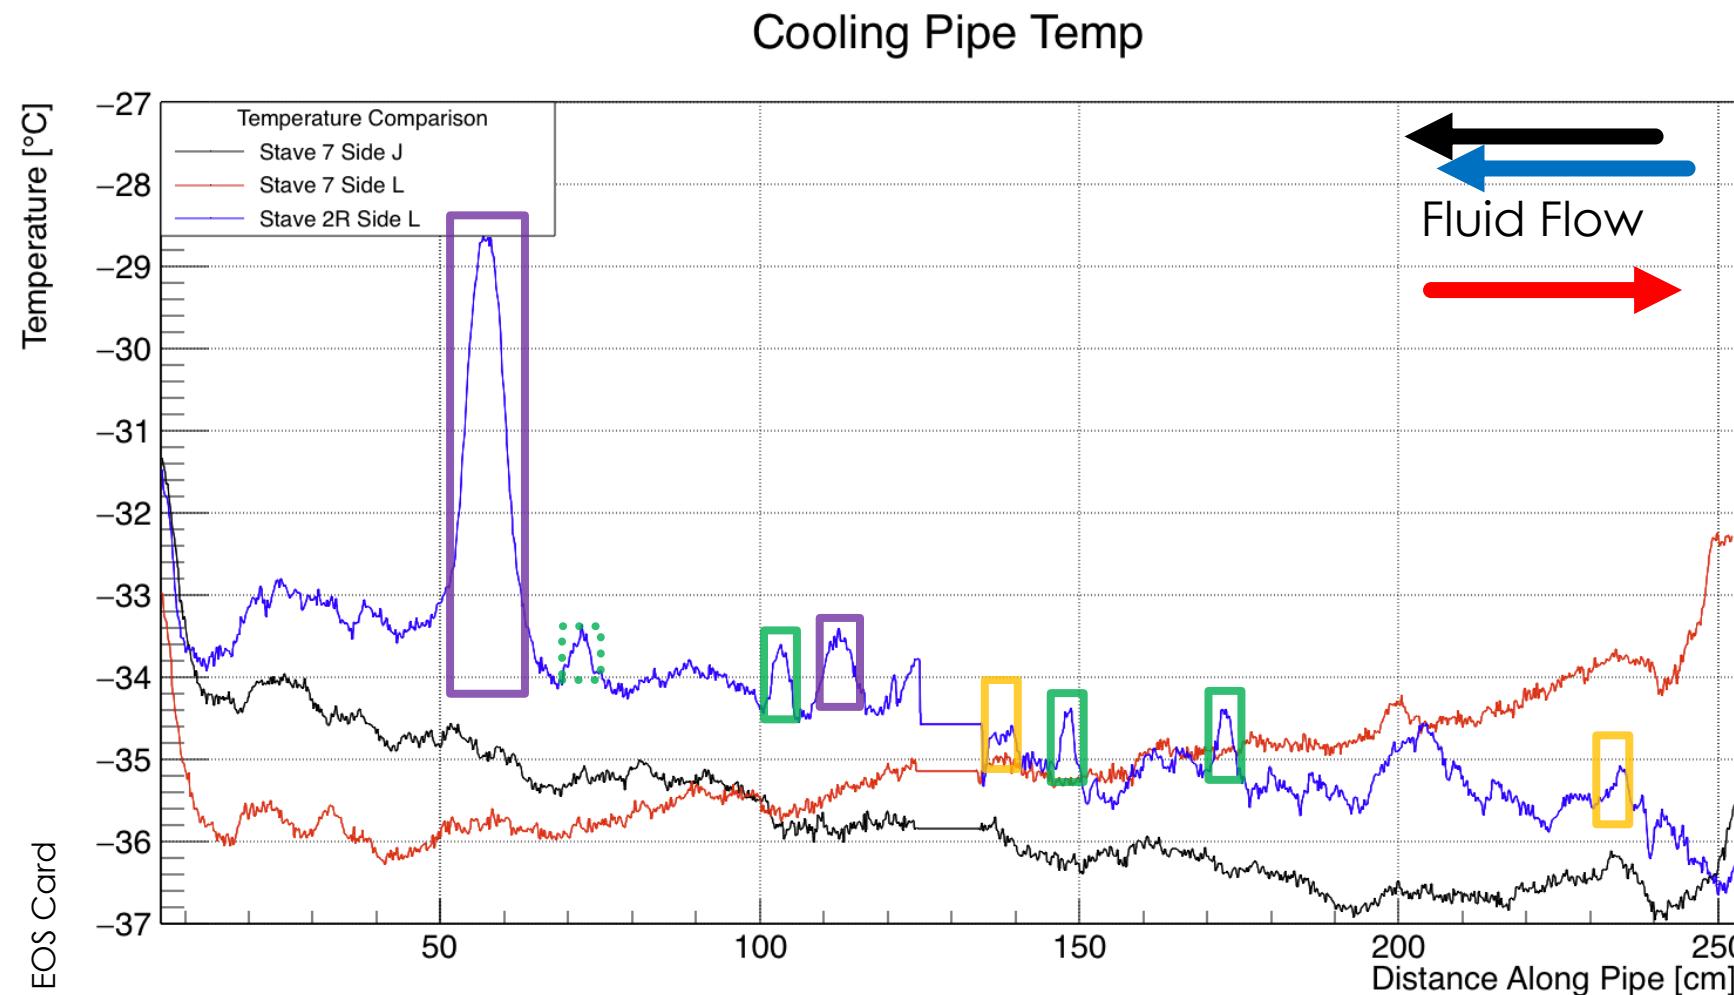
# Stave 7 Comparison with Stave 2R Cold

- ▶ This is a comparison between stave 6 and 2R with -40C fluid flowing
- ▶ Profiles are more chaotic...
- ▶ The defects found are boxed on the 2R profile
  - ▶ **Purple:** Pipe-Foam
  - ▶ **Green:** Foam-Facing
  - ▶ **Green Dotted:** Partial Foam-Facing
  - ▶ **Orange:** Unimplemented
