CAN WE OPTIMISE THE CLEANUP PROCESS FURTHER?

V. Baglin, CERN, Geneva, Switzerland

Abstract

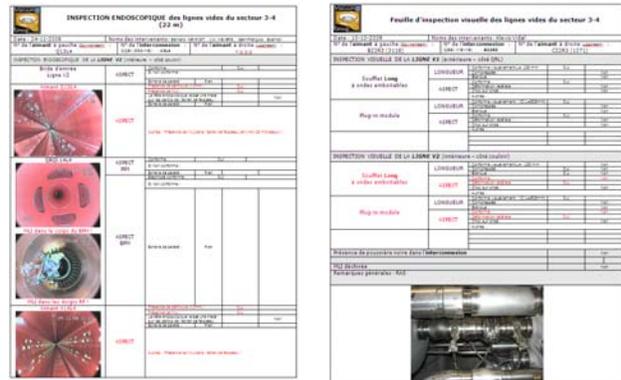
Figure 1 shows extracts of reports issued by the team in charge of the inspections. In the endoscopic report, all components such as beam screens, PIMs and beam position monitors were photographed. Their aspect and the level of their cleanliness were also evaluated. In the interconnection report, the length and the aspect (deformation, presence of shocks ...) of the nested bellows and the PIMs was reported. A picture of the interconnection was also taken.

Figure 1: Left, example of endoscopic report. Right, example of interconnection report

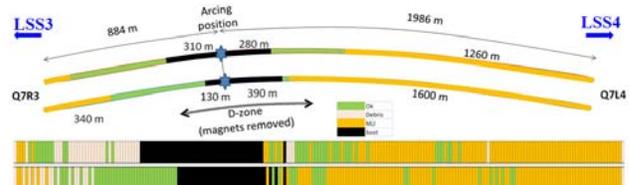
By the end of December 2008, 4.8 km of beam tube and 122 interconnections were inspected and documented. A total of 59 % of beam tube were polluted by super insulation debris (MLI) and 19 % by soot [1].

Figure 2 shows the debris distribution along sector 3-4. Most of the super insulation debris were observed at the extremity of the sector. However, these debris were spread from Q30R3 till Q7L4.

Figure 2: Debris distribution along sector 3-4.

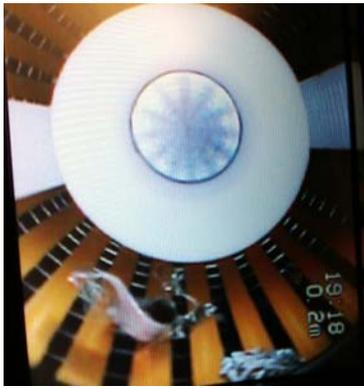
Of course, the work did not progress without difficulties. Several times, the endoscopes were damaged or the nozzle was stuck inside a PIM as shown in Figure 4. In this last case, TE-MSC was requested to open the W below and cut the PIM. There were also issues with coactivity which not only delayed the task but also, some time, decrease the performance of the work. Indeed, dusts were produced in the tunnel by the teams in charge of drilling a hole for the cryostat relief valve beside the team in charge of cleaning the beam tube. Obviously, this could not work!

Figure 4: Nozzle blocked by metallic debris

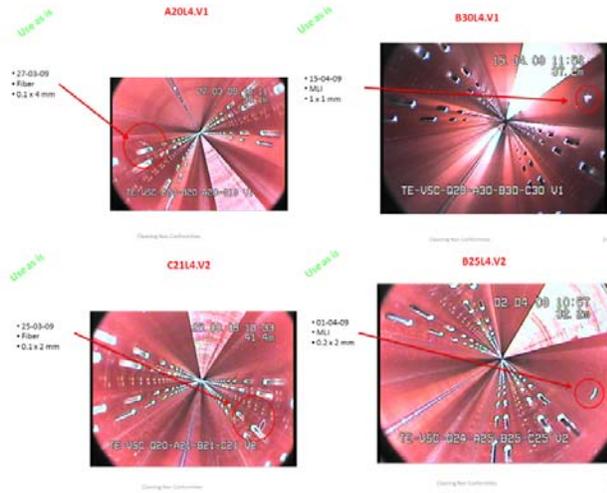
Finally, the validation of the beam cleanliness by simple endoscopic inspection was not always trivial. As shown in Figure 5 where fibre or MLI are hardly identifiable. A total of 101 non-conformities left as “use as is” were recorded. 58 were assigned to super insulation debris, 38 to fibre and 5 to oxidation stains. All these non-conformities were documented and archived.

Figure 5: Examples of non-conformities left as “use as is” identified during the validation step
