# Repair and Consolidation Actions

Francesco Bertinelli

CERN - Technology Department - MSC Group

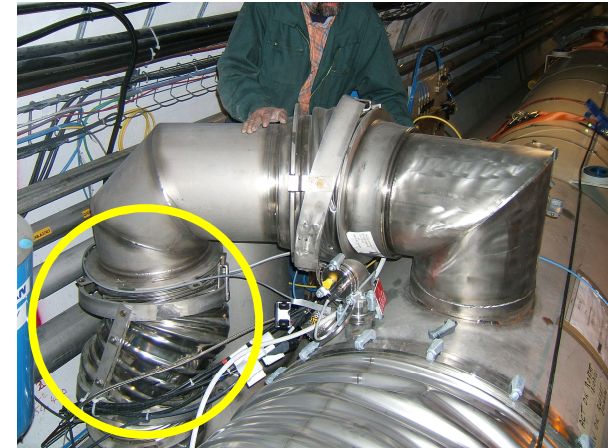
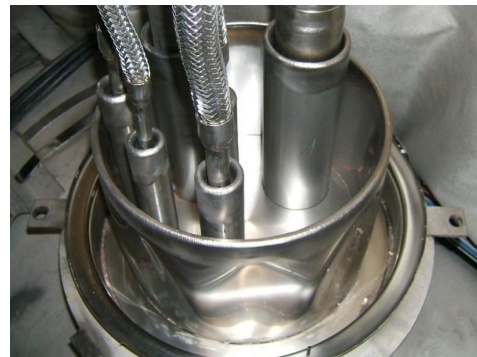
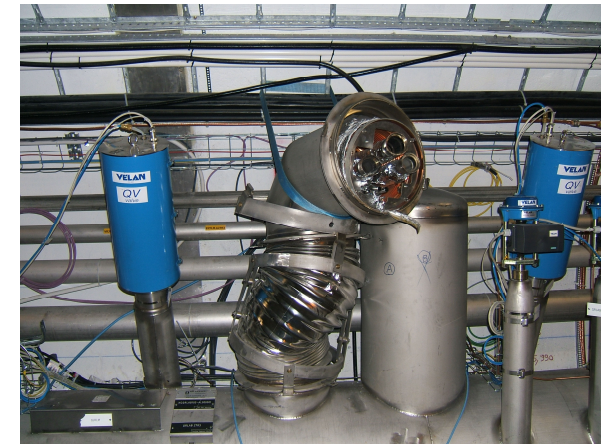
# QRL service modules: jumpers

- First diagnostic:
  - Q23, Q27 & Q31 bellows deformed from displacement
  - Q25 collapsed bellows from inner pressure
- Second diagnostic, more detailed:
  - Some internal bellows damaged
  - some 80K vacuum barriers collapsed due to external over pressure
  - Some soot in QRL piping
- In situ repair

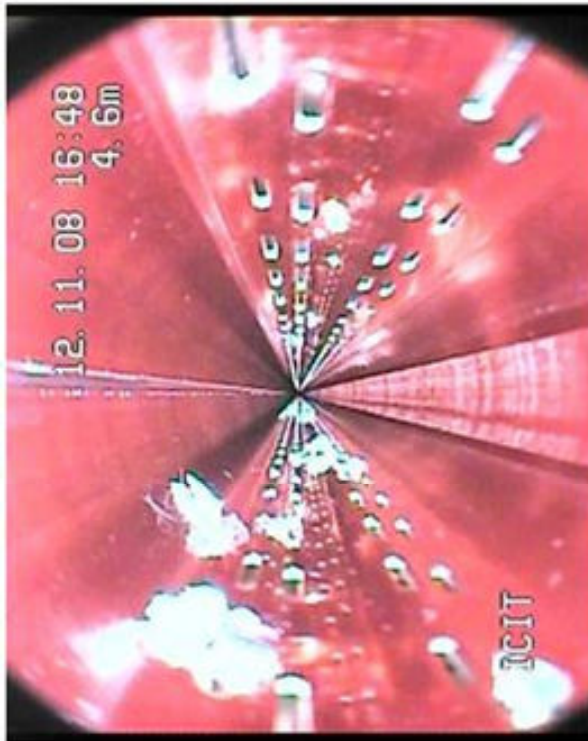
Beam screen contaminated with multi-layer magnet insulation debris

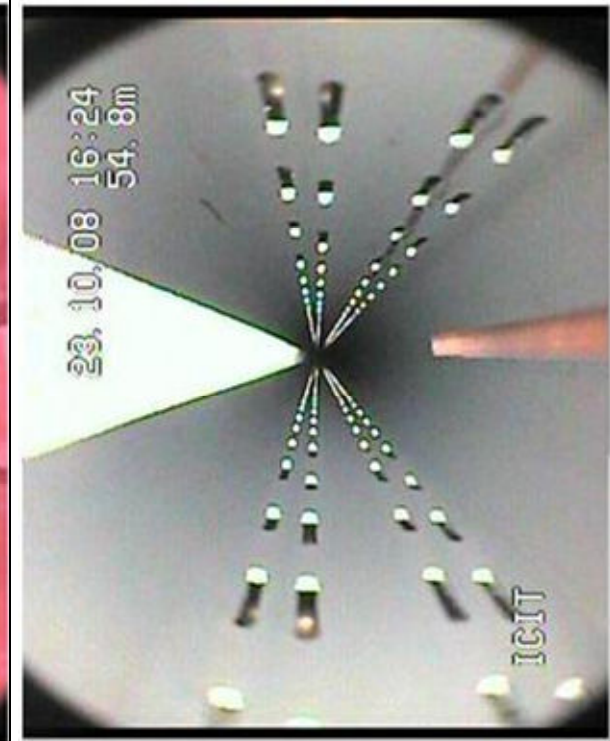
Beam screen contaminated with soot

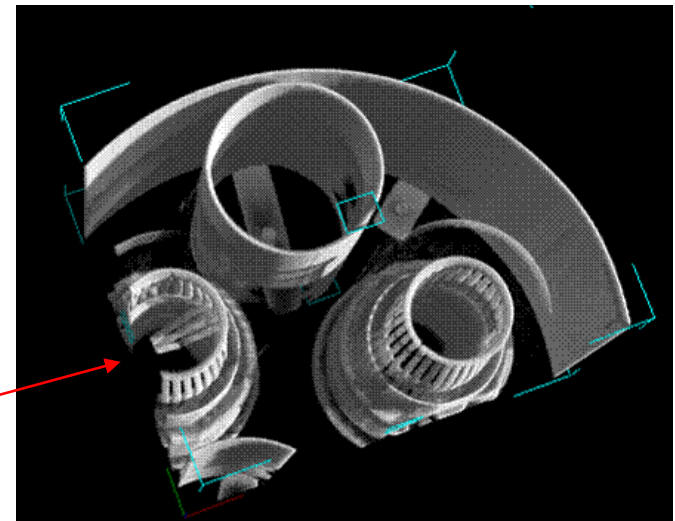
*e.g. PIM RF fingers defect*

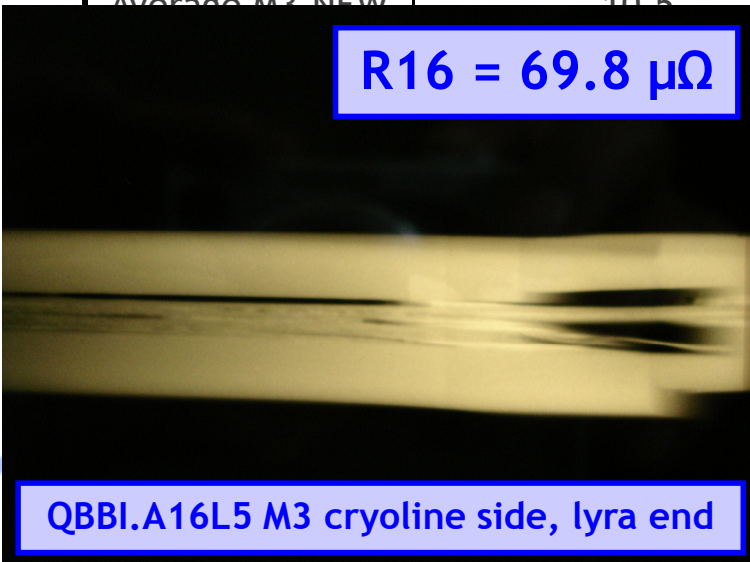
R16 = 69.8  $\mu\Omega$

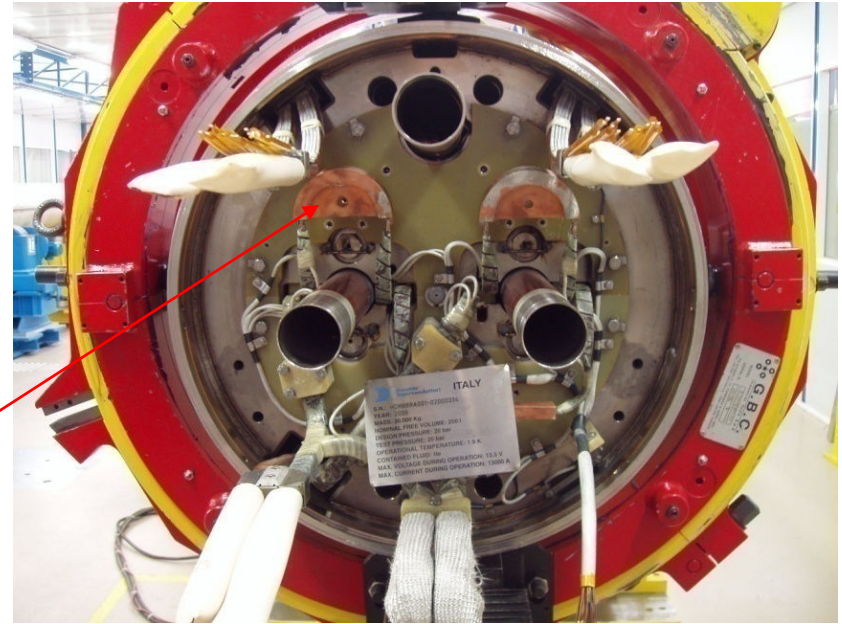
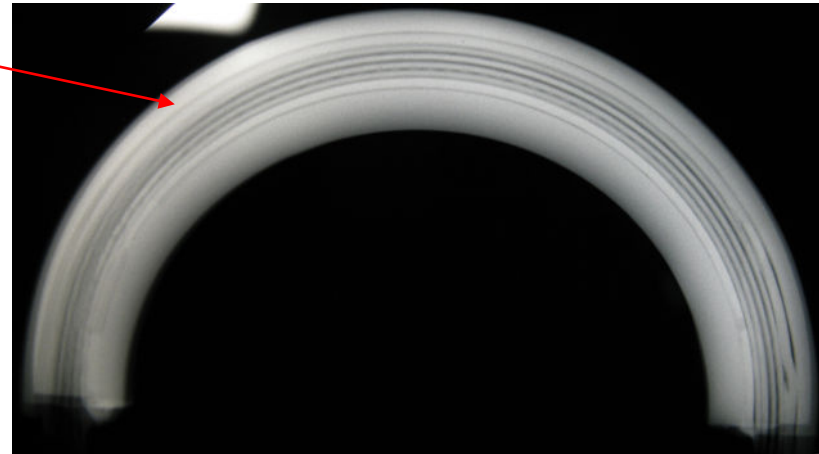
# Dipole MB2334 from Sector 1-2 (B16R1)

- 100 n $\Omega$  joint, internal to the dipole
  - First identified by calorimetry at 1.9K, then by QPS snapshots (and visible also in original SM18 data)
  - Decision to warm-up the whole sector 1-2 (December 2008)
  - MB2334 returned to surface and opened
  - Localised in internal inter-pole splice
  - Gamma-ray radiography
- Lack of solder on joint, not properly brazed: first clear evidence of possible poor workmanship
- Also warmed-up Sector 6-7 (February 2009) to replace MB2303 (B32R6) with 50 n $\Omega$  joint (inter-pole)

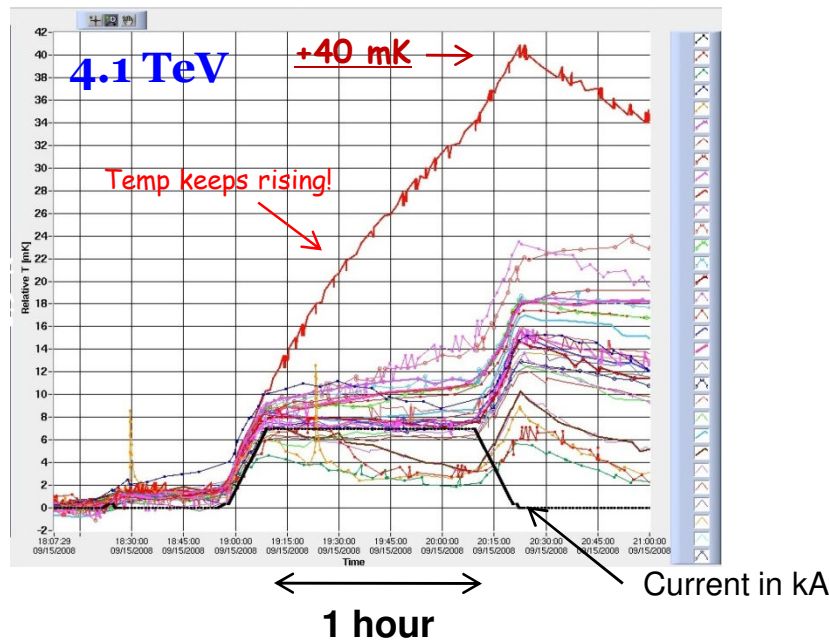
7 kA test on **Sector 34**

- ❑ Logged cryogenic data revealed a temperature anomaly of some 40 mK in the cell of the incident during a previous (lower current) powering cycle.
- ❑ Data from other powering tests indicated the presence of another anomaly in sector 12. Calorimetry suggested a  $\sim 100\text{ n}\Omega$  resistance.
