# Experience with FC7 Failures

*J. Troska*

*on behalf of the CMS TCDS team*

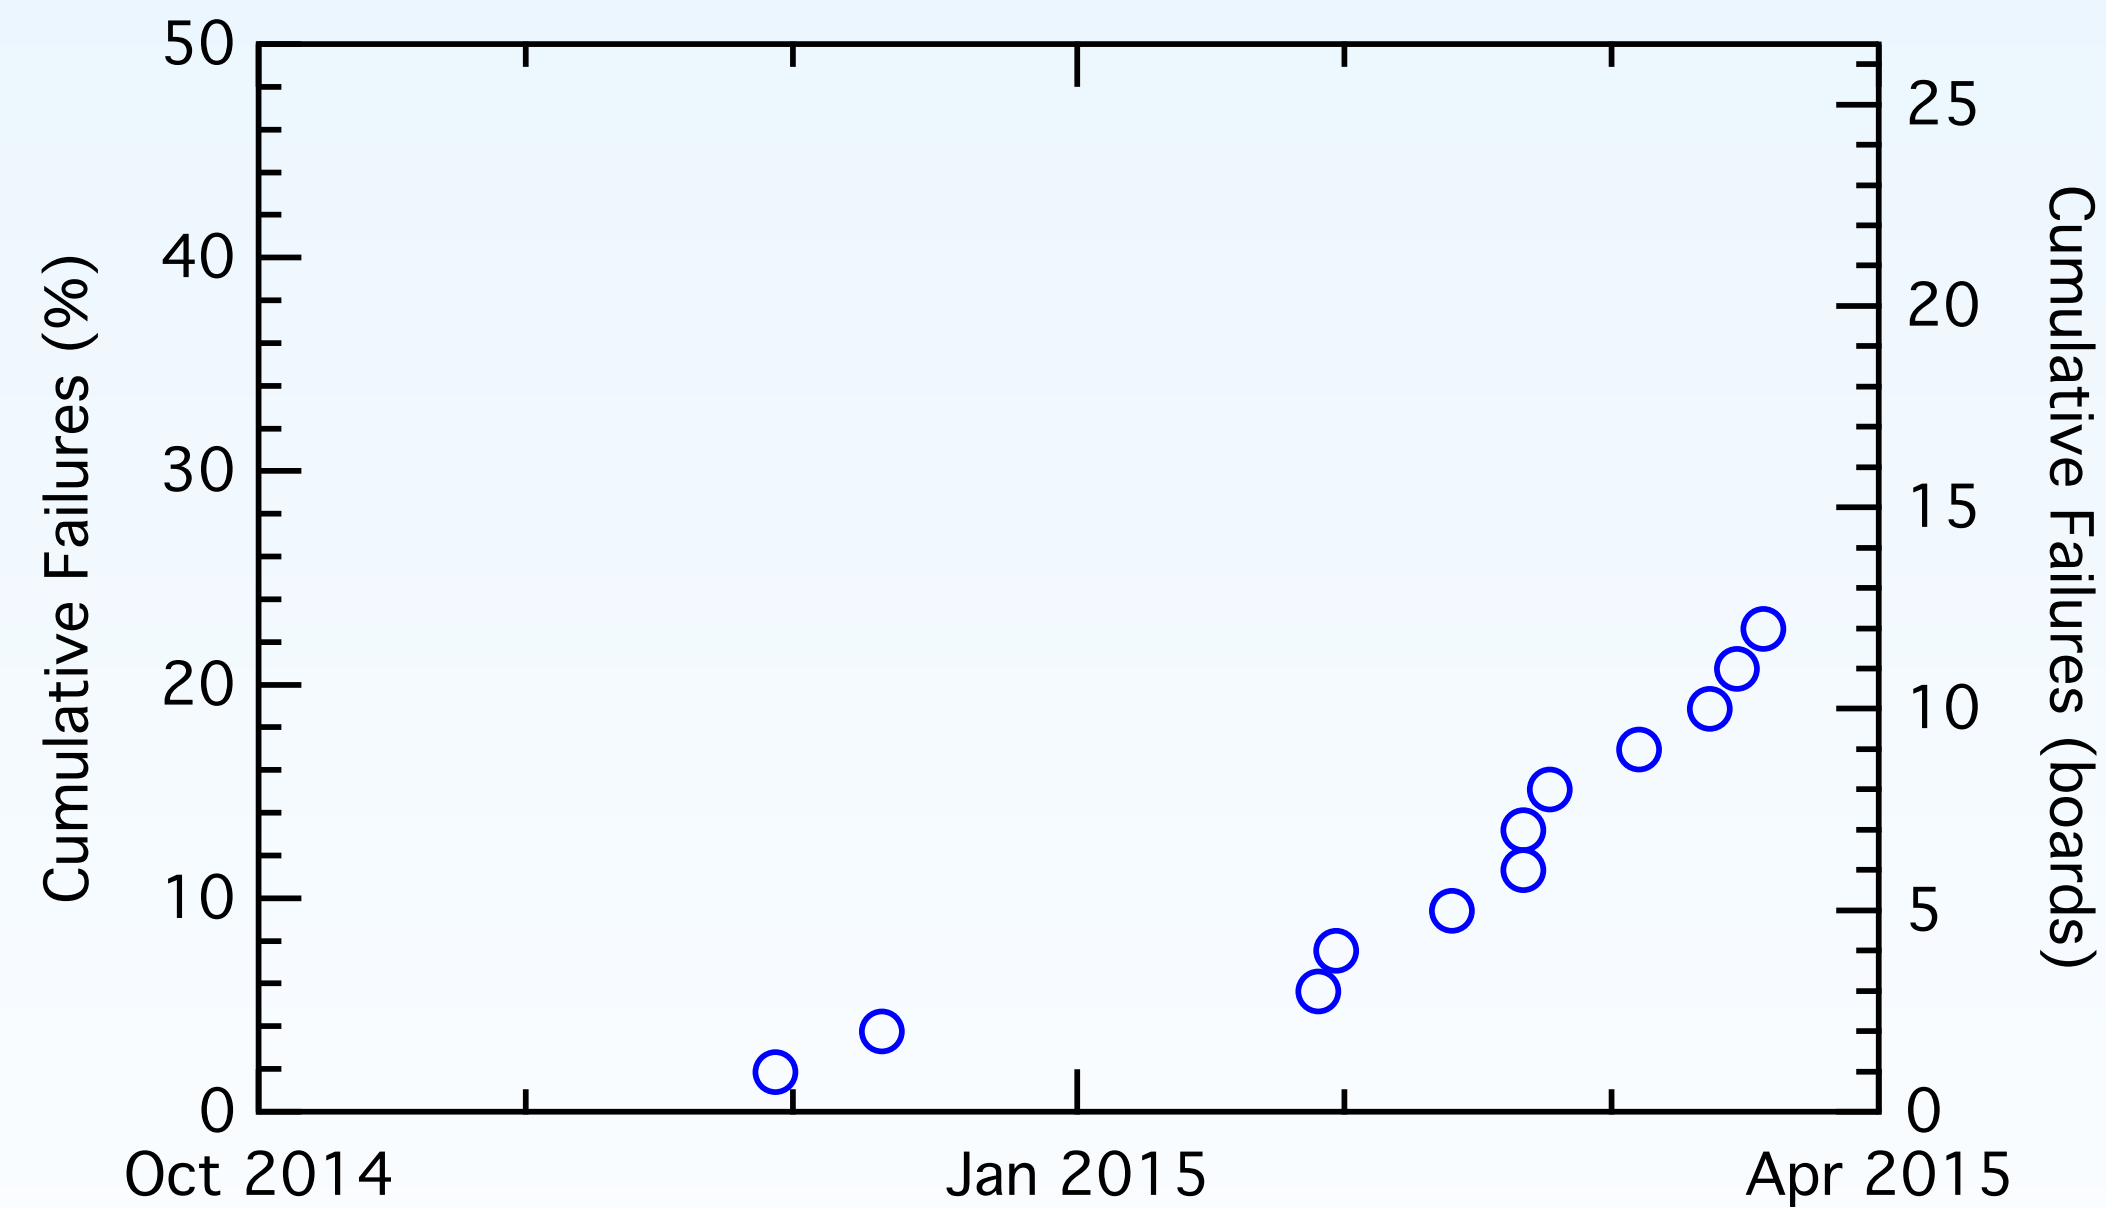
- The CMS TCDS system sustained a very high failure rate of AMCs after ~3 months of operation
- Full system failure was in sight within ~1 year!

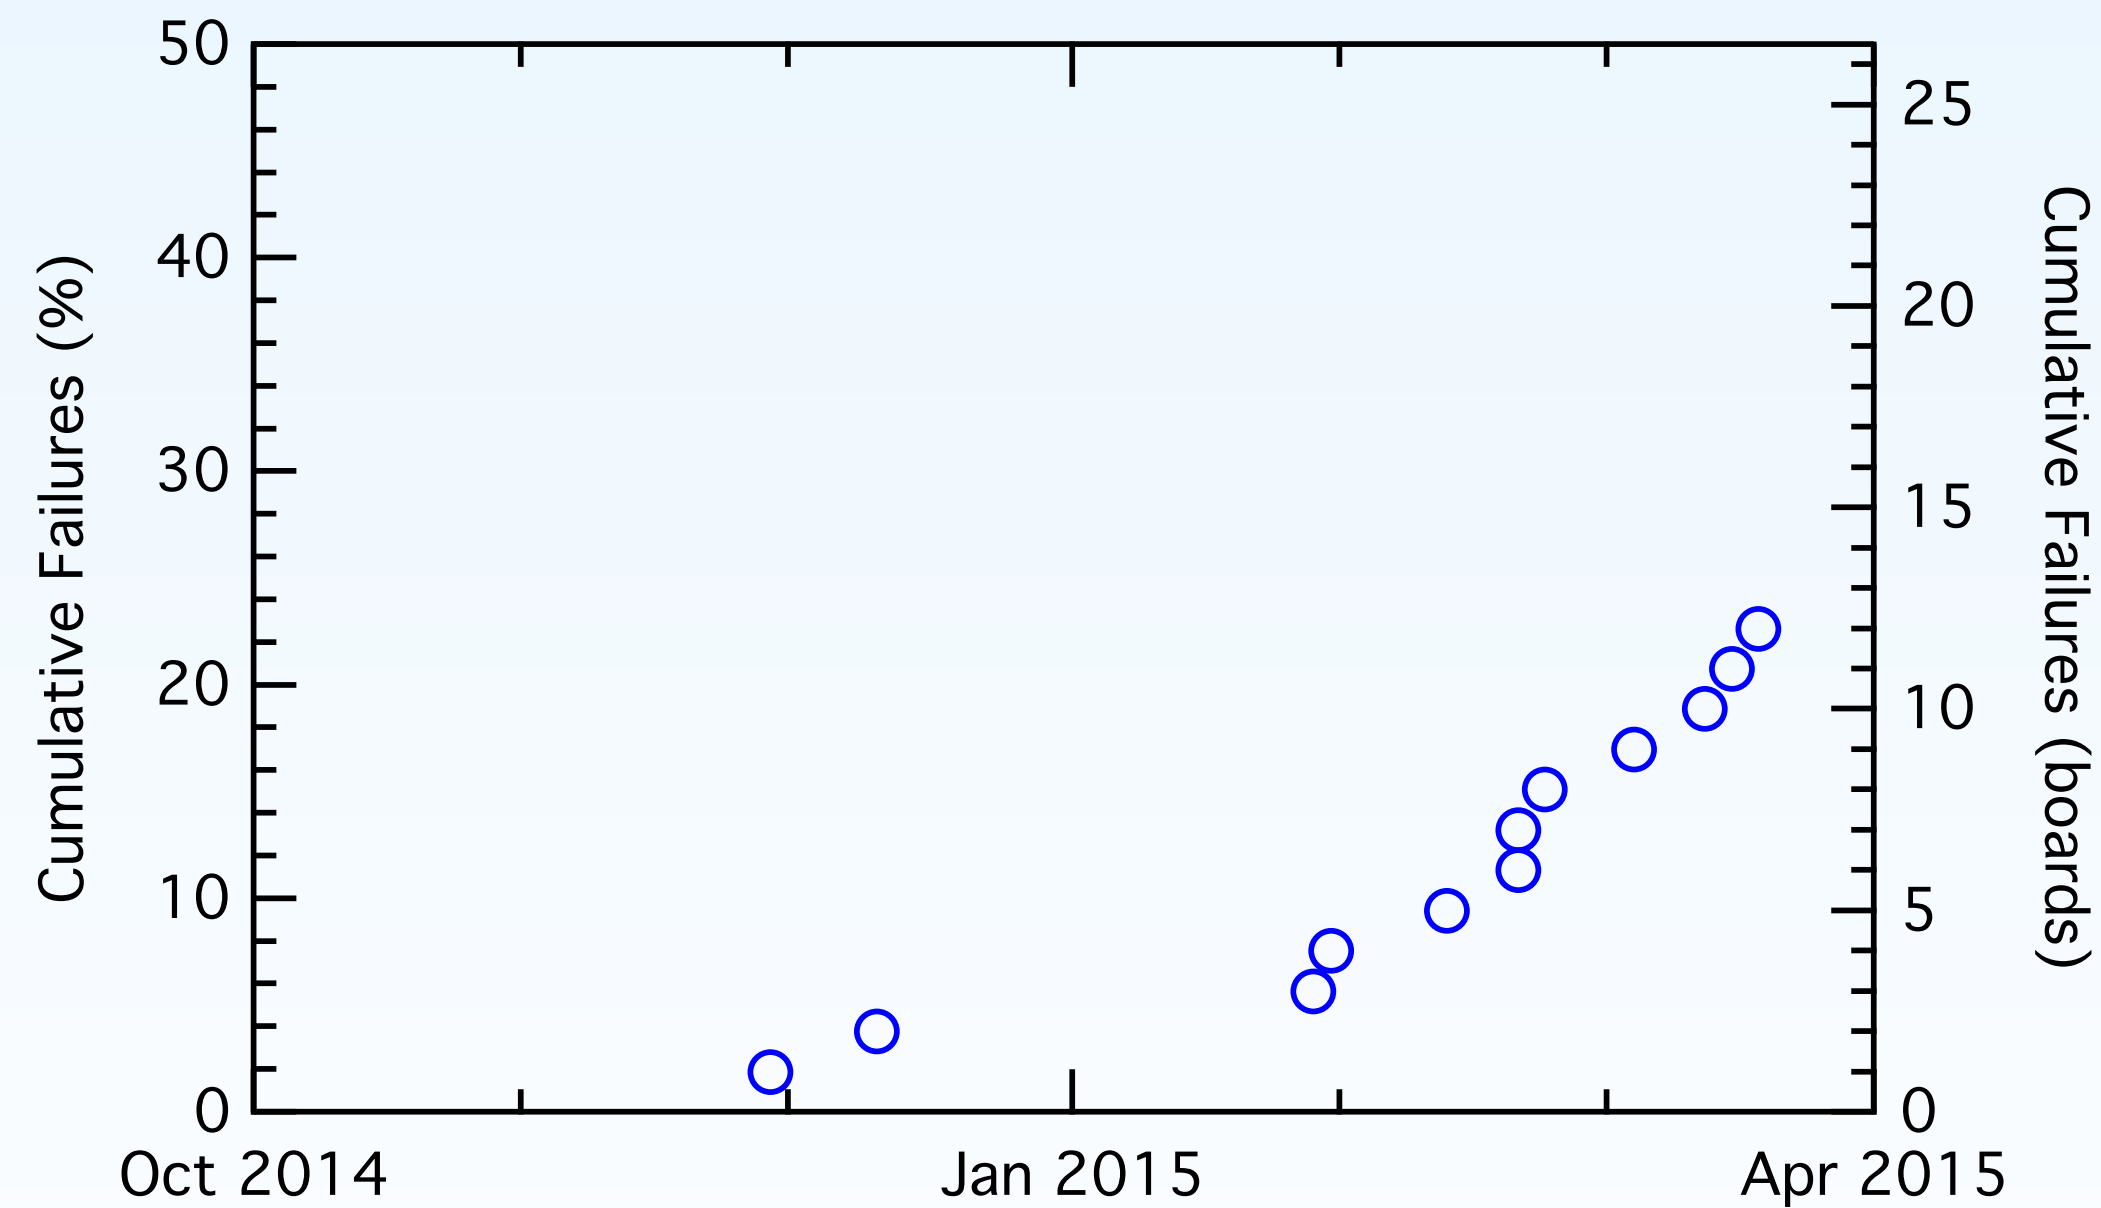
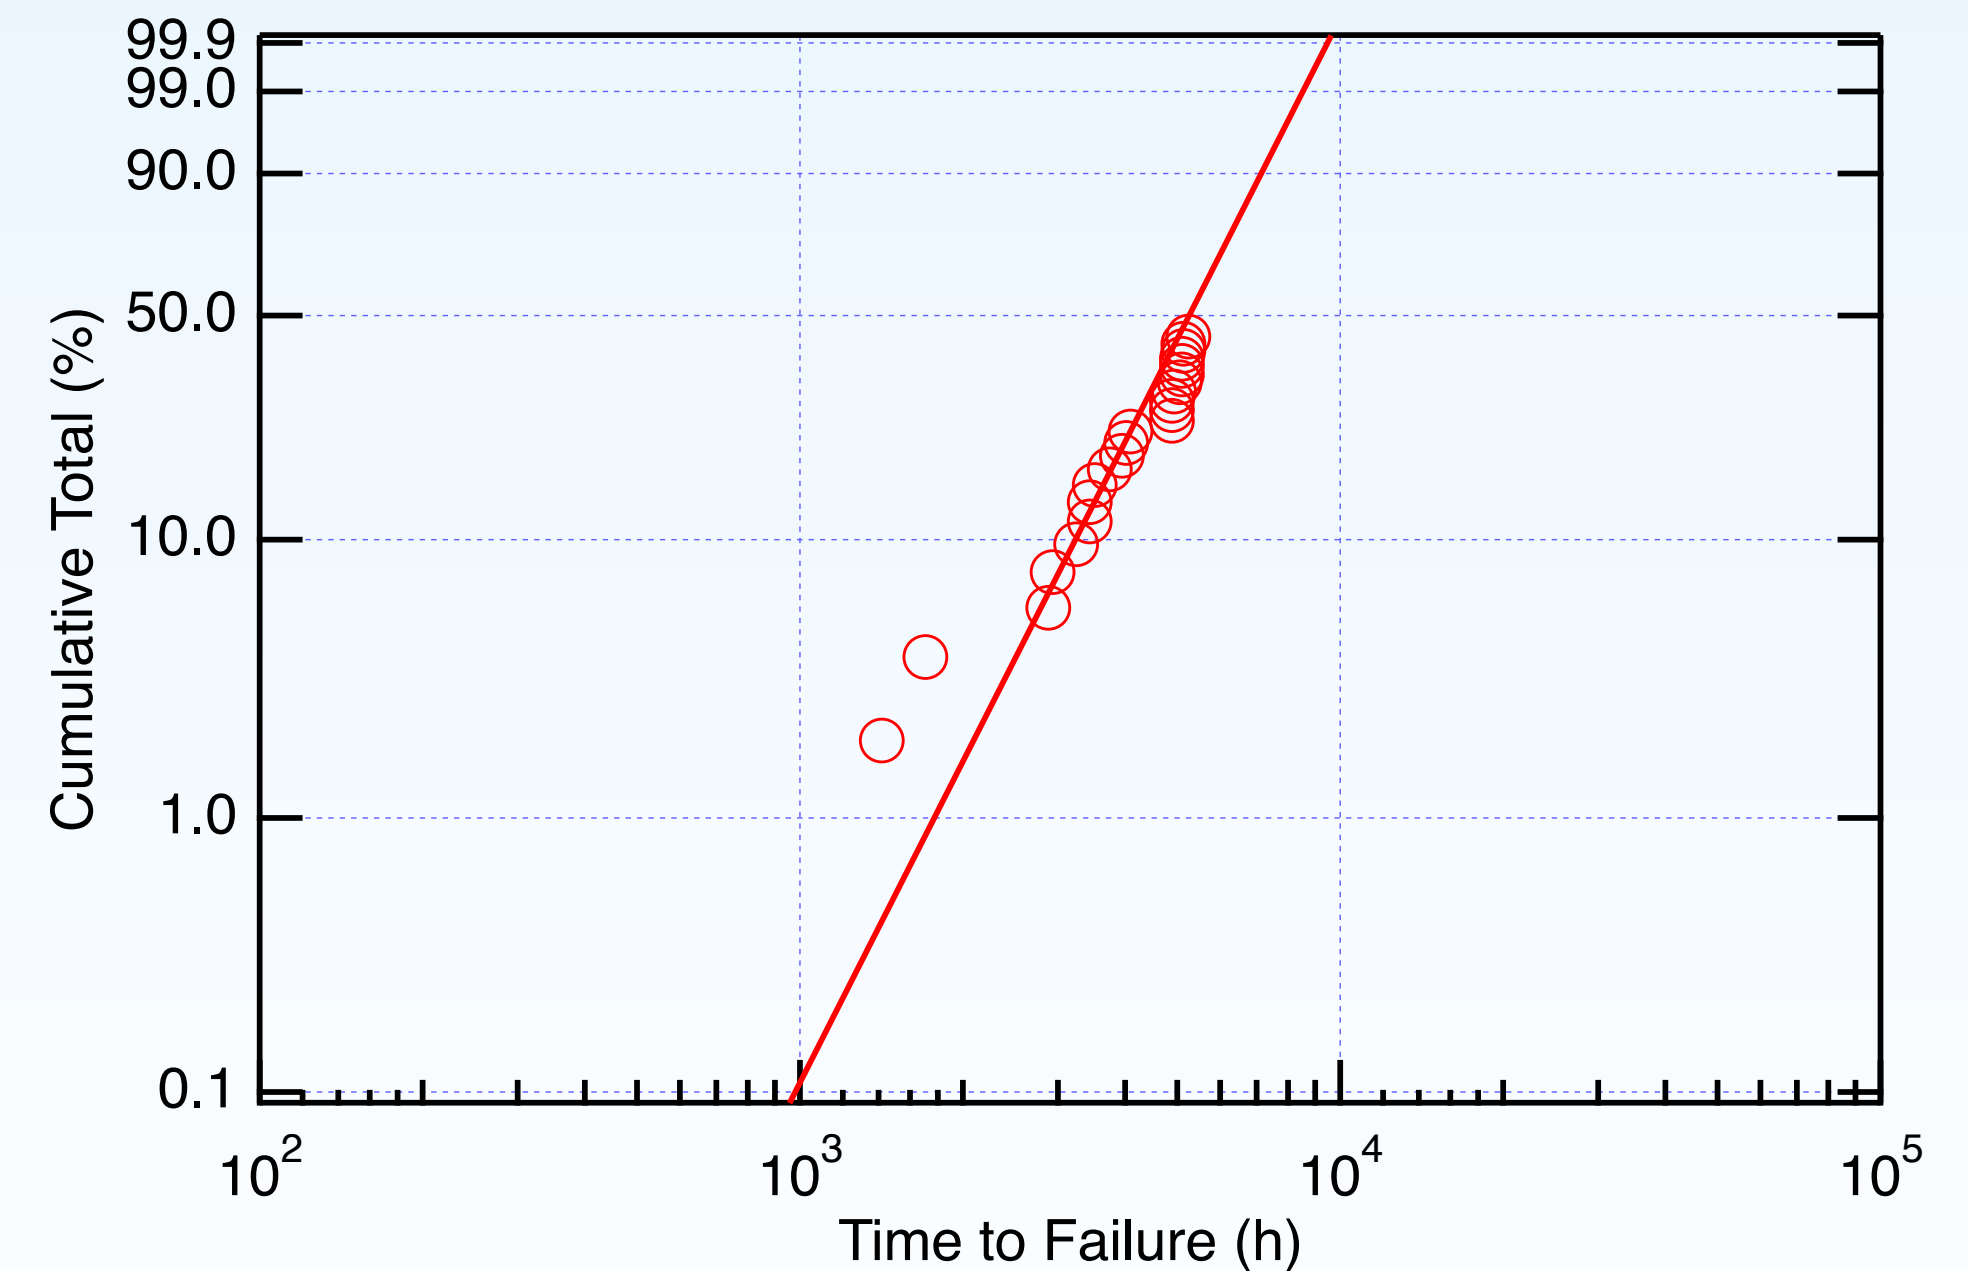
- The CMS TCDS system sustained a very high failure rate of AMCs after ~3 months of operation
- Full system failure was in sight within ~1 year!

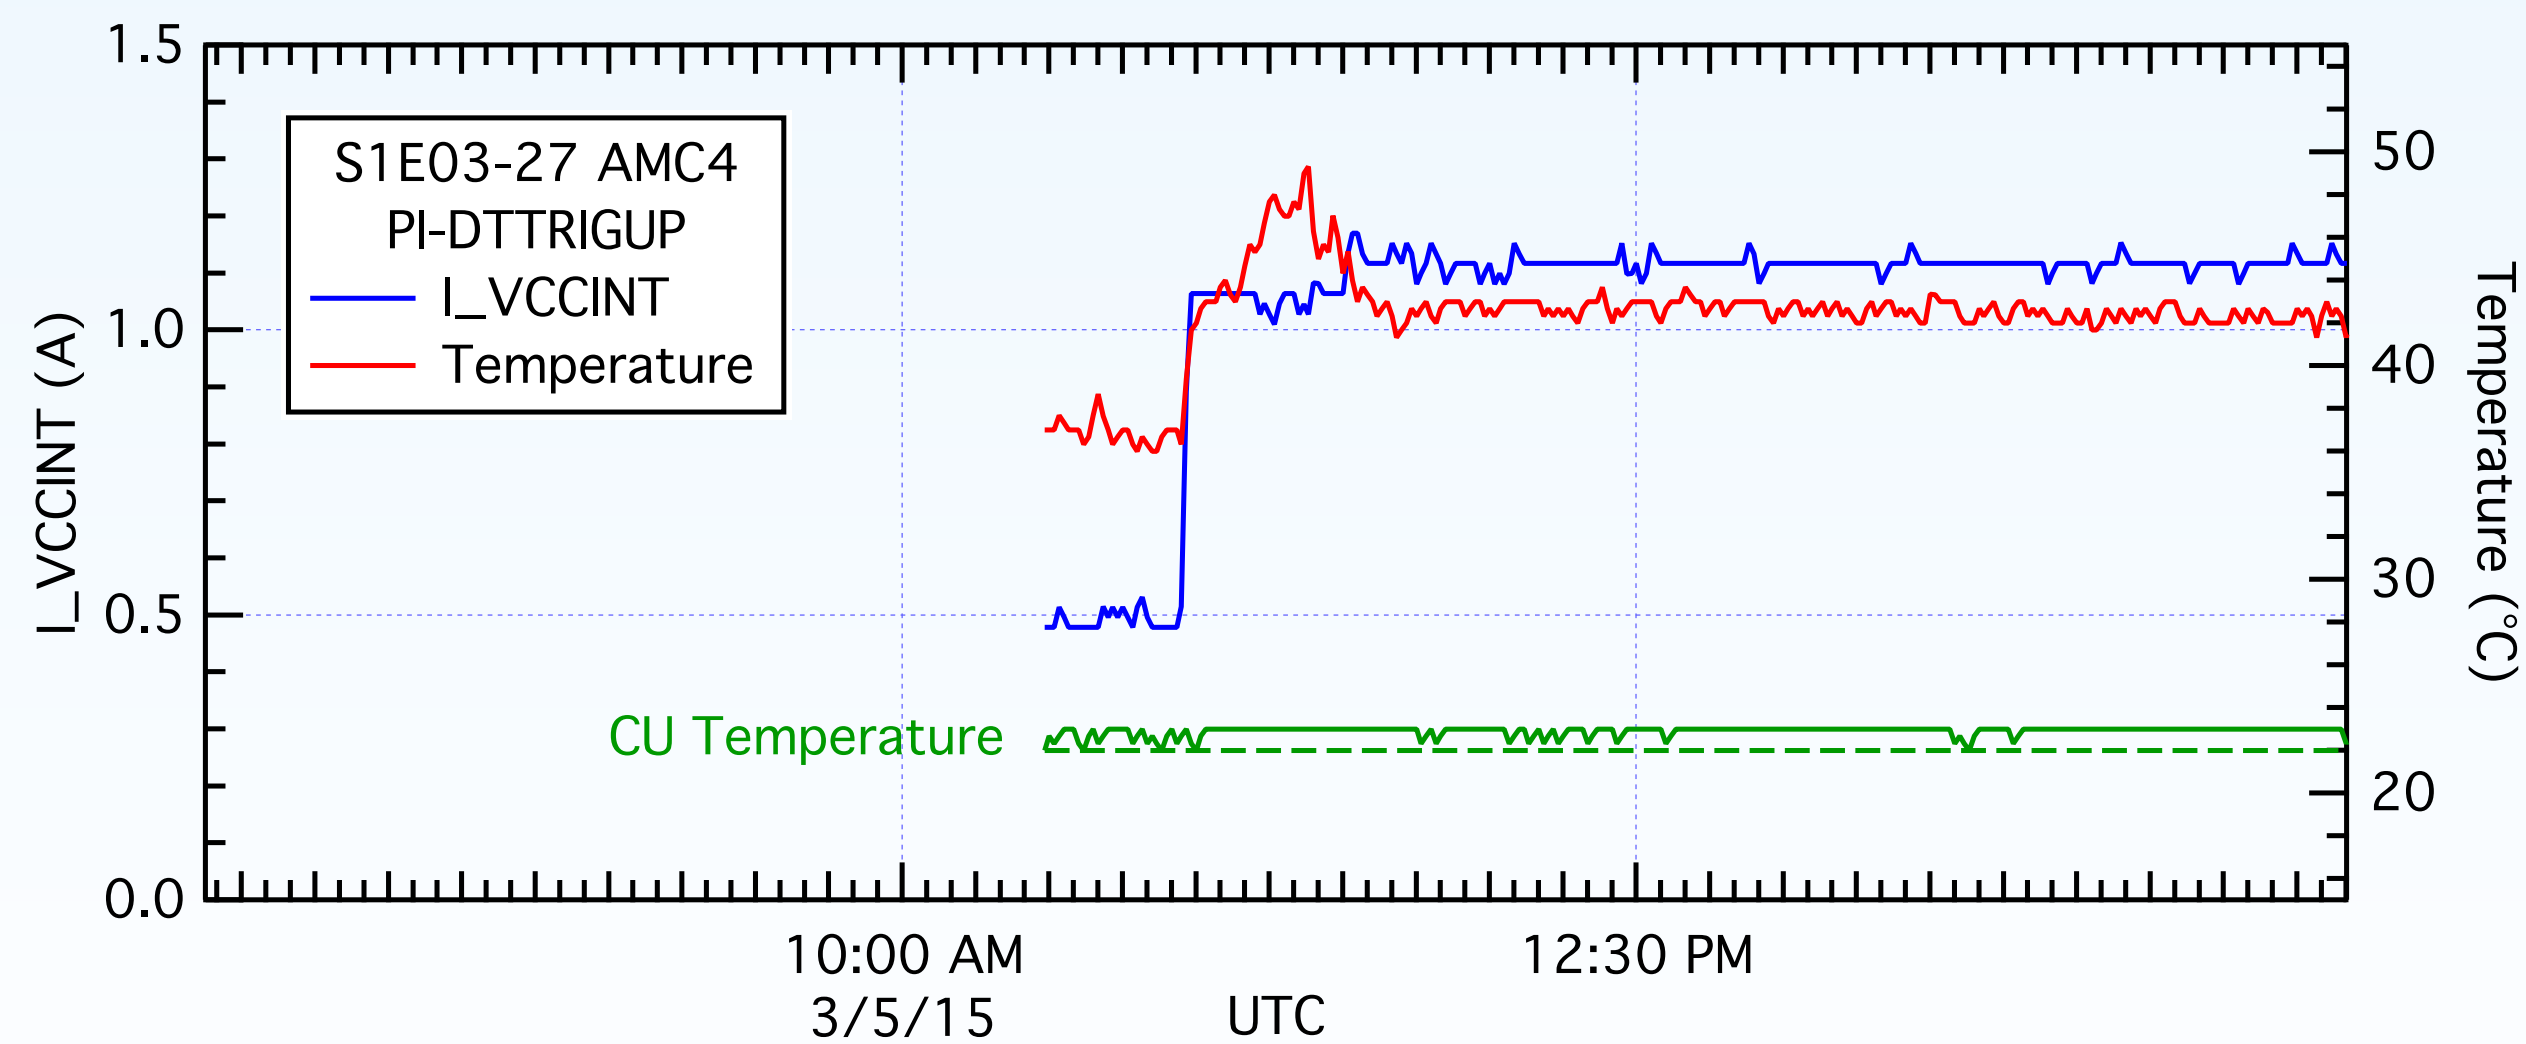
- AMC sensors provided diagnostics
  - Board failure accompanied with increased current drawn on FPGA core voltage
- Increased current an abrupt failure
  - within one monitoring interval (1 minute)

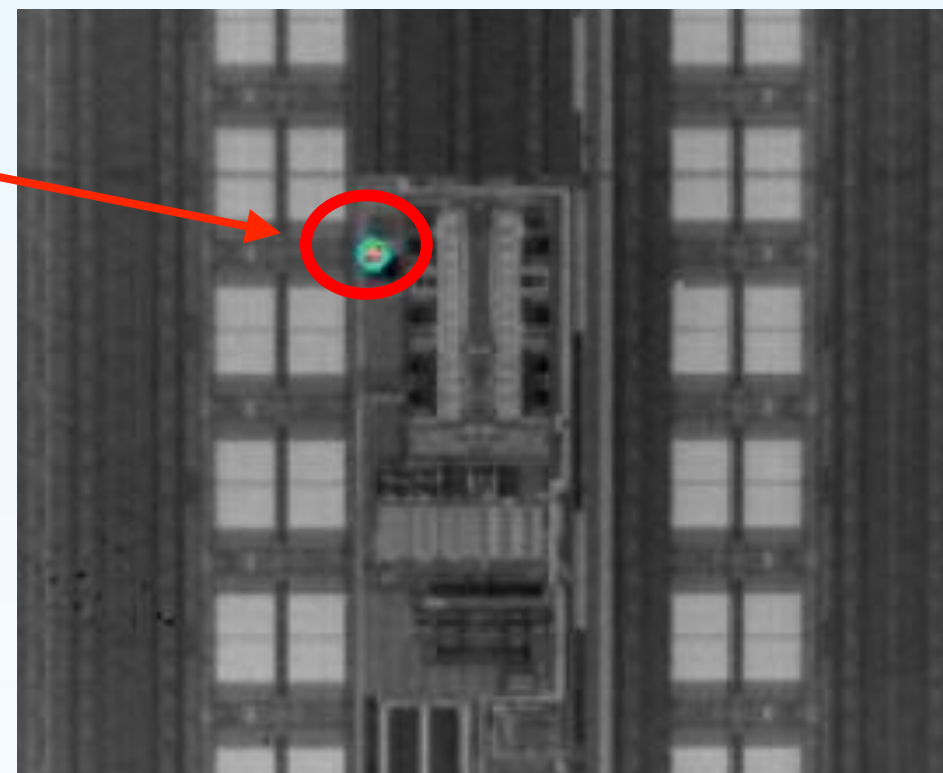
*Hot-spot*

- Lengthy investigations & continued monitoring did not reveal problem
- Eventually Xilinx agreed to do Failure Analysis on failed FPGAs
  - Xilinx FA: de-lidding & testing including High-resolution IR imaging for thermal emission analysis
  - Schematic error identified - incorrect XADC supply voltage caused EOS failure of config. memory

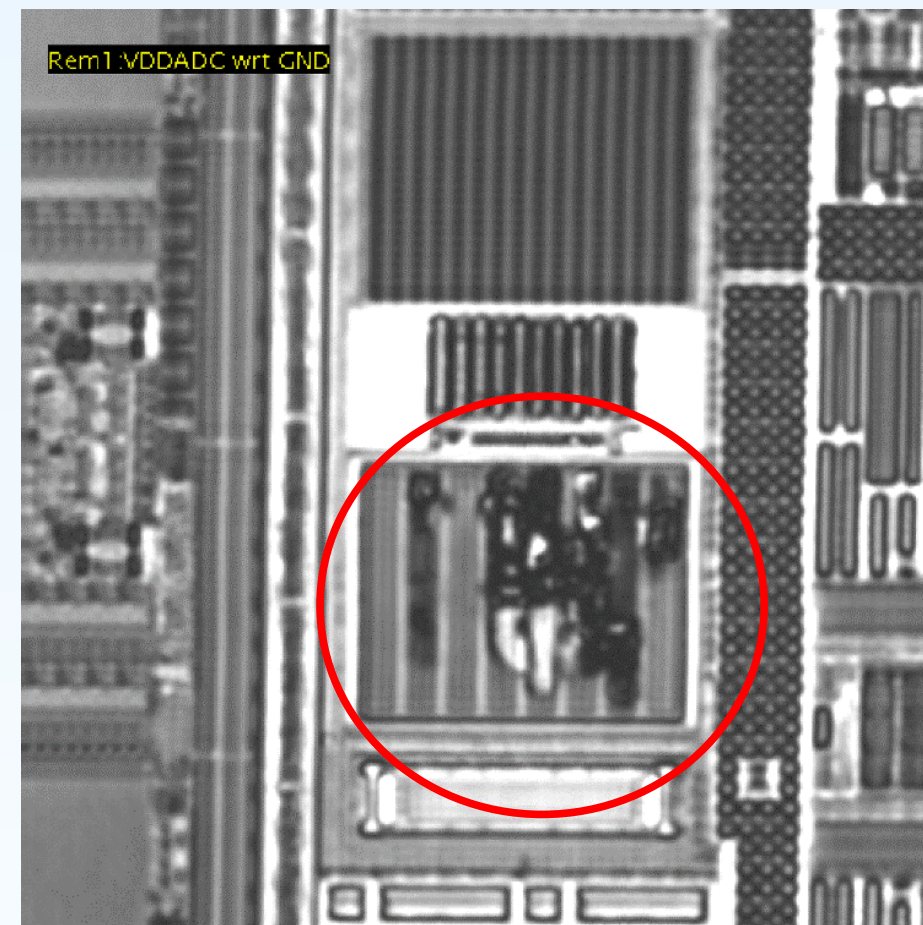
*Thermal Emission*

*Die backside laser imaging of EOS-induced diffusion damage*

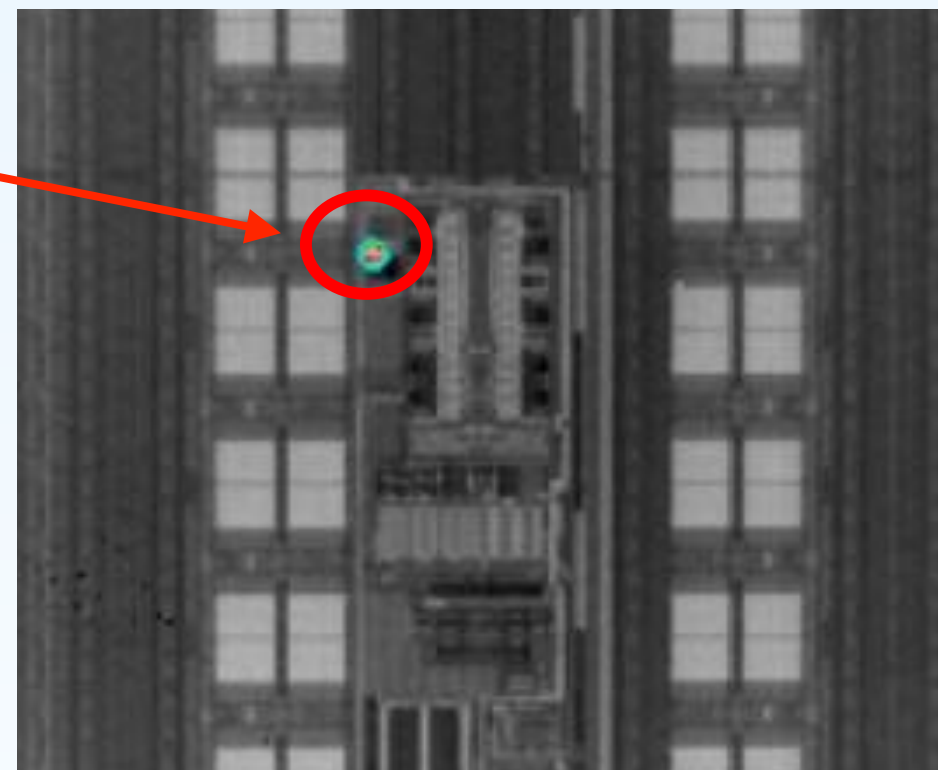
Hot-spot

- Lengthy investigations & continued monitoring did not reveal problem
- Eventually Xilinx agreed to do Failure Analysis on failed FPGAs
  - Xilinx FA: de-lidding & testing including High-resolution IR imaging for thermal emission analysis
  - Schematic error identified - incorrect XADC supply voltage caused EOS failure of config. memory

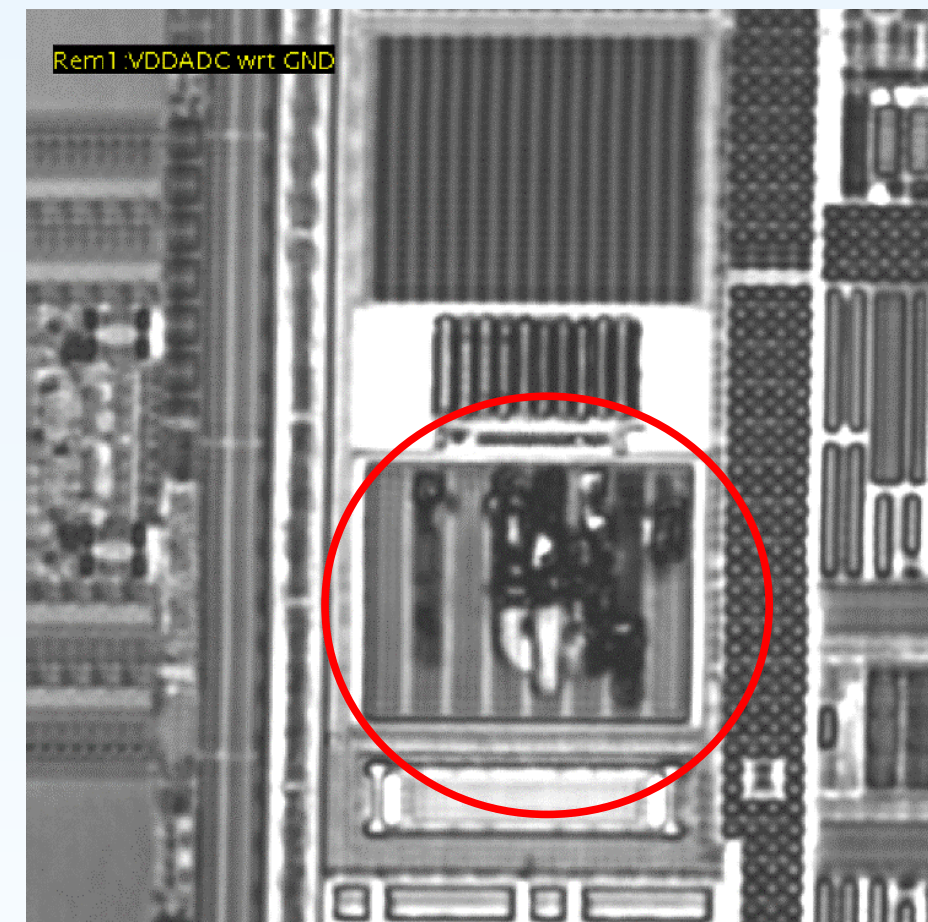
*Thermal Emission*

*Die backside laser imaging of EOS-induced diffusion damage*

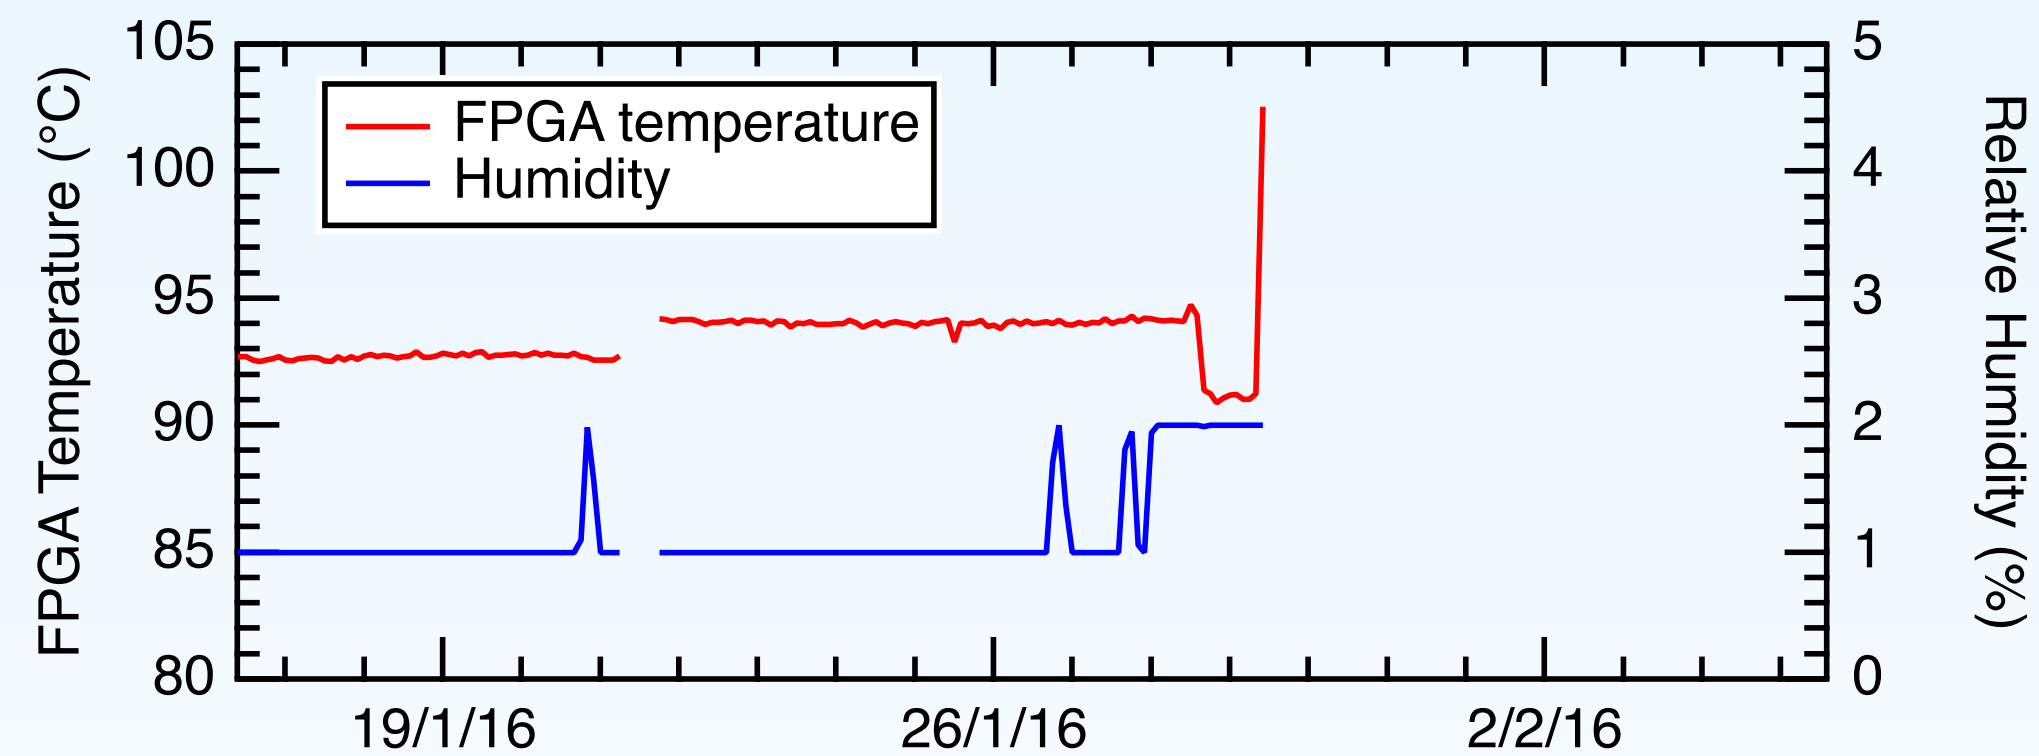
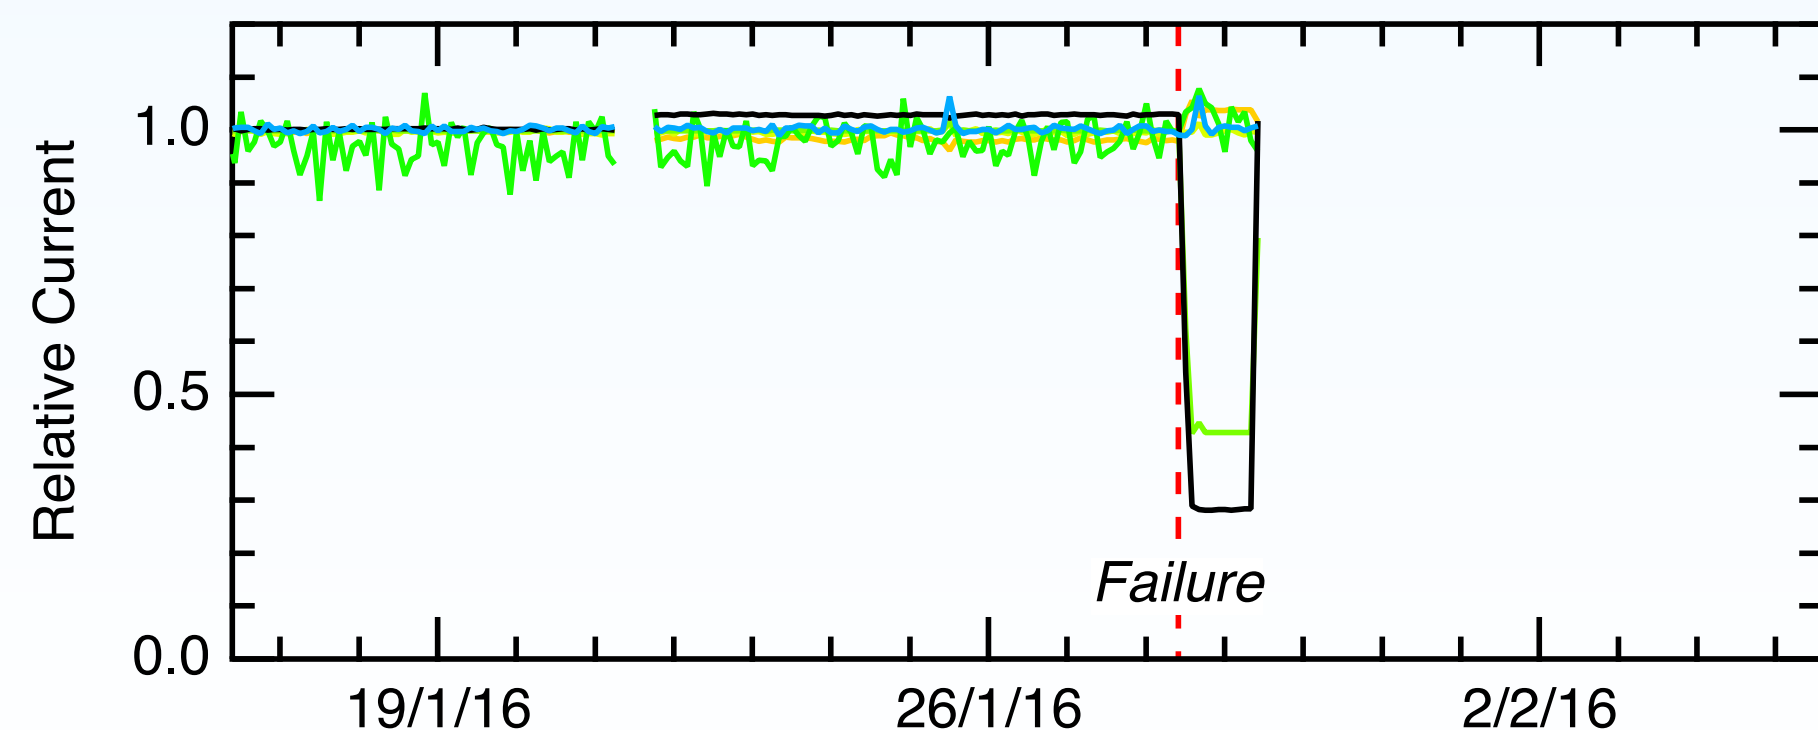
- As a cross-check, HTOL carried out also with FC7 R1 without white-wire fix
- Failure observed after approx. 300 hrs
- Same failure signature as observed in CMS

- Acceleration factor found to be lower than expected for 0.7 eV activation energy
- Calculated 0.5-0.6 eV, compatible with literature

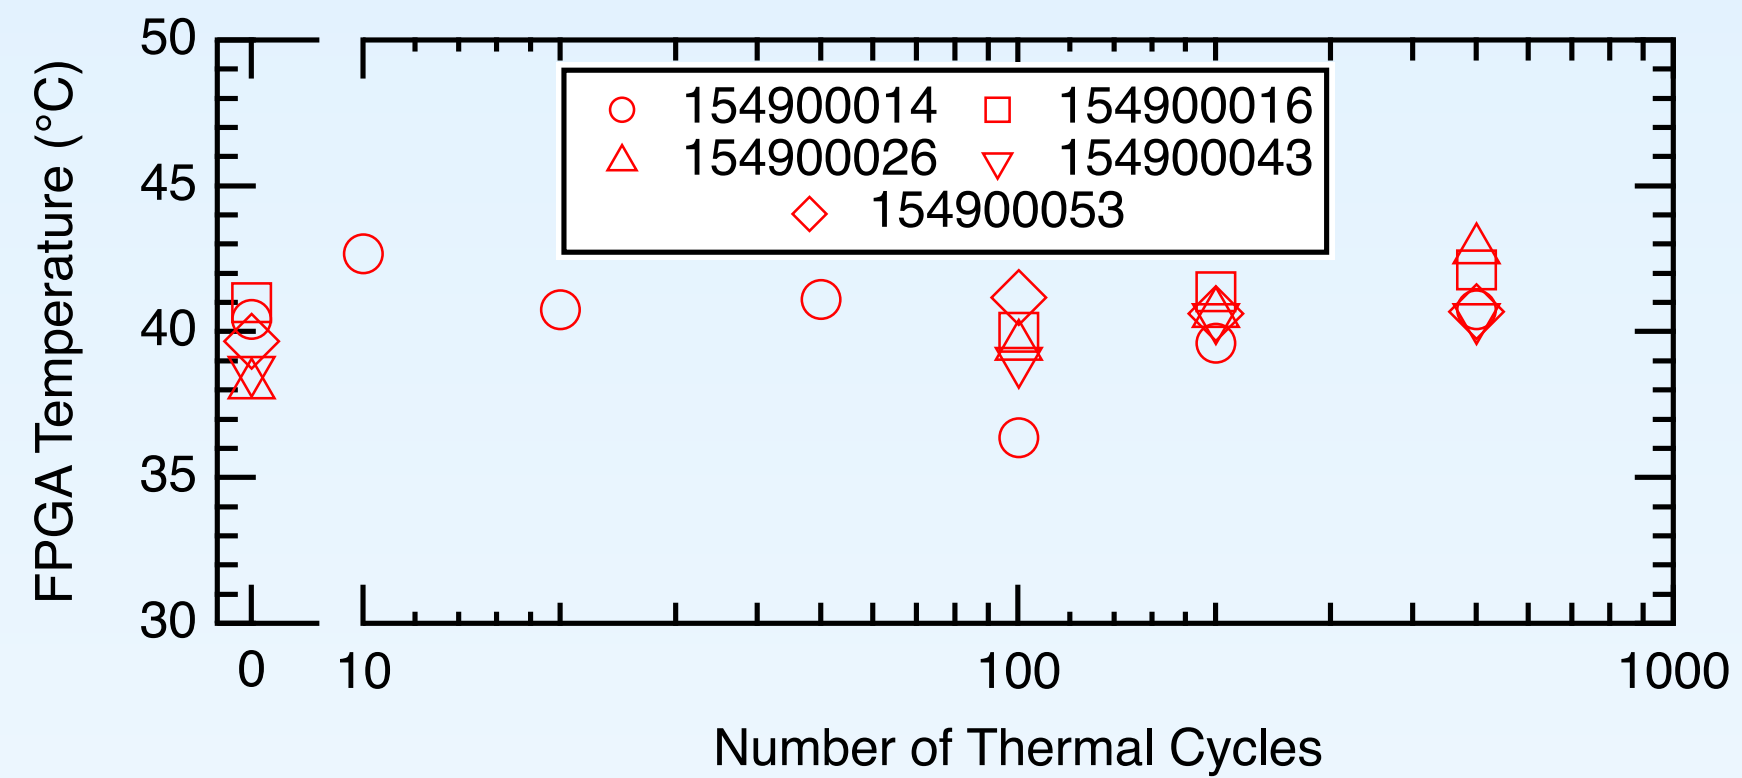
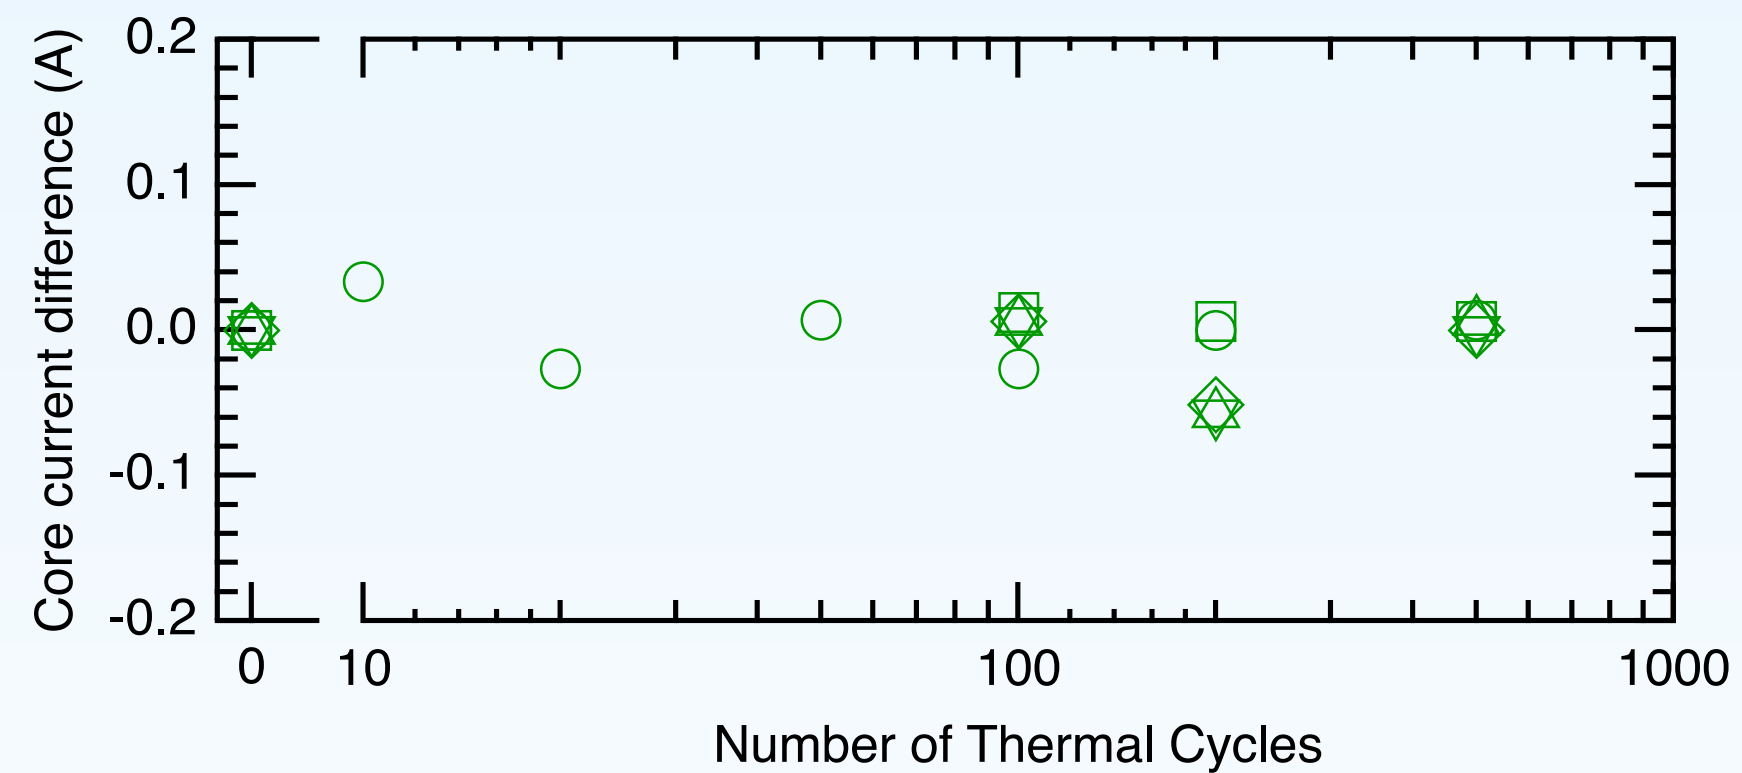
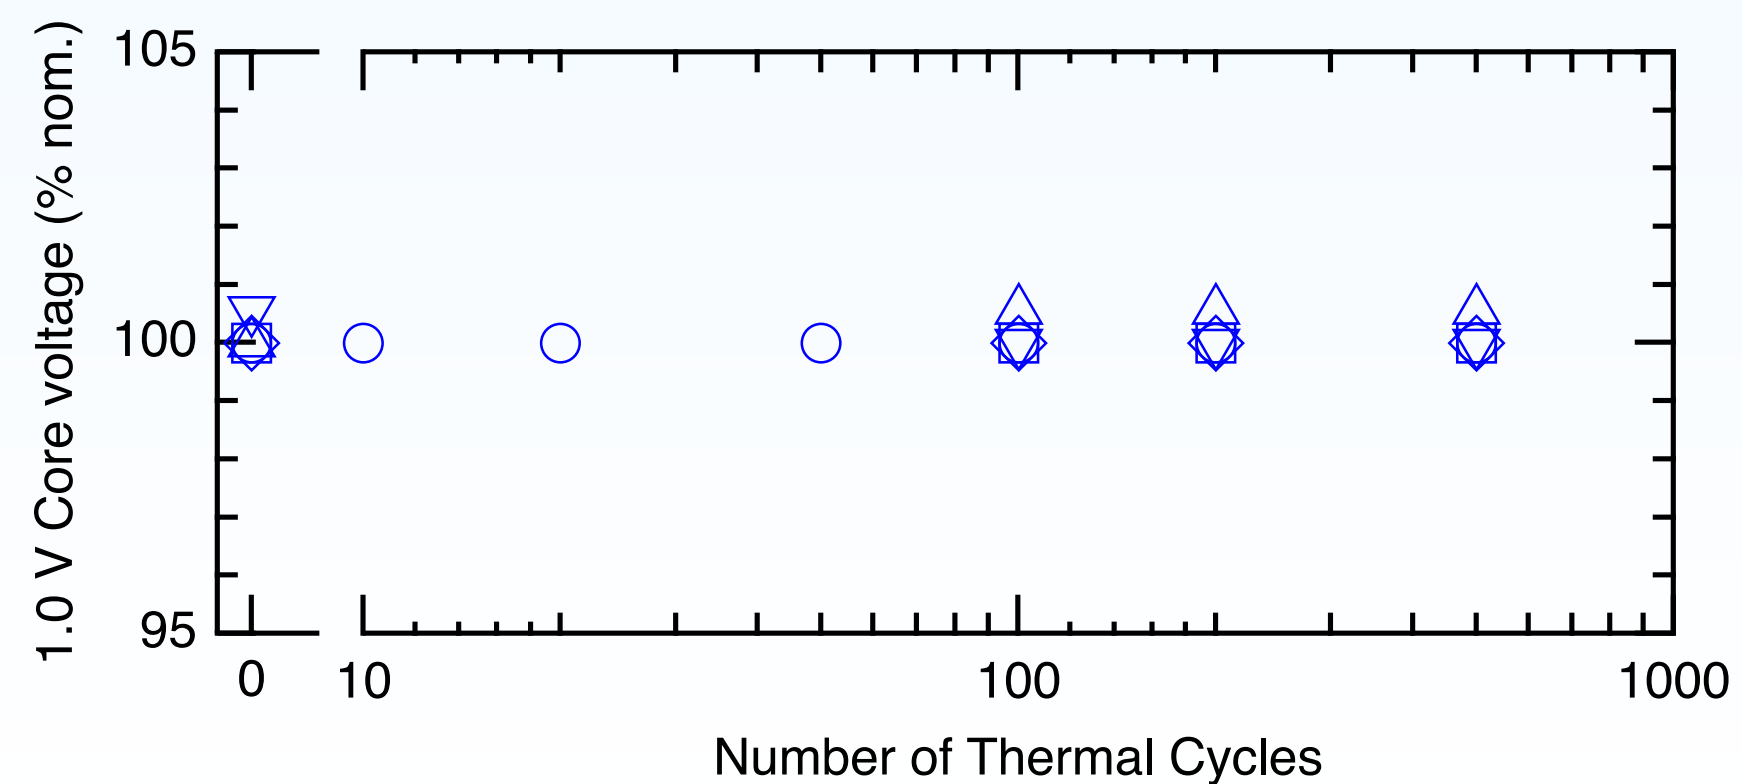
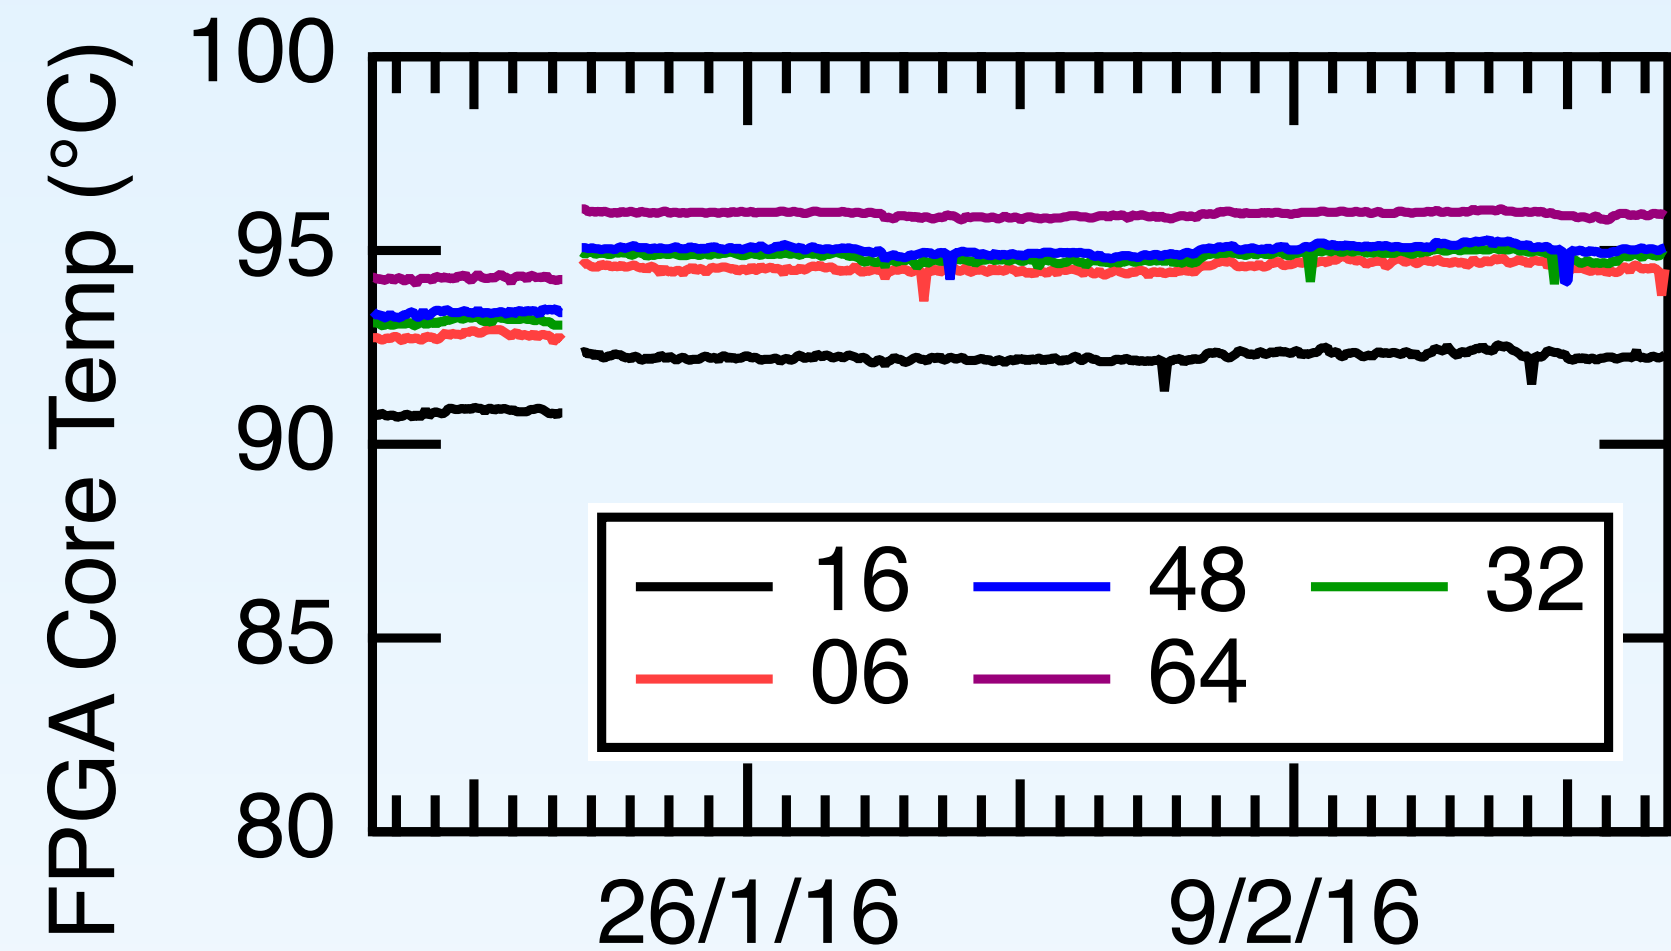
- No significant changes observed in either T-cycling or HTOL tests
- Accumulated 25 device-years of effective operation
- FC7 declared ready for deployment in Feb. 2016
- 17 months after TCDS installation...
