High Power CW RF Sources for Booster and Ring in SSRF

Shenjie Zhao, On behalf of SSRF RF Group

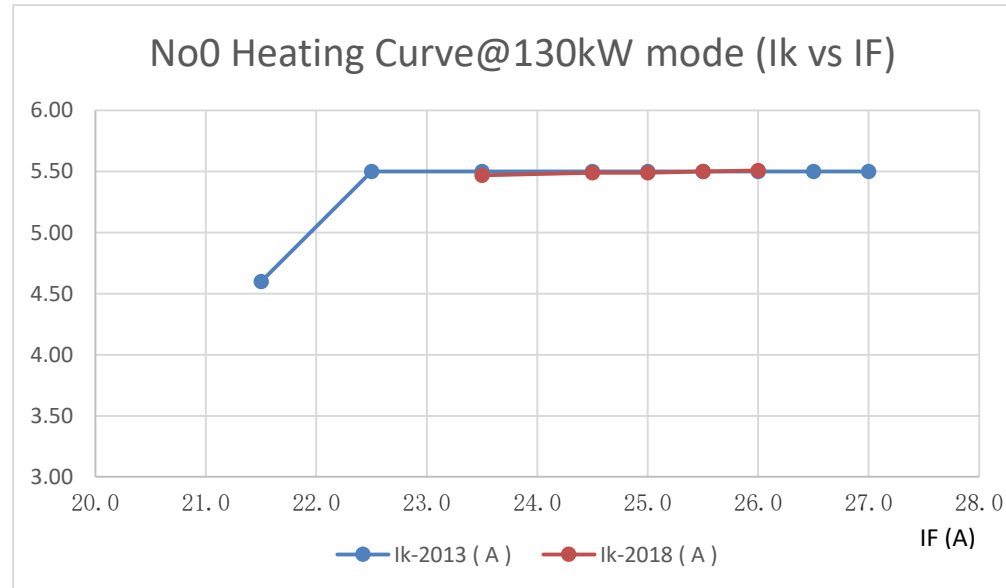
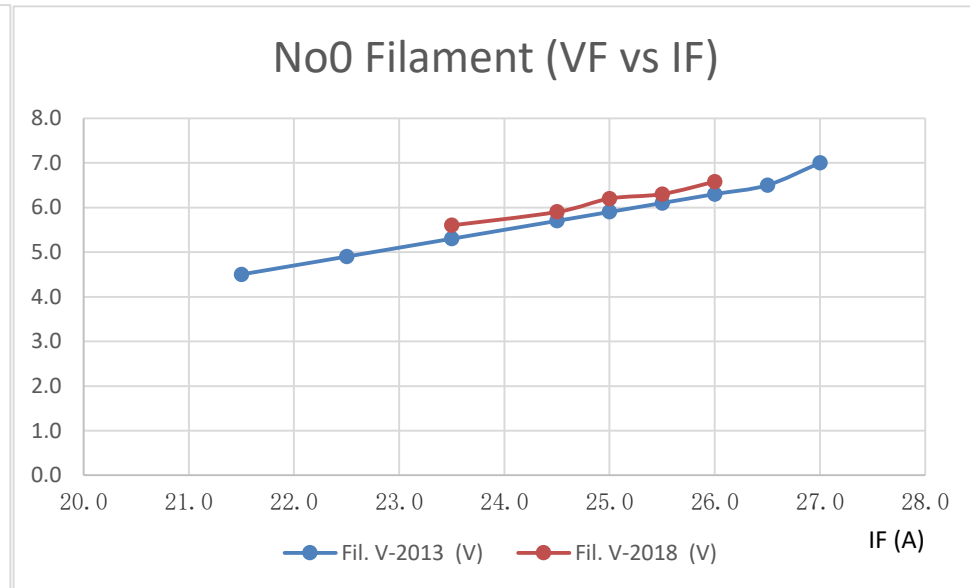
Heating Curves-No0

- Cathode not degraded;
- Filament a little thinner.

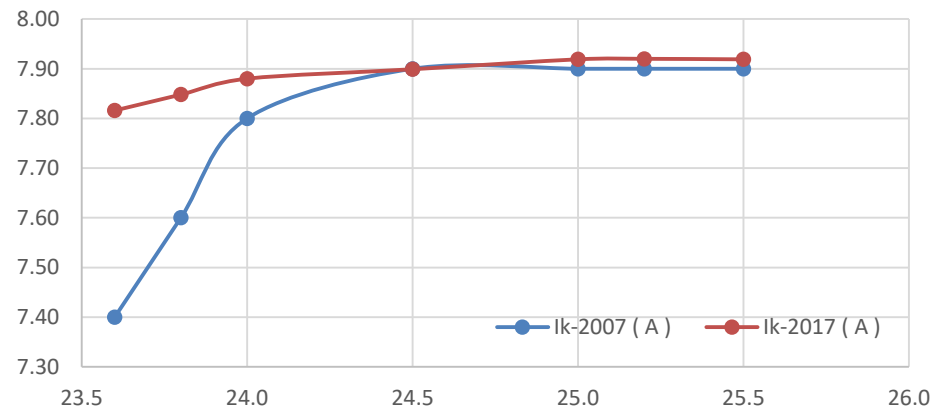
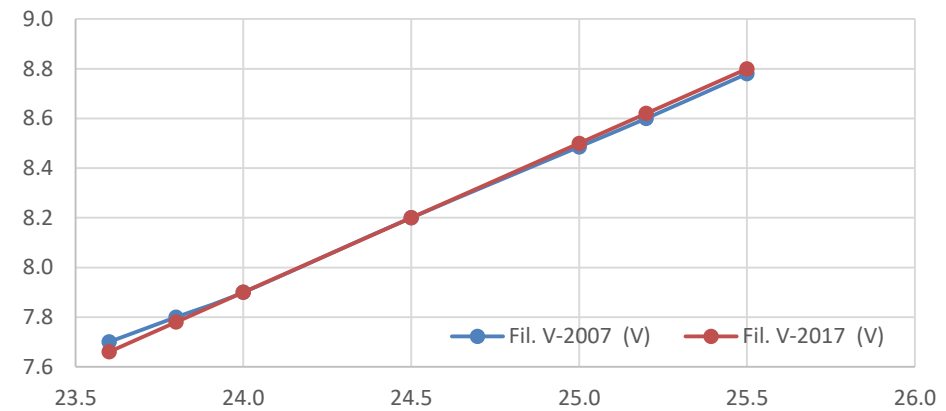
Heating Curves-No1

- Cathode and filament not degraded;

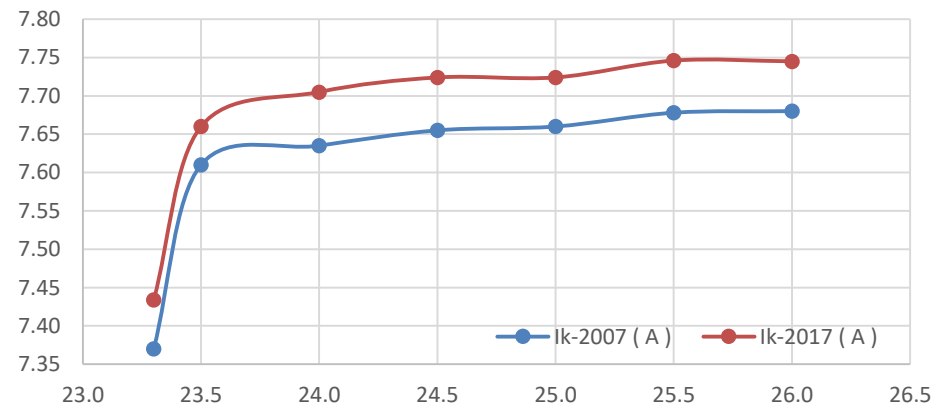
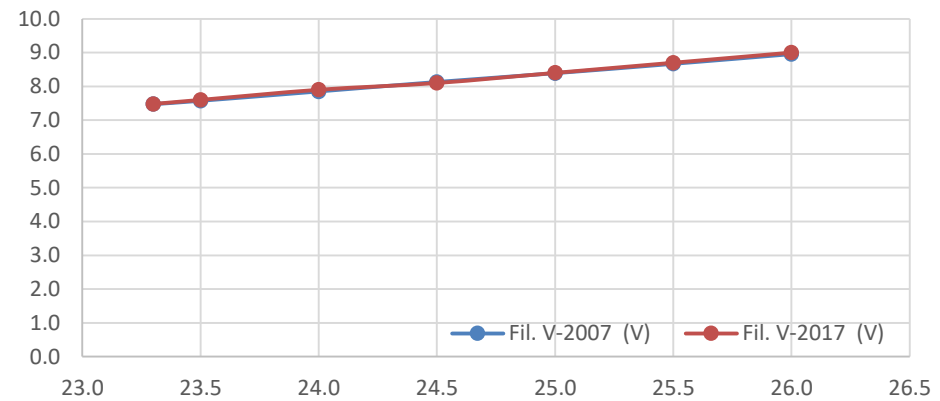
Heating Curves-No2

- Cathode and filament not degraded;

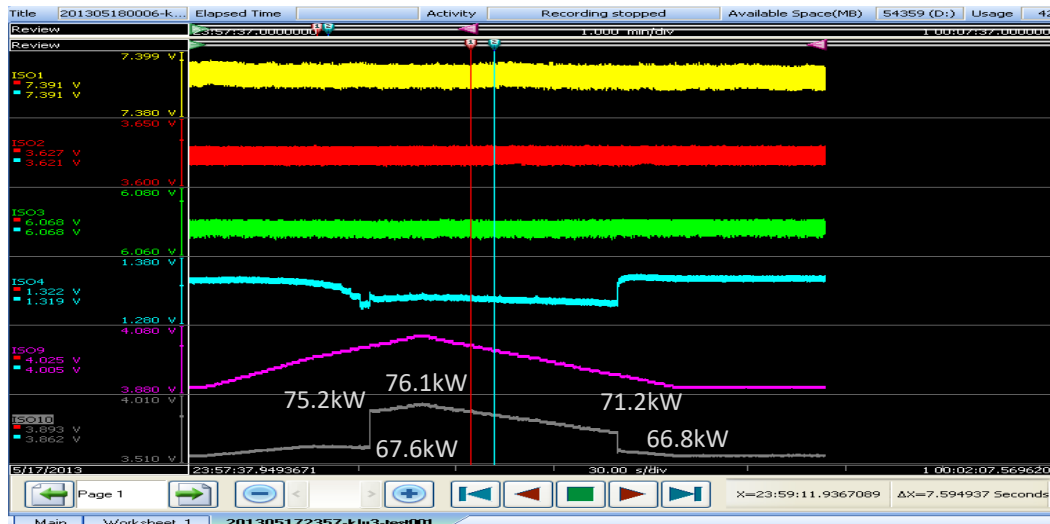
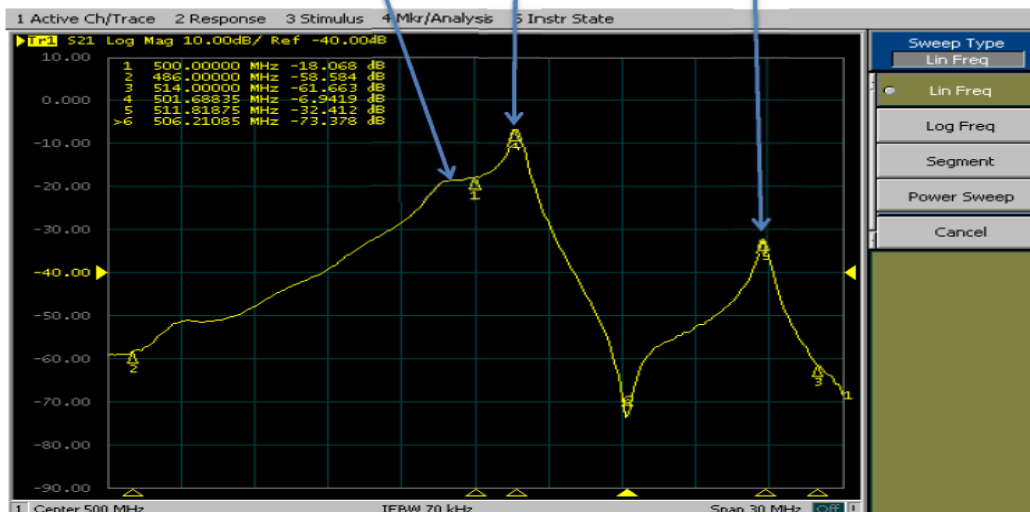
Gain Jump of Original No3 Klystron

- The gain jump around 67~76kW of old No3 klystron start from 2010;
- Retune of the cavities of the klystron only make the gain jump power point changed a little;

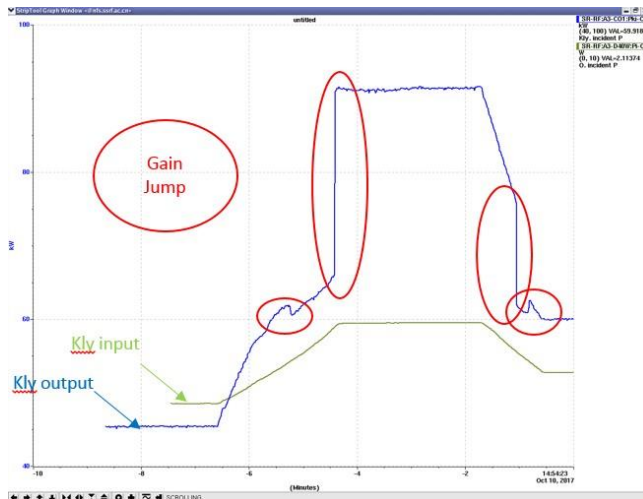
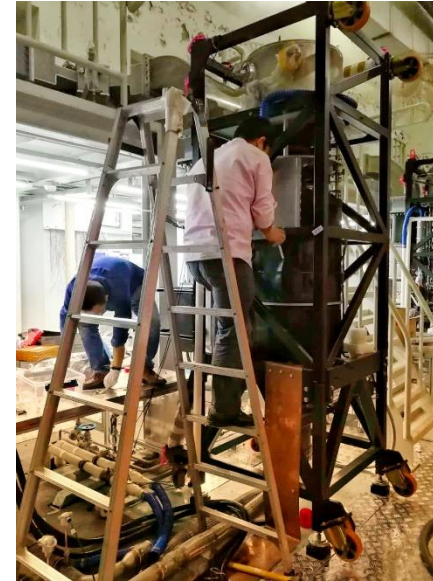
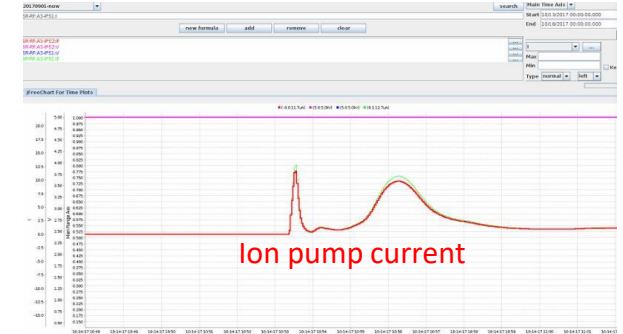
Gain jump of original No3 klystron

201707192108 No3 klystron gain jump lead to the pick up arc of cavity when beam injection in Ring

- 20161129 80kW to 90kW jump was observed in pulse condition. This jump lead to cavity's pick-up arc at 201707192108 ;
- The check or test of this old klystron in Thales will cost ~50,000 EUR, without not any maintenance guarantee.

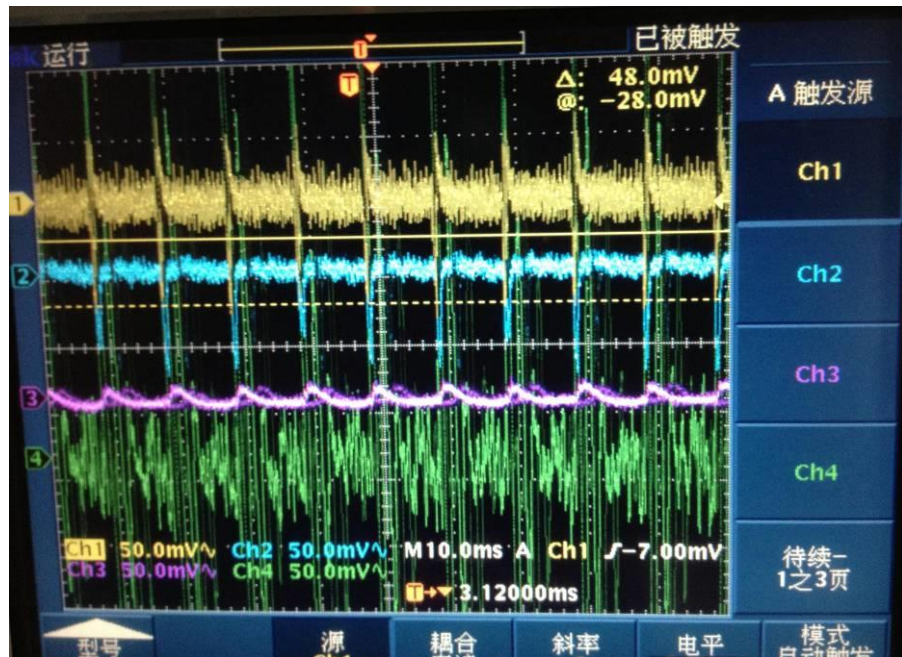
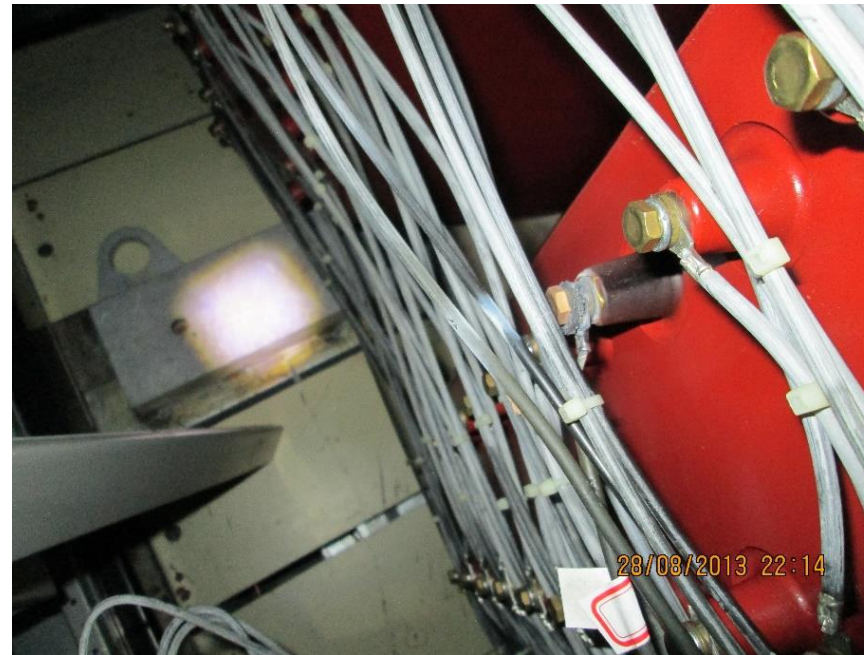
100Hz Noise on Forward Power

201303280820#3KLY 100Hz noise
AC coupling, 1M input resistor.
Ch1-HVPS:I、Ch2-HVPS:V、Ch3-FIL:I、Ch4-CO1:Pki

- A burn connect of No71 module lead to the 100Hz noise;
- 100Hz noise always comes from one abnormal module.

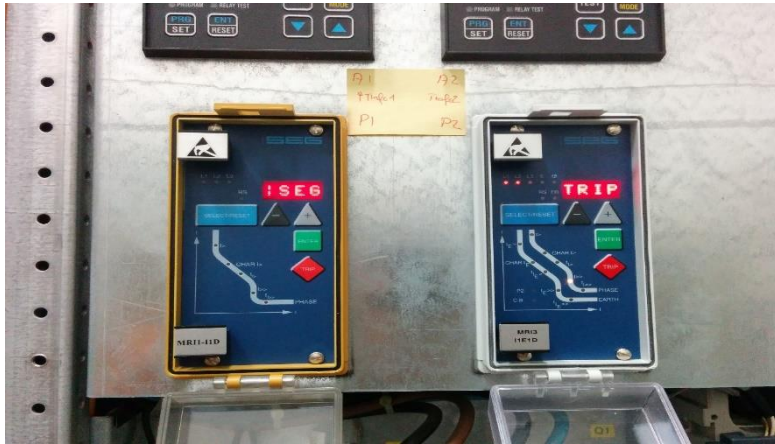
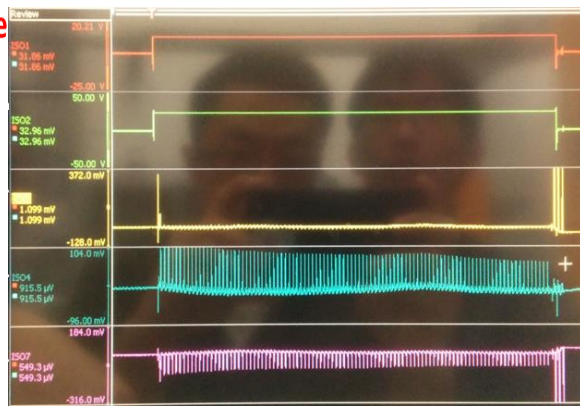
Transformer Current Interlock from PSU0

- During normal running(MOD Voltage On), sometimes (2016/02/25,2016/02/27)Transformer over current trip from P2(measuring the 3 phase current of T2).
- Frequently happen if try to close the step-start(AUX ON->Standby).Most from P2(L1,L2,I>>), one time from P1(L1,I>>)

- During test there is a serious trip.
- **P1 shows ~2000A when trip!**
- We can't turn on the KSU anyway.

- Set the time relay for step-start P10 to 0.5S(original 0.5S, and 2S from 2015/03/31) from comment of Ampegon engineer
- We can close the step-start without any problem

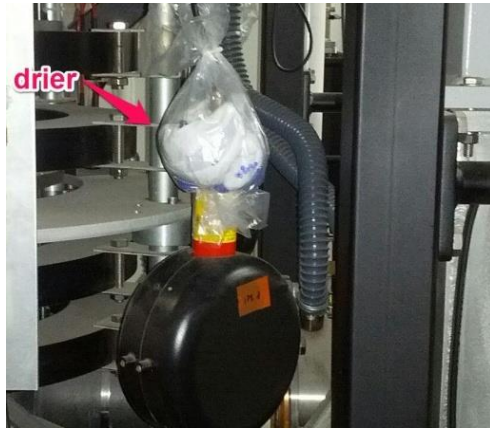
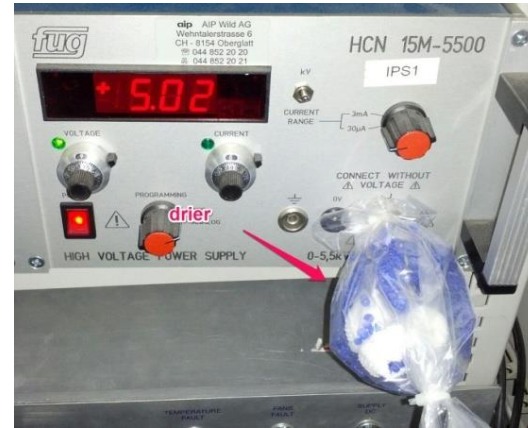
dryer on HV feedthroug for Ion pumps

Some trips happened from high humidity:

- Discharge from HV feedthrough for Ion pumps
- Spark from HV power supply of klystron
- Damaged relay contacts of PSU0 in Booster

- Add dryer surrounding the HV feedthroughs;
- Turn on the fan inside the HV klystron power supply during machine shutting down;
- RF hall Isolating and extra dehumidifiers make the humidity of RF hall decreased from 65% to 55% during raining season.

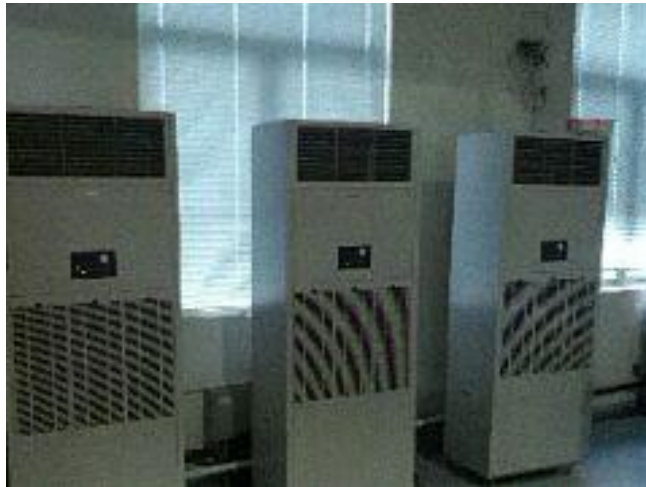
Extra dehumidifiers were adopted in RF hall

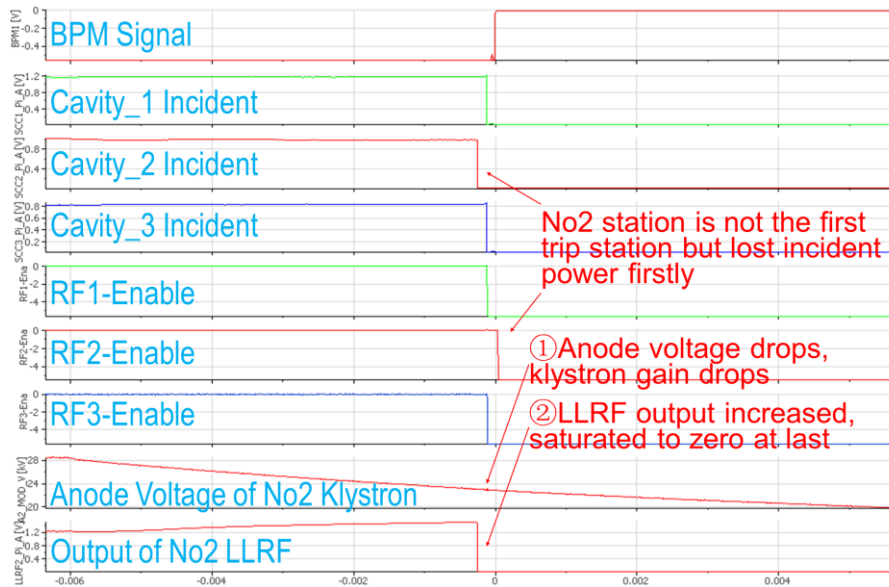
201510162026 trip. Anode voltage drop lead to beam dump

- There are many auxiliary power failures, focus power, 24V power, filament power, anode power, ion pump power etc;
- Now we exchange them periodically.
