| The European Synchrotron

UHV-leakage problems on BPM-buttons for EBS

DEELS Workshop @ Diamond Light Source

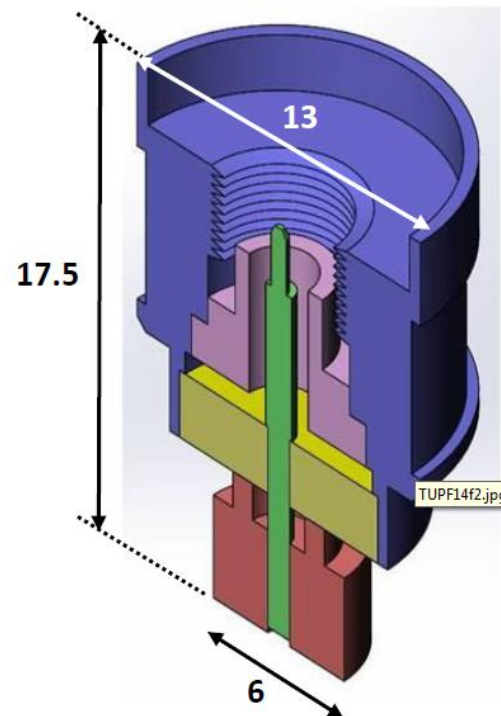
- ☉ Vacuum leaks discovered after welding of BPM buttons into vacuum chambers end of 2016 (~ 25 % leaking units)

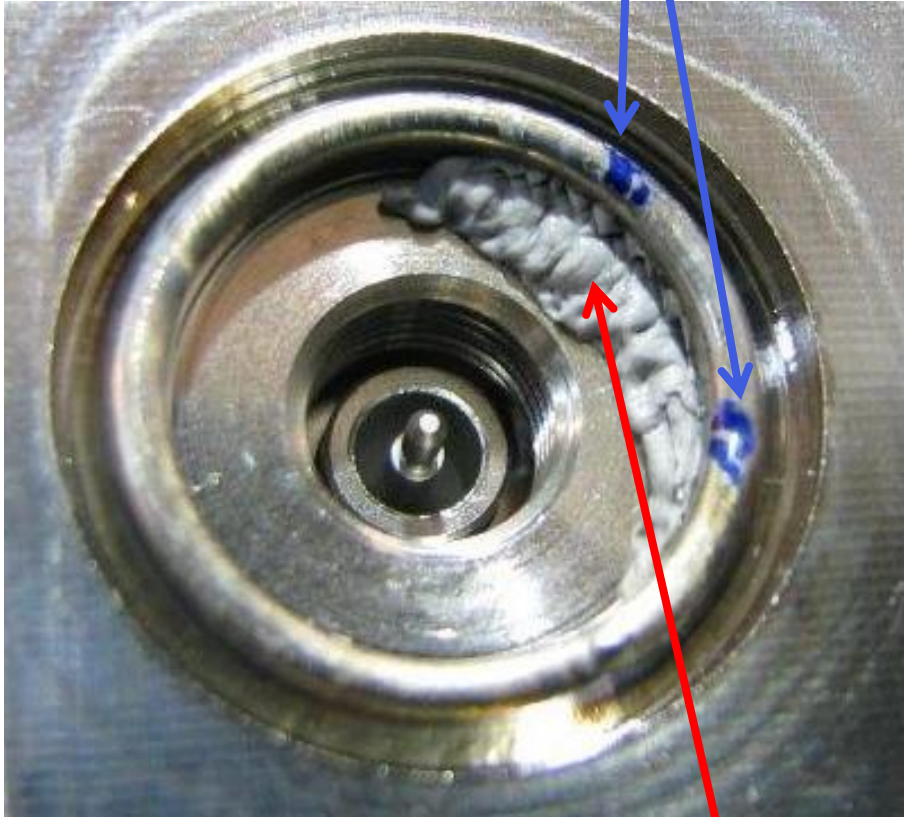
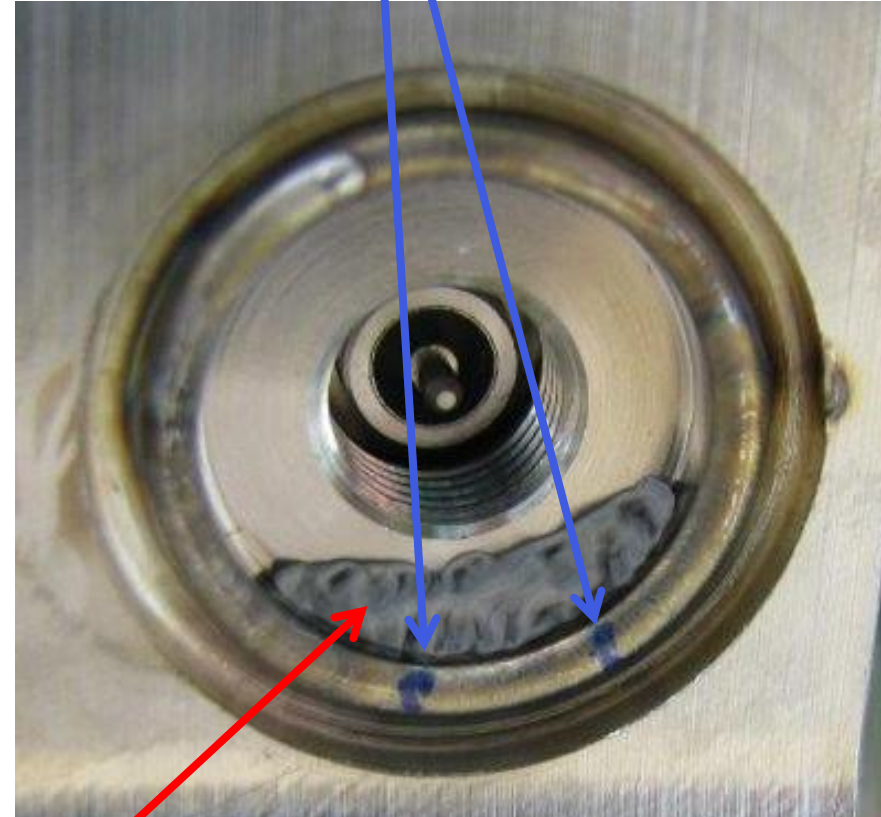
Leaks roughly located close to the welding

Wax applied in the corner between welding lip and main body :

→ The leak is stopped !

→ The welding is OK !

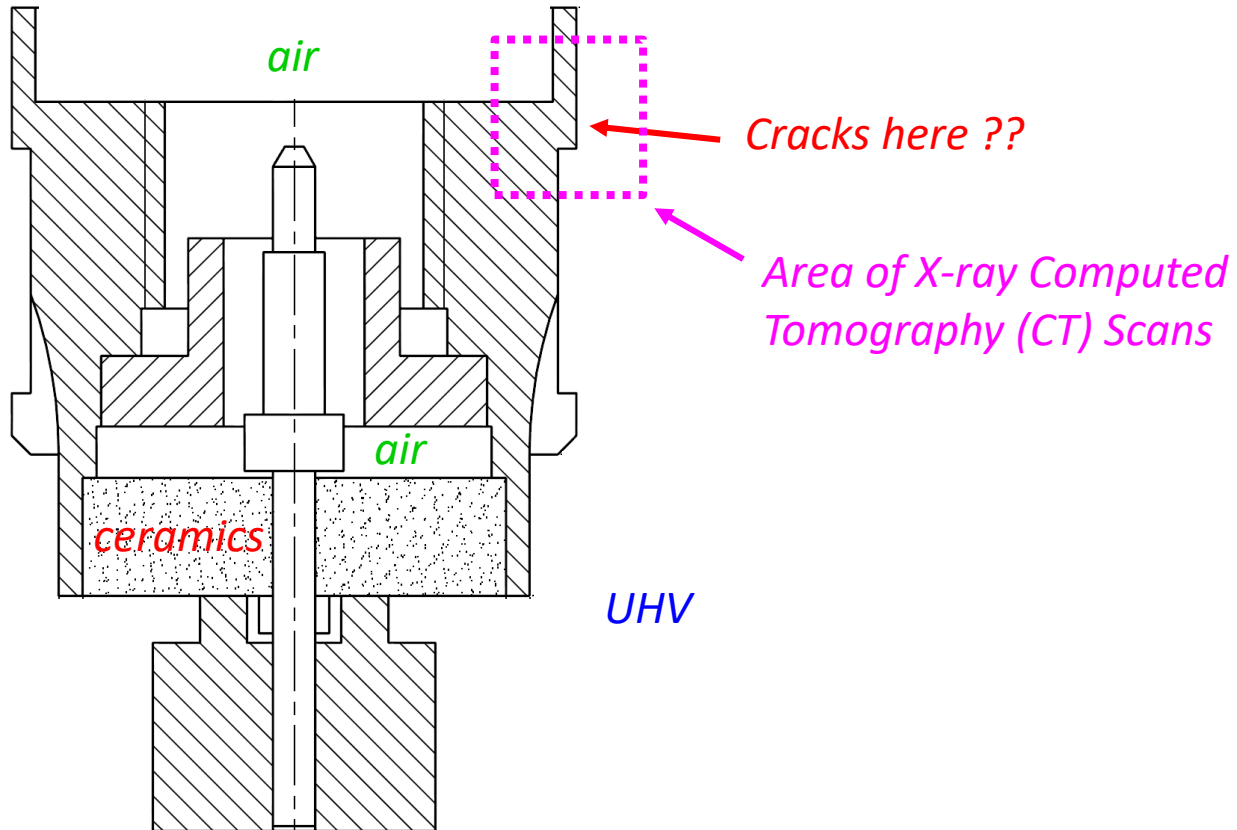
1st Suspicion: Cracks in the welding lip due to mechanical stress

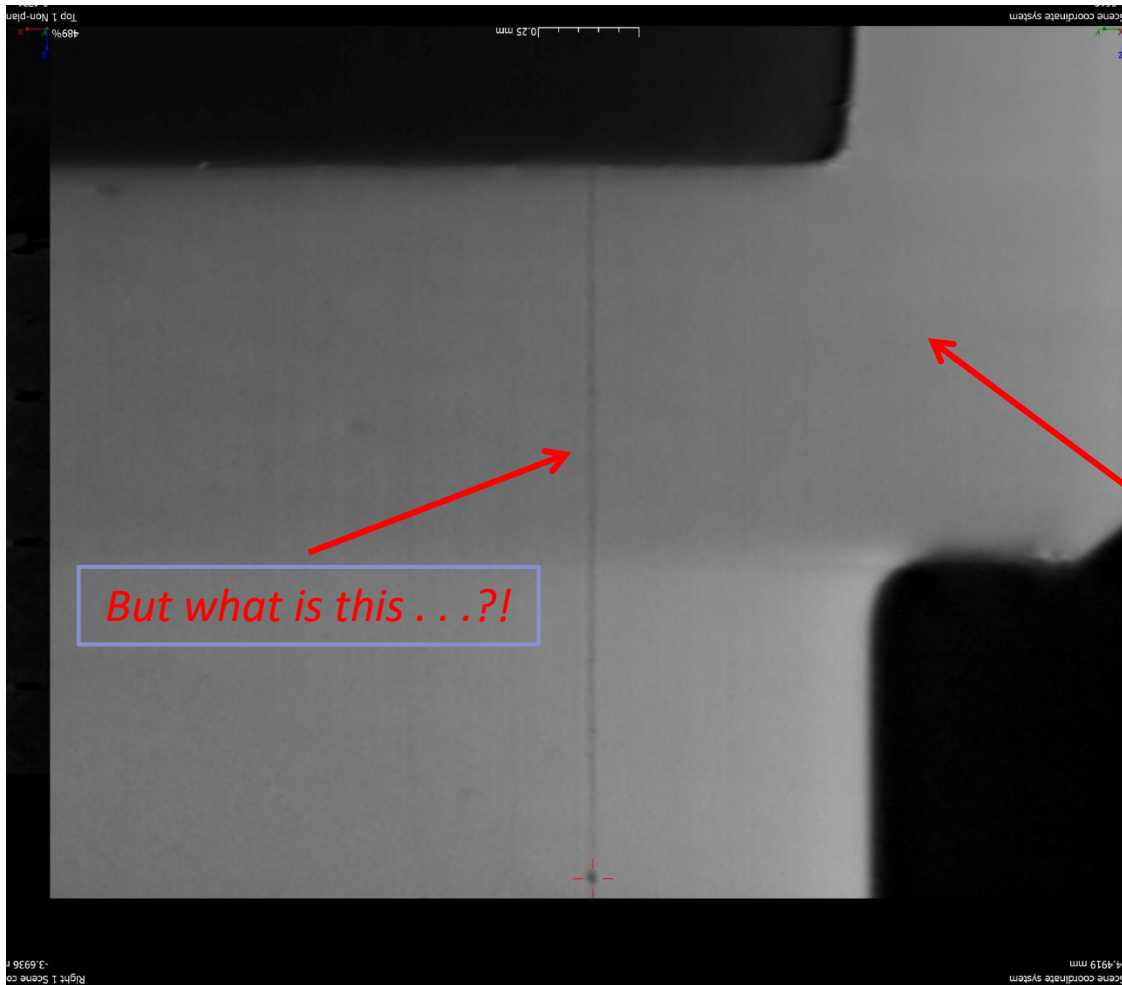
X-ray Computed Tomography done @ ESRF on a leaking button

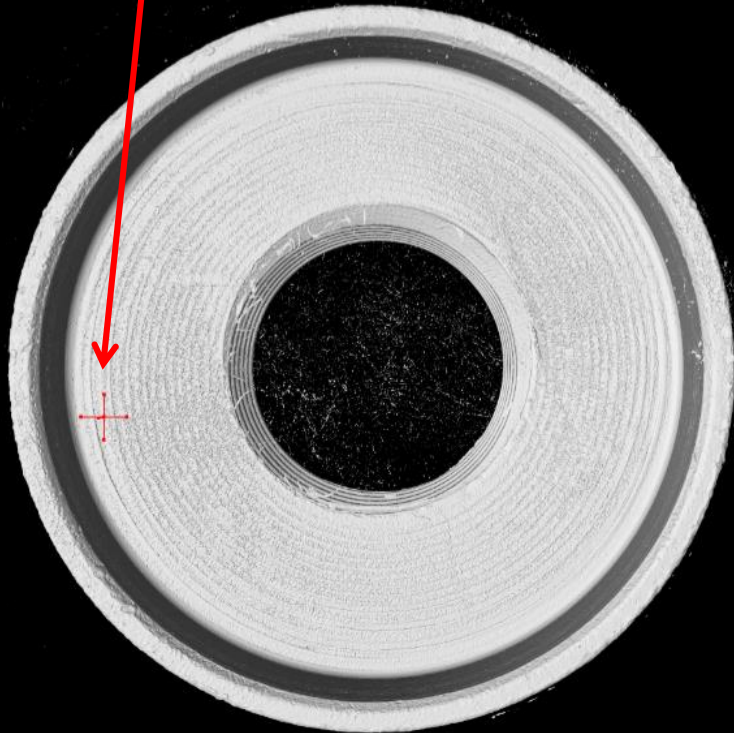
Leak position located with He-leak test

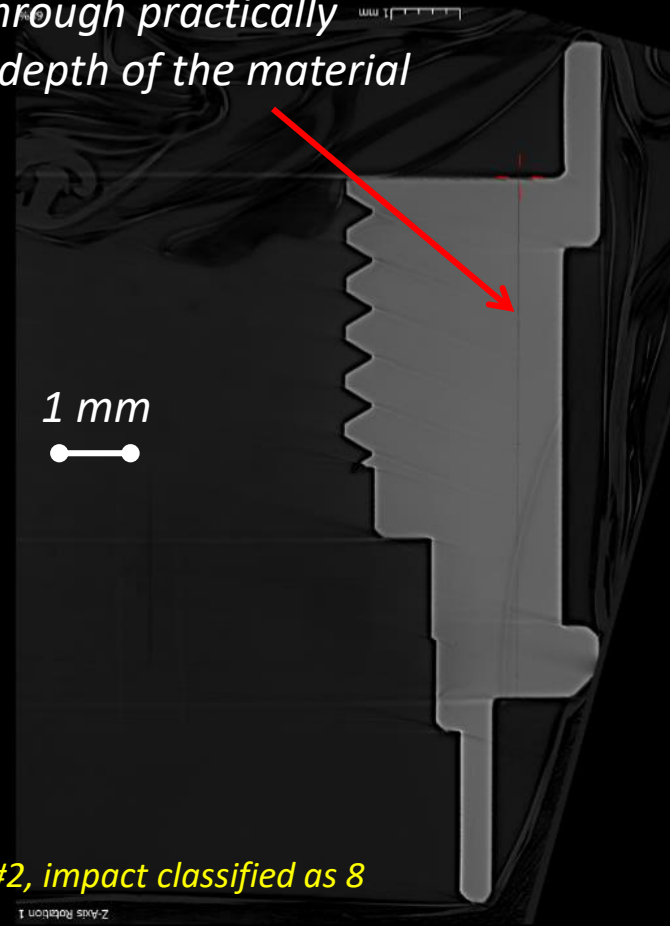
sample #2, defect #2, impact classified as 8

Channel / pipe of large diameter, going through practically the full depth of the material

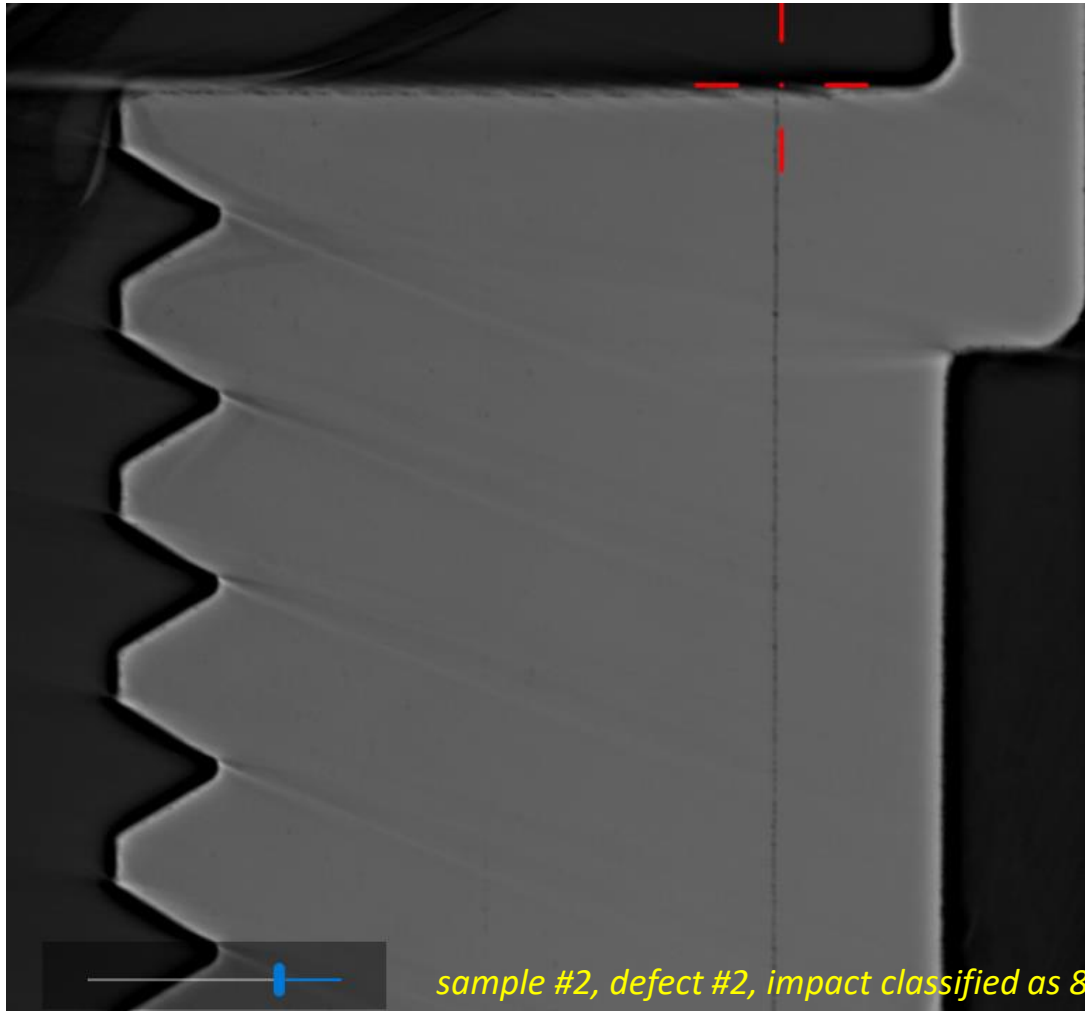
Zoom: Channel is an alignment of small “bubbles”

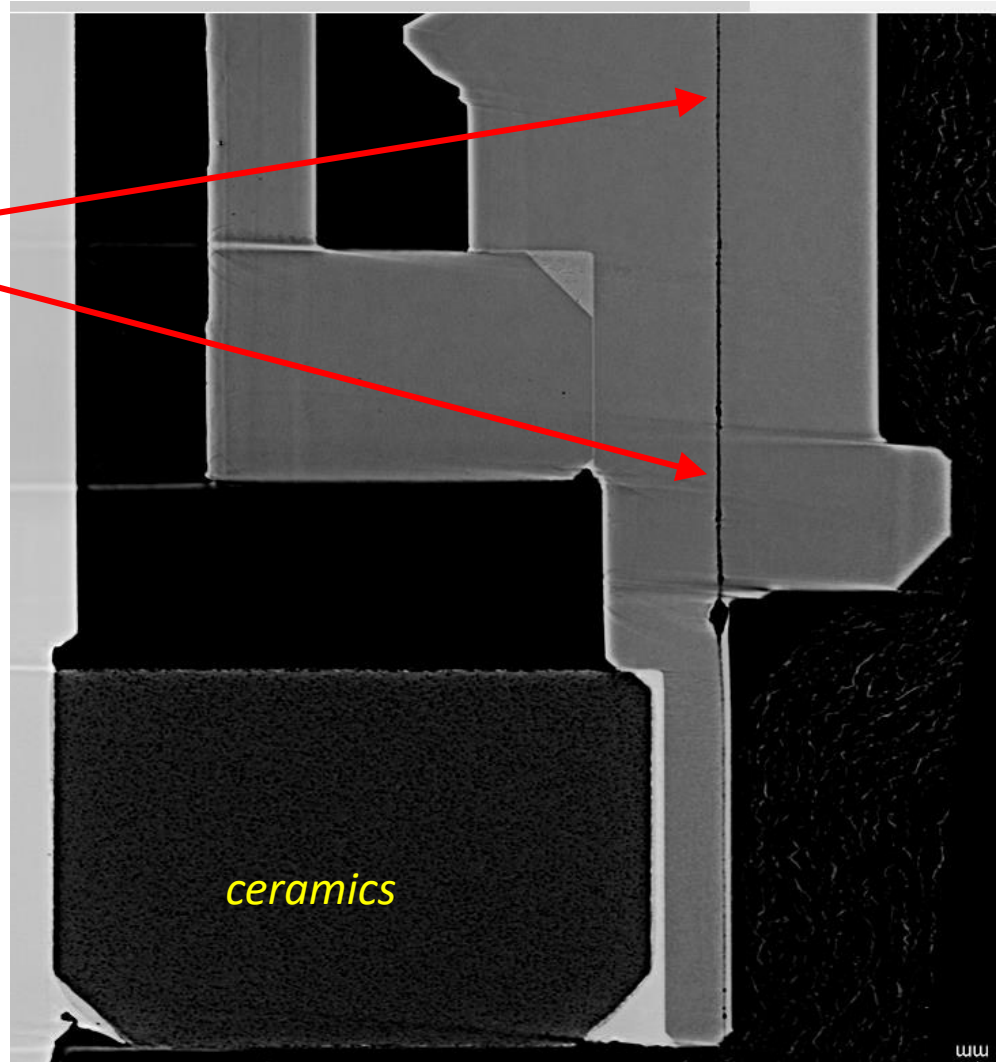
The channel passes through the full depth of the steel outer-body

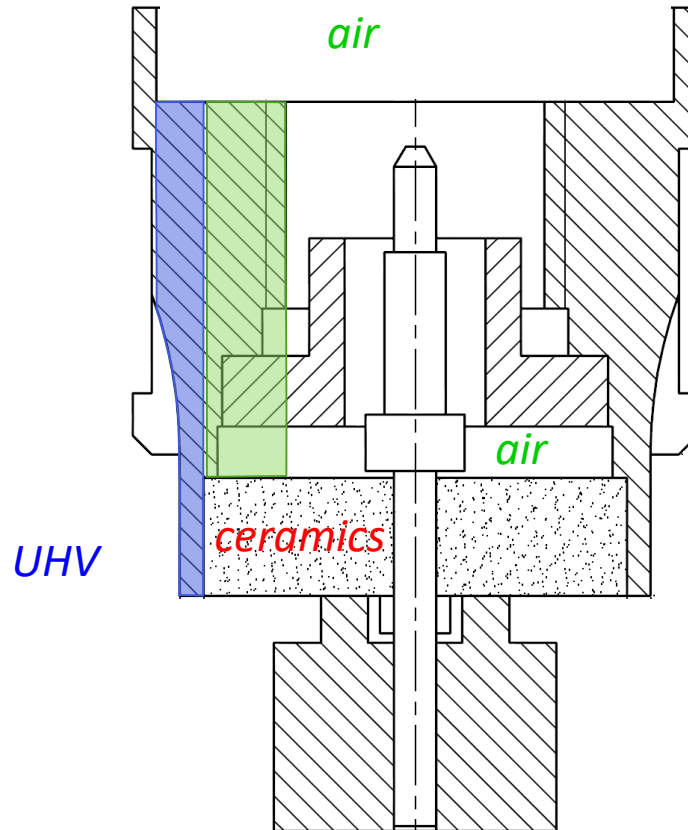
The “crack theory” is cancelled ; channel-like bulk defects create the leaks

~~cracks here ??~~ → No.

Bulk defects lead to UHV leaks
ONLY in the blue area,
NOT in the green area (not connecting
with UHV)

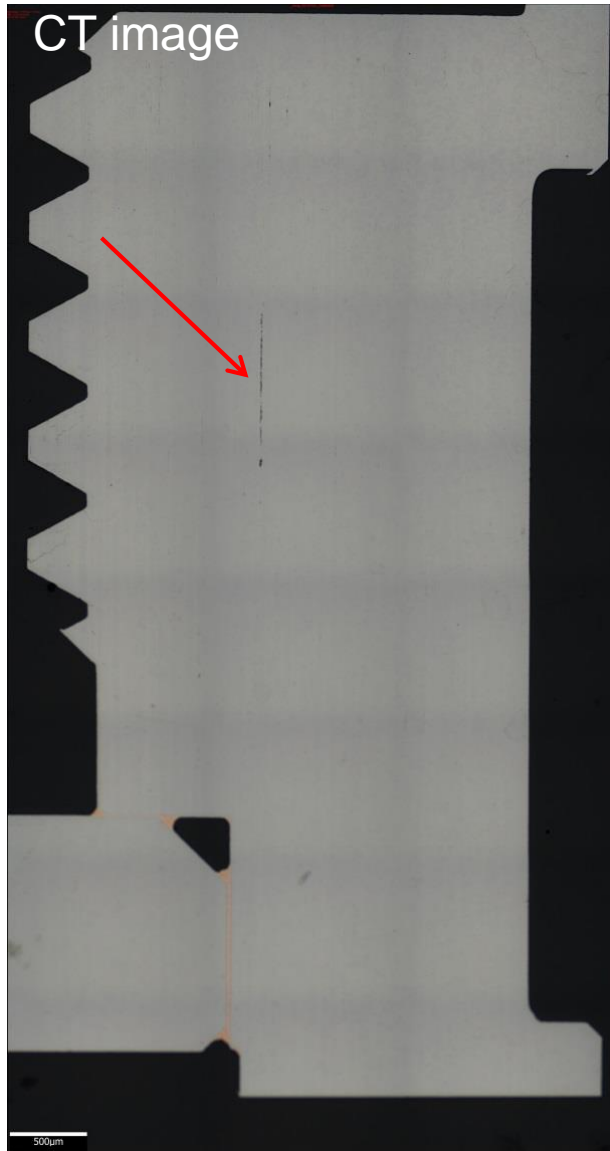
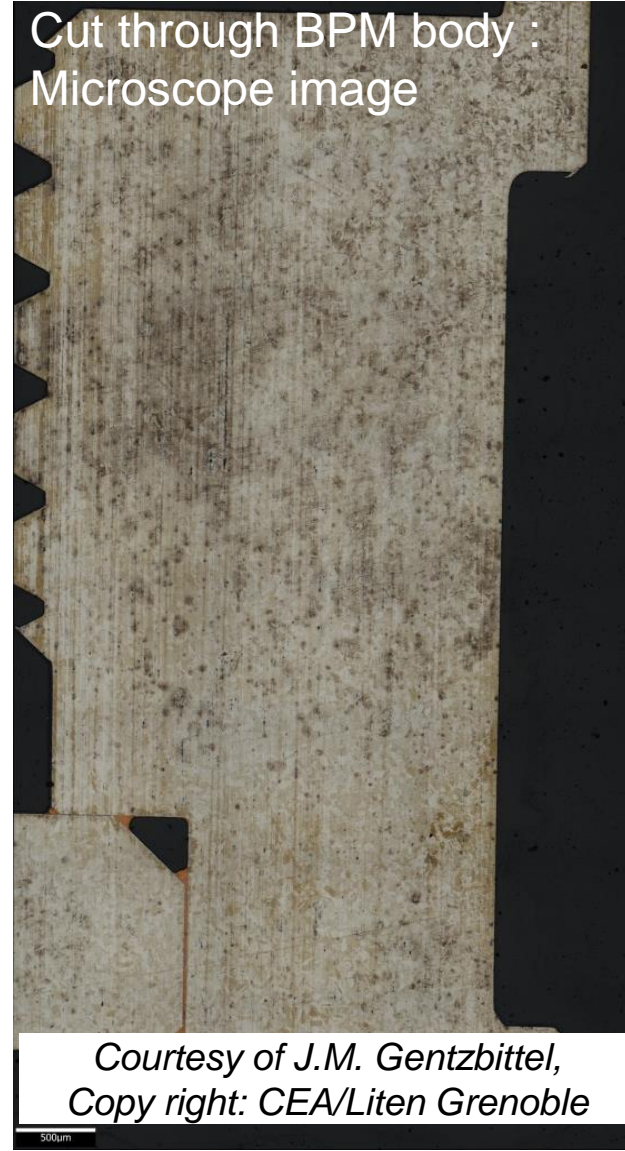
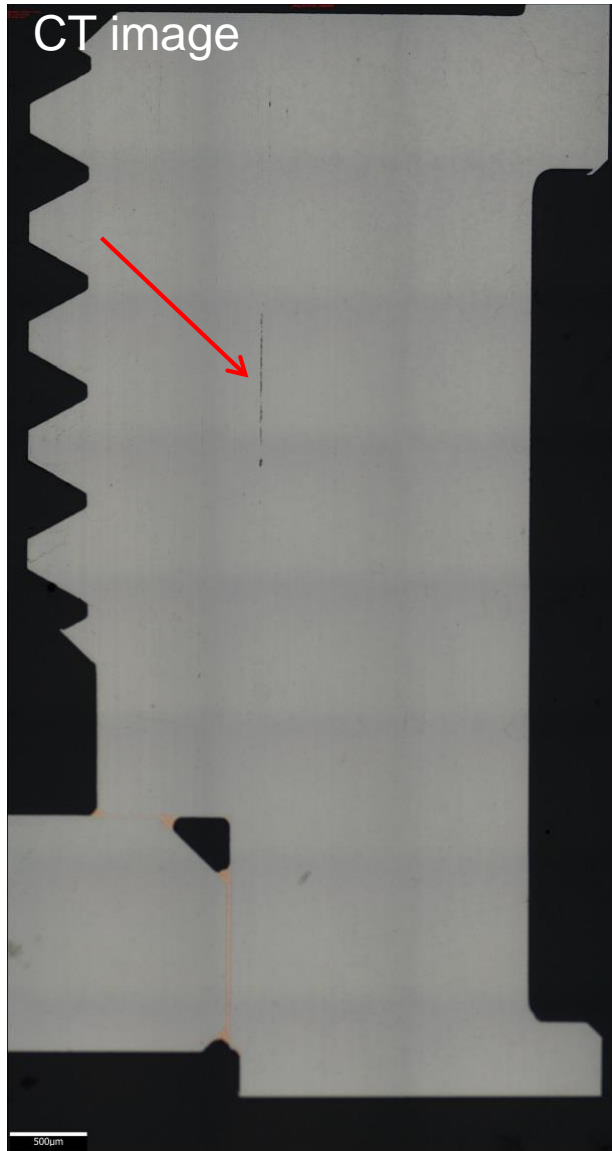
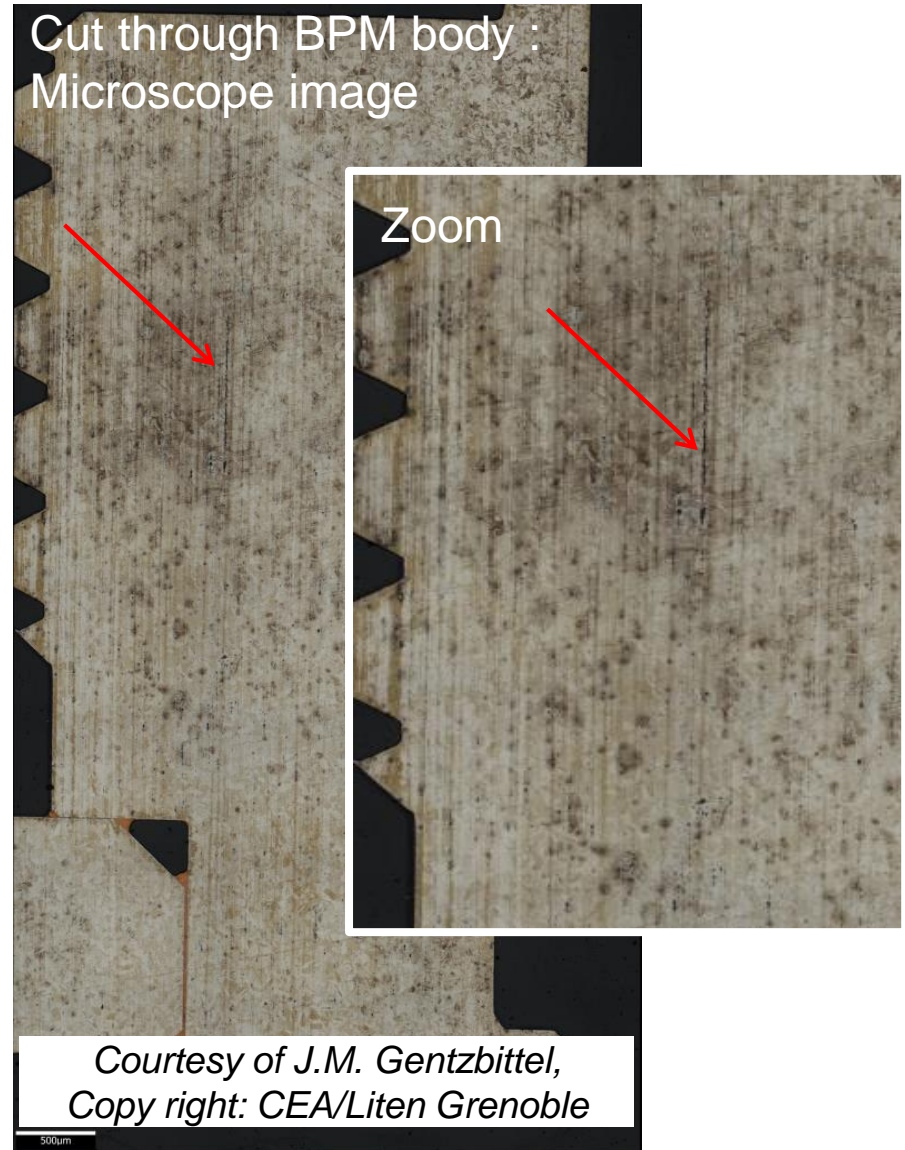
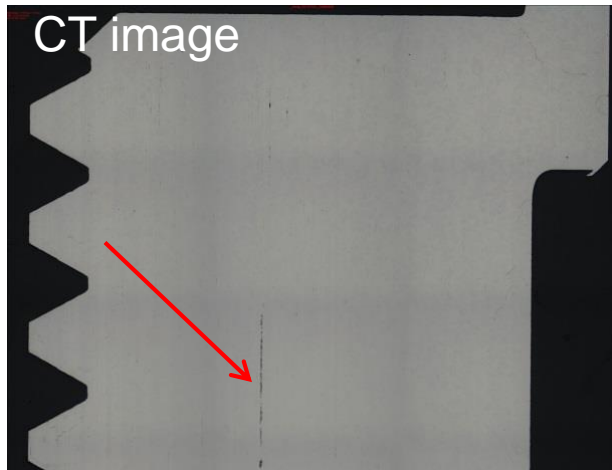
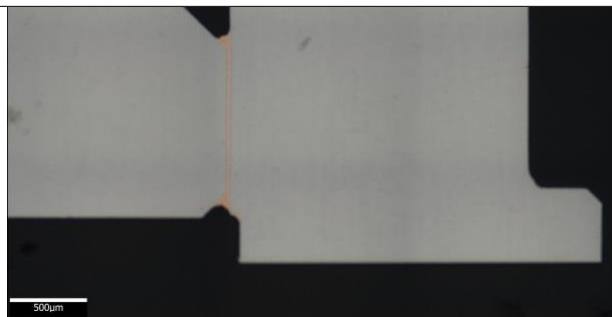
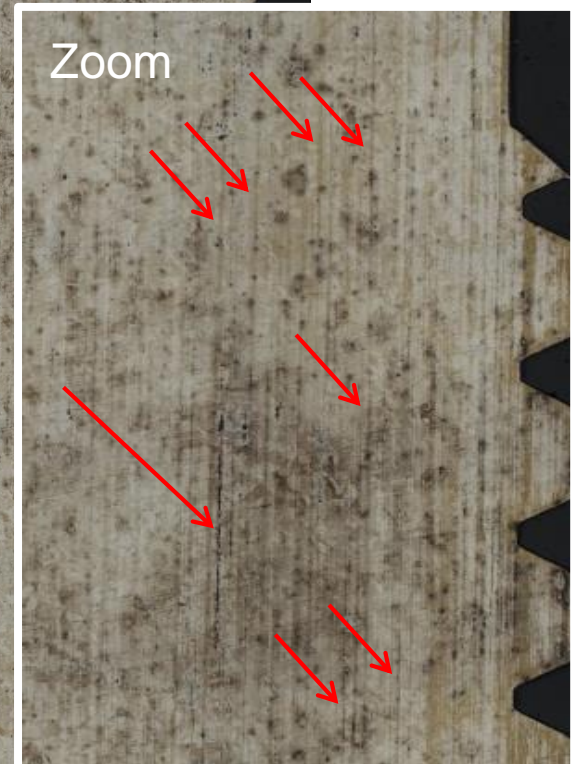
The used steel is even more porous than believed from X-ray CT images !

Channels are formed by alignment of small voids of less than 10 um diameter.

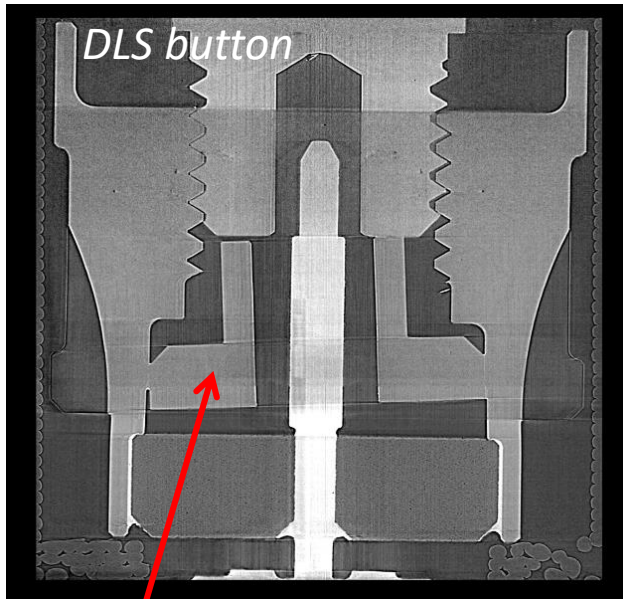
This part not completely inserted and oblique

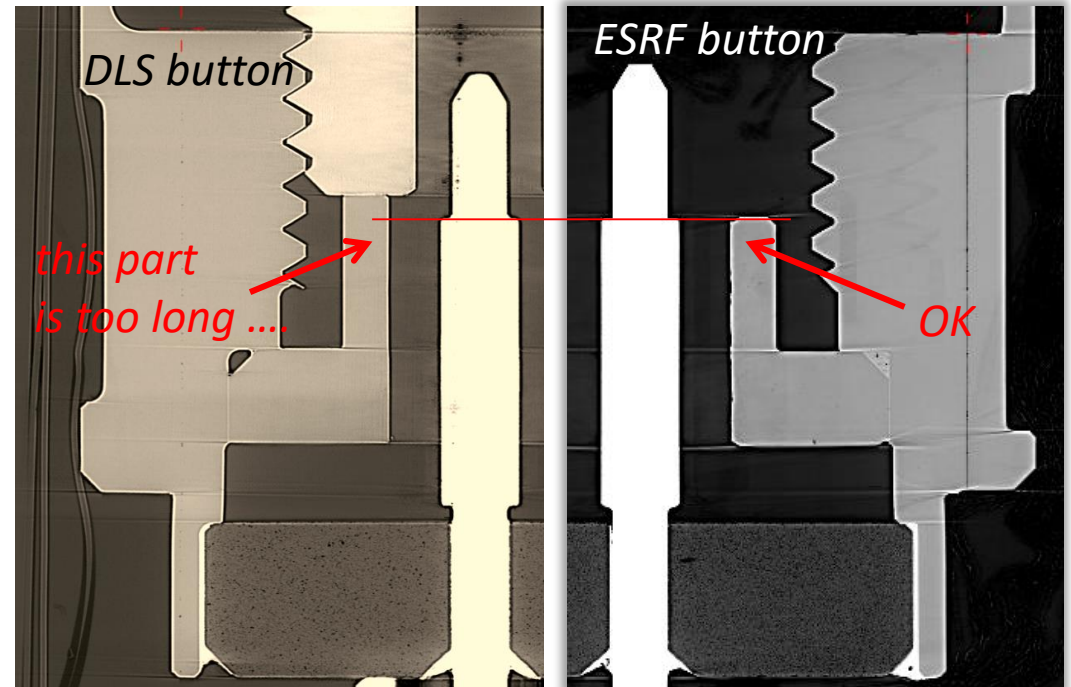
Zoo of Curiosities: Misplaced end stop for SMA connector (only 3 out of 250)
