Wolfram Erdmann, PSI  
for the CMS pixel group

“Radiation Effects at the LHC and impact on operation and performance”  
CERN, 23-24 April 2018

CMS pixel overview  
SEU expectations and mitigation strategy  
Operational experience

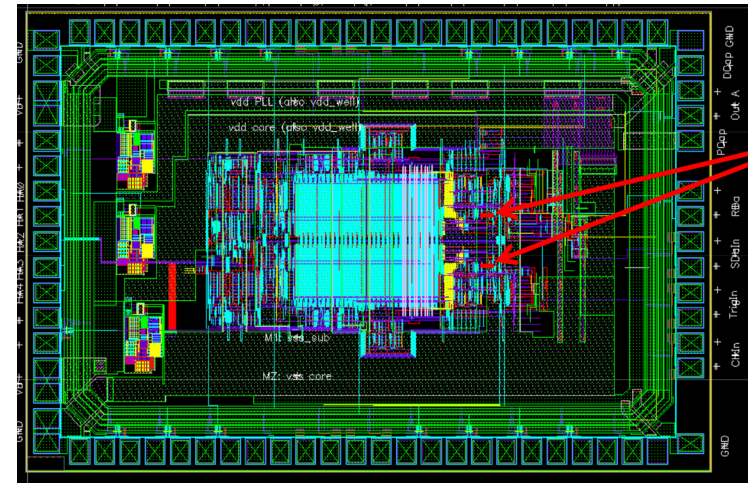
- New error mode observed in Run2 (Phase 1) :
  - TBM cores ( $1/2$  TBM) stop sending data, the other half continues without problems
  - Reset or reconfigure does not fix the problem
  - Only power cycling does
- Behaviour consistent with an SEU in one particular TBM FF (readout control)
  - Dynamic SEU, no connection with control registers, not cured by reconfiguration
  - Connected to power-on reset, but not soft-reset  
previous TBM versions had an additional “hard-reset” which was never used and therefore removed :(
  - Circuit modified with respect to the Run 1 / Phase 0 TBM
  - Not SEU protected (unlike DACs/Registers and many other flip-flops)

- In 2017 modules were power cycled when the fraction of unresponsive module reached a threshold value (few %)
  - Time between power cycles at high luminosity : several hours
  - More frequent: Soft-error recovery (reconfigures ROCs/TBMs, does not fix TBM SEU)
- Contributed <1 % inefficiency,
  - not a show-stopper, but painful ( in combination with other problems)
- During LS2 the first layer will be replaced, the TBM has been revised
  - Capacitor protection for the suspected FF
  - Connection to general soft reset
  - Additional reset signal (encoded on trigger line)
- Dedicated tests with micro beams are in preparation to confirm diagnosis and cure
