# ***ISOLDE Lines - Survey Results***

***Measurements of  
November/December 2012***

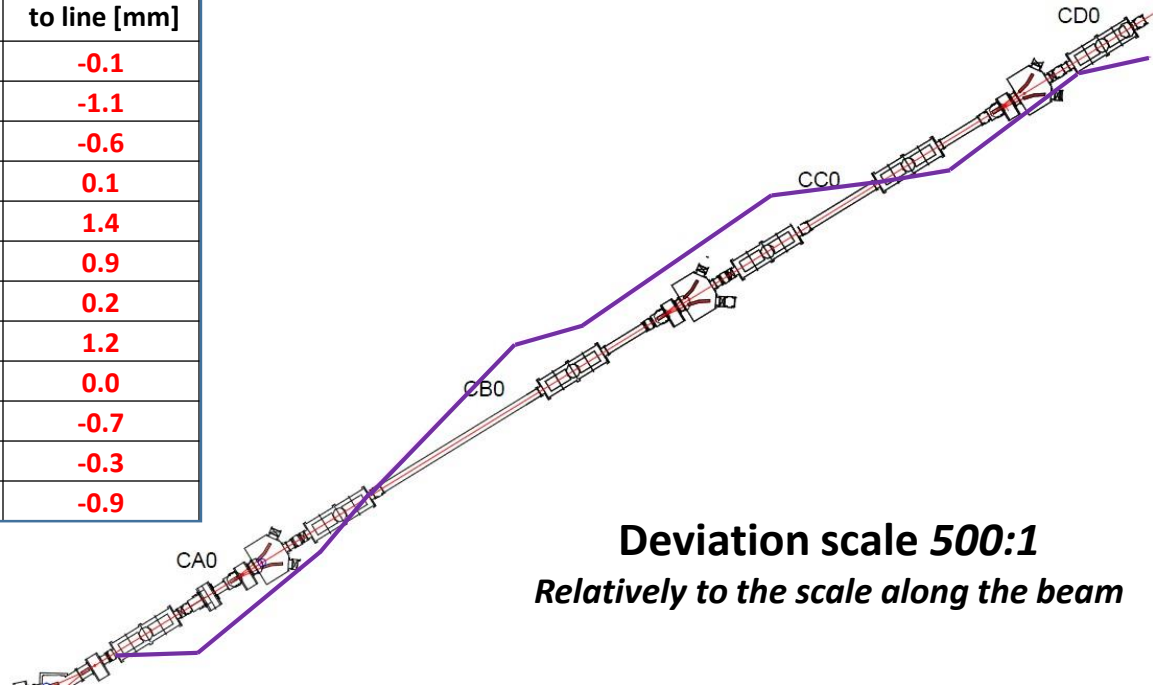
Line: **CA0-CB0-CC0-CD0** Bearing [g]: **351.4005**

Name	X [m]	Y [m]	Distance to line [mm]
CA0_Q_E	1879.3962	2239.1236	-0.1
CA0_Q_S	1878.7661	2239.7807	-1.1
CB0_Q1_E	1877.3575	2241.2535	-0.6
CB0_Q1_S	1876.7272	2241.9131	0.1
CB0_Q2_E	1874.9036	2243.8206	1.4
CB0_Q2_S	1874.2733	2244.4785	0.9
CC0_Q1_E	1872.8599	2245.9545	0.2
CC0_Q1_S	1872.2301	2246.6140	1.2
CC0_Q2_E	1871.3751	2247.5059	0.0
CC0_Q2_S	1870.7443	2248.1640	-0.7
CD0_Q1_E	1869.3341	2249.6383	-0.3
CD0_Q1_S	1868.3920	2250.6219	-0.9

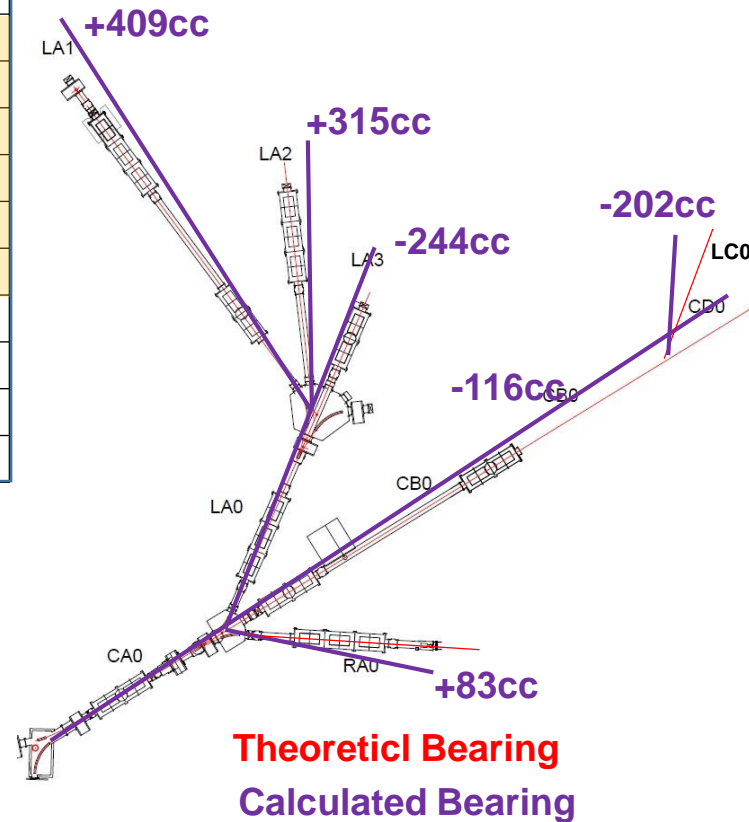
Line	Theoretical Bearing	Calculated Bearing	Difference Calc-Theo
	[g]	[g]	[cc]
CA0-CB0-CC0-CD0	351.4121	351.4005	-116
LA1	245.8565	245.8974	409
LA2	279.1898	279.2213	315
LA0-LA3	312.5232	312.4988	-244
LC0	312.5232	312.5030	-202
RA0	390.2997	390.3080	83
RB0	390.3010	390.2699	-311
RC0-RC2-RC6	390.3010	390.2941	-69
RC3	29.1899	29.1670	-229
RC4	323.6343	323.6108	-235

10cc ~ 0.16 mm/10m
