TCDLA brazing test – January 2018

Summary

Last test in date with Glidcop that was subjected to:

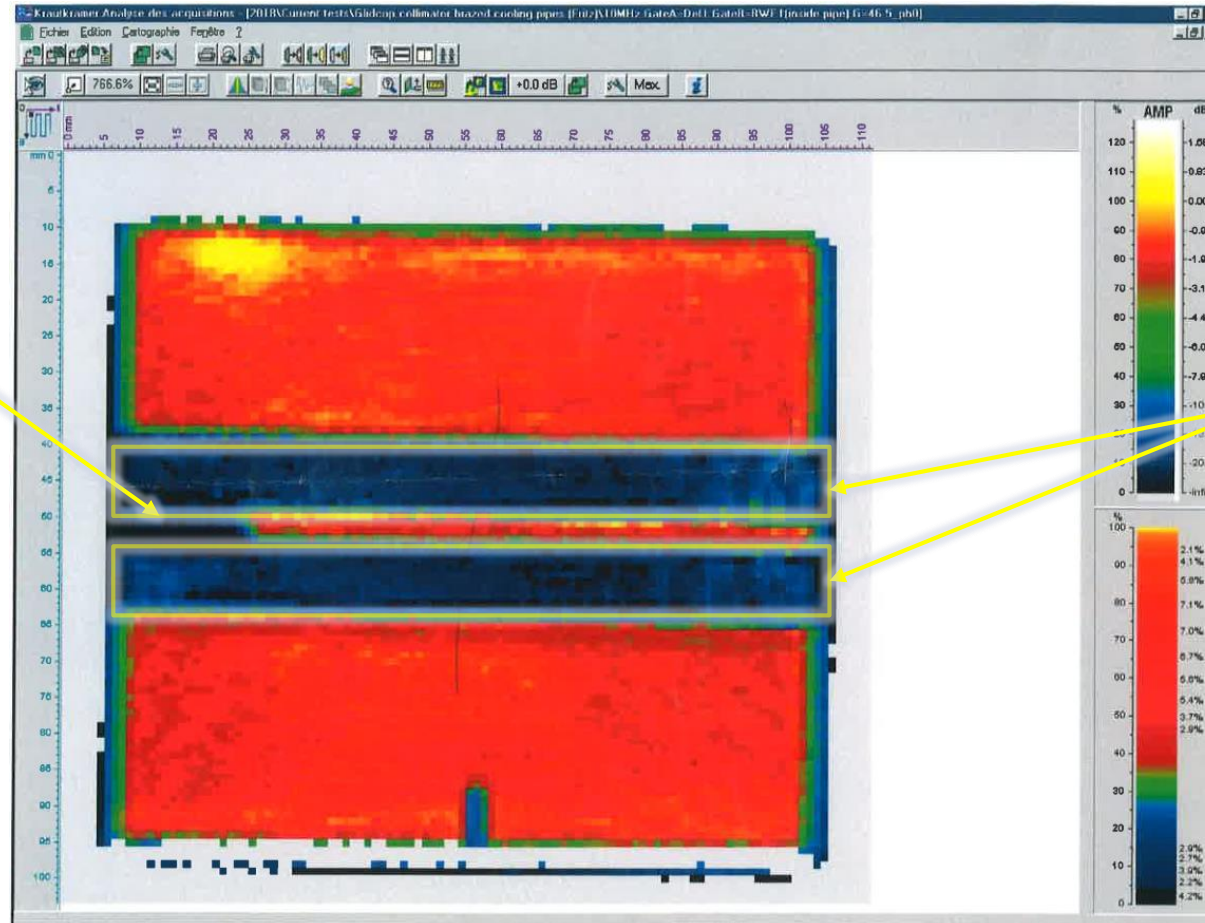
UT scan

→UT is very good (see scan on next slide)

Threaded hole

brazing interface

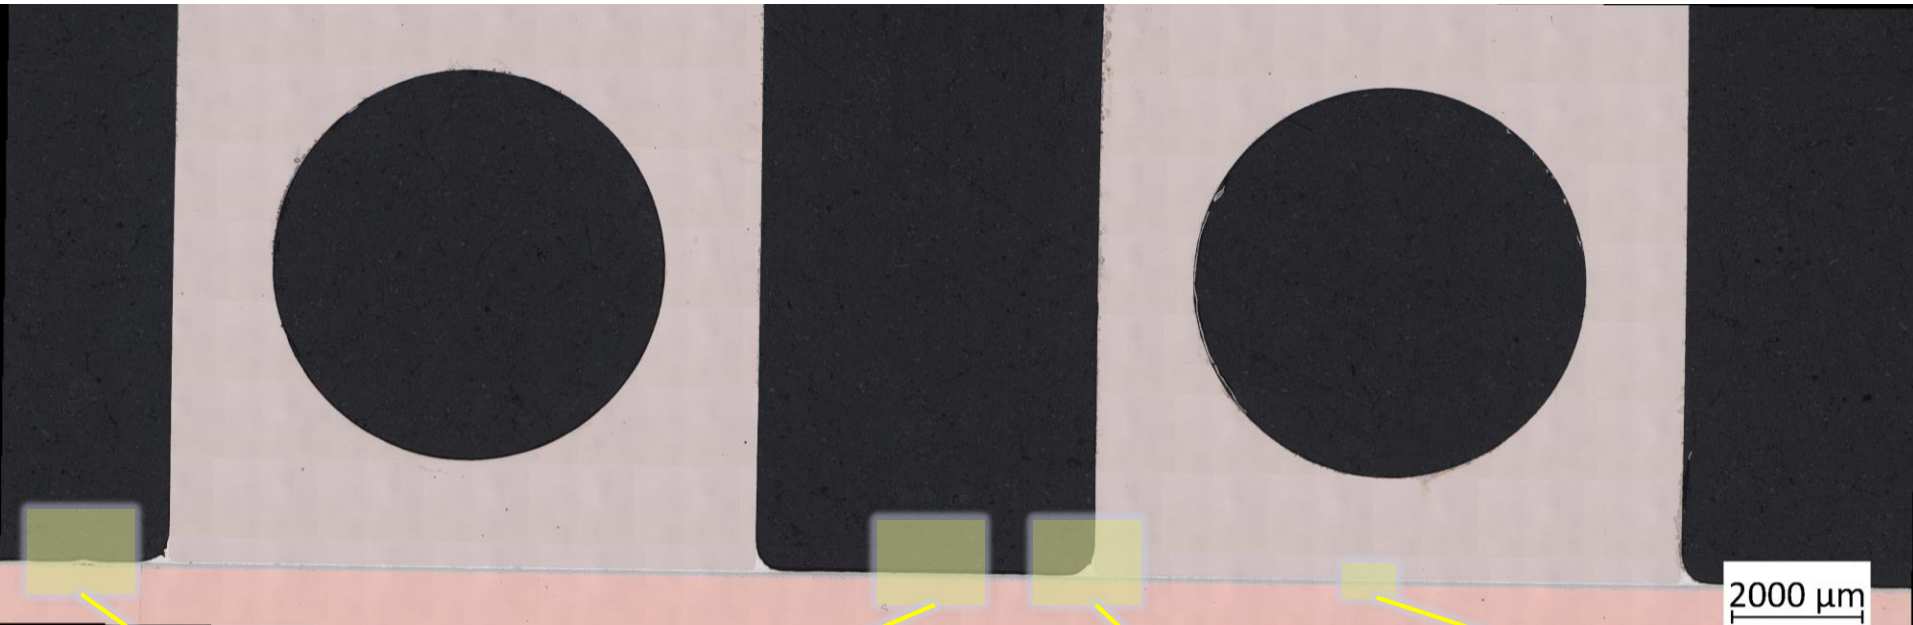
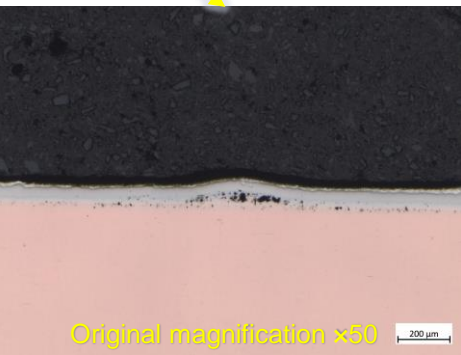
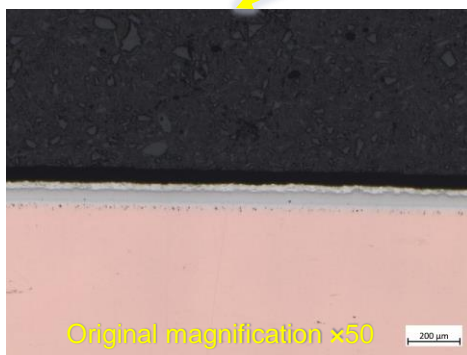
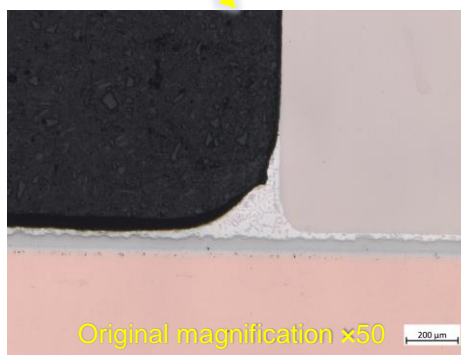
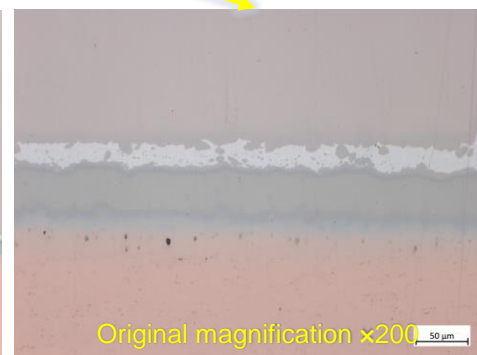
Cut 1

- Cut 1: good brazing interface free from imperfections (rare micro-pores). Micro-porosities are noticed just below the Ni layer,
- Cut 2: good brazing interface free from imperfections (rare micro-pores). Micro-porosities are noticed just below the Ni layer,
- Thicker Ni layer close to the edge of the piece.
