## Quality Control of the dismounting of MBHDP102 First results – De-collaring process

11T Dipole Task Force Meeting # - CERN – 21/02/2018

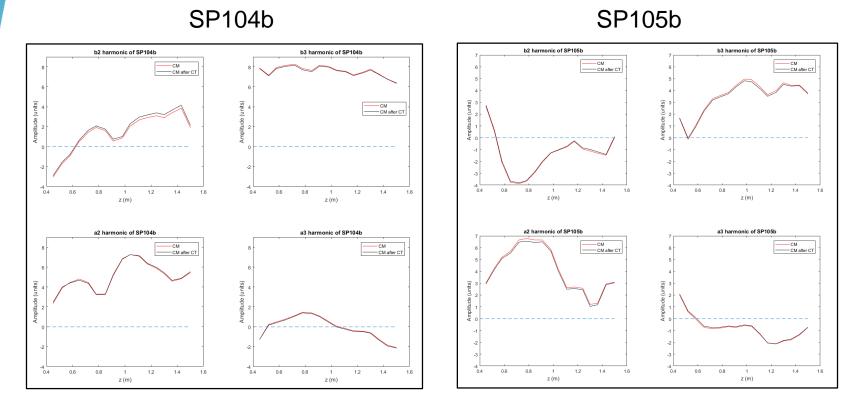
No significant variations Before / After cold test.

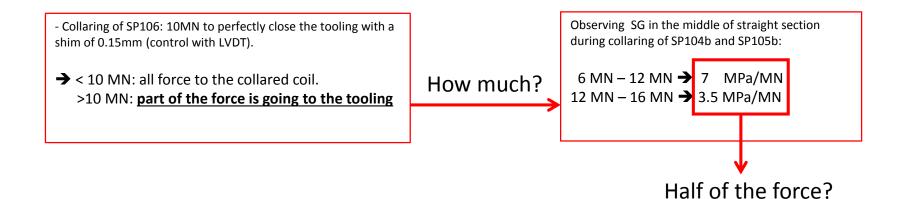
- Shim between stoppers: 0.15 mm
- Removal of the keys ≈ 8 MN

- Decollaring: shim 0.15 mm between stoppers (enough clearance for keys insertion) with 8 MN.

- **Decollaring:** above ≈ 10 MN (it depends on the coils size), the tooling is already closed and the extra force **could POSSIBLY be** share half and half between CC and Tooling.
