MQYYM Coil 7 issue

February 21st 2018

H. Felice, D. Simon, M. Segreti, J.M. Rifflet

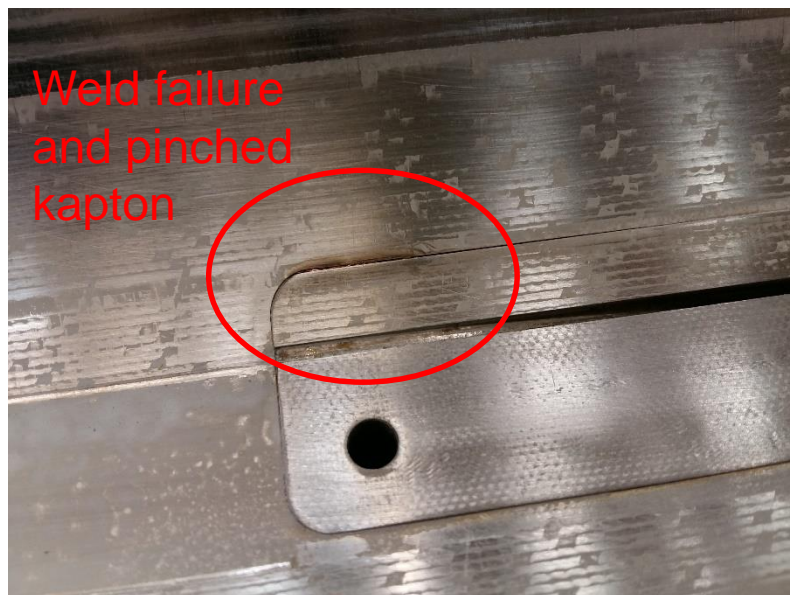
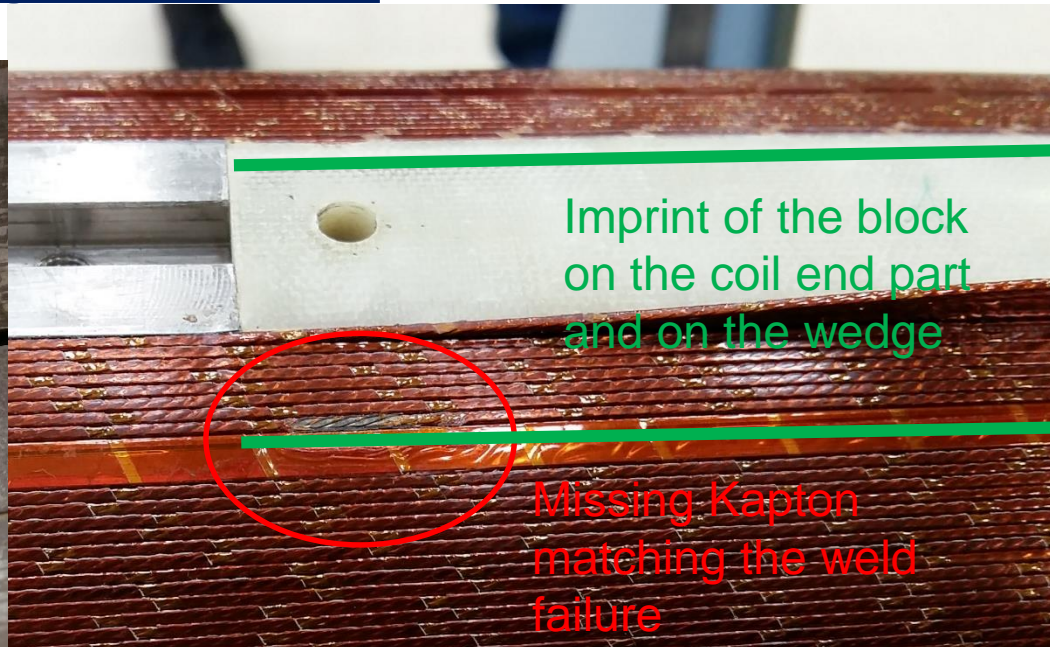
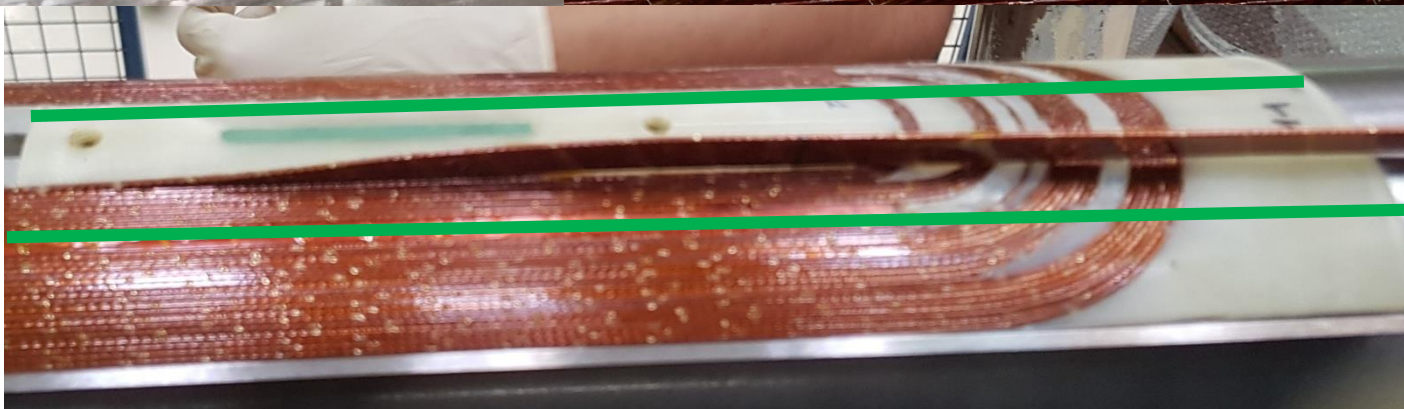
Issue encountered after the IL curing sheet removal:

Imprint also seen in Coil 1 and subsequent coils without insulation damage

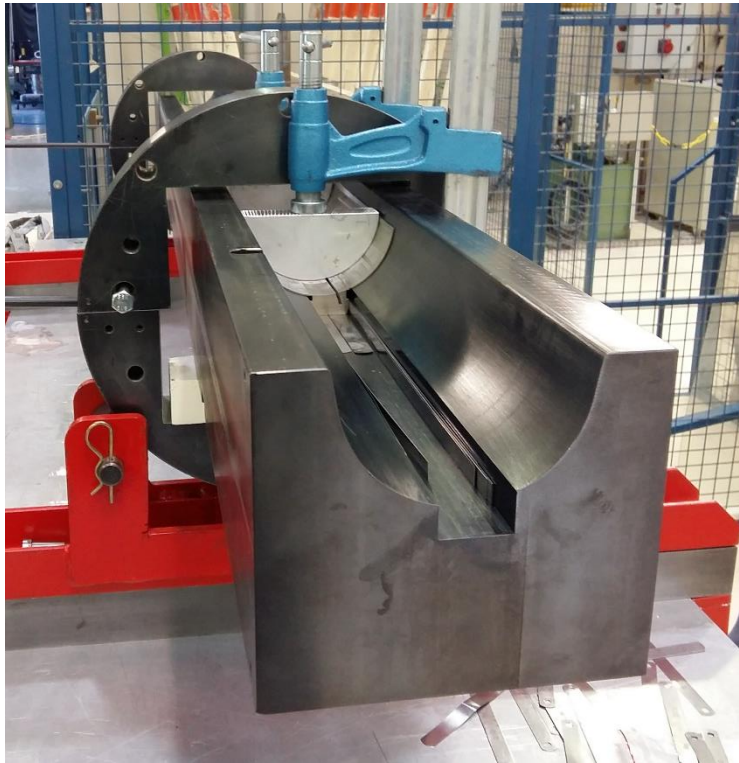
The layer jump guide moved inward by $\sim 0,3$ mm
The layer jump guide has an interference with the mould ranging from **0,22 mm to 0,26 mm** => **imprint in parts / failure**

=> The curing sheet has been repaired. Interference has been removed

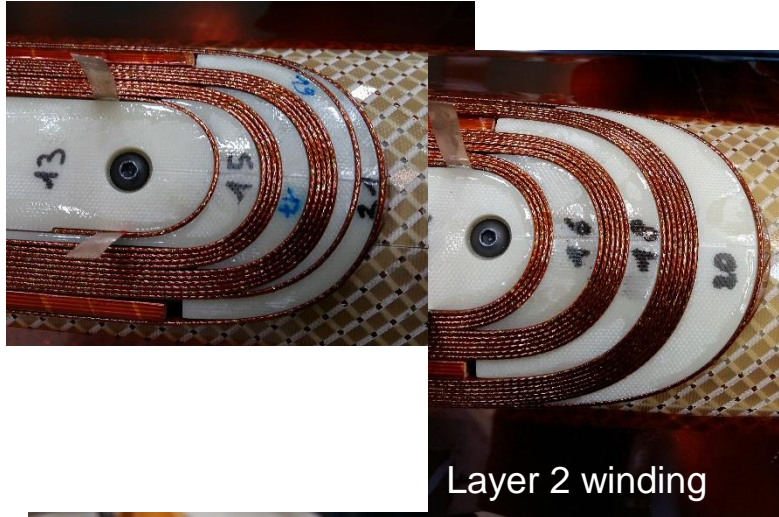
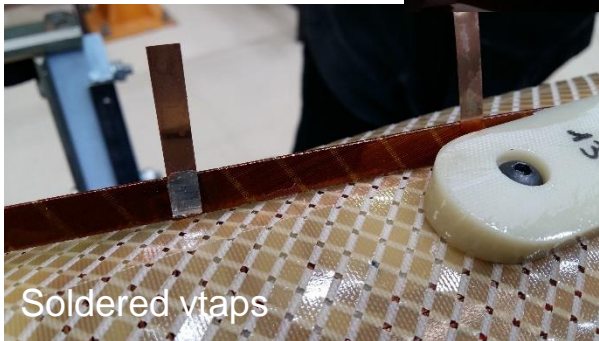
- Good matching of the coil parts with the winding
- **CuBe Broken flags** after polymerization
=> Require smoothing of the sharp edges to avoid damaging the flags
- Impulse test showing change of frequency as V increases
=> Turn to turn weakness?
=> likely due to the weld of the vtaps using Tin Indium solder (fusion T < polymerization T!)

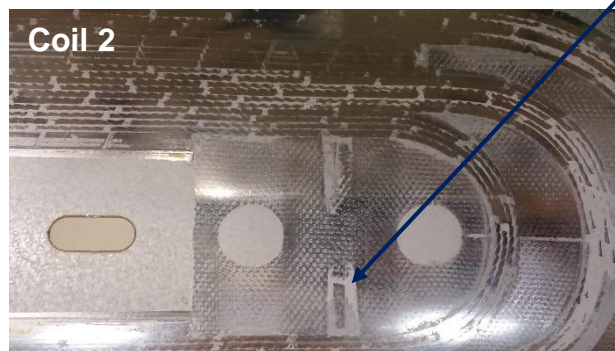
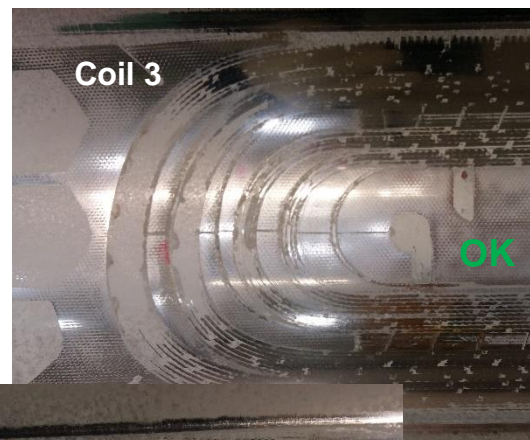
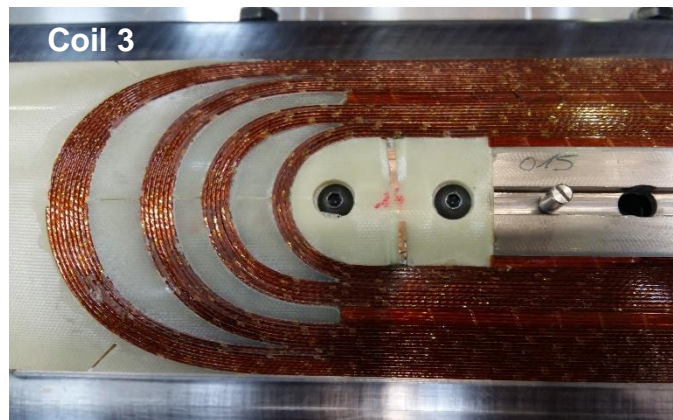
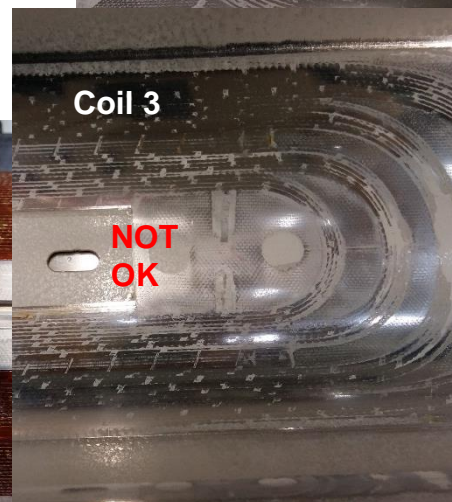
- No major issue during coil fabrication of coil 2 and 3
- Concern on vtap flags: grooves are not deep enough => some compression of the taps

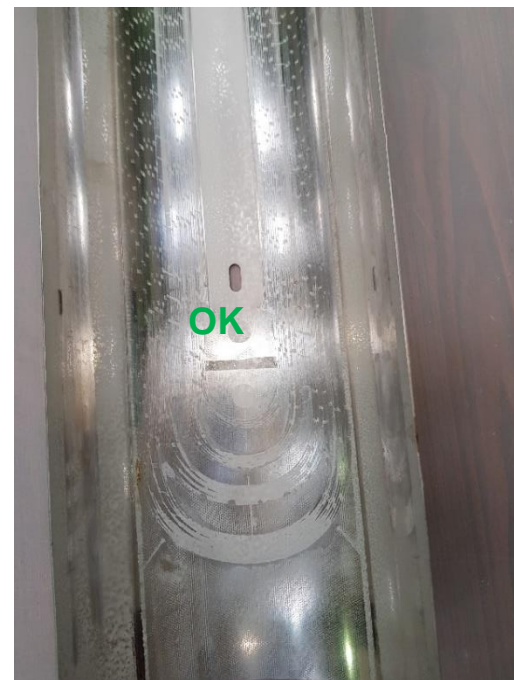
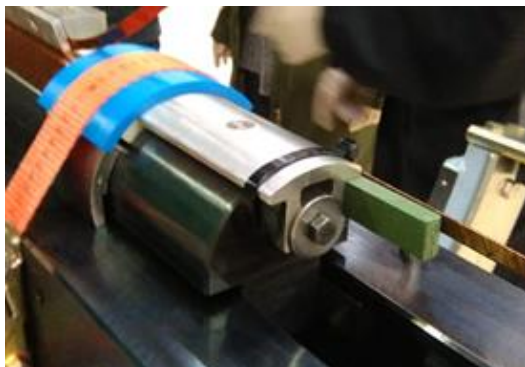
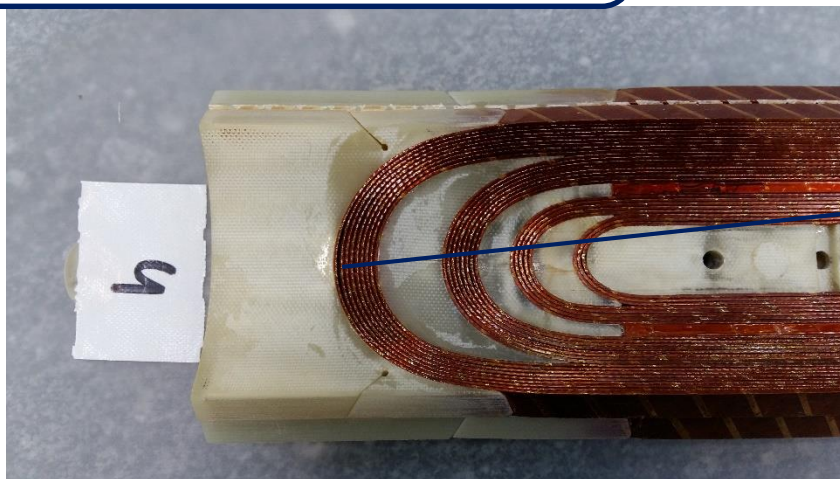
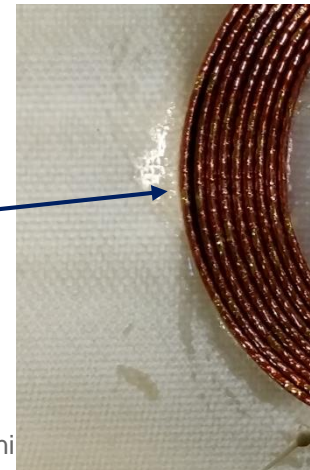
- Vtaps/endpart groove problem solved
- But :
 - Unglued turn on the outer layer => adhesive missing?
Unexpected cleaning?
 - Gap in the last but one turn in the RE IL
 - Repair: Filling the area with resin is considered but of concern
 - **Change of process:** Release of the end pusher after press top plate positioning and before mandrel release

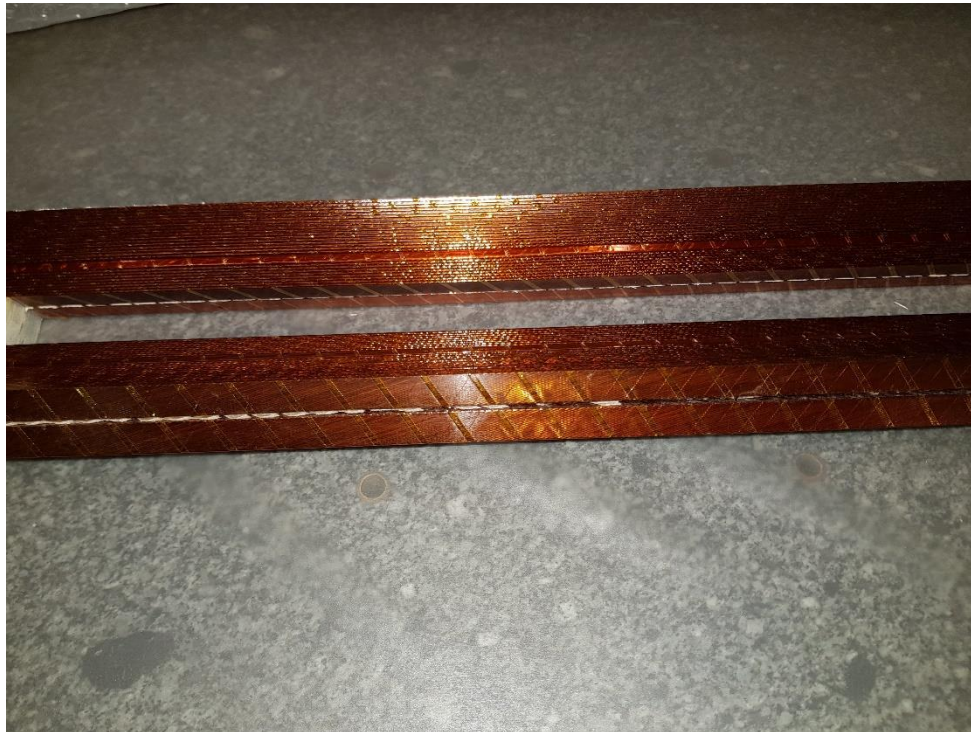
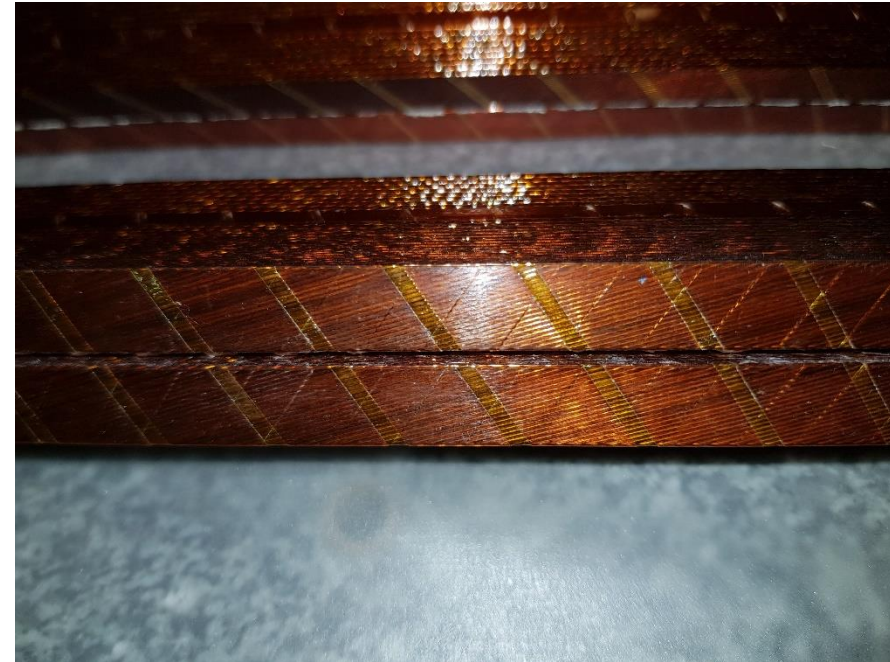
Issue encountered after the curing of the external layer

- Uneventful winding
- But damage of the interlayer insulation after fabrication during the cutting of the insulation

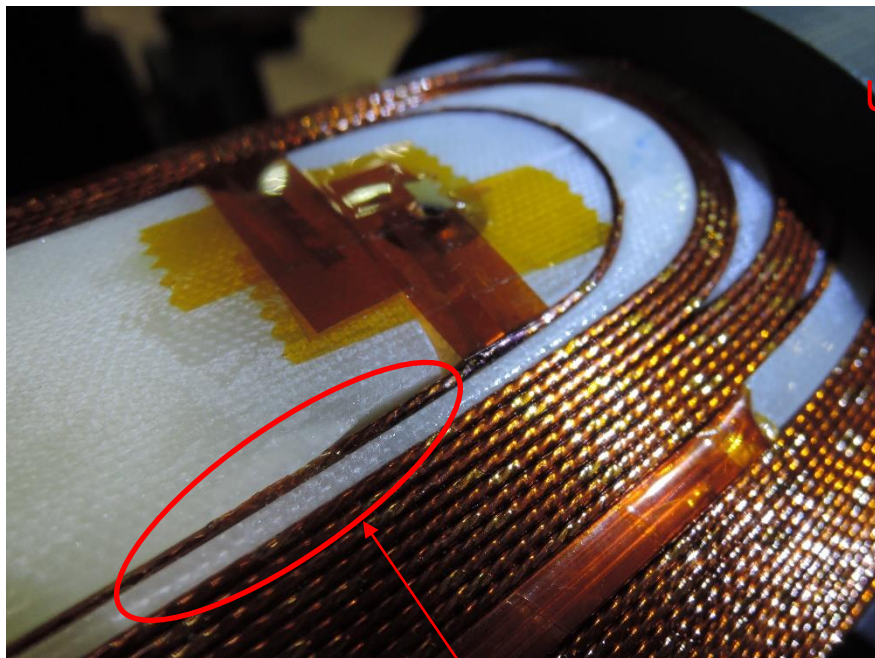
Issue encountered before curing of the external layer

Layer jump is mispositionned
G11 seems weakened locally

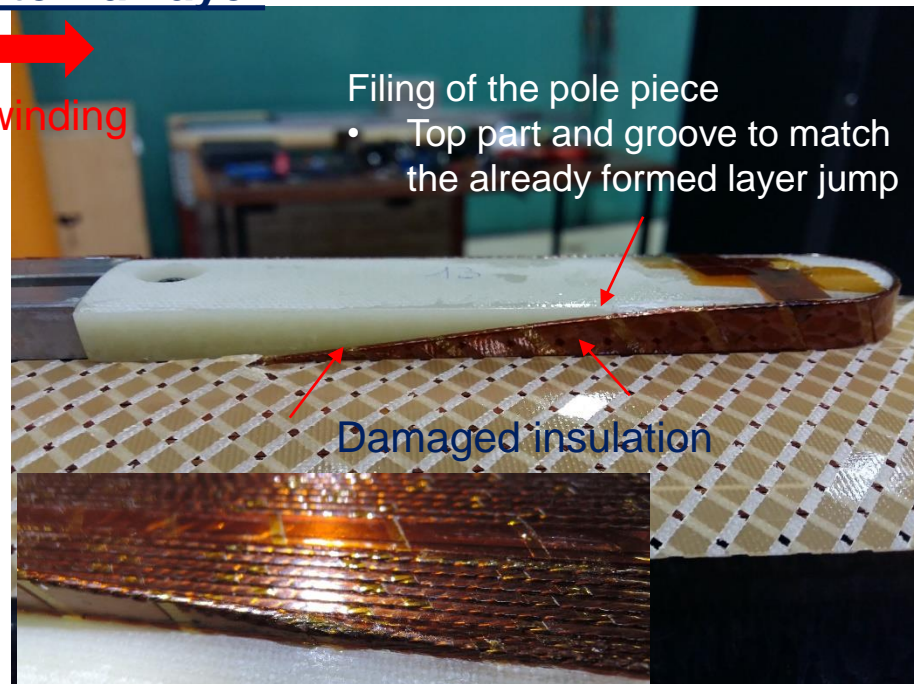
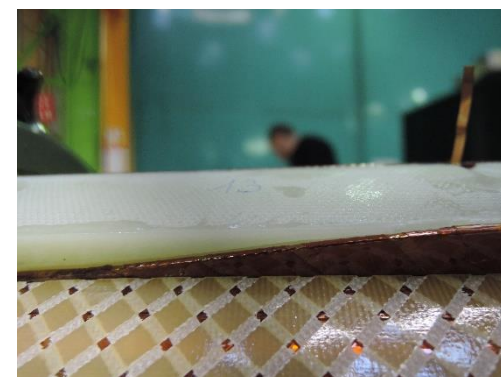
Unwinding

- At QA step: notice an issue with the layer jump
- Decision to unwind layer 2
- Damaged insulation repaired and layer rewound
- Curing ongoing
