Analysis of the ISIS Target Station 2 Proton Beam Window Failure

Service Conditions, Design Analysis and Irradiation Effects

RaDIATE, 17-12st December 2018, CERN.

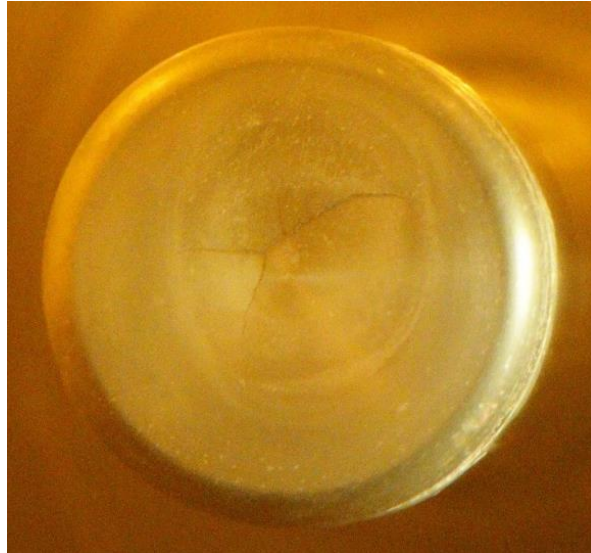
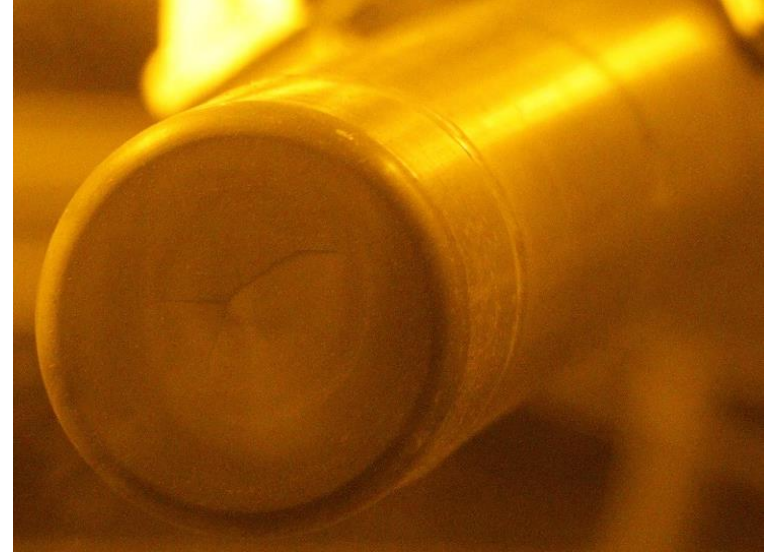
BEW failure in
October 2017.
Replaced
during
planned
shutdown.

Abnormal instrument reading and beam-scan
Was it an abnormal event?
Or did the window break due to radiation damage?
(how much did these factors contribute?)

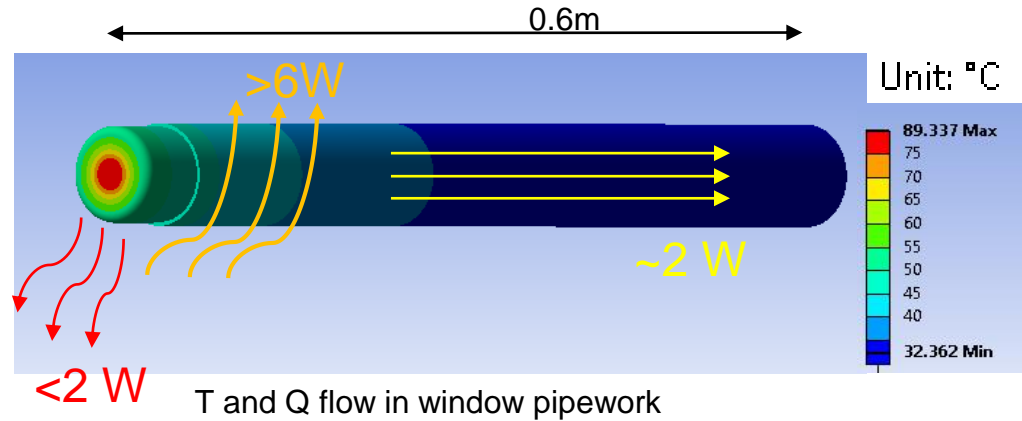
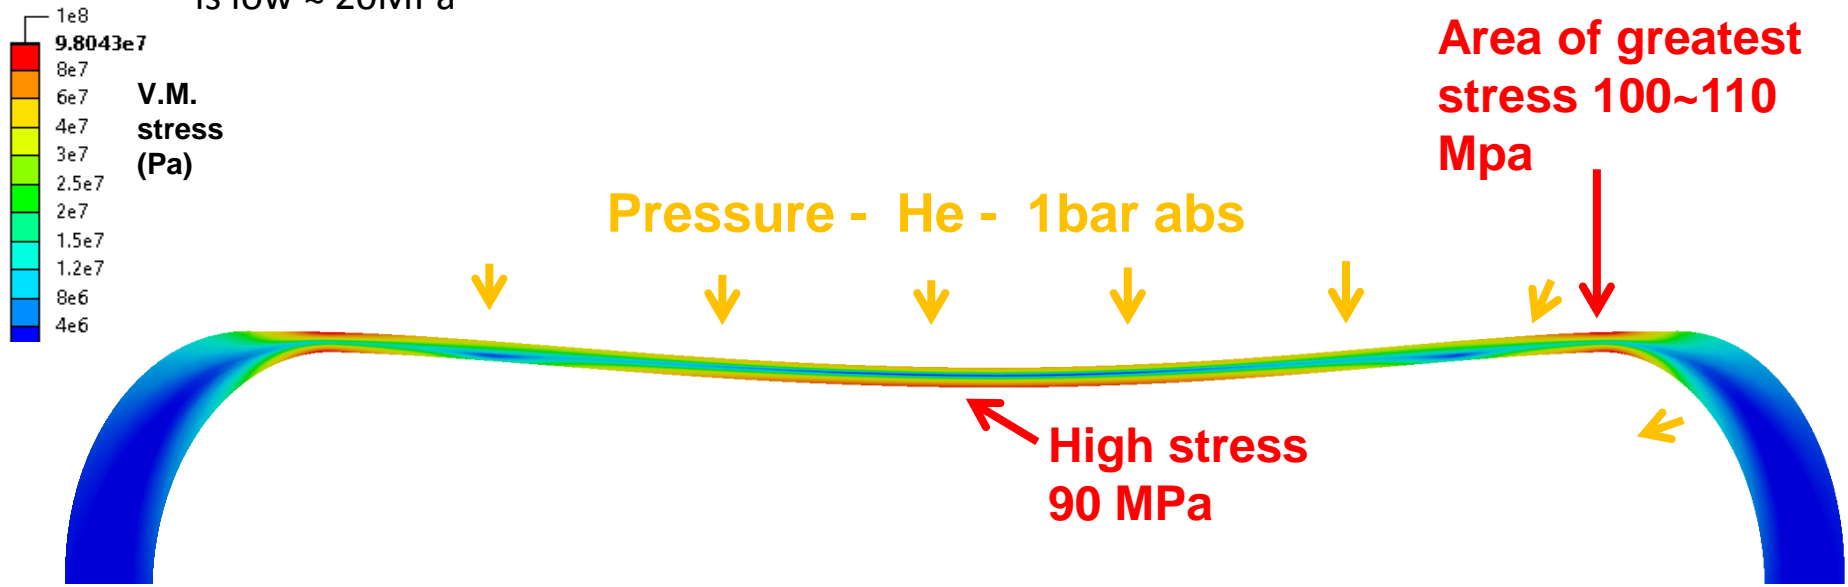
- Maximum operating temperature
 $\approx 90\text{ }^{\circ}\text{C}$
- Heat transfer from window face
 Primarily from conduction
- Bows inwards due to pressure
 $\approx 0.9\text{mm}$
- High stress in materials
 $\approx 100\text{MPa}$
- Stress due to thermal expansion
 is low $\approx 20\text{MPa}$

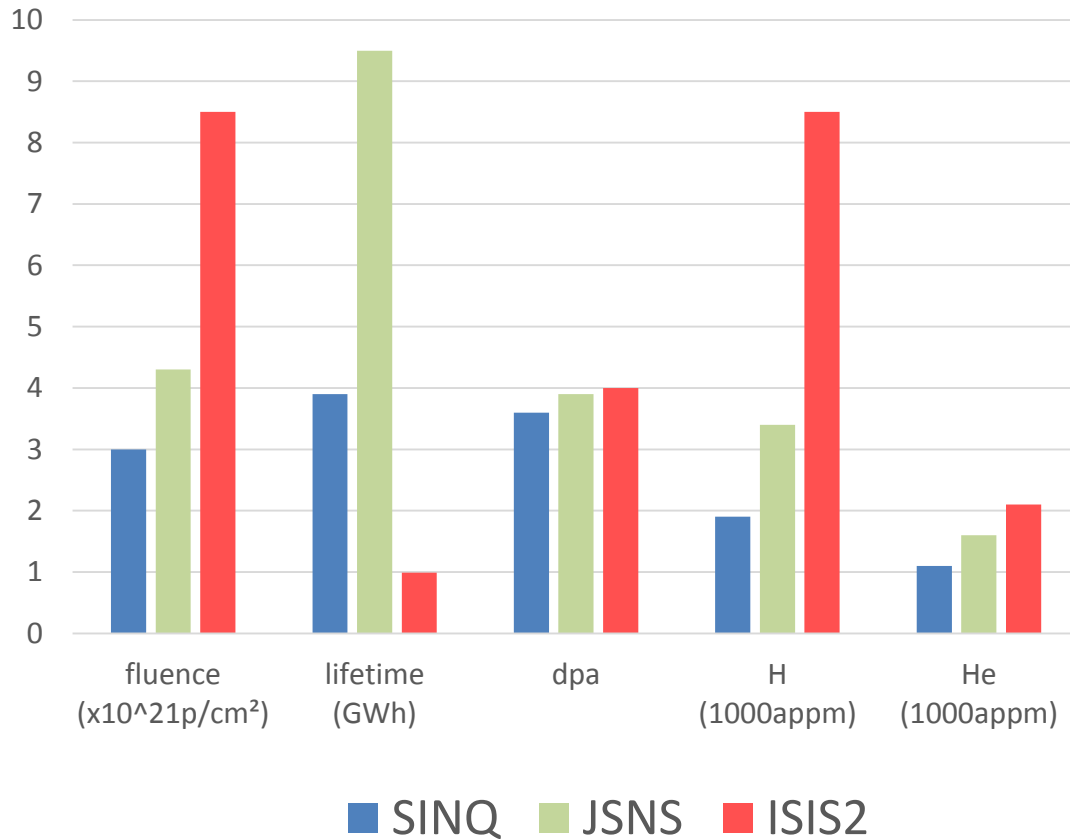
Lifetime and operating conditions comparison

- Analysis indicates Isis BEW 2 runs at a high temperature of ≈ 90 °C.
- Use of Al 5083 not recommended above ≈ 70 °C [PD5500, EN 13445-8]
- He appm >2000
