Situation of the power converters of the SPS and PS experimental areas

Y.Gaillard
AB/PO

SPS NORTH and PS EAST AREAS POWER CONVERTERS

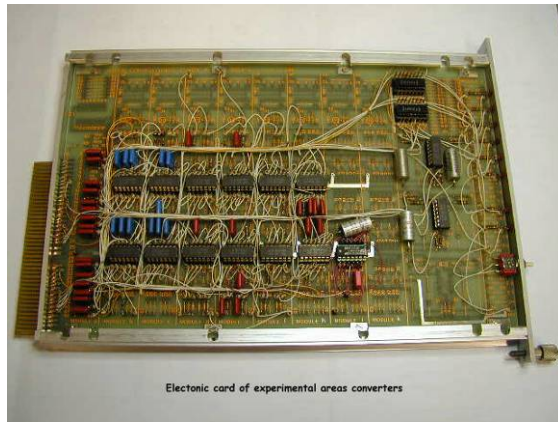
Electronic card reliability

~ 6600 electronic modules of this type are in operation

Wire wrap
Obsolete components

- ◆ Keep the same maintenance level with special actions
 - ⦿ Change obsolete IC of the address cards
 - ⦿ Clean connectors of the address cards

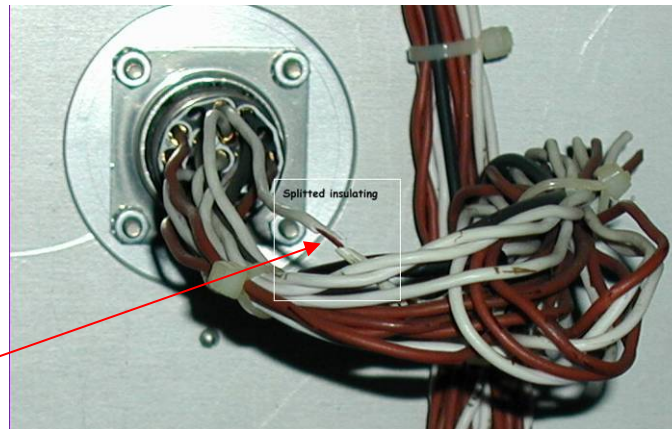
Cabling ageing

Split insulation

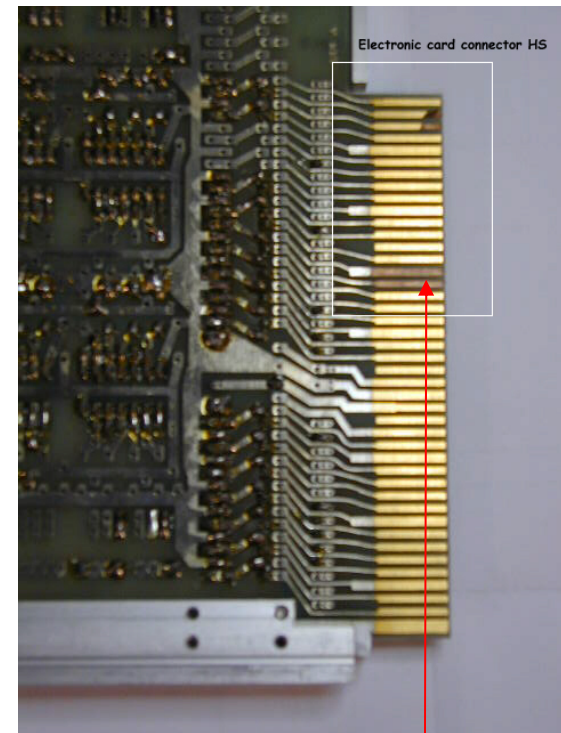
PCB connector contact

Damaged gilded contacts
