I PS EAST HALL MAGNETS

II SPS NORTH EXP. AREA MAGNETS

PS+SPS days 24-1-2007 W.Kalbreier, D.Smekens, T.Zickler AT-MEL, CERN, 1211 Geneva 23

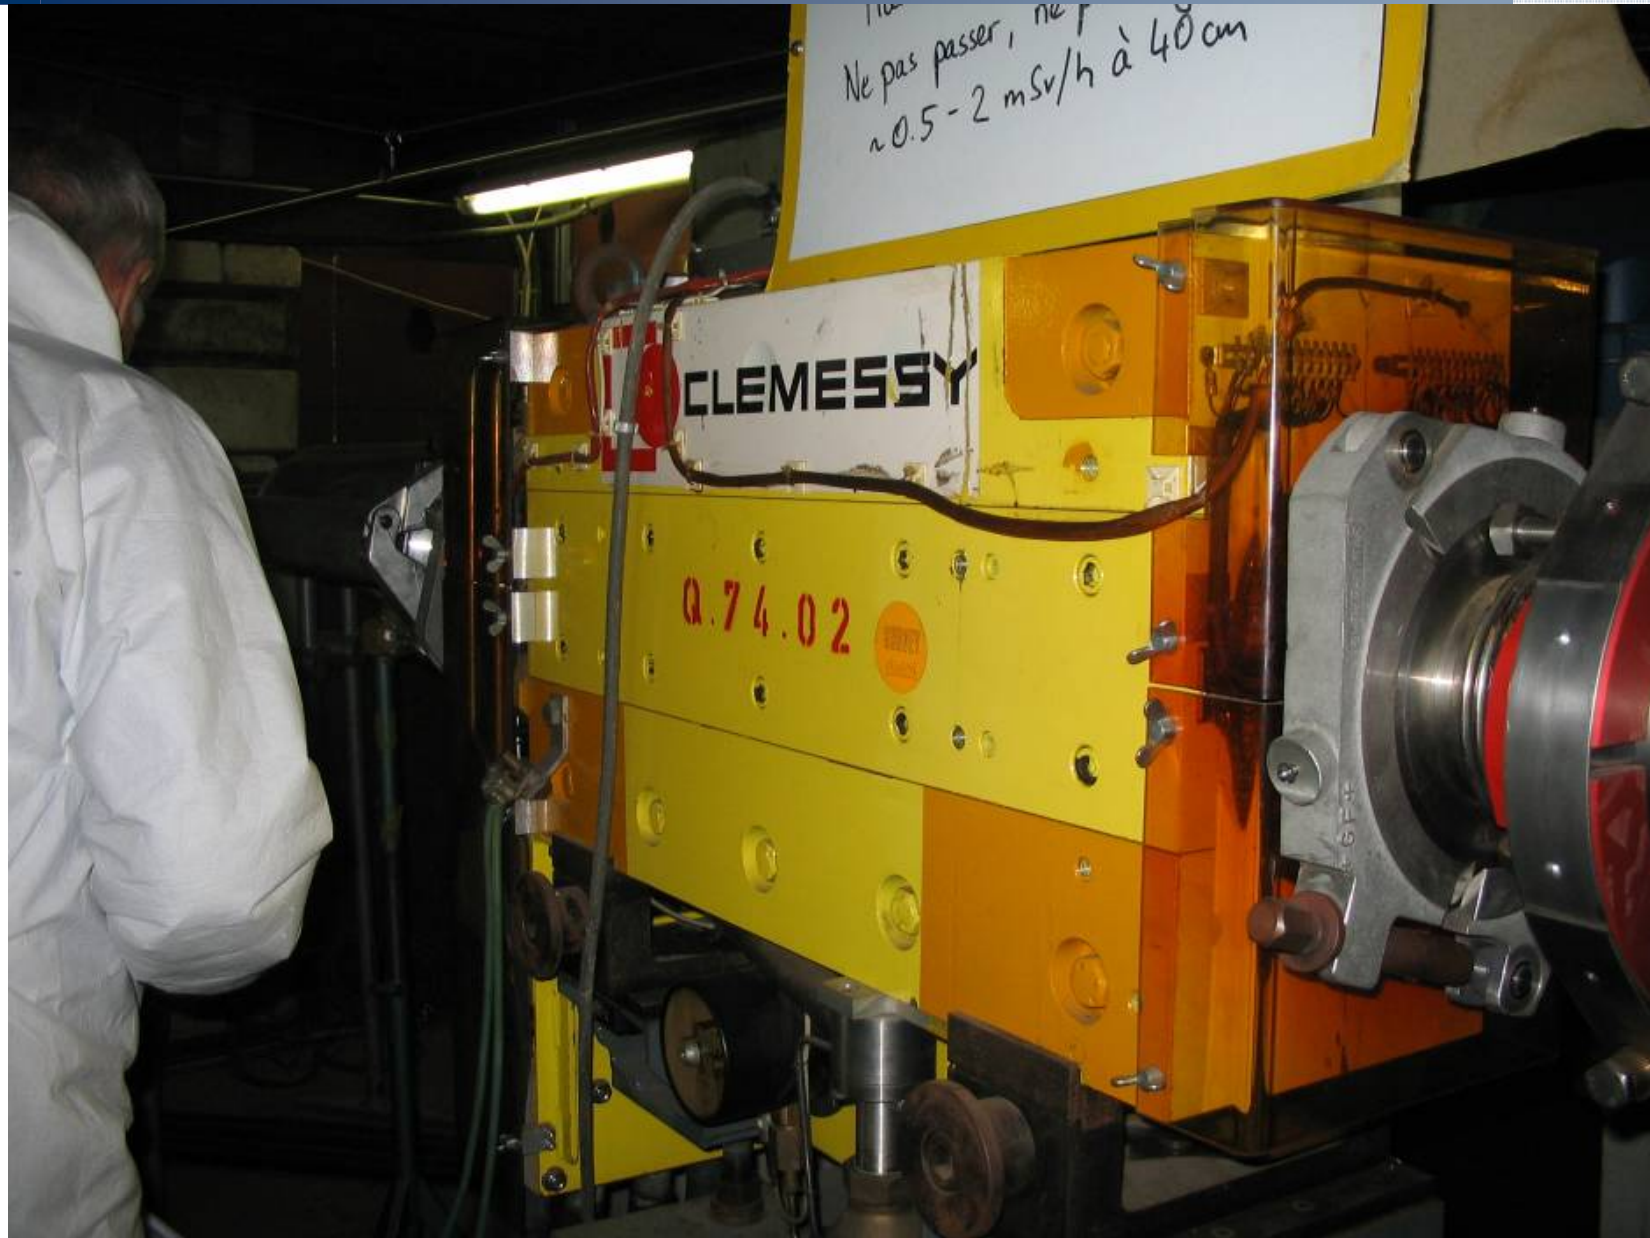
Q74

NEW	OK	RISKY	SUM
OPERATING	0	1	1	2
	NEW	OK	UNKNOWN	SUM
SPARES	0	1	0	1
Importance issues	Risky magnet is in T9 line at QDE01.Q74.02 for AMS/T2K-KEK.			
2007	Replace risky magnet in 2007 if feasible. If high priority → ask budget for 1 new magnet.			
2008	If budget + additional staff obtained, 1 new magnet could be fabricated.			
2009	1 spare available

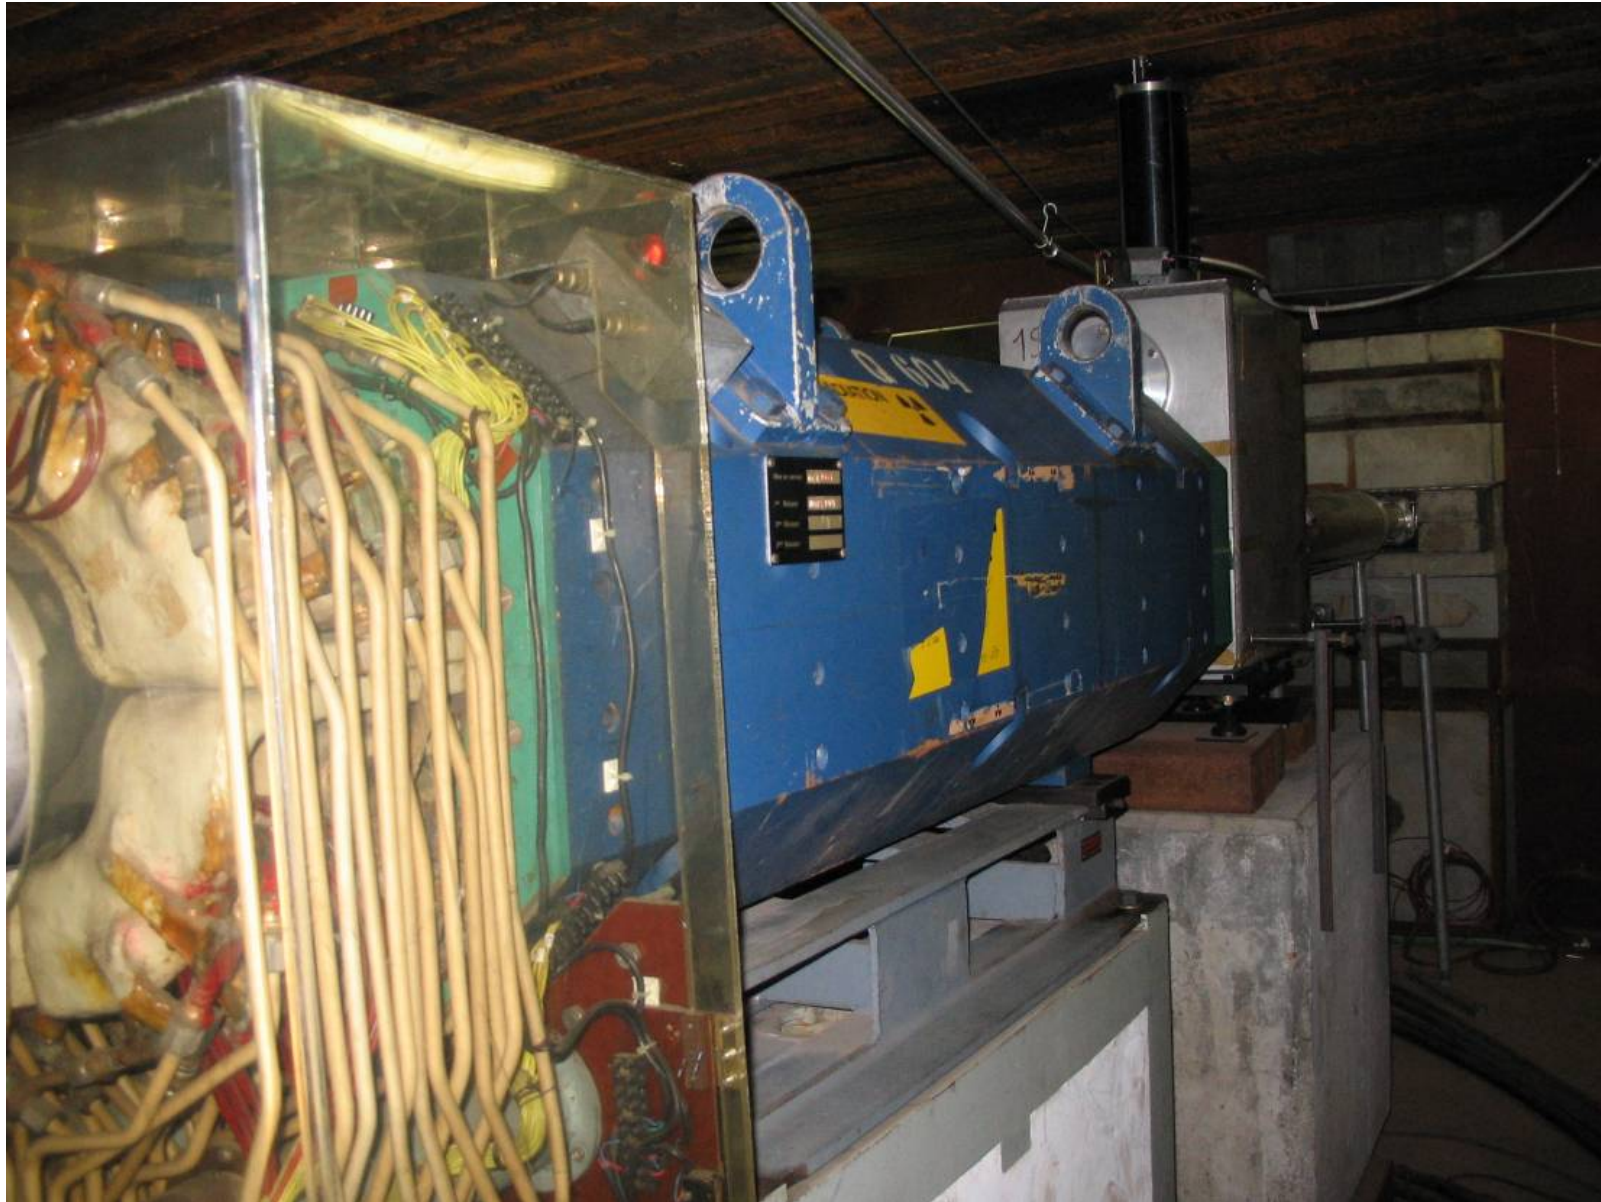
Q 600

NEW	OK	RISKY	SUM
OPERATING	0	1	4	5
	NEW	OK	UNKNOWN	SUM
SPARES	0	3	2	5
Importance issues	<p>T7.QFO01.Q606+QDE02.Q607 for OPERA. T7 Beam energy reduced: 10 → 9 GeV T11.QDE01.Q604 + QFO02.Q602 for CLOUD</p>			
2007	<p>3 risky magnets will be replaced. The 2 spare units (unknown) must be revised in order to obtain 2 operational spares. If successful, replace 4th risky magnet in 2008. If unsuccessful + priority → budget for 1-2 new magnets.</p>			
2008	<p>If budget + additional staff obtained, 1-2 new magnets could be fabricated.</p>			
2009	<p>risky magnet could be replaced + 1 spare left</p>

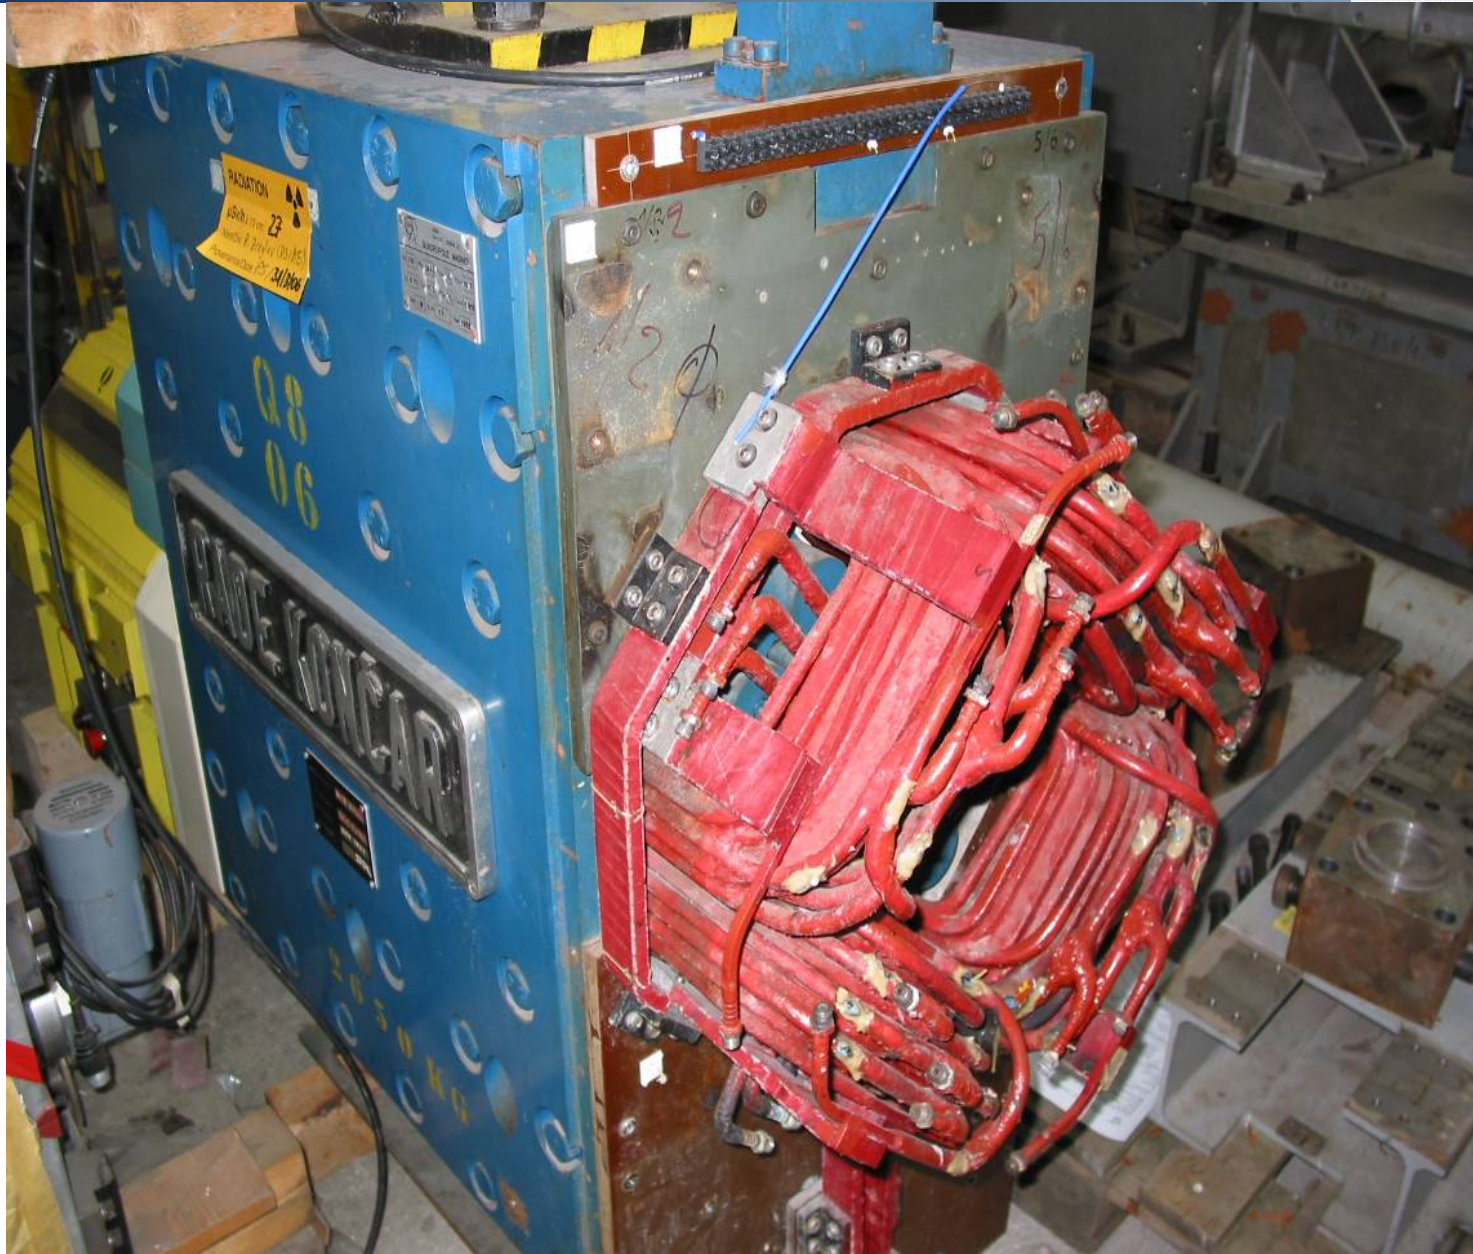
Q 800

NEW	OK	RISKY	SUM
OPERATING	0	0	2	2
	NEW	OK	UNKNOWN	SUM
SPARES	0	0	1	1
Importance issues	<p>2 operating magnets are overheating.</p> <p>T10 beam energy reduced: 7 → 6 GeV ALICE</p> <p>T10.QDE01.Q804 + QFO02.Q803</p> <p>Already 3 broken non-repairable units.</p>			
2007	<p>1 (highly radio-active) spare must be revised in order to obtain 1 operational spare.</p> <p>If successful, keep it as spare.</p> <p>If unsuccessful + high priority → ask budget for 3 new magnets.</p>			
2008	<p>If budget + additional staff obtained, 3 new magnets could be fabricated.</p>			
2009	<p>risky magnets could be replaced + 1 spare</p>

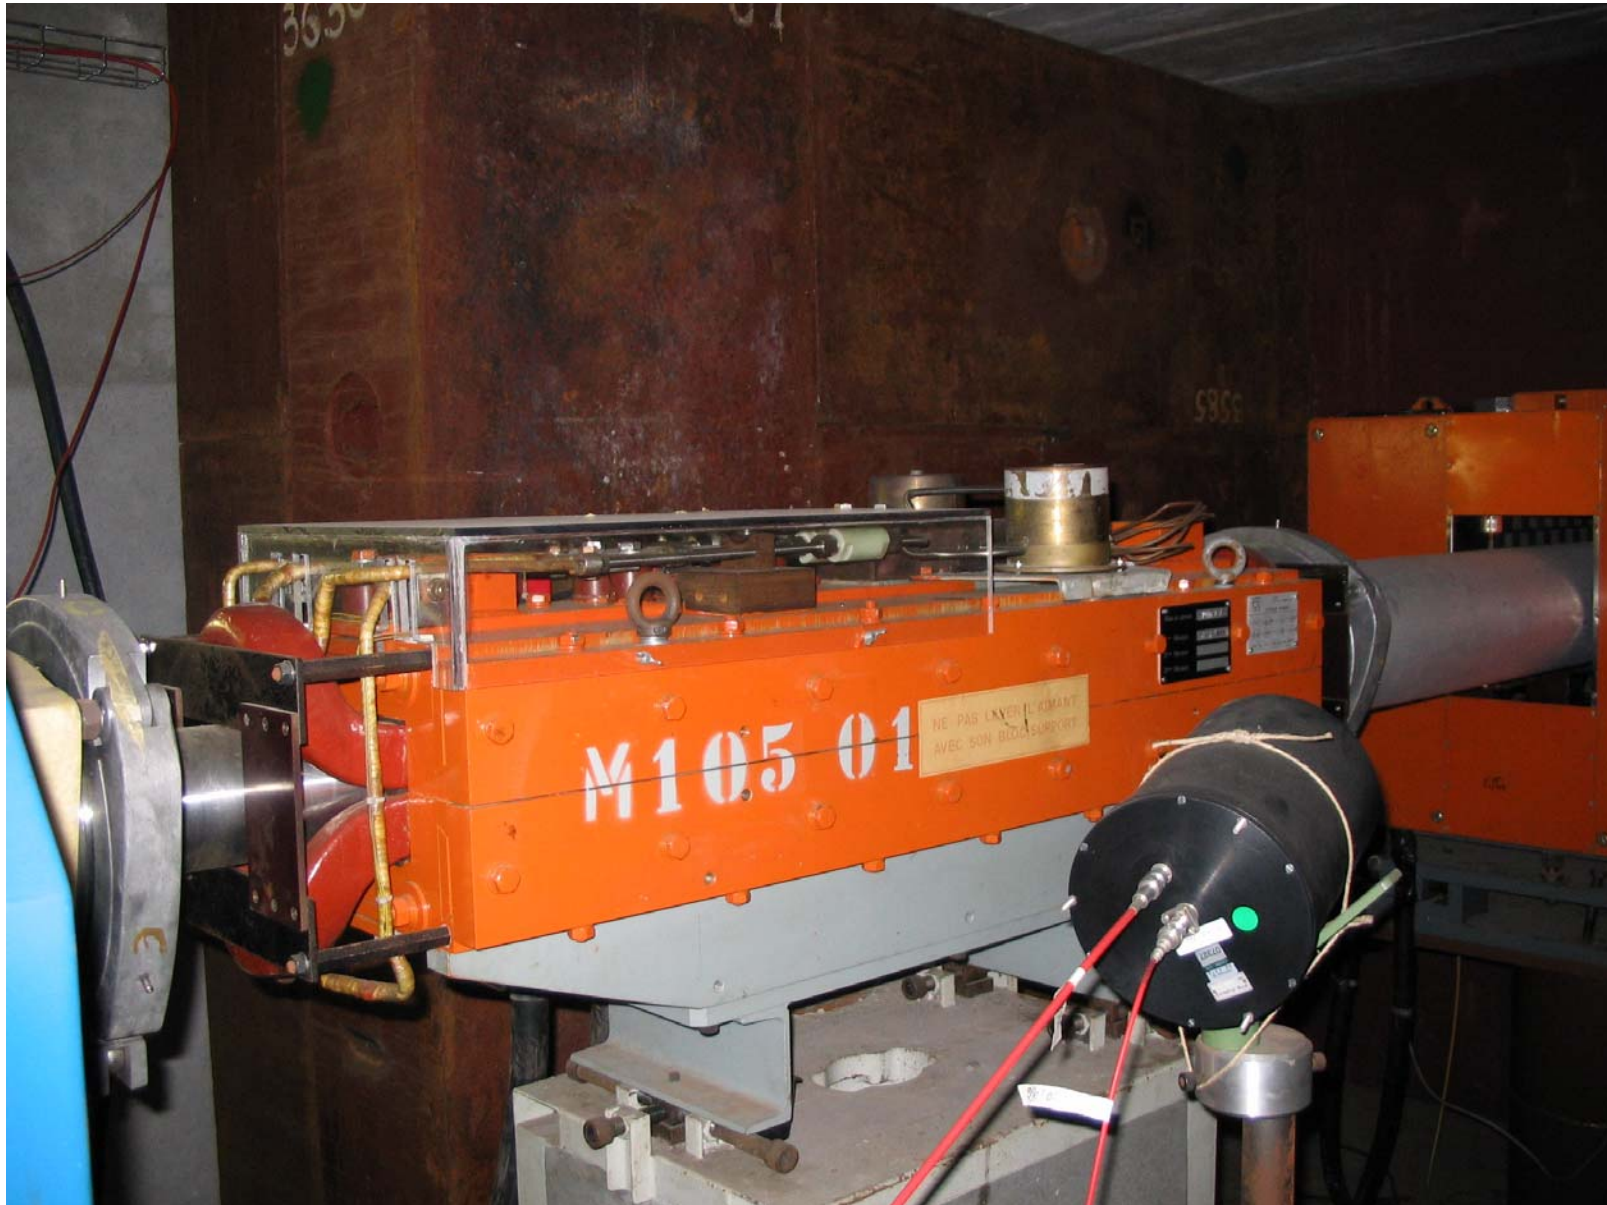
M105

NEW	OK	RISKY	SUM
OPERATING	0	3	0	3
	NEW	OK	UNKNOWN	SUM
SPARES	0	0	0	0
Importance issues	<p>No spare for primary lines</p> <p>F61N.DHZ01.M105.02+F61S.DHZ01.M105.03</p> <p>T8.DHZ01.M105.01</p>			
2007	No spare unit → Define priority → If high, ask budget for 1 new magnet.			
2008-9	If budget + additional staff obtained, 1 new magnet could be fabricated.			
2010	spare status ok

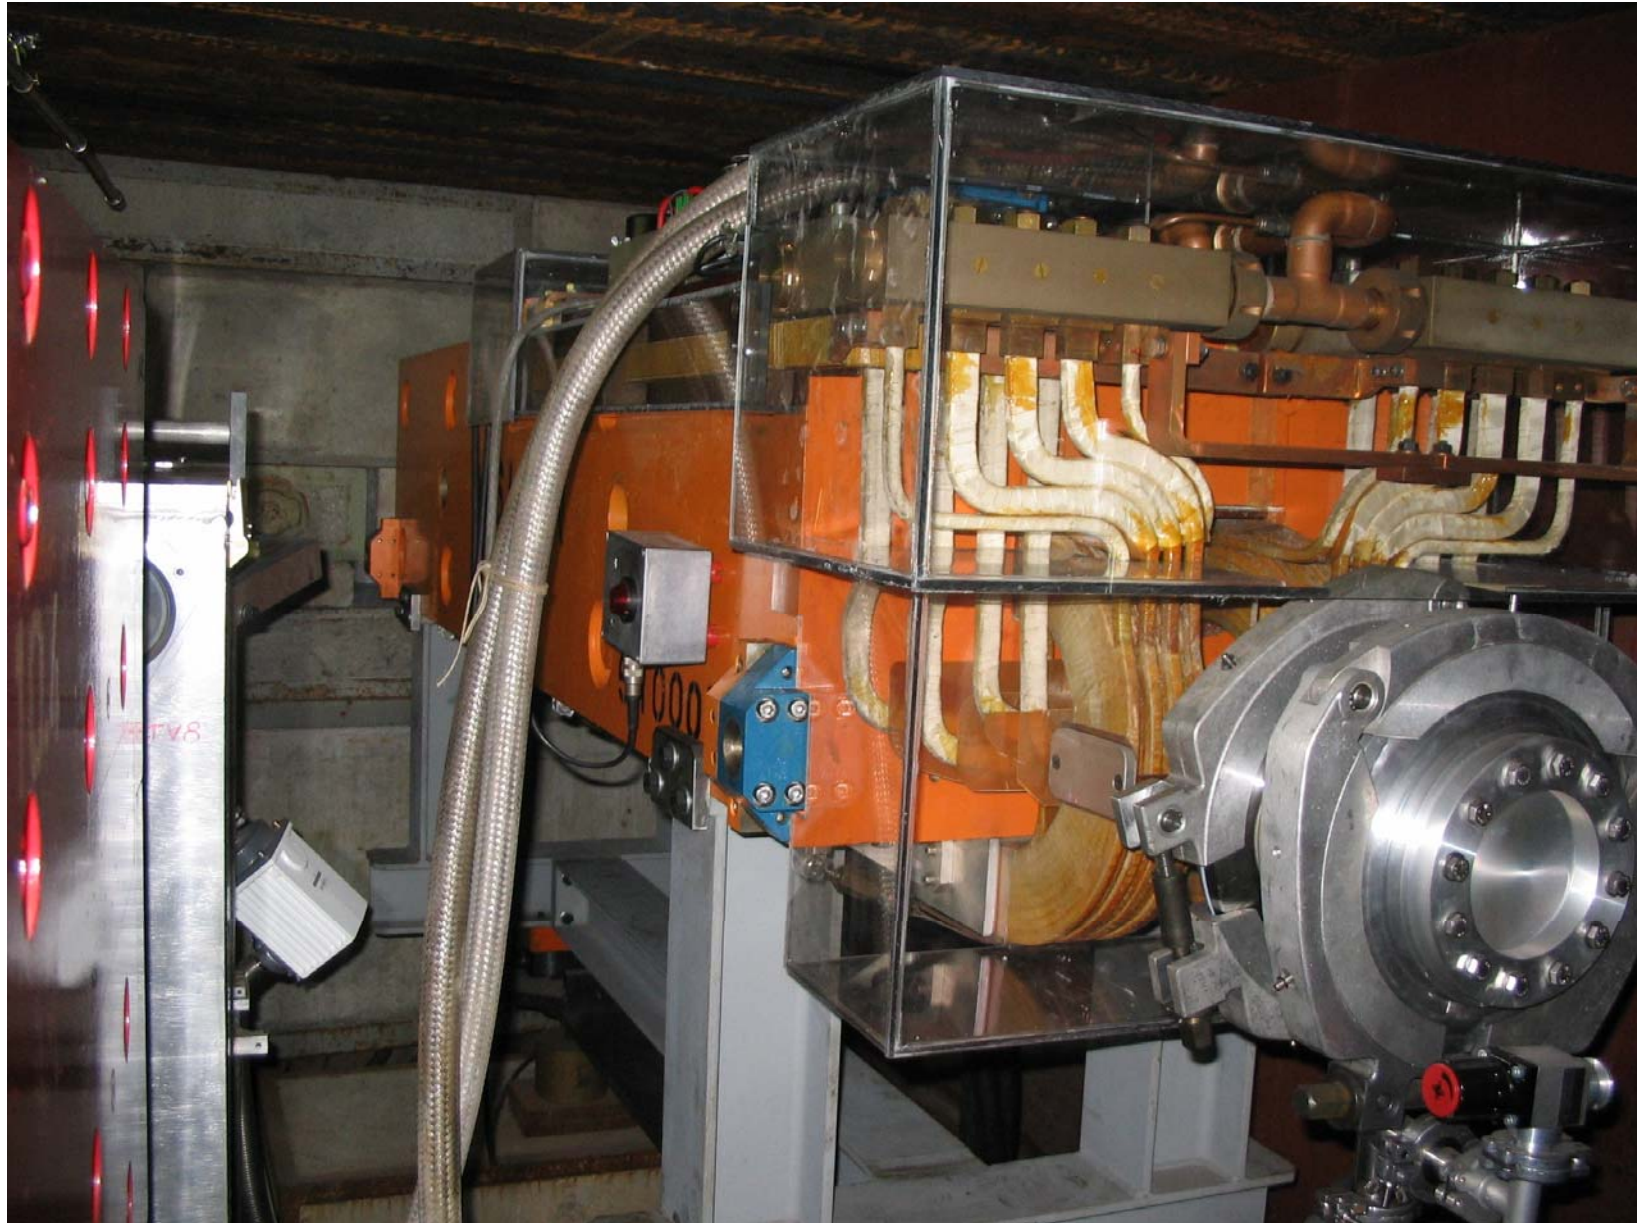
'weak' magnets MEP19

NEW	OK	RISKY	SUM
OPERATING	0	0	1	1
	NEW	OK	UNKNOWN	SUM
SPARES	0	0	0	0
Importance issues	<p>No spare</p> <p>F61N.BVT01.MEP19 with high induced radiation level.</p>			
2007	<p>No spare unit → Define priority → If high, ask budget for 1 new magnet.</p>			
2008	<p>If budget + additional staff obtained, 1 new magnet could be fabricated.</p>			
2009	<p>spare status ok</p>

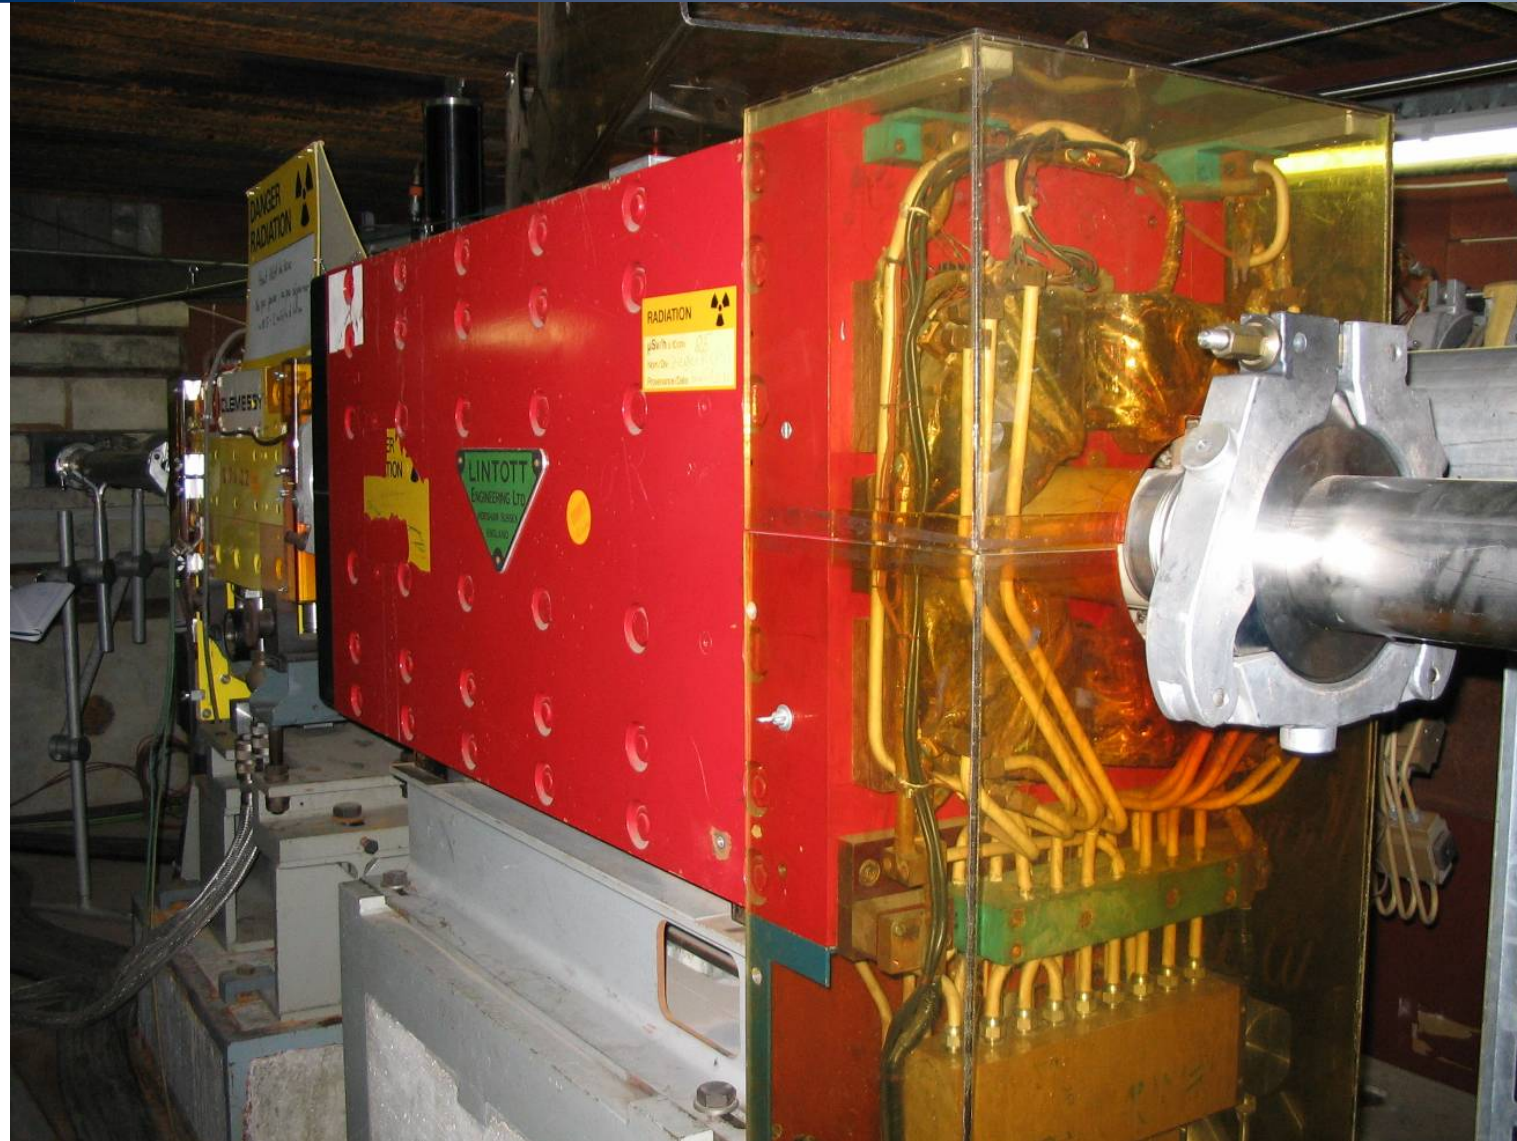
Q120

NEW	OK	RISKY	SUM
OPERATING	2	0	3	5
	NEW	OK	UNKNOWN	SUM
SPARES	1	0	0	1
Importance issues	<p>F61S.QFO01.Q120.04+QDE02.Q120.06 T9.QFO02.Q120.02 AMS/T2K-KEK</p>			
2007	<p>Consolidation budget obtained. M. Karppinen AT-MEL-MI will launch + follow-up the fabrication. 3 Magnets will be fabricated.</p>			
2008	<p>3 risky magnets could be replaced, leaving 1 new spare.</p>

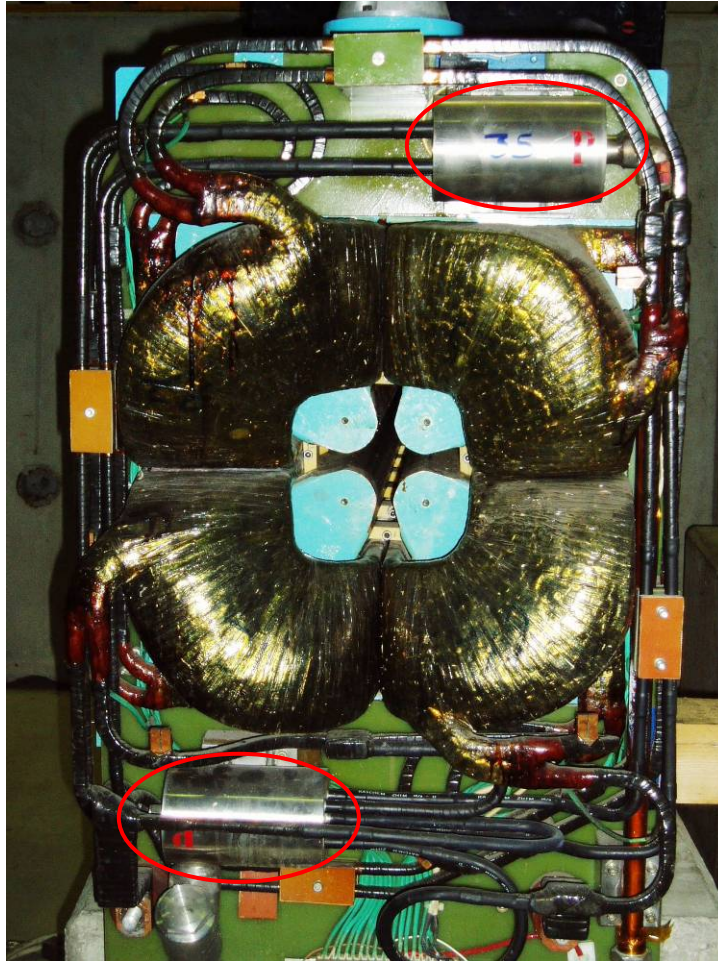
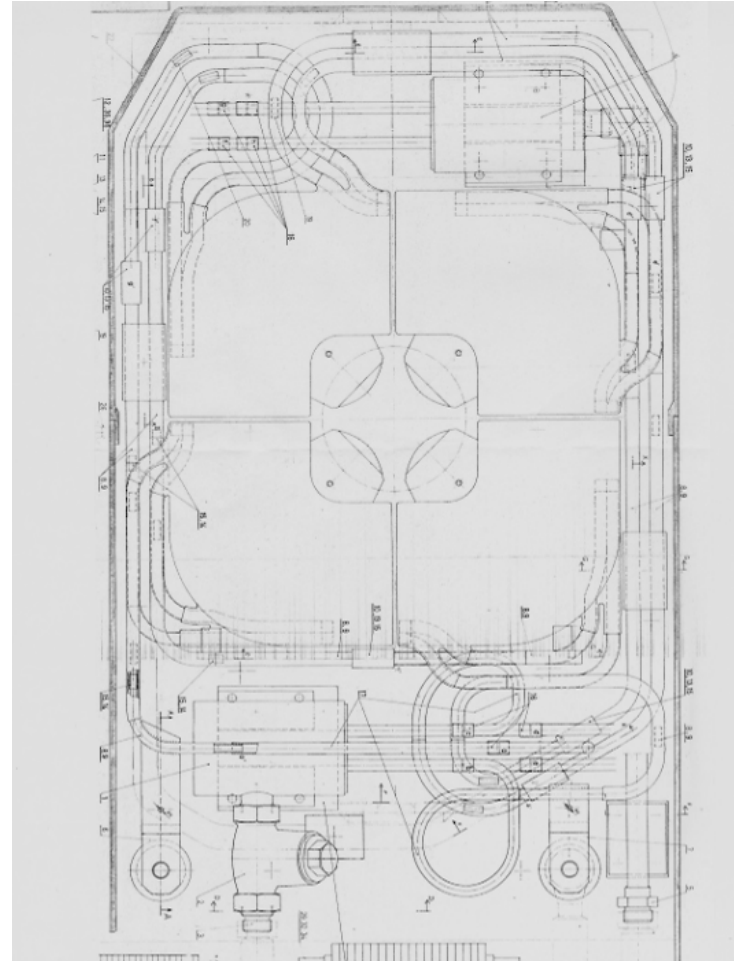
Weak Magnets: QTA/L/R/S

Situation	RISKY	SUM
OPERATING	<u>EA standard:</u> QTA:0 / QTL: 1 / QTR: 0 / QTS: 14 <u>BT standard:</u> in TT20/TDC2 :QTA:19 / QTL: 11 / QTR: 0 / QTS: 2 in other BT lines: QTA:0 / QTL: 14 / QTR: 2 / QTS: 2 TOTAL: 65	> 20 magnets	65 magnets in operation. 30% of them risky
SPARES	<u>EA standard:</u> QTA:0 / QTL: 19 / QTR: 4 / QTS: 36 <u>BT standard:</u> QTA:4 / QTL: 5 / QTR: 2 / QTS: 8	Not assessed	78 magnets spare ! Mostly QTS
Importance issues	Main BT quadrupoles for primary beamline TT20/TDC2. Mainly QTA magnets in TDC2, few spare QTA		
since 2006	Assembly Tool + workshop + spare coils to reconstruct QTA/QTL/QTR/QWL		
2007	Small consolidation budget available. Manufacture of new parts for 25 magnets (targeting repairs of QTA and QTL in TDC2 – 24 magnets)		
2008	Replacement of weak parts in situ (TDC2).

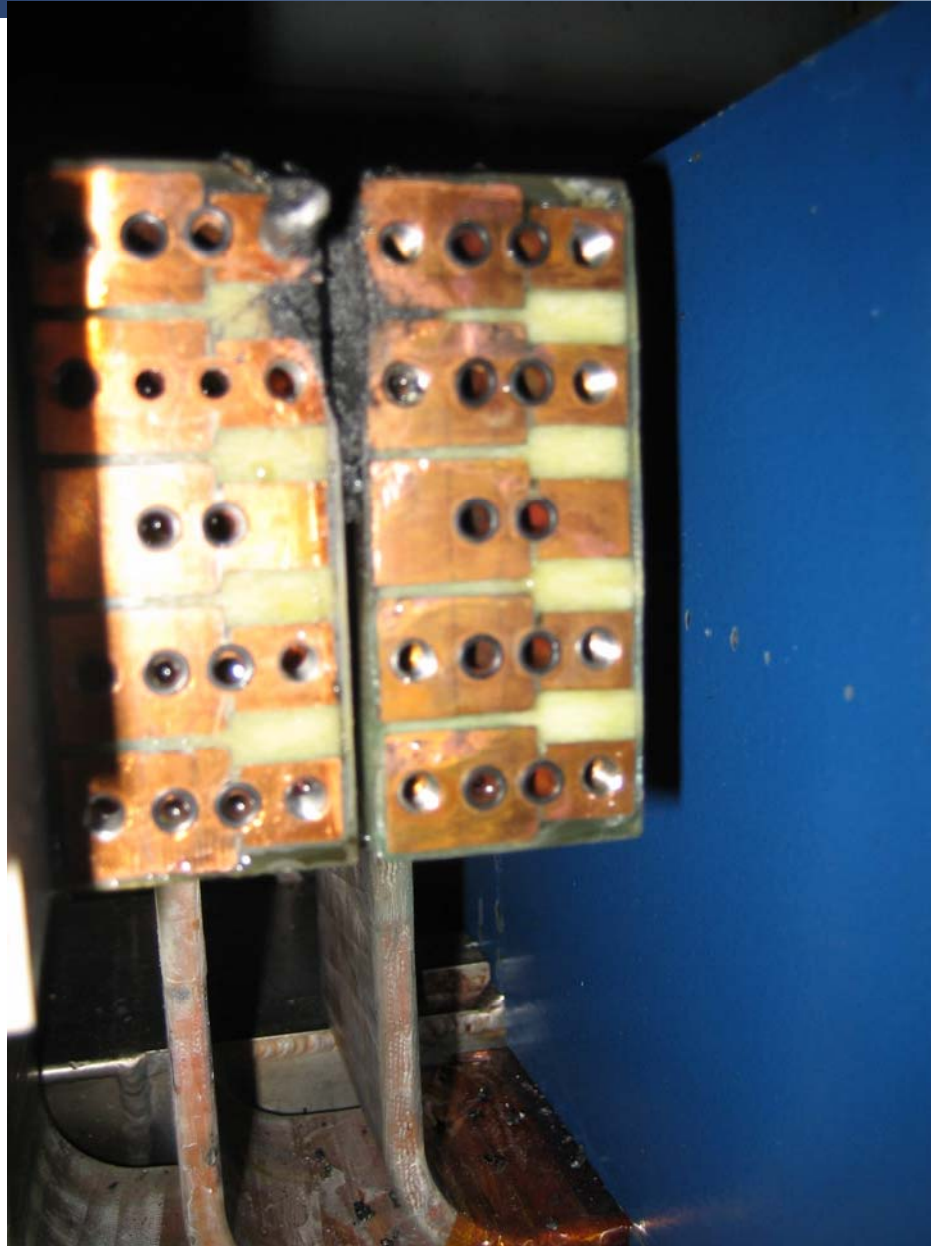
ANNEX 1 F61S BHZ01-MNP23

→ 1st generation (3 different designs) showed coil insulation + water cooling + short circuit leading to completely burnt coil insulations) problems starting already in the 1990^s.

Status in 2001. → No more spares from 1st generation + F61S-BHZ01 needed to be replaced.

→ 3 new magnets were built in 2001 at OSWALD/DE by T. Zickler (2nd generation).

→ Damaged unit in F61S was replaced the 1st unit of the new septum in March 2002 & operated until November 2003 (→ water leak + cooling channels blocked due to corrosion).

- July 2004: high leakage current + cooling channels blocked by a deposit stemming from corrosion. → required the replacement of the 2nd unit operating since March 2004.
- November 2004: same problems with the 3rd unit operating since September 2004.

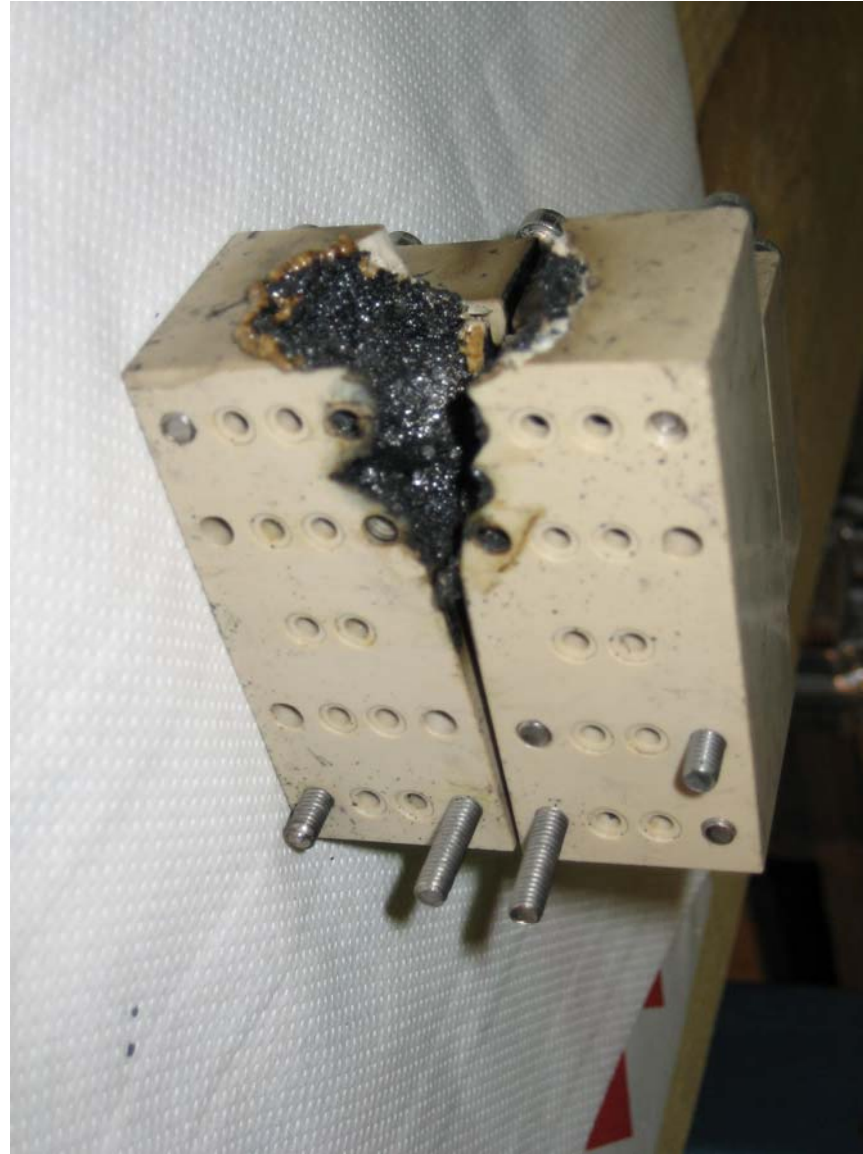
ANNEX 1 F61S.BHZ01.MNP23

- ➔ An analysis by V. da Silva AT/MEL/MI in 2005 showed that corrosion problems were due to insufficient quality of the demineralized water:
 - too high conductivity (up to 15 microS/cm, nominal 0.5 microS/cm),
 - resin cartridges not regularly exchanged and problems of monitoring the conductivity.
 - As a consequence of the low water quality the inner walls of the cooling channel were corroded resulting in a deposit of $\text{CuO} + \text{Cu}_2\text{O}$ blocking the water circulation of the coils .
- ➔ In close collaboration with TS/CV we purchased + installed new devices to monitor the water quality online (operational since 3-2006).

- ➔ 2005: Fabrication of 5 new coil sets (3rd generation) to be mounted in the existing yokes at SEF/FR. The coils had improved cooling features (cooling per half-turn instead per full-turn) in order to reduce the very high water speed and the maximum coil temperature.
- ➔ March 2006: Installation of MNP23 with 1st new coil set from SEF.
- ➔ April 2006: a short circuit required the replacement of the MNP23 just before beam operation.
- ➔ July 2006: an electrical breakdown in the 2nd coil set required the replacement of the magnet.
- ➔ October 2006: an electrical breakdown in the 3rd coil set ended its operation after 4 weeks only.

- ➔ As the origin of the breakdown was fully unclear, it had been decided to use the 4th coil set in order to launch a study including simulations and measurements under true operating conditions (except beam).
- ➔ A study started in November 2006 by M. Zerlauth AB-CO & J. Kozak AT-MTM, D. Bodart AT-MEL & A. Beuret AB-PO using the 4th coil set. .
- ➔ The preliminary results after about 4 weeks were as follows:
 - no convincing fault explanation yet
 - the max over-voltage spikes from the power converter are only about 50% above the nominal max of 400 V.
 - several kV are required for causing the severe damage observed!

- ➔ Mid-February 2007: The study will continue when cooling water is again available until the origin is found.
- ➔ Results will be used for an improved fabrication of the 5th new coil set followed by long-term testing before an eventual re-installation in 2008.
- ➔ February 2007: install C-shaped MCB magnet to replace MNP23 for 2007 operation.

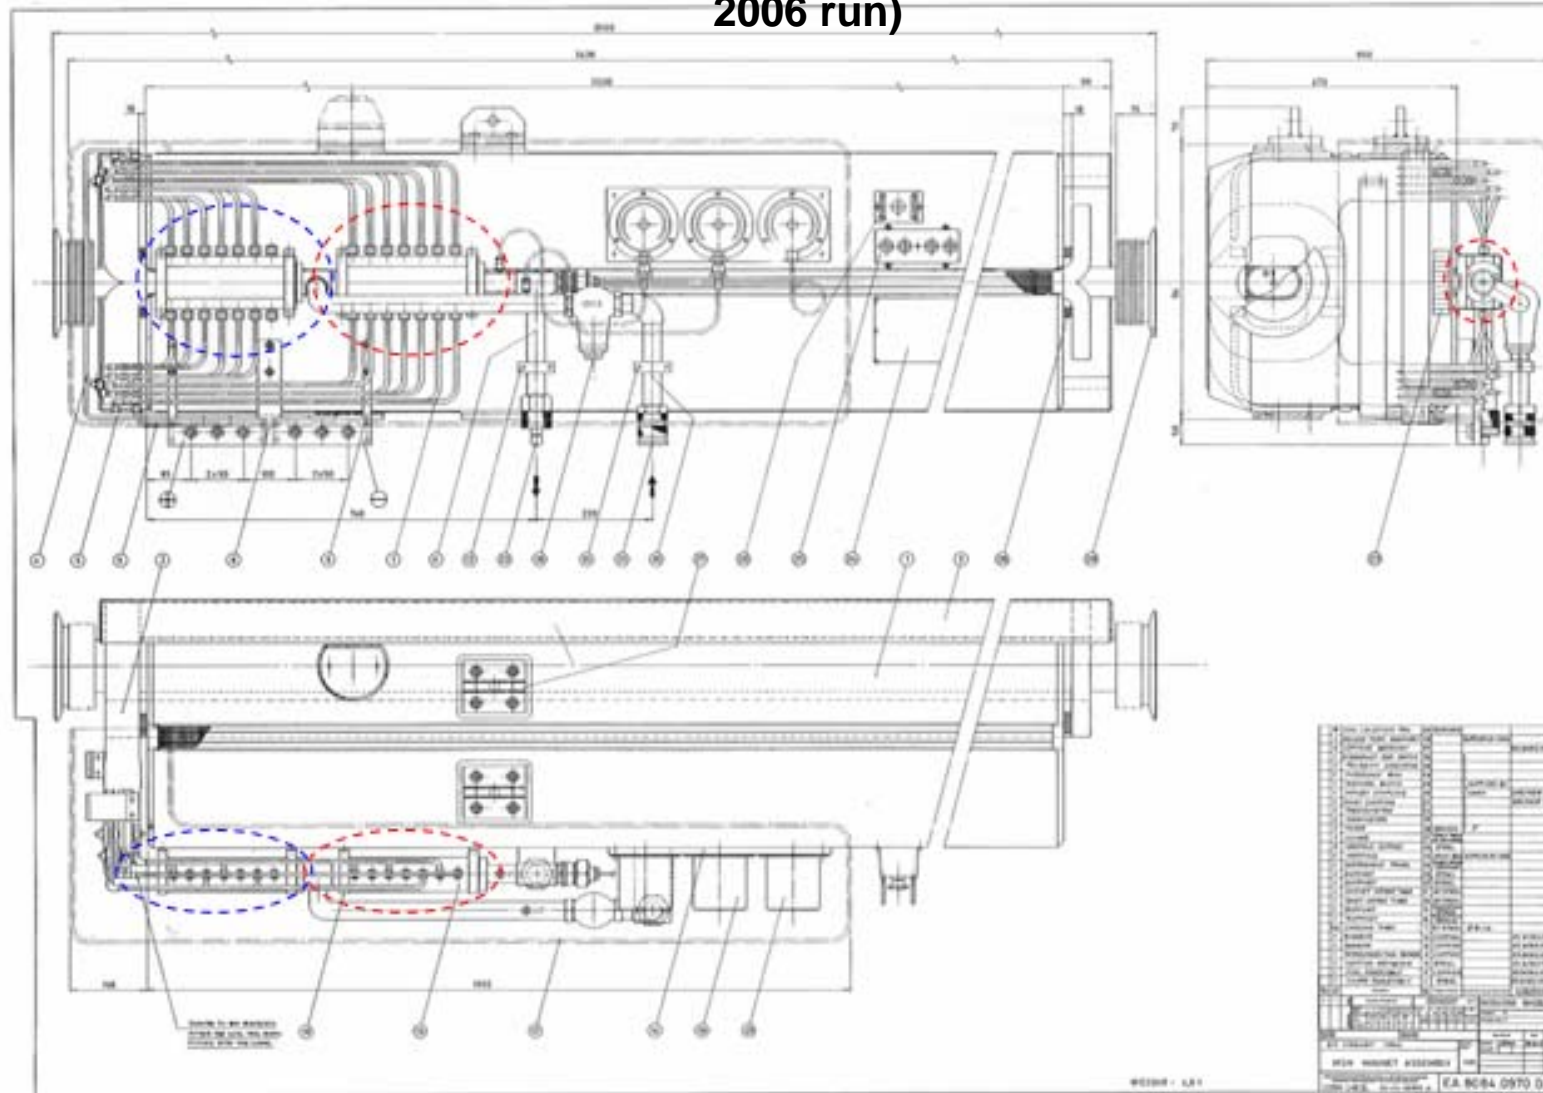
Weak Magnets: splitters MSSB

→ 2 recent breakdowns on MSN manifolds (1 during 2005 shutdown, 1 during 2006 run)

Situation	RISKY	SUM
OPERATING	<u>NEA standard:</u> MSSB Type 2: 6 magnets in use in TDC2 <u>WEA standard:</u> MSSB Type 1: 0 in use	All MSSBs in TDC2	6
SPARES	<u>NEA standard:</u> MSSB Type 2: 1 spare new magnet <u>WEA standard:</u> MSSB Type 1: 4 spares (recuperated magnets)	None	5 spares (4 not compatible with NEA)
Importance issues	2 triplets of MSSB used to split the primary beam toward T2/T4/T6 targets		
2007	No consolidation budget available. Study feasibility to convert WEA MSSB into NEA MSSB (NEW UPPER YOKE + VACUUM TANK REQUIRED)		
2008-09	If consolidation money available, conversion of 1 to 2 WEA to NEA MSSB

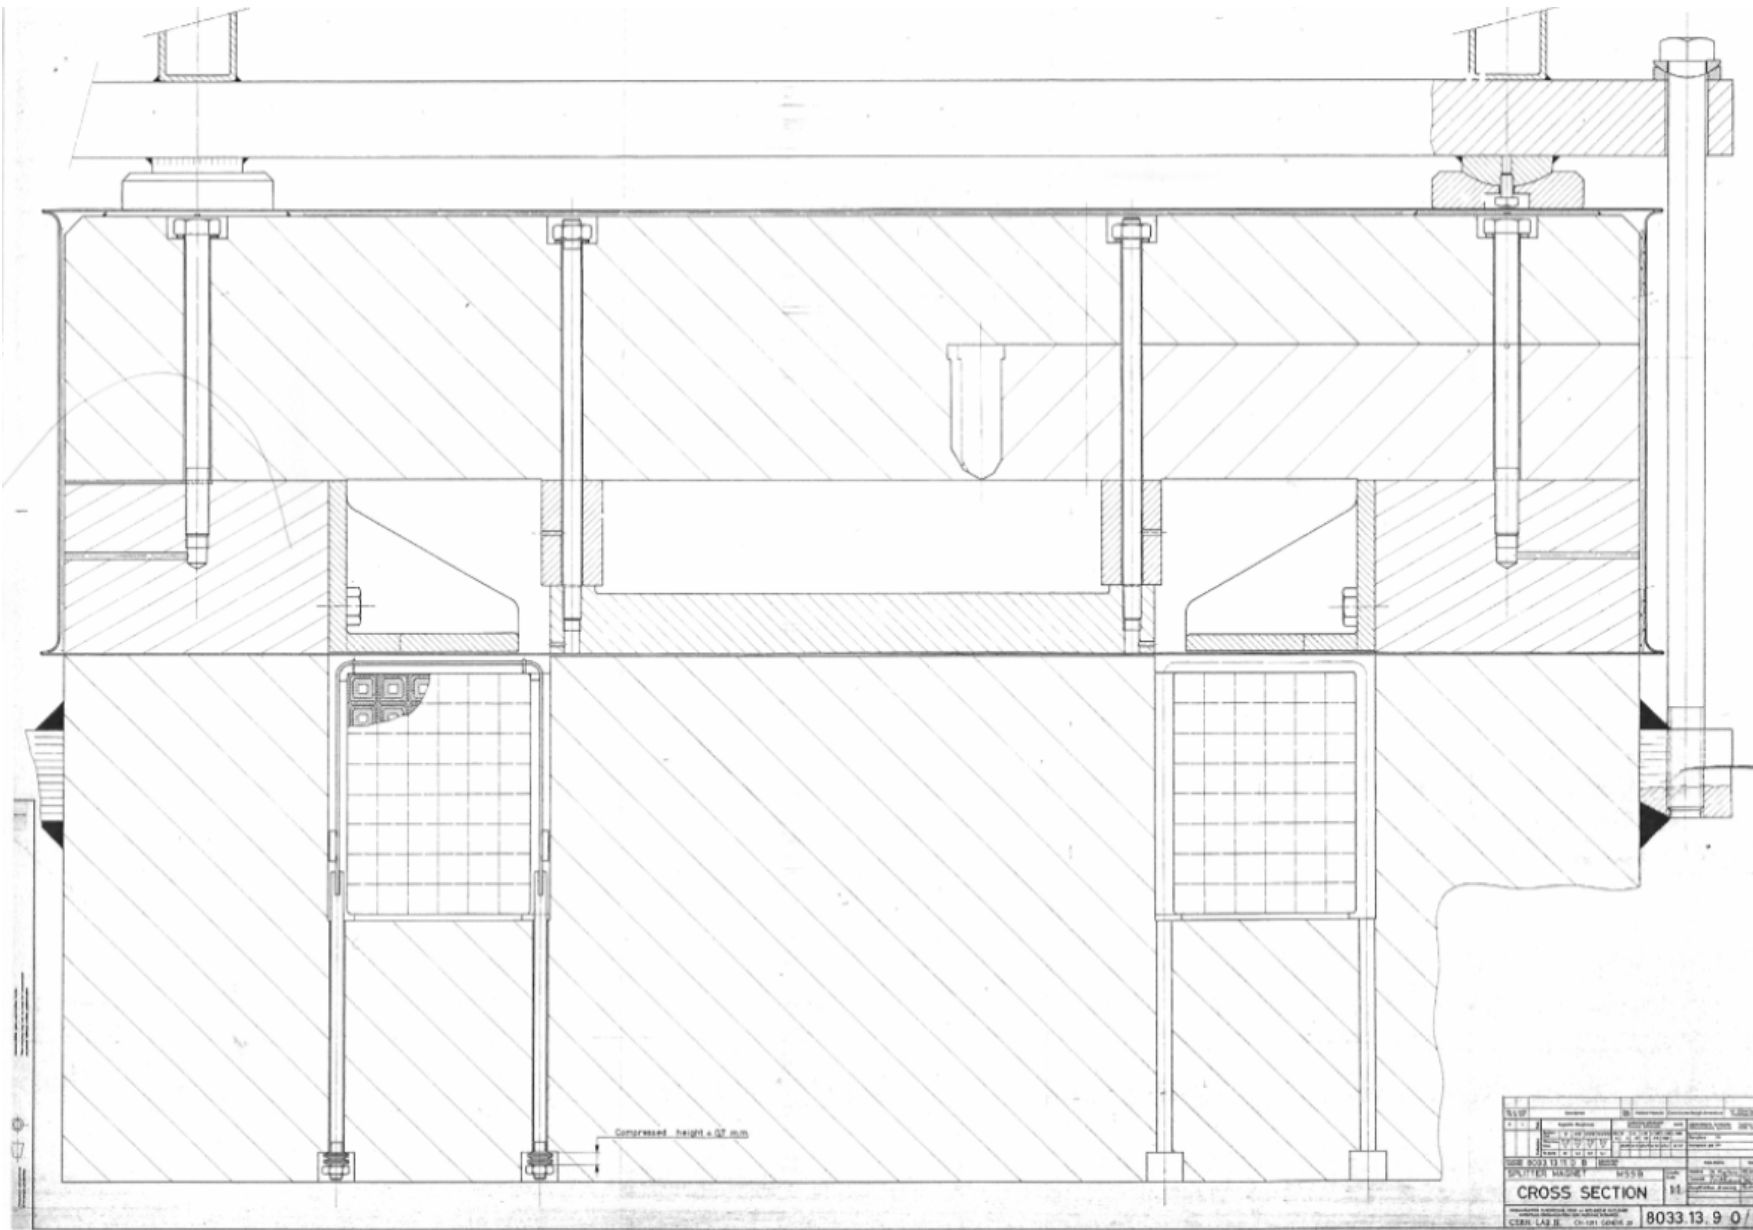
MSSB Splitter magnet: Cross Section

- ➔ Vacuum leaks. Due to corrosion of the stainless steel in contact with the PVC material used for the covers (made in the 70's).
- ➔ Not repairable in situ. Leaky Magnets have to be replaced
