## I PS EAST HALL MAGNETS

## II SPS NORTH EXP. AREA MAGNETS

ATC-ABOC days 24-1-2007 PS+SPS EA magnets W.Kalbreier, D.Smekens, T.Zickler AT-MEL

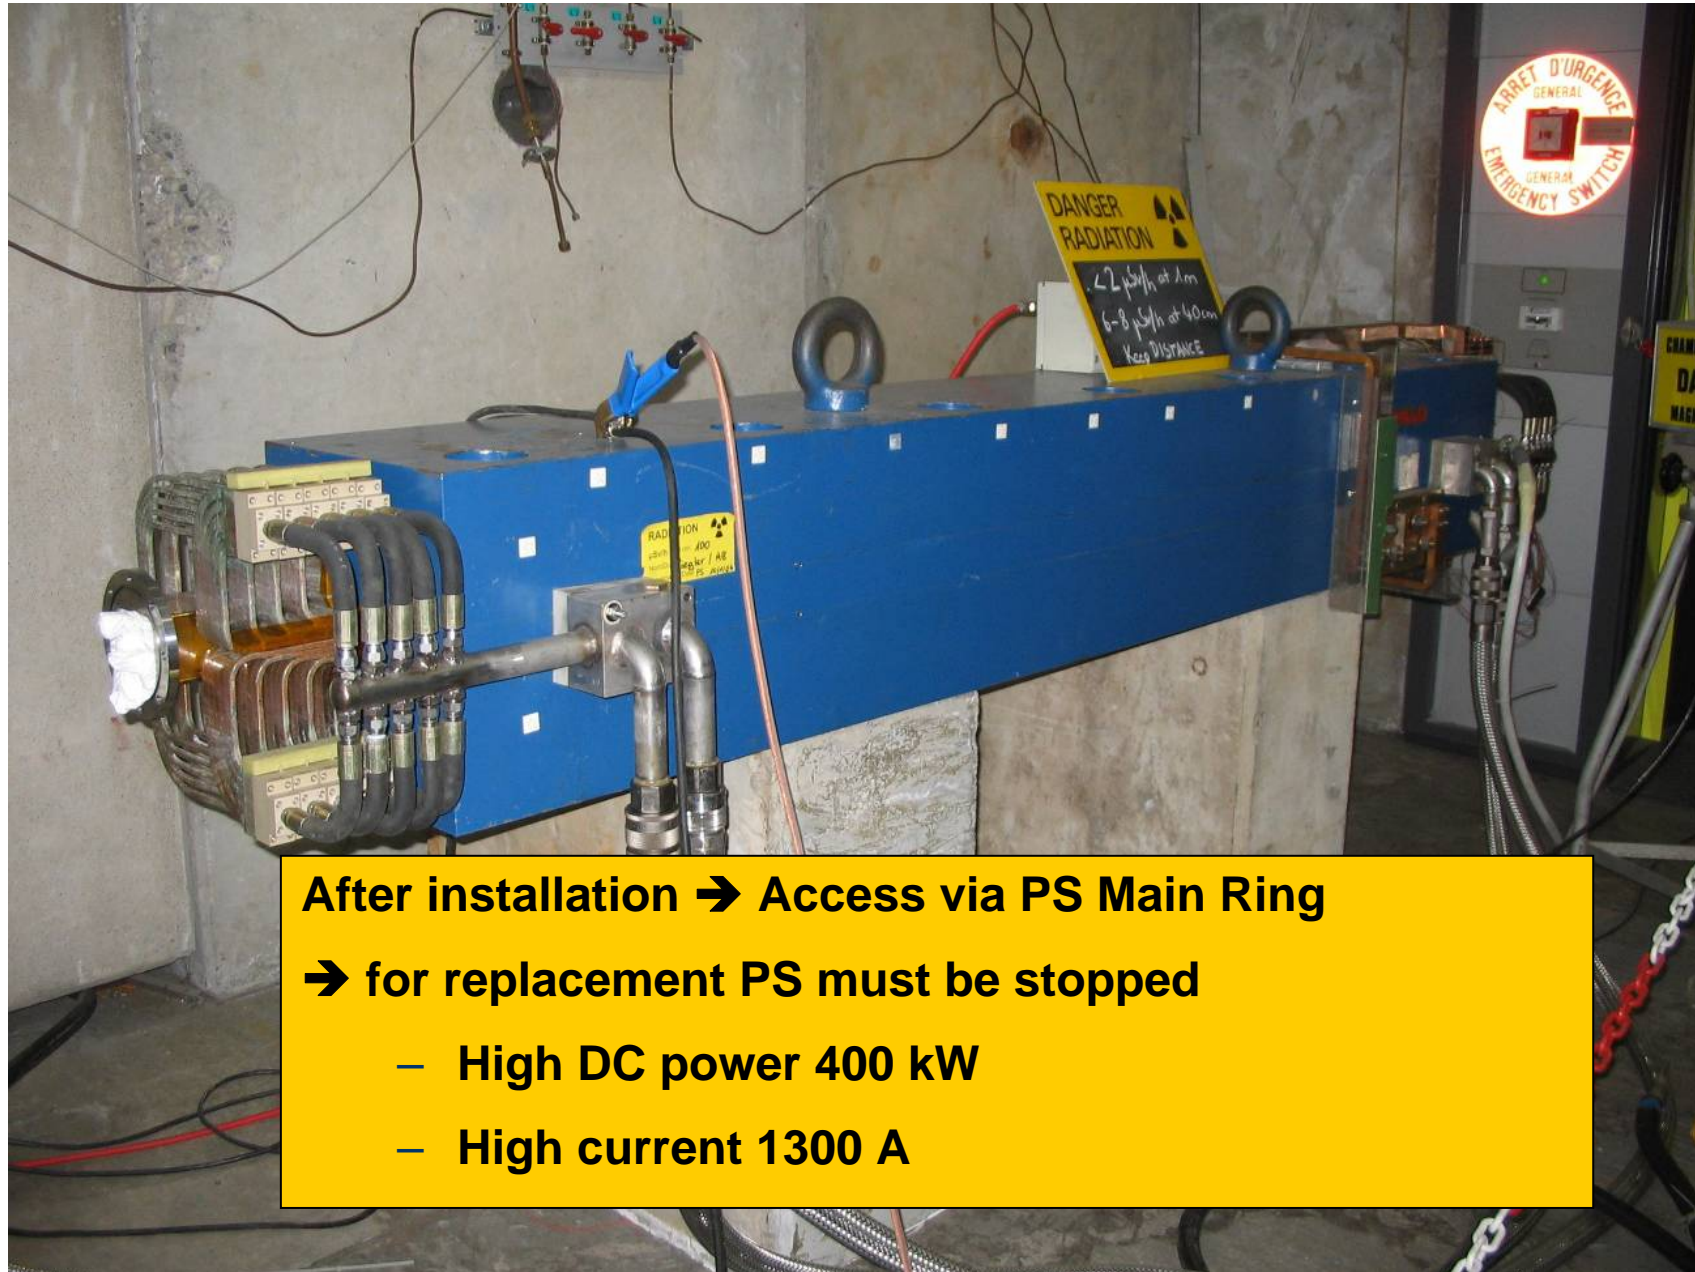
**SEPTUM BHZ01-MNP23**

**After installation → Access via PS Main Ring**  
**→ for replacement PS must be stopped**

- High DC power 400 kW
- High current 1300 A

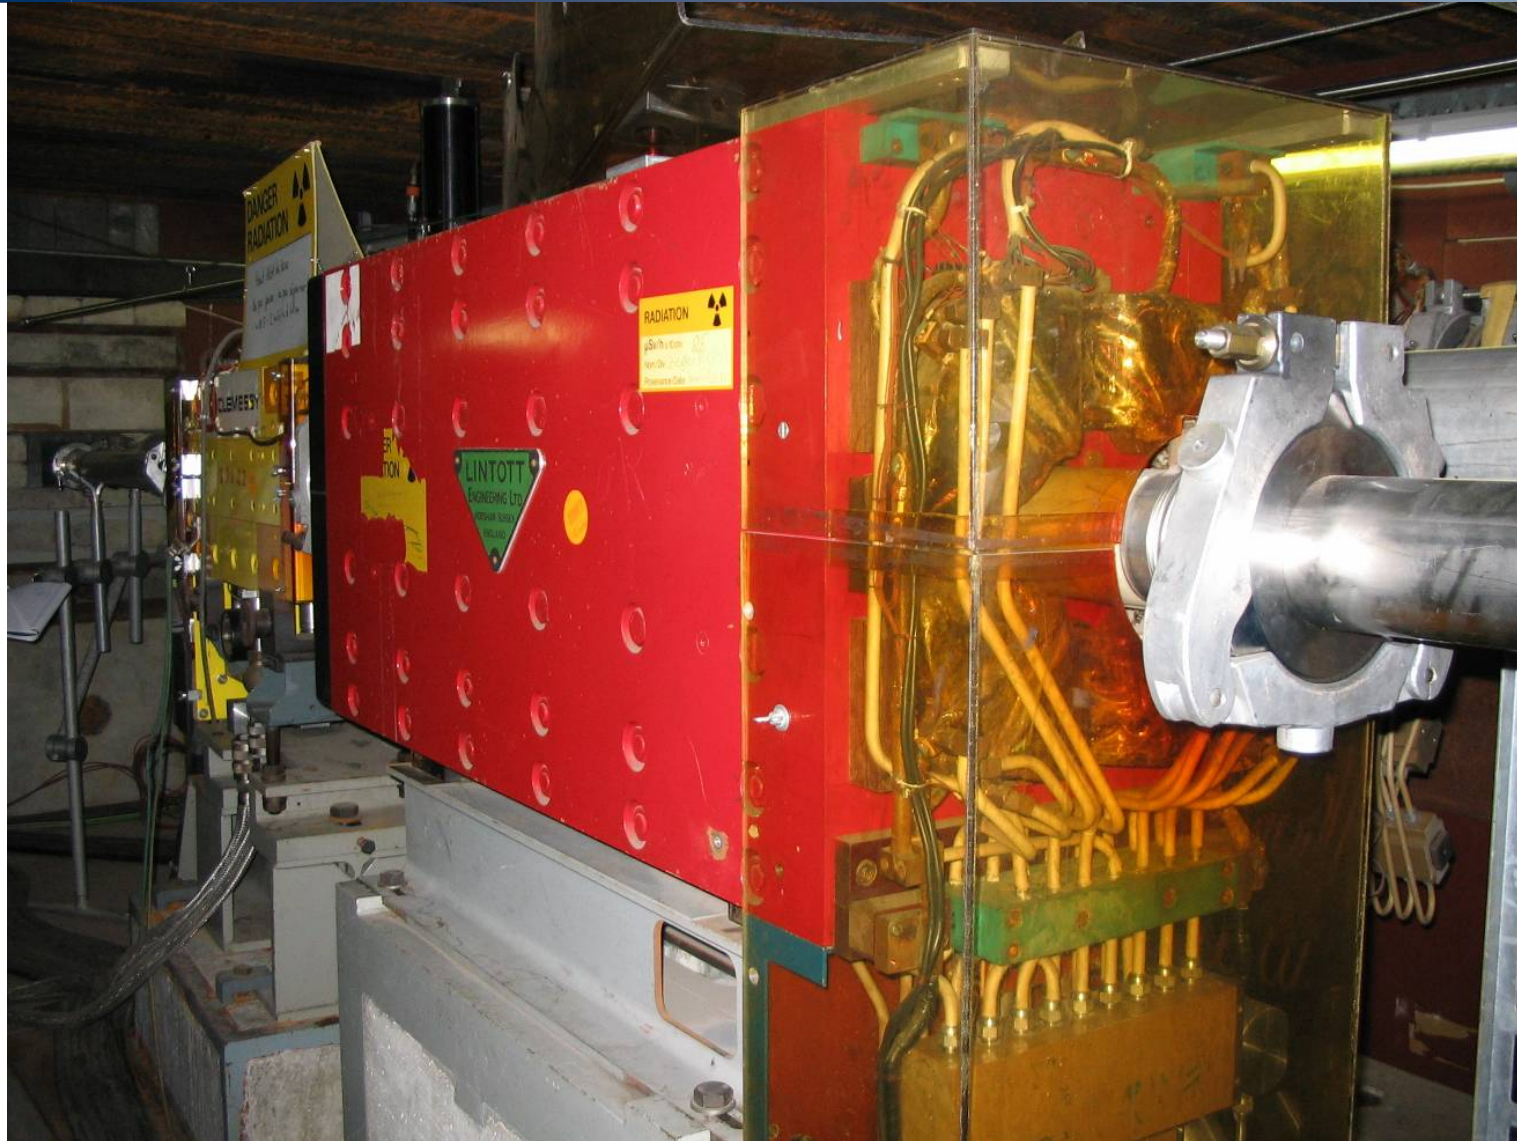
# 'weak' magnets MEP19

NEW	OK	RISKY	SUM
<b>OPERATING</b>	0	0	1	1
	NEW	OK	UNKNOWN	SUM
<b>SPARES</b>	0	0	0	0
<b>Importance issues</b>	<p>No spare</p> <p>F61N.BVT01.MEP19 with high induced radiation level.</p>			
<b>2007</b>	<p>No spare unit → Define priority → If high, ask budget for 1 new magnet.</p>			
<b>2008</b>	<p>If budget + additional staff obtained, 2 new magnets could be fabricated.</p>			
<b>2009</b>	<p>spare status ok</p>

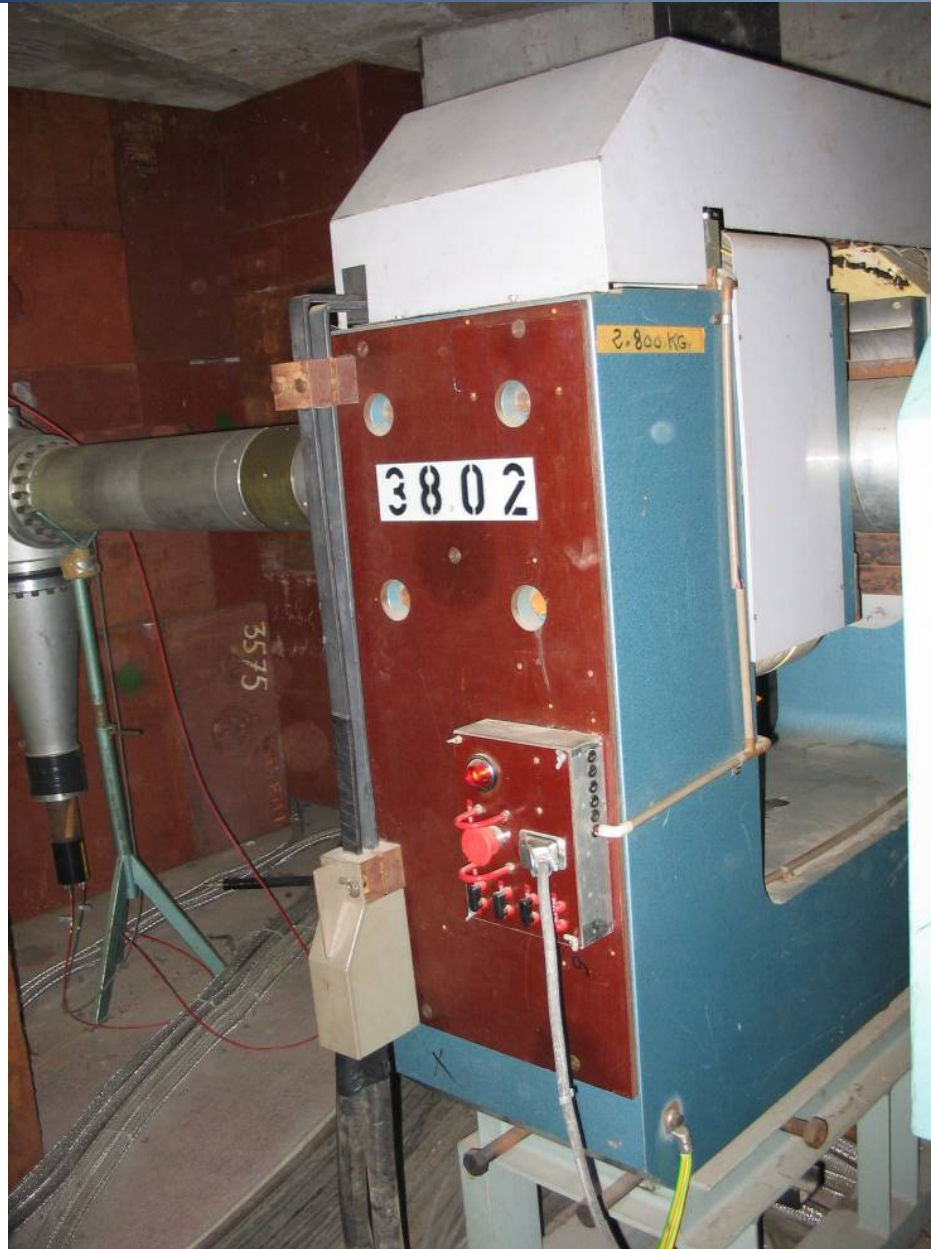
# MEP 35

NEW	OK	RISKY	SUM
<b>OPERATING</b>	0	1	0	1
	NEW	OK	UNKNOWN	SUM
<b>SPARES</b>	0	0	2	0
<b>2007</b>	<p style="text-align: center;">Splitter Magnet in primary line F61.SMH01 producing the beam intensity sharing between North and South branch.</p> <p>Magnet fully enclosed in vacuum container + motorized yoke.</p> <p style="text-align: center;">Maintenance of motorization shall be done by AB as AT-MEL-MI has no staff in this professional category.</p> <p>1 spare unit shall be revised; if unsuccessful + high priority → ask budget for 1 magnet.</p>			
<b>2008-2009</b>	If budget + additional staff obtained, 1 new magnet could be fabricated.			
<b>2010</b>	spare status ok

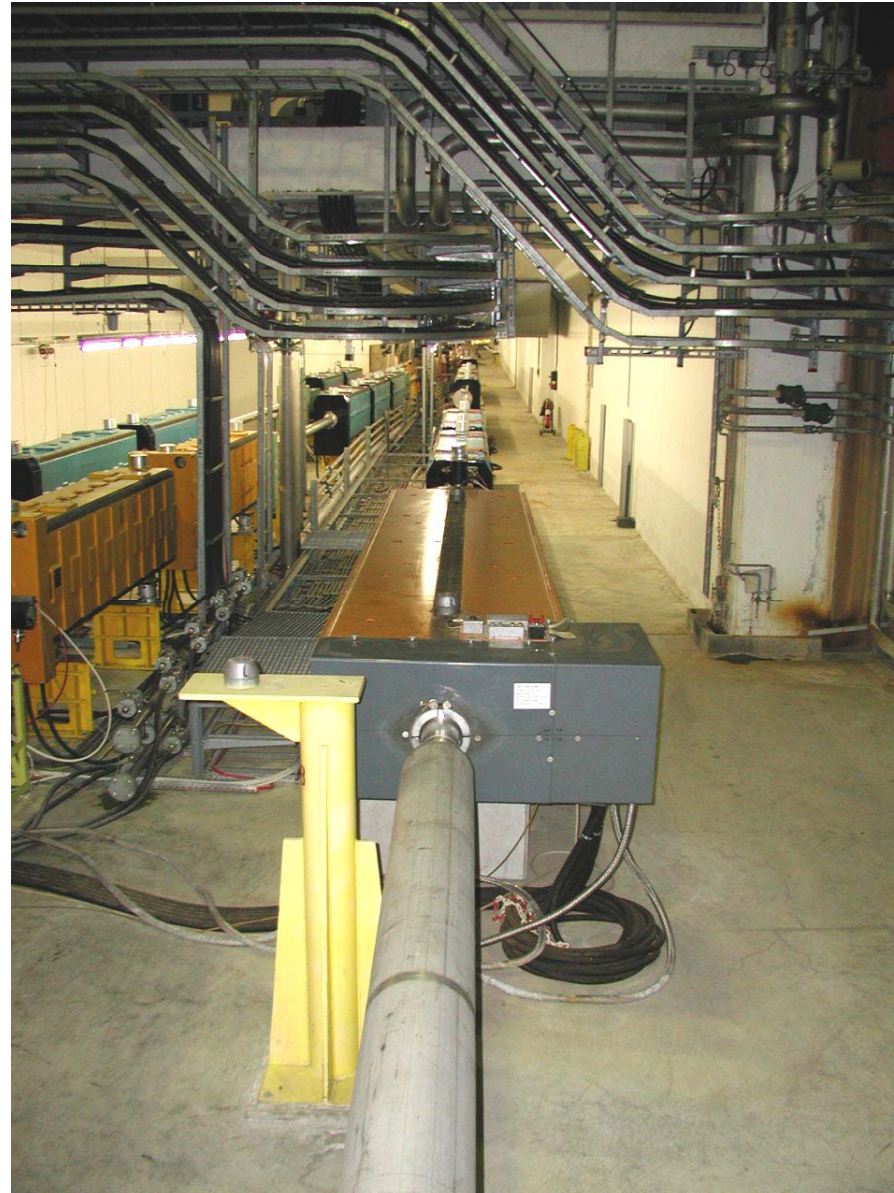
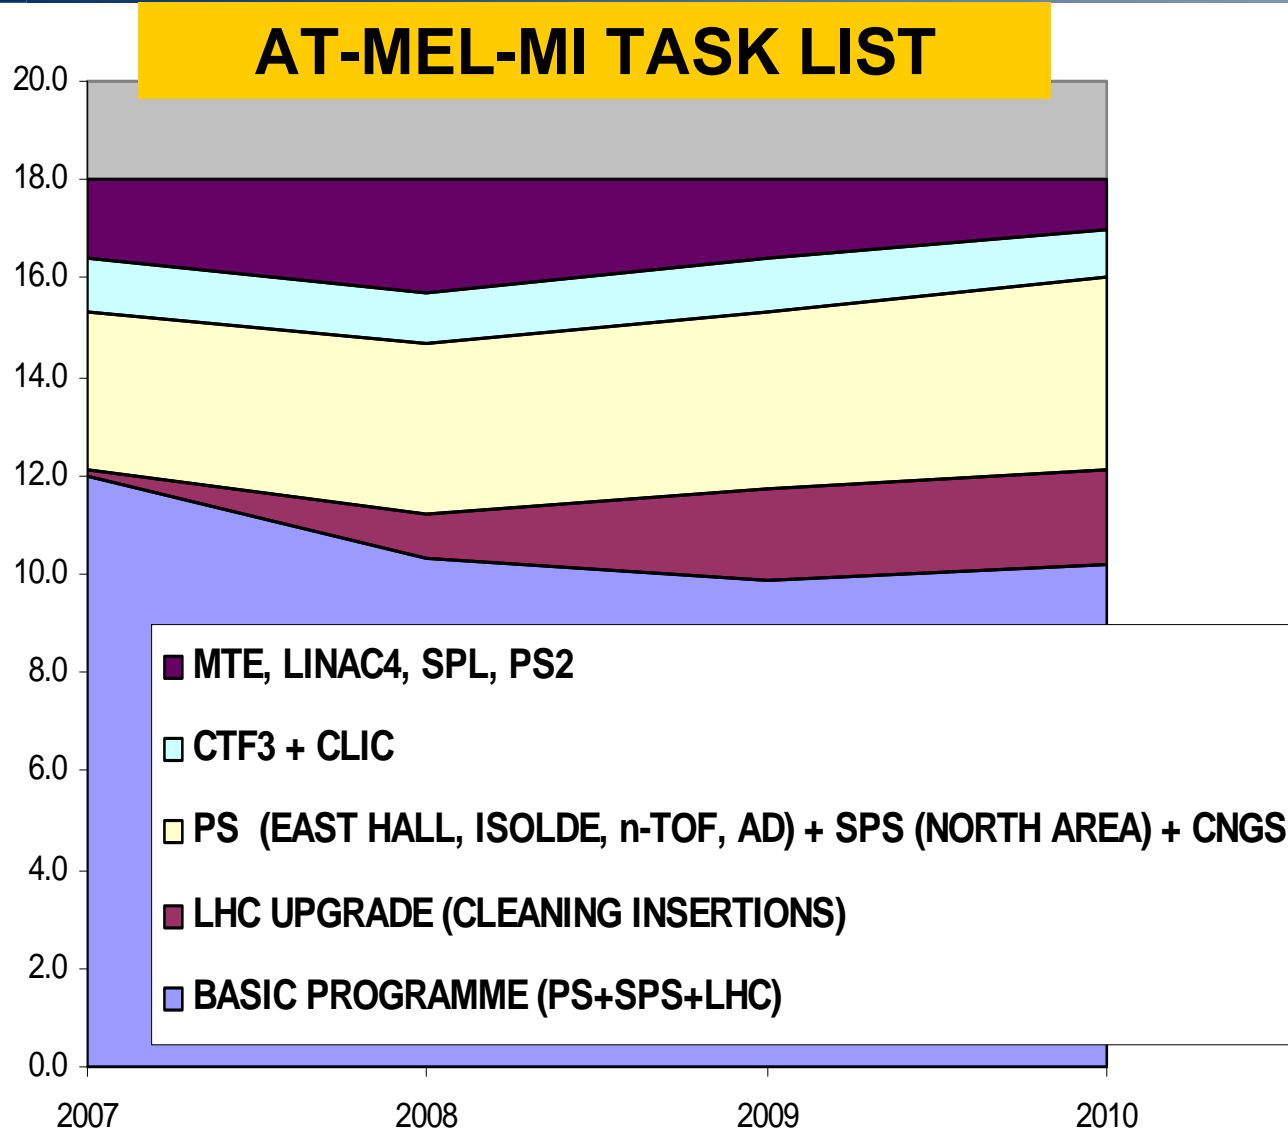
- ➔ Vacuum leaks. Due to corrosion of the stainless steel in contact with the PVC material used for the covers (made in the 70's).
- ➔ Not repairable in situ. Leaky Magnets have to be replaced

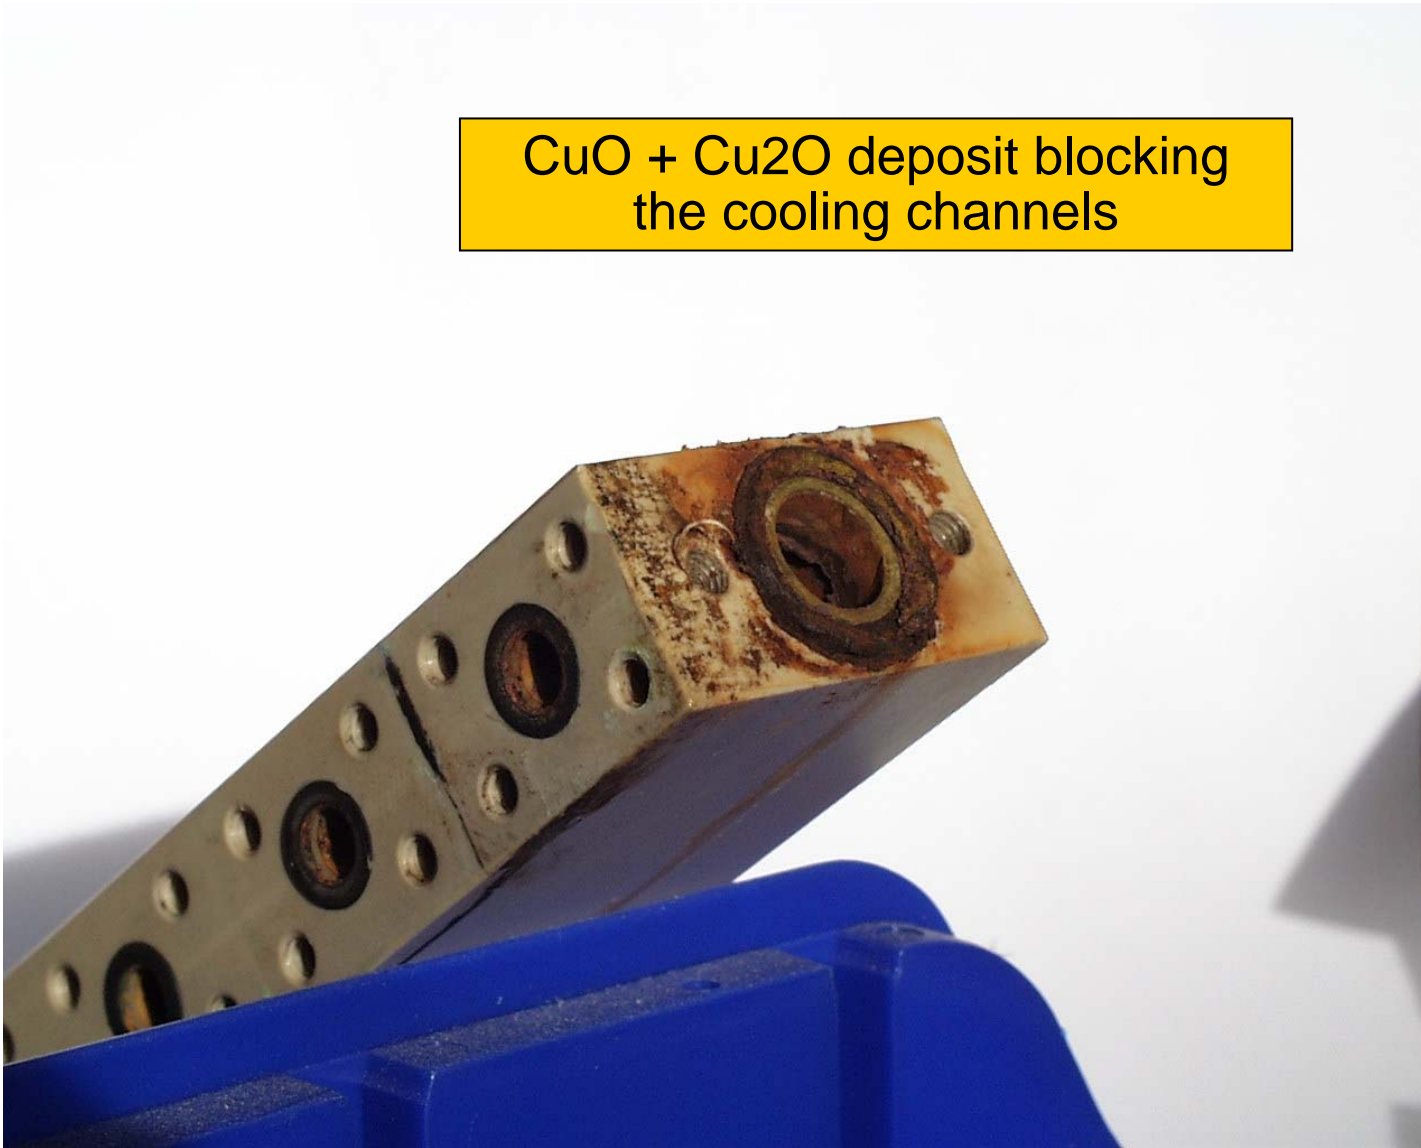
- An analysis by V. da Silva AT/MEL/MI in 2005 showed that corrosion problems were due to insufficient quality of the demineralized water:
- too high conductivity (up to 15 microS/cm, nominal 0.5 microS/cm),
  - resin cartridges not regularly exchanged and problems of monitoring the conductivity.
  - As a consequence of the low water quality the inner walls of the cooling channel were corroded resulting in a deposit of  $\text{CuO} + \text{Cu}_2\text{O}$  blocking the water circulation of the coils .
- In close collaboration with TS/CV we purchased + installed new devices to monitor the water quality online (operational since 3-2006).

CuO + Cu<sub>2</sub>O deposit blocking the cooling channels

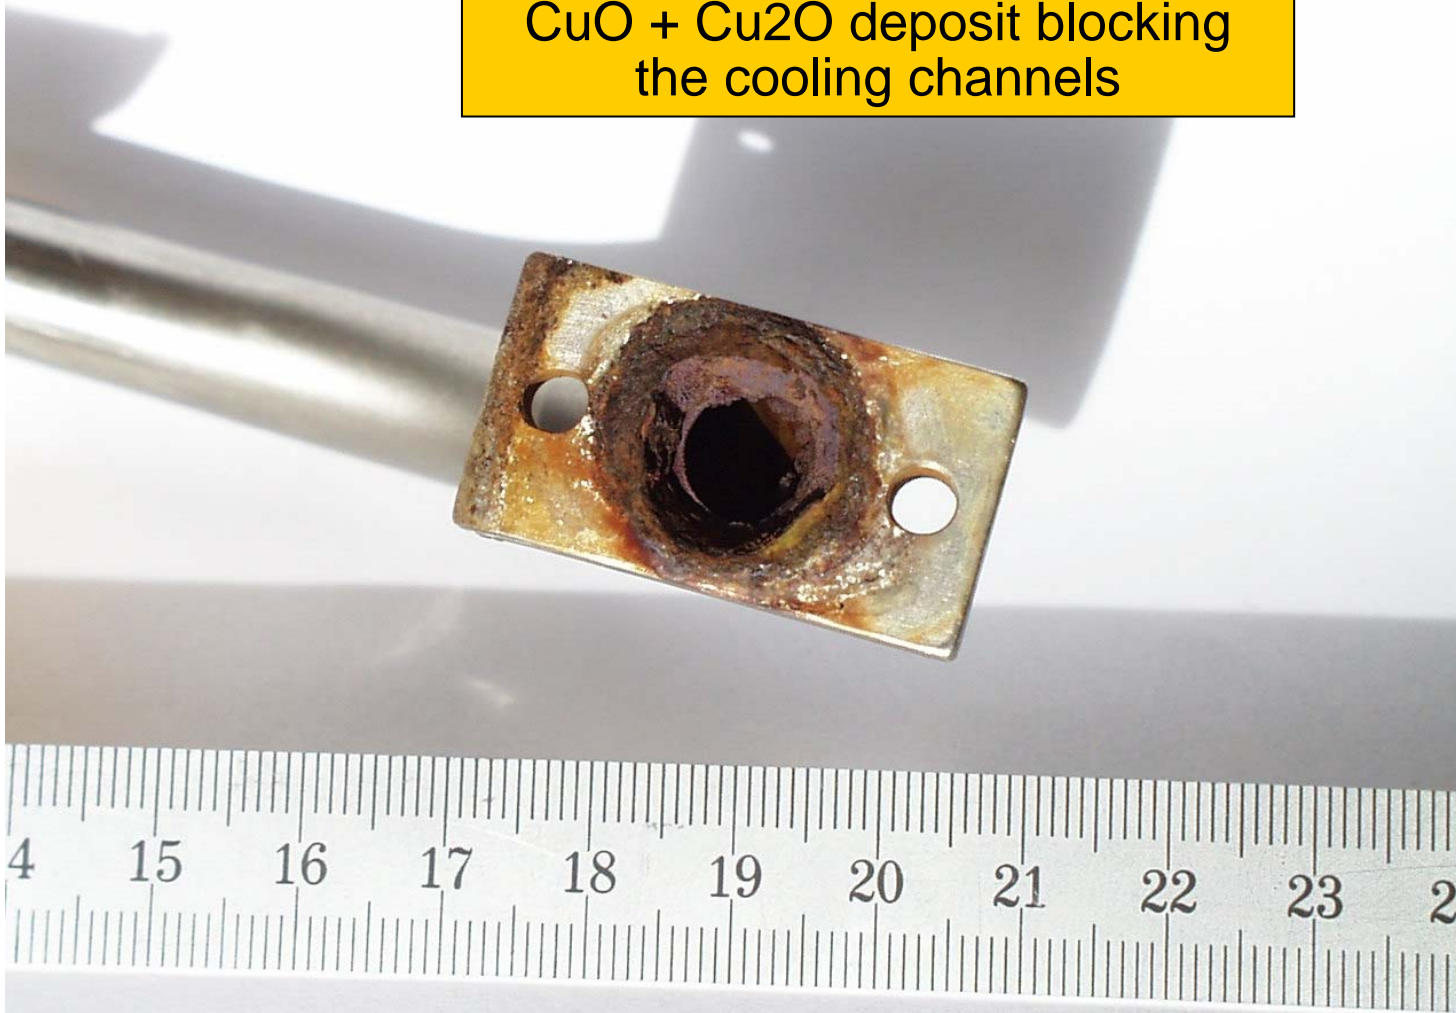
CuO + Cu<sub>2</sub>O deposit blocking the cooling channels

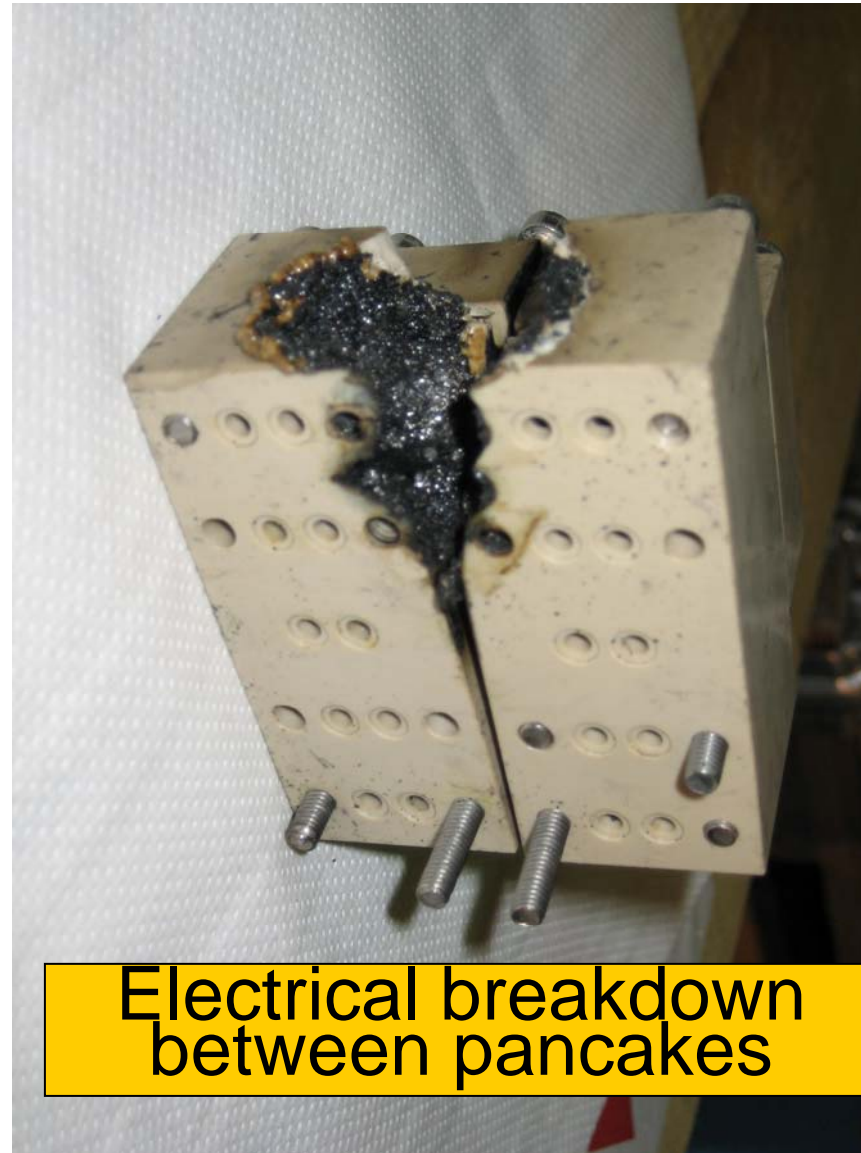
Electrical breakdown  
between pancakes

- ➔ As the origin of the breakdown was fully unclear, it had been decided to use the 4<sup>th</sup> coil set in order to launch a study including simulations and measurements under true operating conditions (except beam).
- ➔ A study started in November 2006 by M. Zerlauth AB-CO & J. Kozak AT-MTM, D. Bodart AT-MEL & A. Beuret AB-PO using the 4<sup>th</sup> coil set. .
- ➔ The preliminary results after about 4 weeks were as follows:
  - no convincing fault explanation yet
  - the max over-voltage spikes from the power converter are only about 50% above the nominal max of 400 V.
  - several kV are required for causing the severe damage observed!

- ➔ Mid-February 2007: The study will continue when cooling water is again available until the origin is found.
- ➔ Results will be used for an improved fabrication of the 5<sup>th</sup> new coil set followed by long-term testing before an eventual re-installation in 2008.
- ➔ February 2007: install C-shaped MCB magnet to replace MNP23 for 2007 operation.

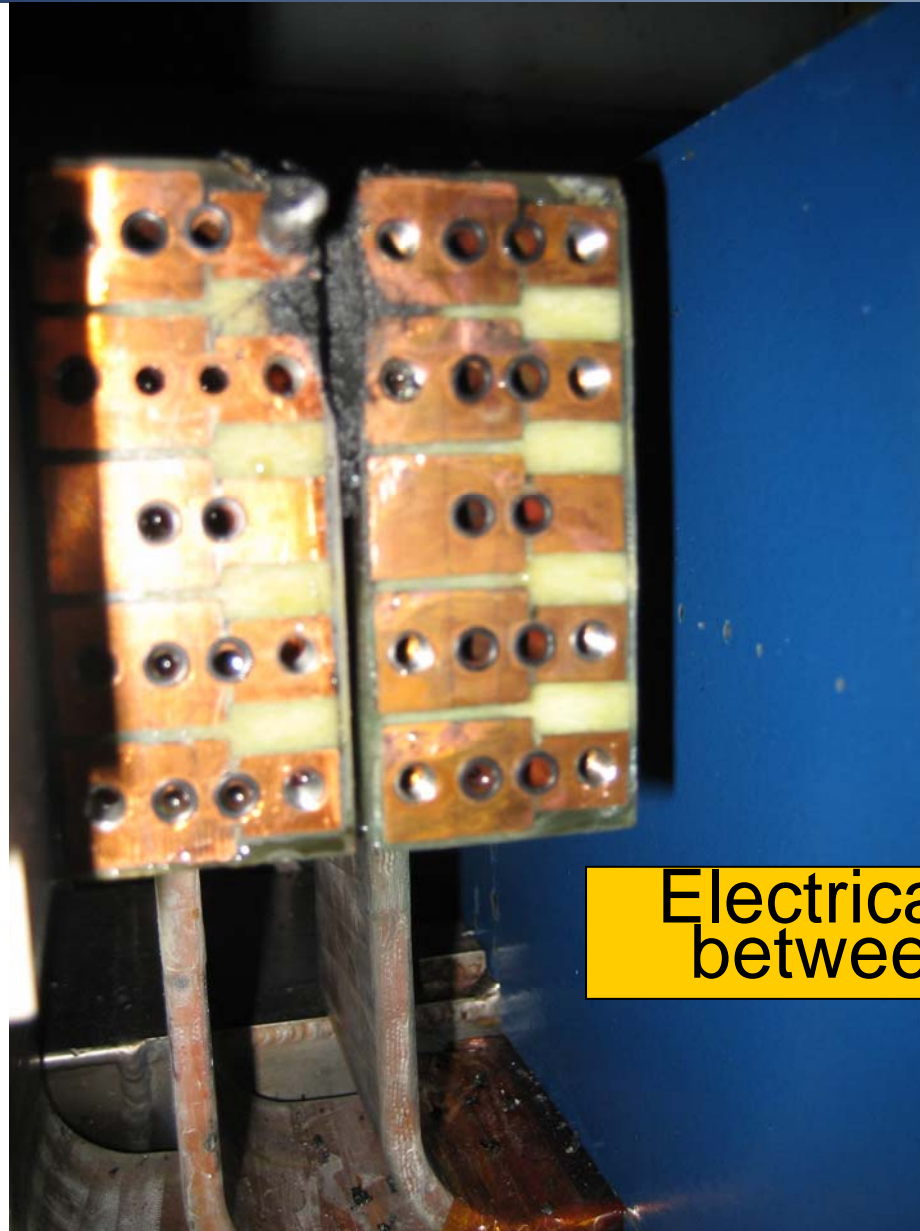
Electrical breakdown  
between pancakes
