The SPS Beam Dump

Jan Uythoven (AB/BT)

SPS Beam Dumping System

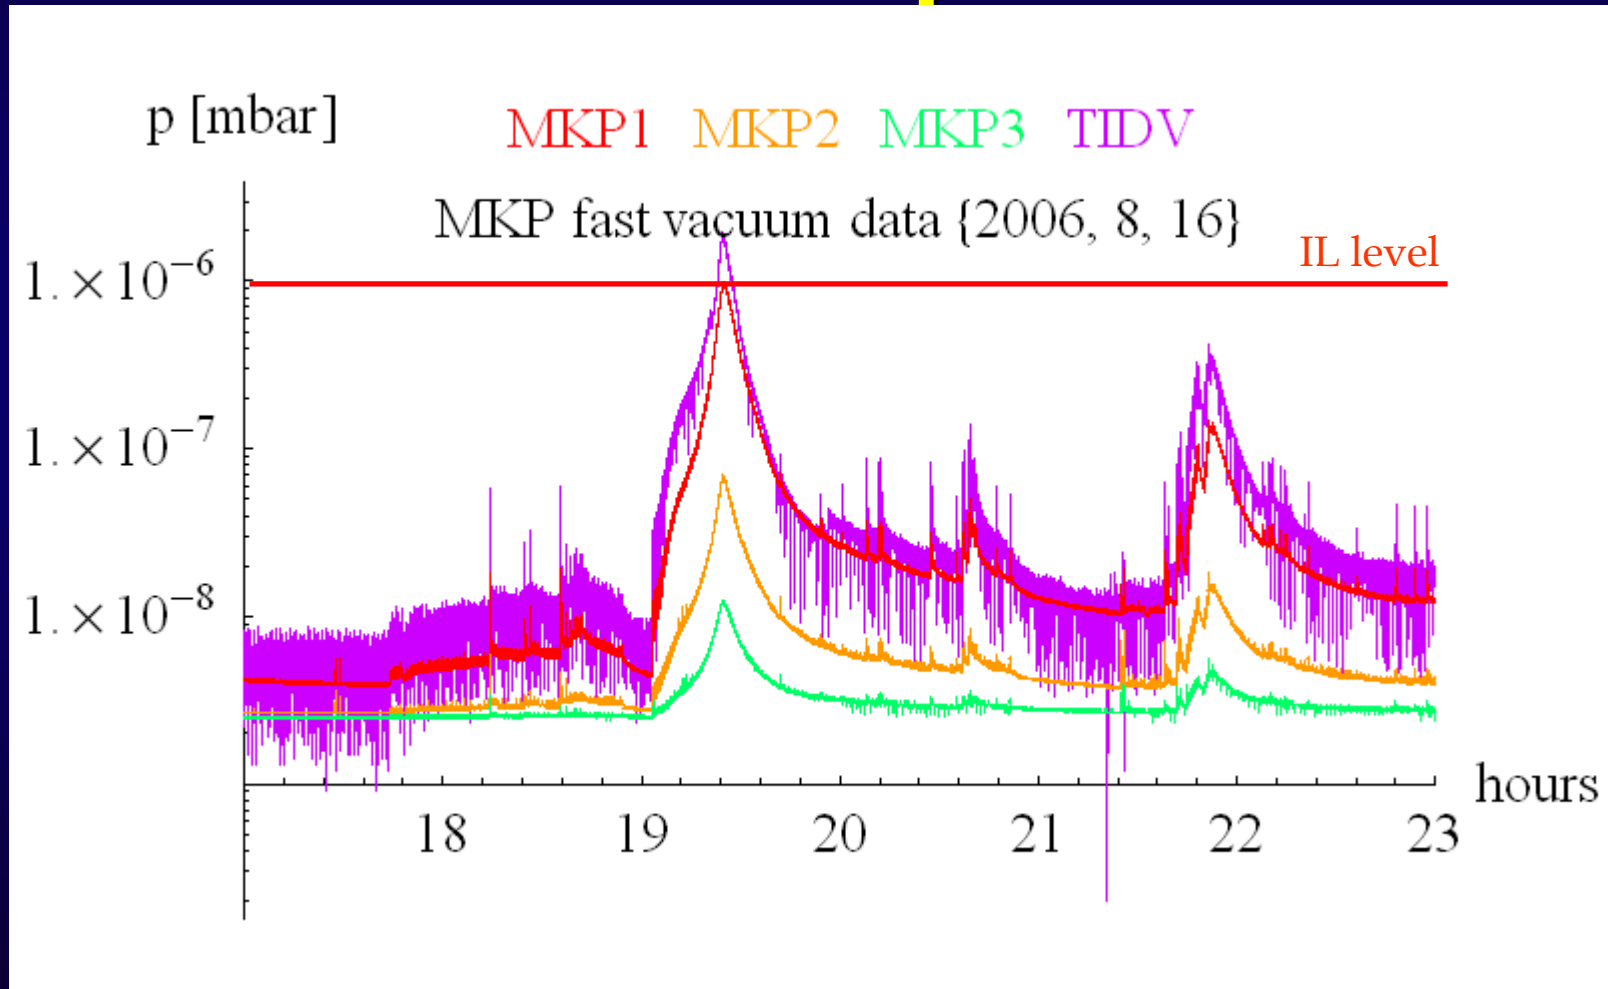
Vacuum behaviour during CNGS operation

- ◆ **CNGS operation**
 - ◆ **High intensity beam not extracted because of extraction inhibit (most critical: position of the extracted beam, variations with beam intensity)**
 - ◆ **'Couple' of full intensity beams ($3e13$) dumped on the TIDVG caused the vacuum of the adjacent injection kickers MKP $> 1 \cdot 10^{-6}$ mbar; injection interlock**
 - ◆ **Impact on operation reduced towards the end of the 2006 run by creating an injection inhibit when 4 x extractions 'stopped'**
 - ◆ **Had to be changed for new super cycle with 3 CNGS cycles = 6 CNGS extractions**
 - ◆ **Reset counter for injection inhibit by super cycle with all beams properly extracted**
 - ◆ **Not a solution for high intensity MDs when beam should not be extracted**

- ◆ **Conditioning with beam**
 - ◆ **Conditions by increasing temperature and 'shocks'**
 - ◆ **Needs beam time**
 - ◆ But probably well on the way with the present beam dump

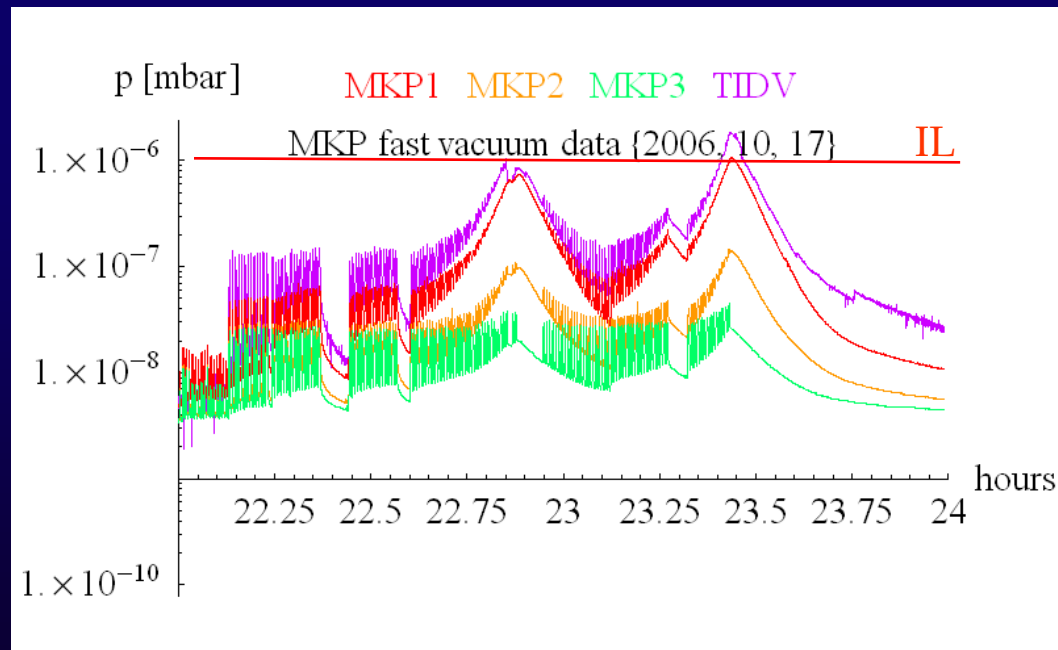
Operation with 5 batches of 48 bunches @ 80 % nominal intensity (=2.1e13):

- ◆ High Intensity LHC beam, being dumped, also causes the vacuum of the injection kickers MKP $> 1 \cdot 10^{-6}$ mbar, injection interlock
- ◆ Problem during MDs and later for set-up of high intensity LHC beams

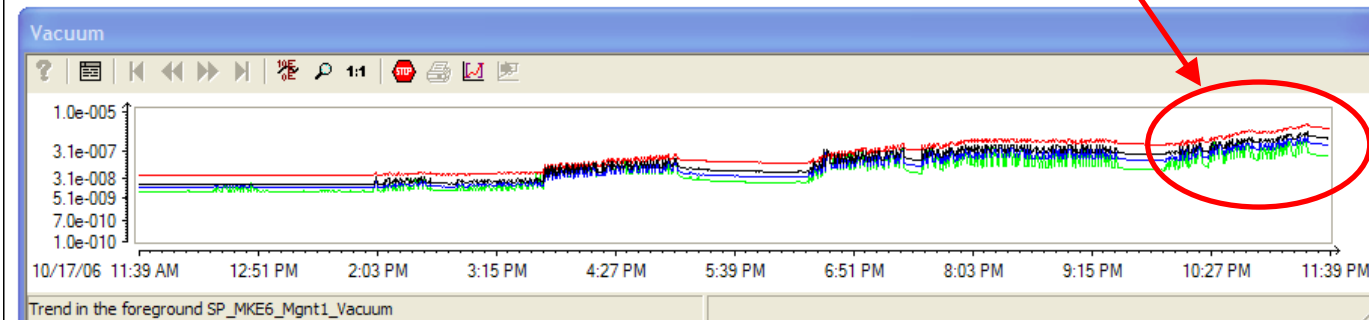
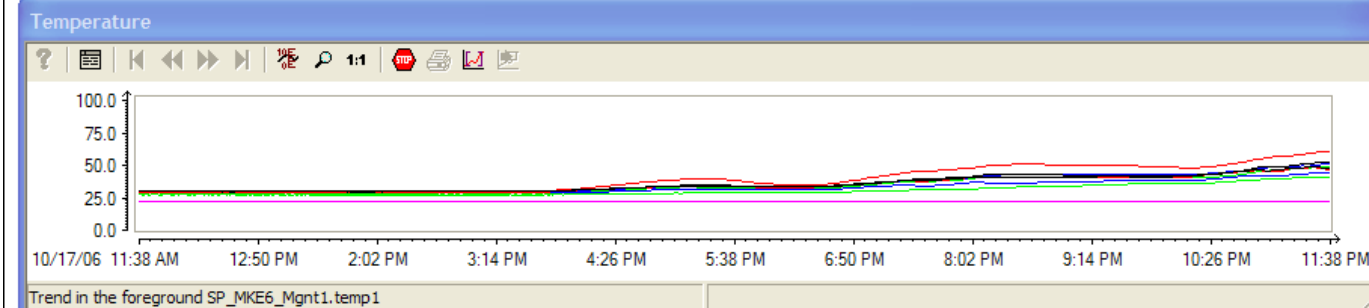
SPS - MKE6 - Data

Vacuum also going up to Interlock Level at the extraction kickers in 6 at the same time.

Peak around 1e-6 mbar as well!

“electron cloud”?
and/or outgassing

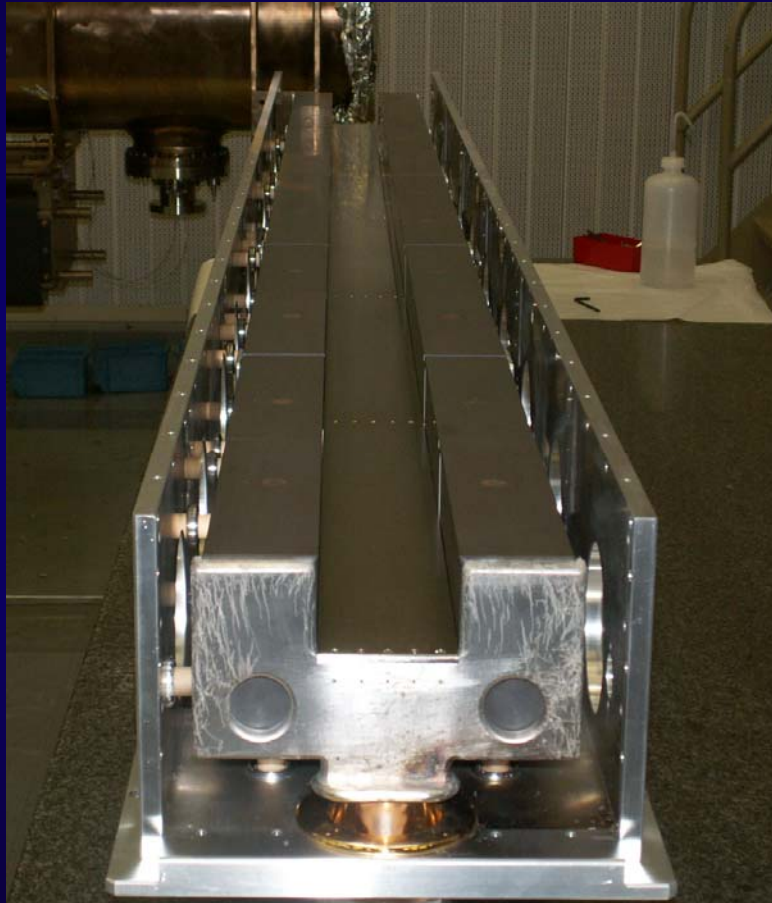
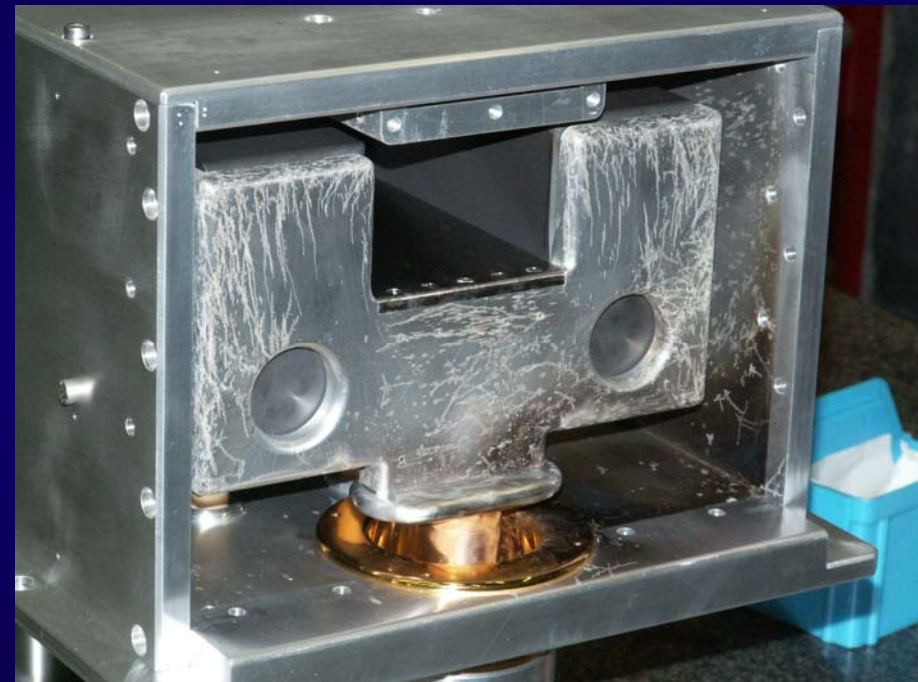
MKDV1 Damage

- ◆ **Vertical SPS Beam Dump Kicker, MKDV1, high voltage problem in 2006**
 - ◆ **Spark = breakdown to earth about 1x per week with 'nominal' operation voltage**
 - ◆ **HV feedthrough MKDV1 changed beginning of 2006, see photo's ->**
- ◆ **After approval ABOC October 2006: operational voltage MKDV1 and MKDV2 reduced to 40 kV**
 - ◆ **Since then no breakdowns any more**
 - ◆ **Reduced protection in case of 'sweep' or breakdown**
 - ◆ **But protection already limited because MKDV1 and MKDV2 are physically linked, does not get much worse by lowering the voltage**

- ◆ However, in 2006 we needed to replace a HV feedthrough and already reduced the operating voltage from original 52 kV to 47 kV to 40 kV due to frequent breakdowns in the MKDV1 magnet

- ◆ **Shutdown 2006 – 2007**
 - ◆ **Repair MKDV magnet, ongoing**
 - ◆ **Operation at nominal voltage starting 2007 (52 kV)**
- ◆ **Further future**
 - ◆ **Have to regain the full contingency of the MKDV systems by fully separating the MKDV1 and MKV2 systems**
 - ◆ Otherwise risk to damage the machine when breakdown in one MKDV magnet while high intensity beam is being dumped
 - ◆ **Several options:**
 - ◆ Reverse diodes
 - ◆ Two PFNs (modified 2 Ω) with one high current switch each
 - ◆ Two PFNs (modified 2 Ω) with two switches each

- ◆ **MKDV1 magnet being fixed this shutdown for next start-up**
 - ◆ Hope to be able to run at nominal voltages like < 2006
 - ◆ **Should fully separate MKDV1 / MKDV2 systems in the future to obtain full contingency -> reliability**

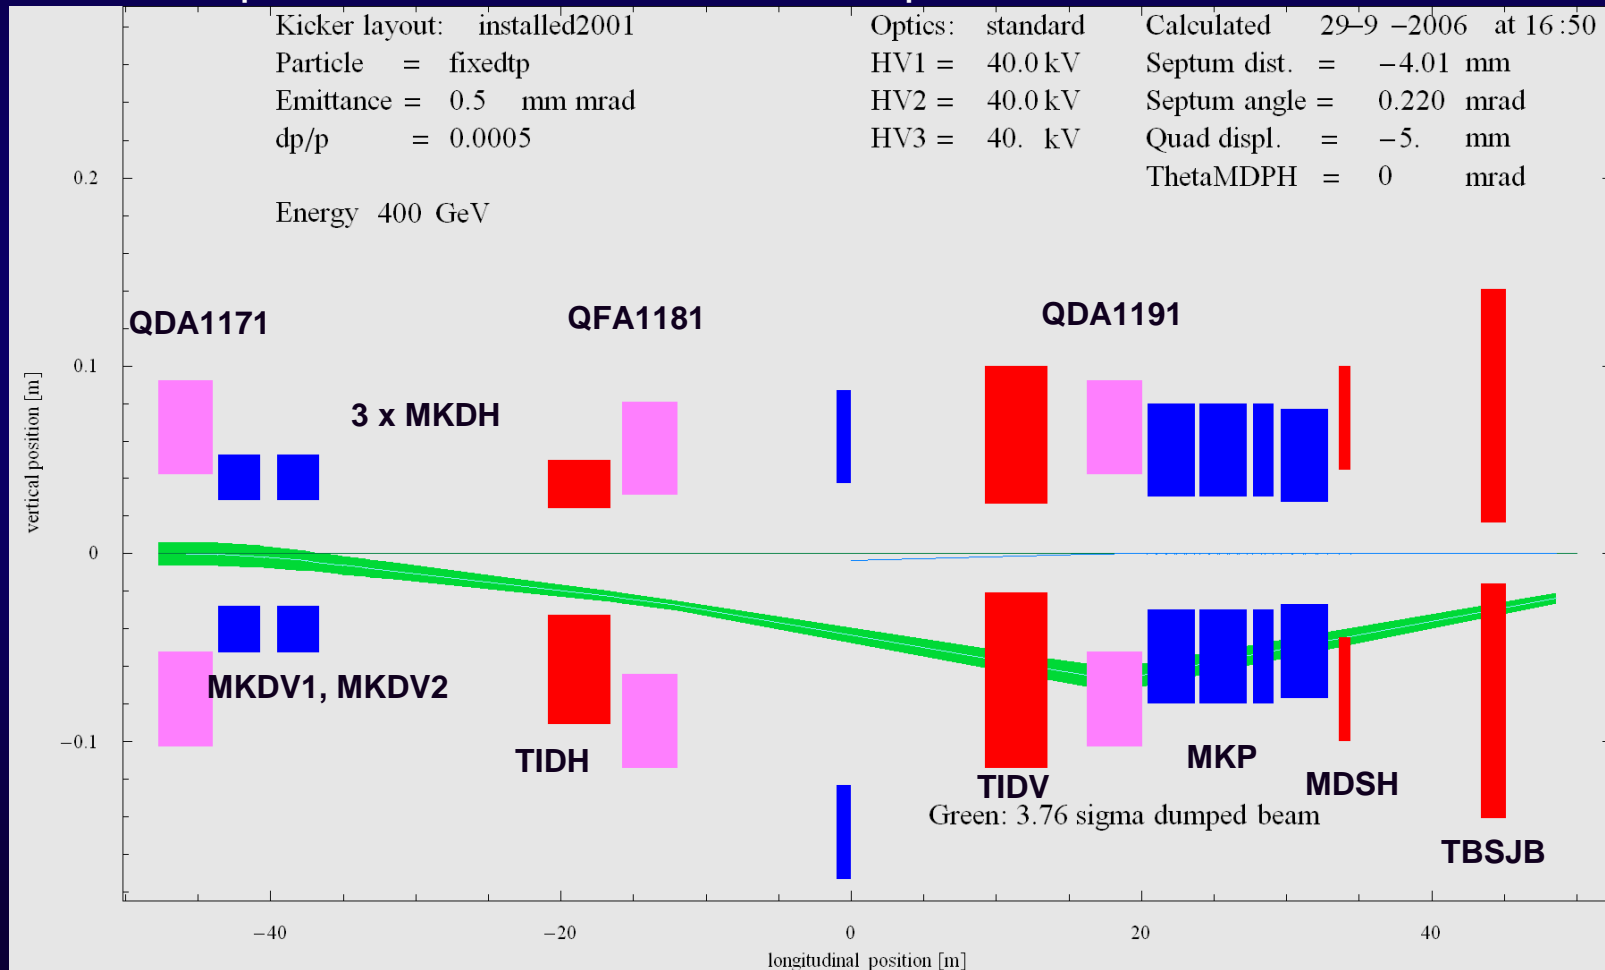
ftp beam at 400 GeV, when dumped with 47.3 kV on MKDVs

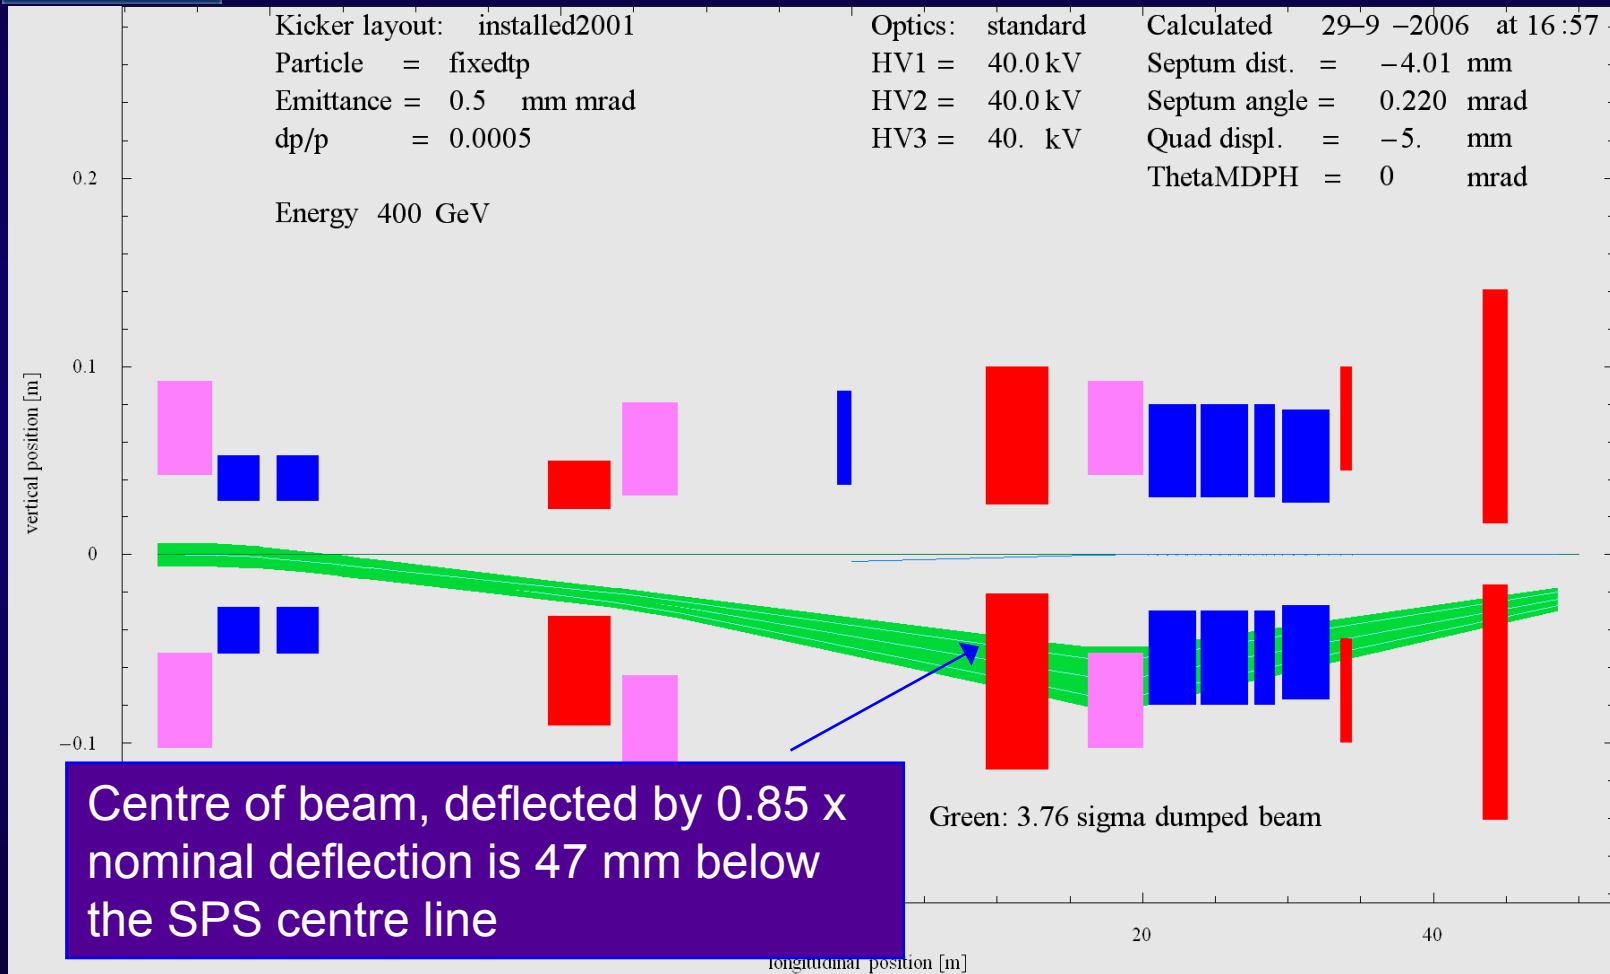
ftp beam at 400 GeV, as we dumped it with 47.3 kV on MKDVs ...with +/- 15 % field modulation

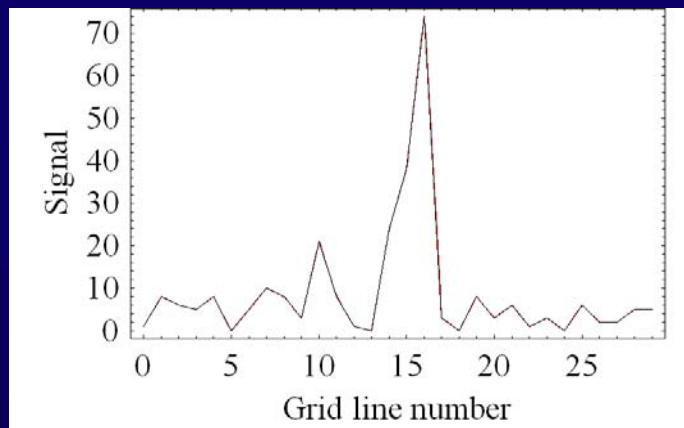
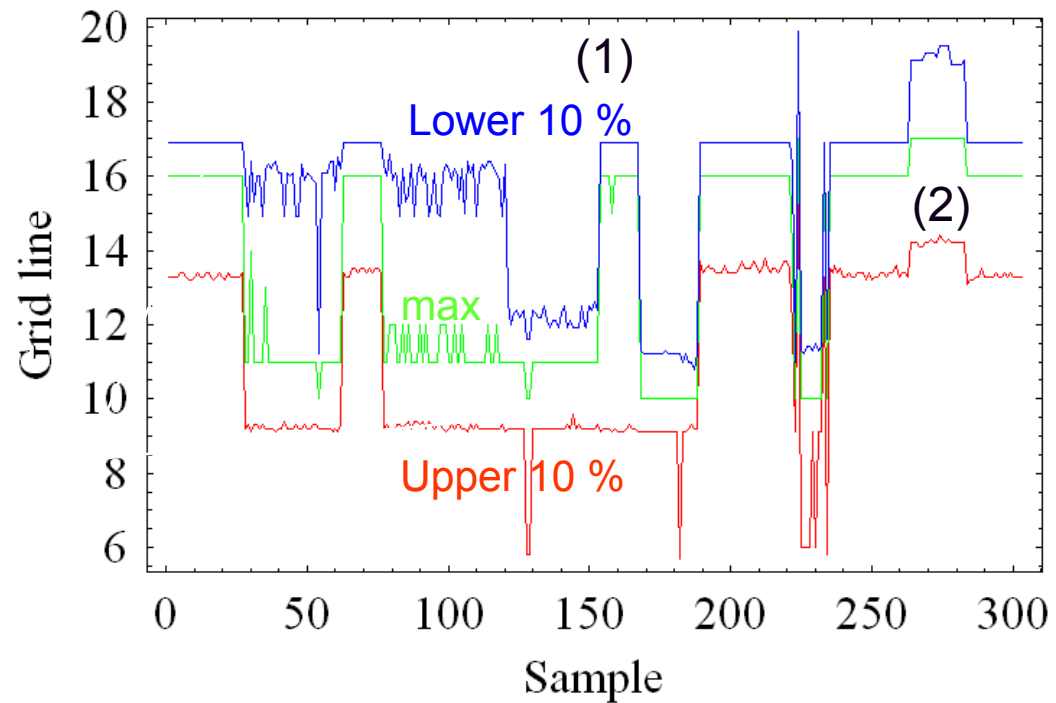
- ◆ varied 'fine timing' of MKDV, to sample the MKDV curve (1)
- ◆ Early Dump (2): expected lower position on block confirmed

Extreme positions centre (top = 115 % / bottom = 85 %) between grid line 10 and 16 = 49.4 and 64.35 mm from centre SPS

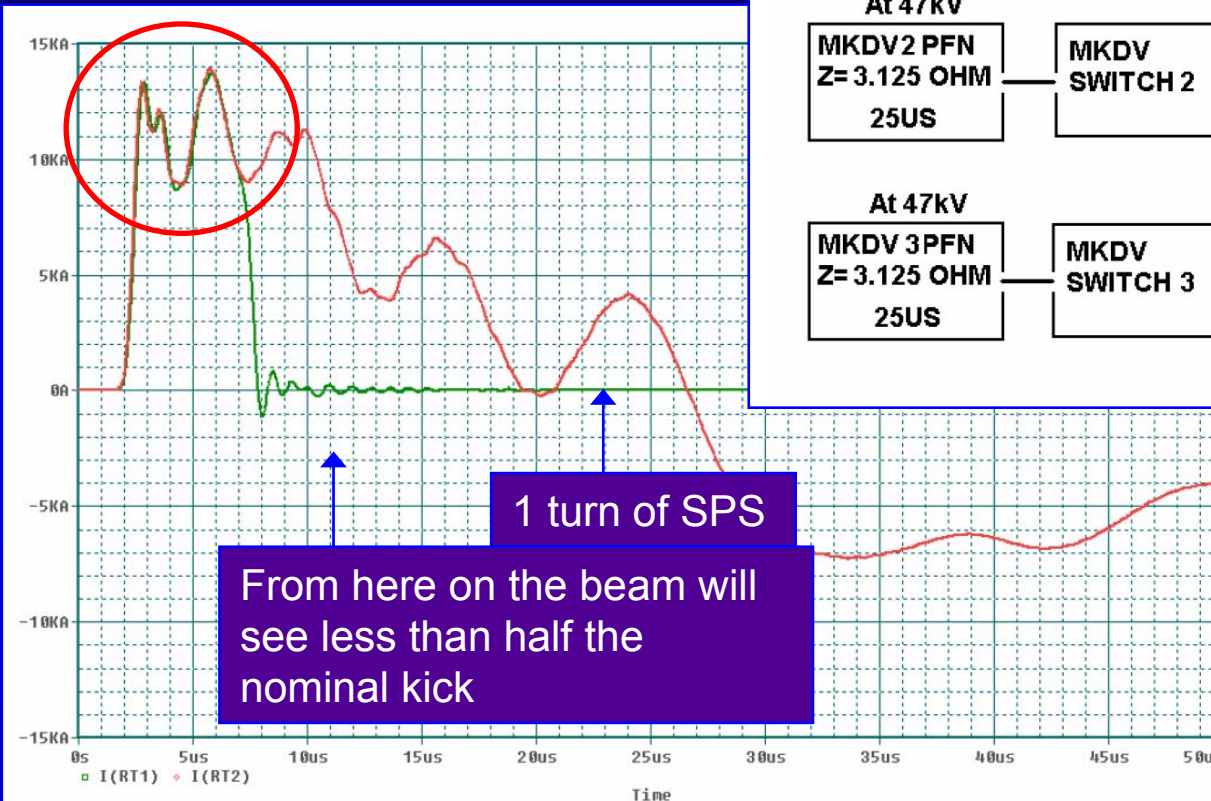
Normal $\pm 15\%$ oscillation

Fig. 7. Short circuit at 6 μ s, green: RT1 current (kA), red: RT2 current (kA).

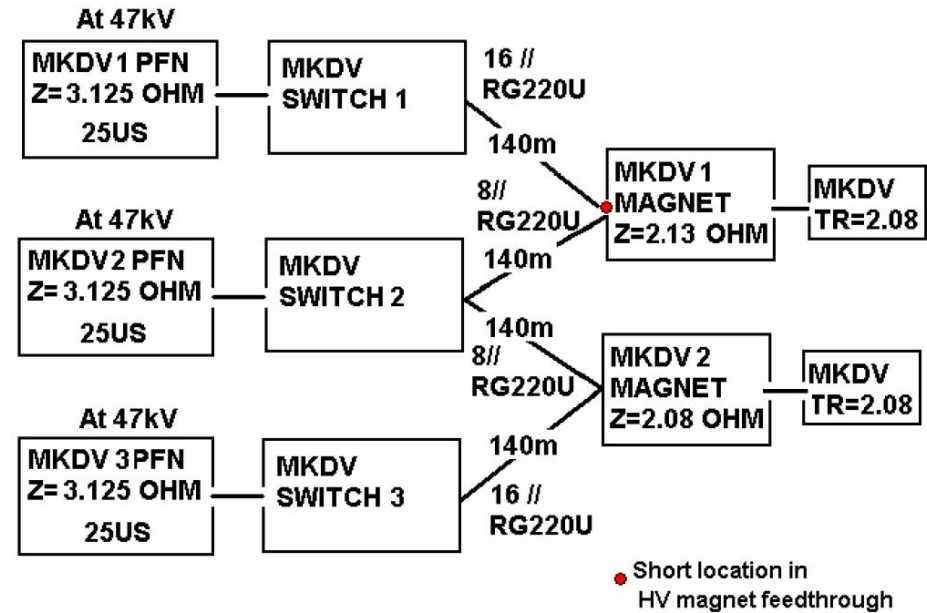
Magnets linked by common PFN

- ◆ If one magnet now breaks down, the short circuit also pulls down the other magnet via the common PFN, one is not any more protected against magnet failure
