Analysis of Booster and Storage Ring RF System Reliability at the Advanced Photon Source

Doug Horan – Advanced Photon Source RF Group
2010 – Sixth CW and High Average Power RF Workshop
ALBA, Barcelona, Spain

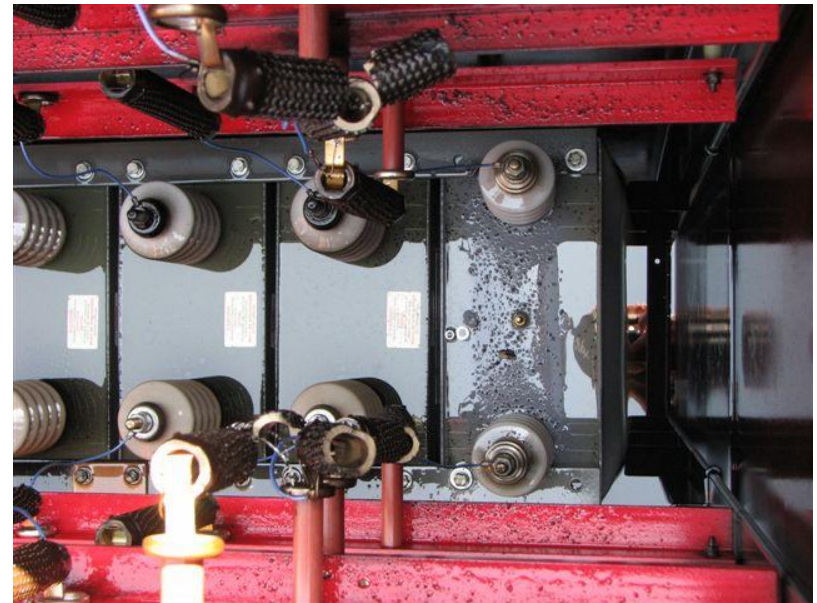
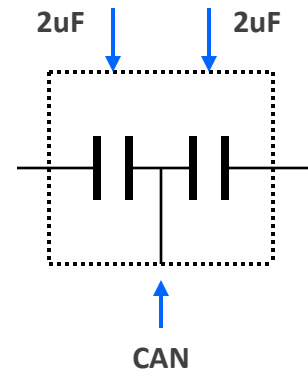
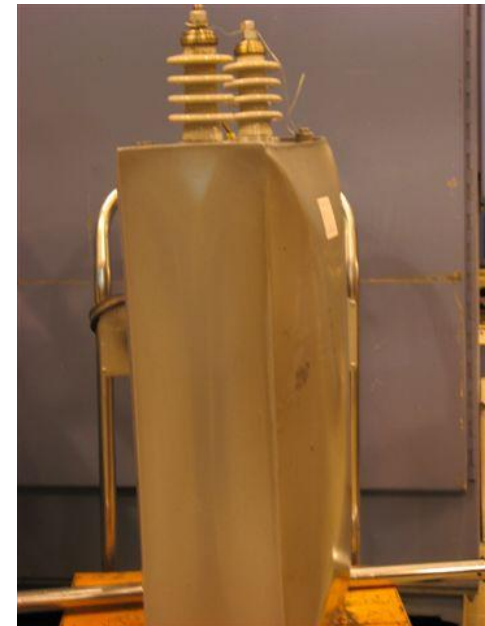
Transformer-Rectifier Set Capacitor Failures

- T-R set capacitor bank consists of eight 2x2uF capacitors arranged in series/parallel:
→ $C_t = 8\mu\text{F}$ at 95kV max
- Routine inspection of the RF5 T-R set in May 2008 revealed several failed capacitors – predicted lifetime was 20 years
- Original capacitors were obsolete and out of production by manufacturer
- Replacement capacitors were second-sourced to another manufacturer, hipot tested twice, and installed in the RF4 T-R set in May of 2009

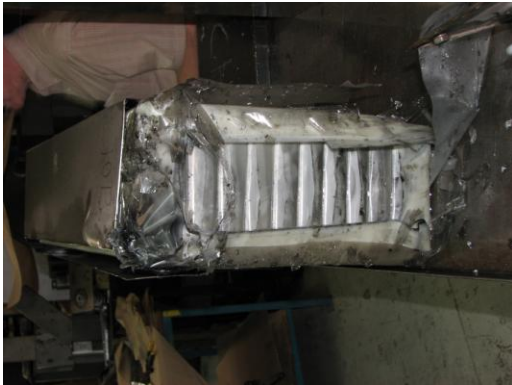
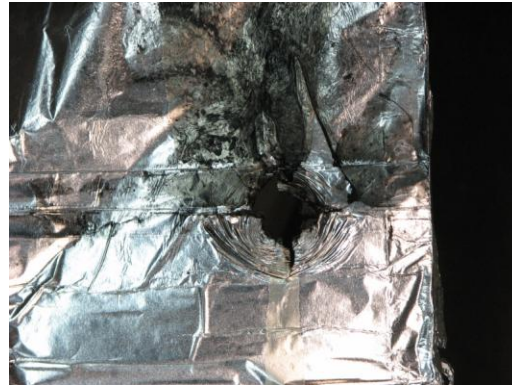
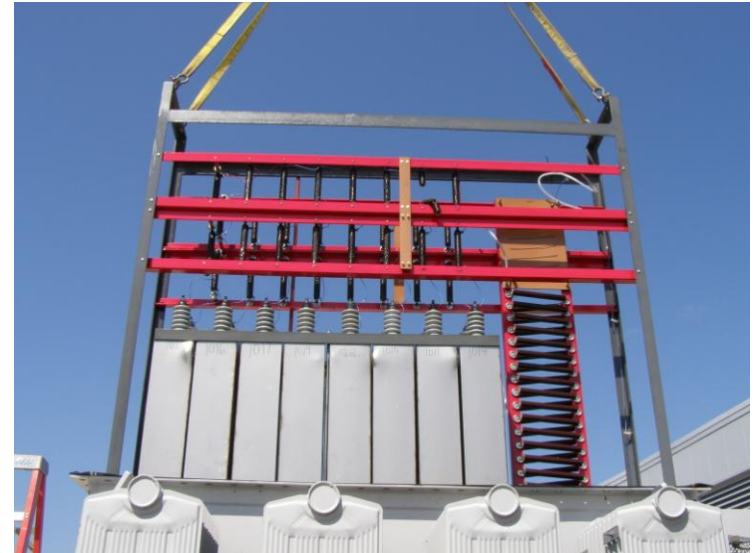
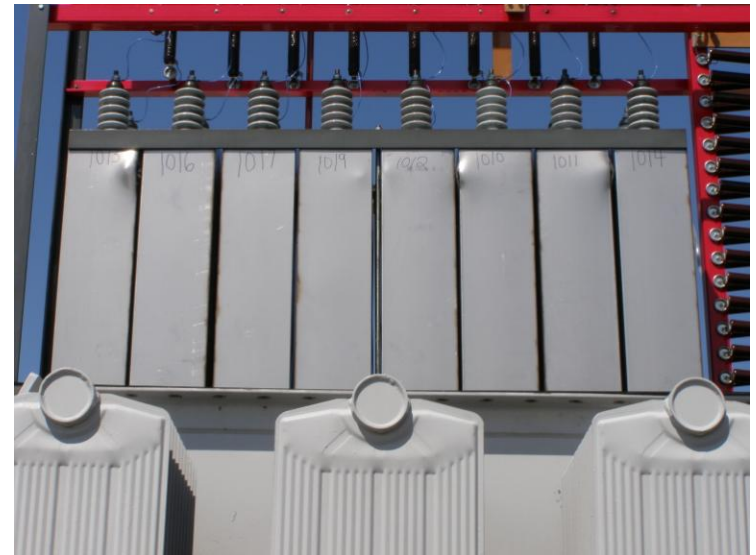
Transformer-Rectifier Set Capacitor Failures

- **Most of the new caps failed after approximately one week service!**
- **The cause of the failures was determined to be incomplete oil impregnation to all sections of the capacitor:**

- The original caps were re-installed in the RF4 T-R set so operation could resume
- A search for a second vendor was started
- New caps were ordered from Vendor #2 and were installed in RF4 during the August 2009 maintenance shutdown
- No further problems with caps from vendor #2
- Lessons learned:
 - *“old-school” high-voltage components may not be so easy to get nowadays*
 - *try to secure two vendors for such parts, and maintain adequate spares*

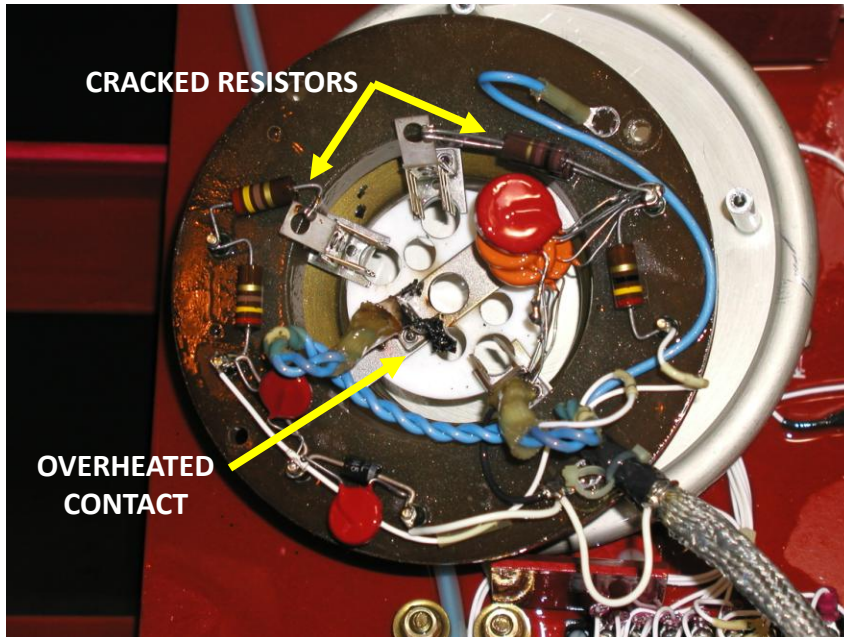
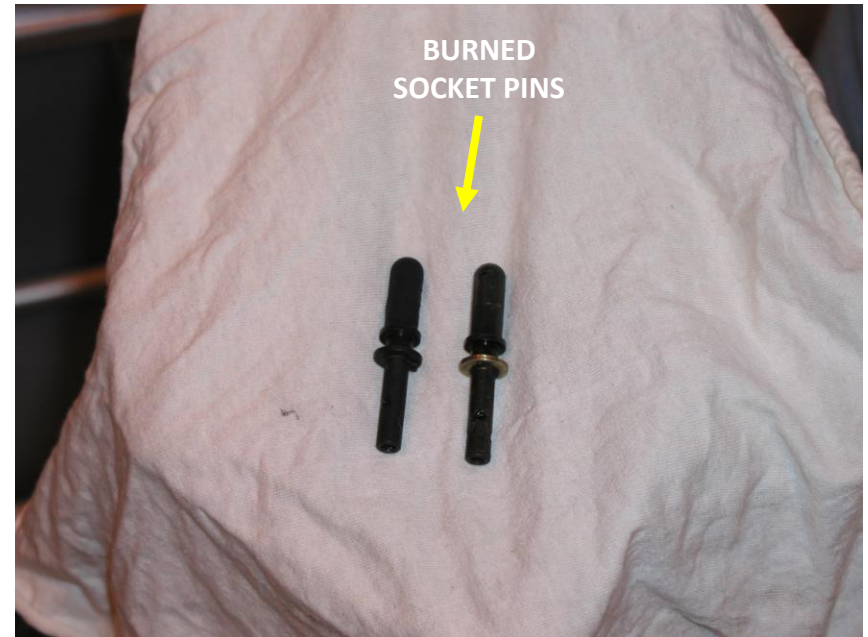
Mod-Anode Tetrode Socket Failures

- Over-heating of center pin tetrode contact due to trapped oil, causing intermittent loss of heater power
- 2-watt carbon composition resistors cracking

→ *temperature?.....old age?*

Solution: Drill oil escape hole in center of socket cover, and replace all carbon composition resistors with 3-watt metal film

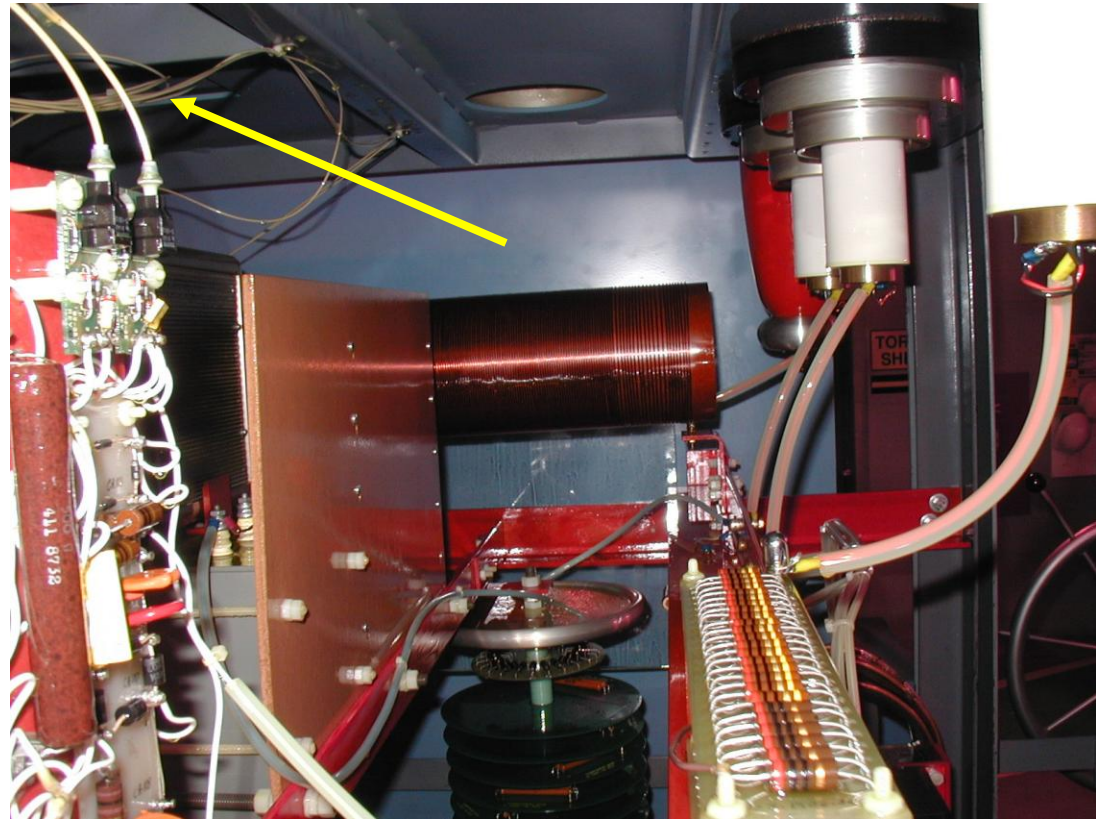
Mod-Anode Fiber Optic Cables

- X-rays from tetrodes degrade fast glass fiber optic cables, impeding analog communication with tetrode control electronics cages and resulting in loss of anode regulation

Solution: Convert to radiation-resistant plastic fiber cables with larger active area

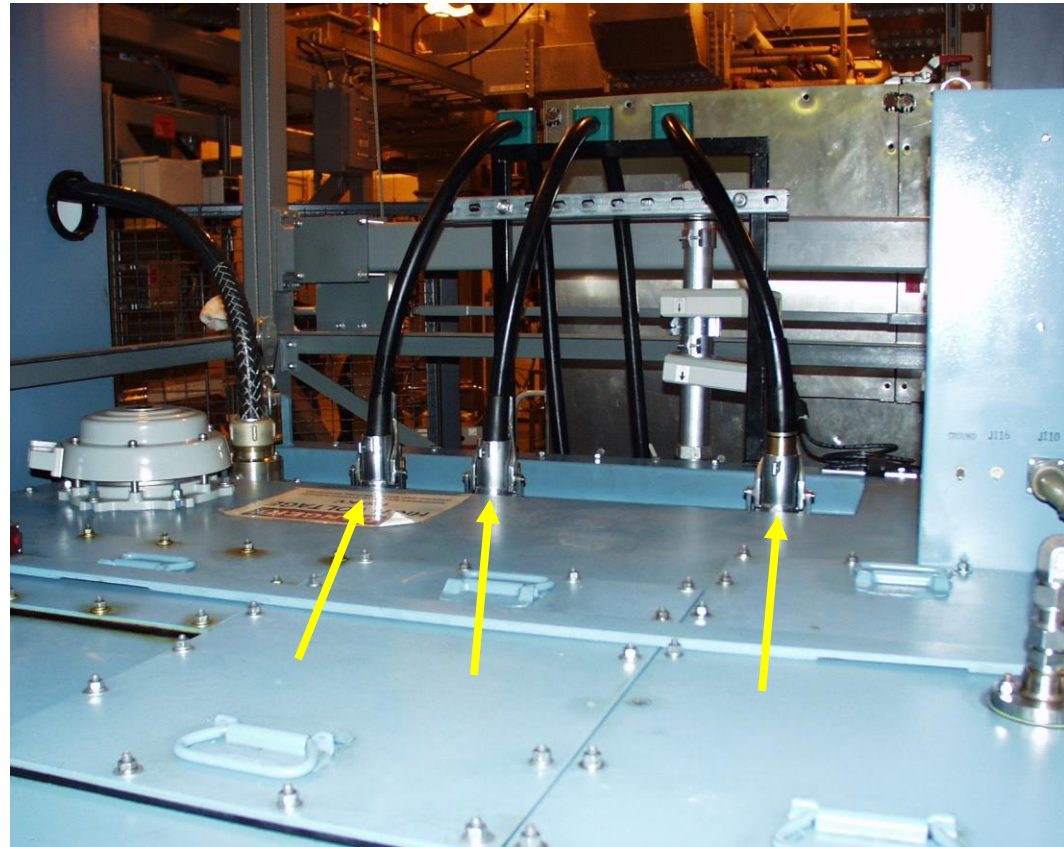
Problems with Pantak Cable Connections Between HVPS and Klystron

- Numerous HVPS system failures have occurred due to:

→ *cable failures due to high voltage breakdown*

→ *Intermittent socket connections*

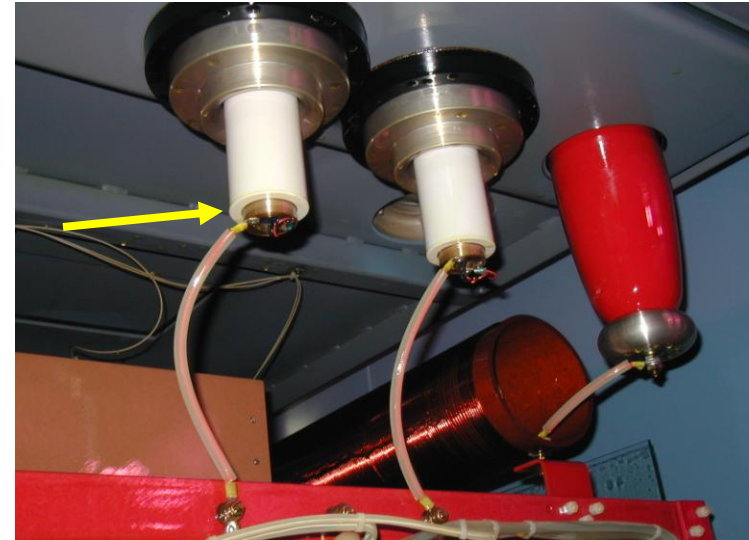
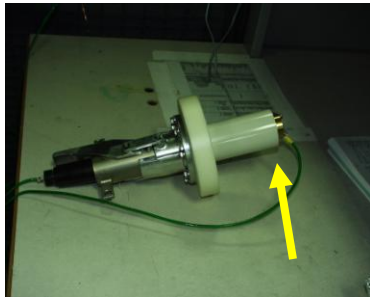
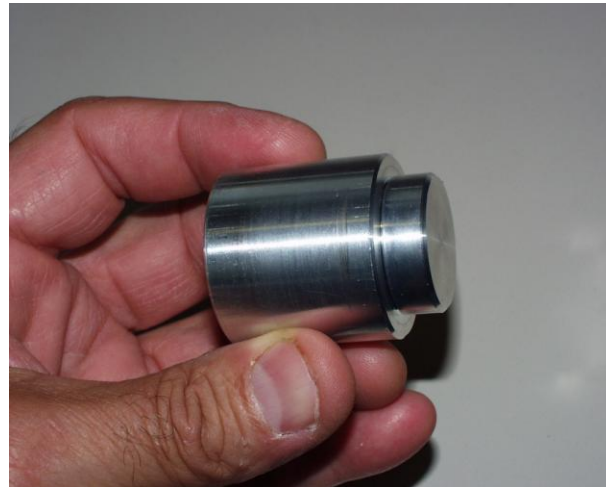
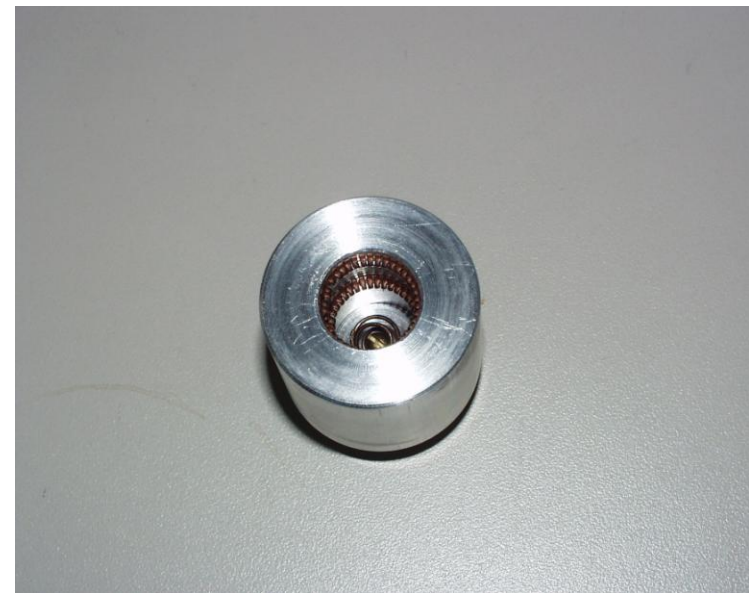
Improved Pantak Socket Tip Connector

- Original tri-axial tip connector was sensitive to insertion force and would result in intermittent filament contact

Solution: Re-designed one-piece tip contact with fingerstock provided positive contact to tip and ring bushings on plug

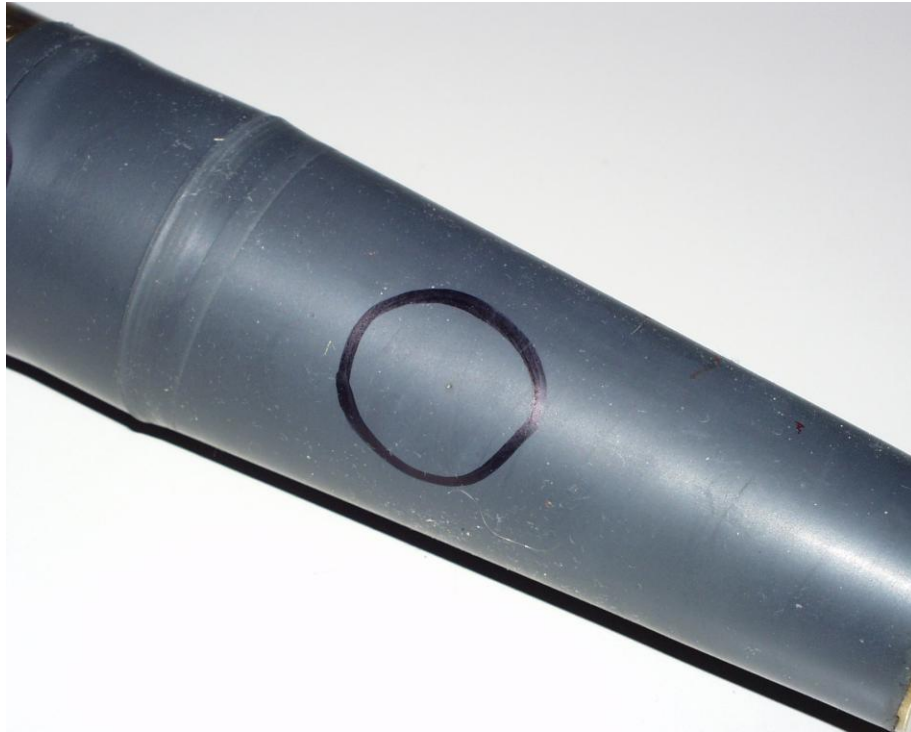
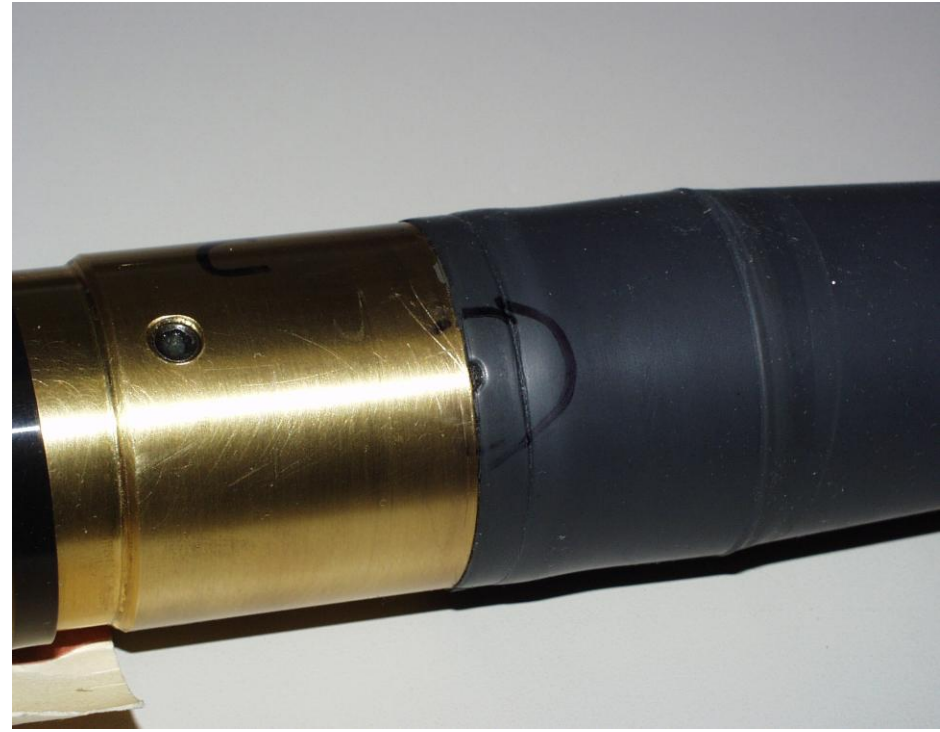
Pantak Cable High Voltage Failures

- Suspect causes include defects in connector or plug molding, potting, or material, incorrect plug insertion force, insufficient grease, undetected HV damage to the mating socket

Solution: Increased awareness of proper insertion force, improved technician training on Pantak connector inspection and maintenance

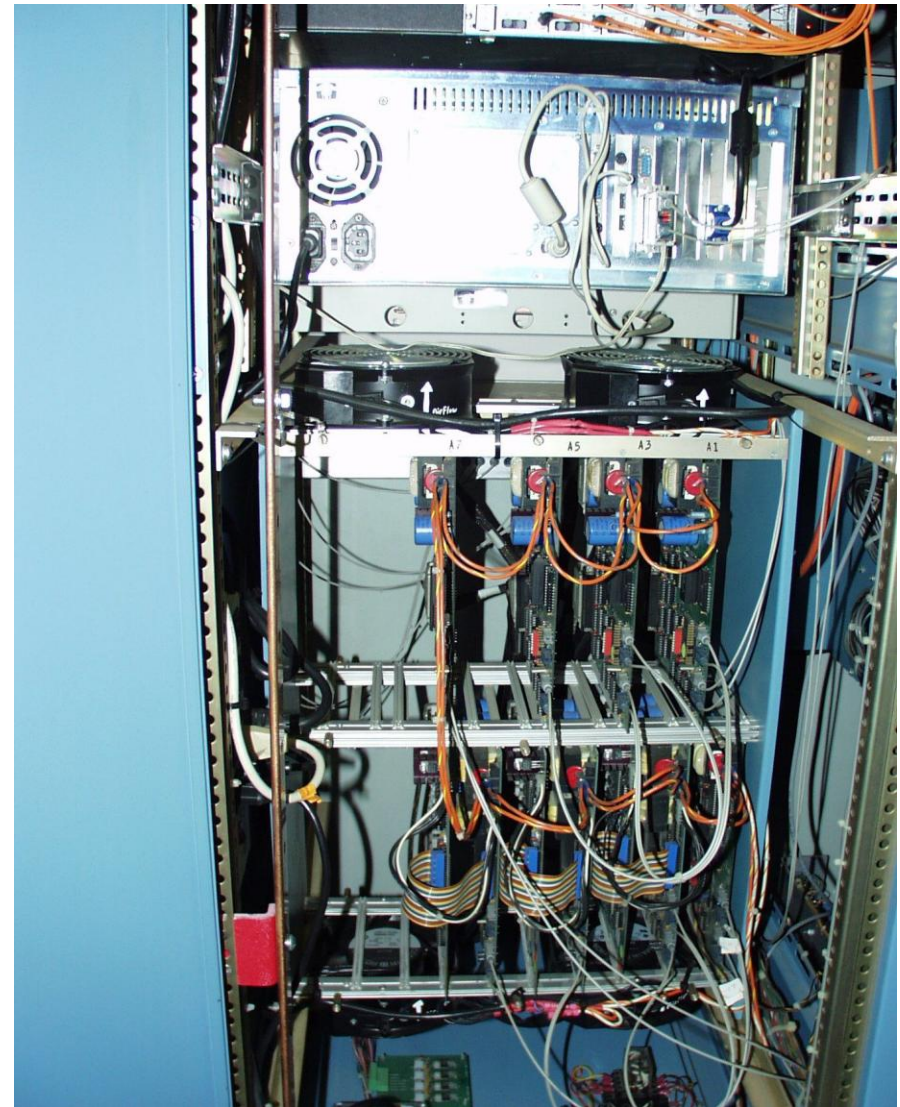
Failures in HVPS Control System

- Original control system, circa 1990:

→ *many obsolete parts*

→ *PC computer interface program written in Windows 3.1, running on Windows 95 OS!*

→ *many intermittents on board connectors*

Solution: Replace entire control system with a modern PLC.....*project currently underway*

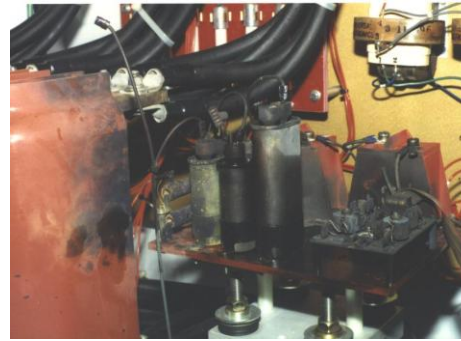
1996 EVENT

- Three catastrophic events have occurred: 1996, 2003, 2007
- Root cause in 1996 and 2007 events was traced to failure of SCR snubber capacitors

Solution: Replace original capacitors, and re-configure wiring between SCR stacks to reduce possibility of phase-to-phase shorts when components fail

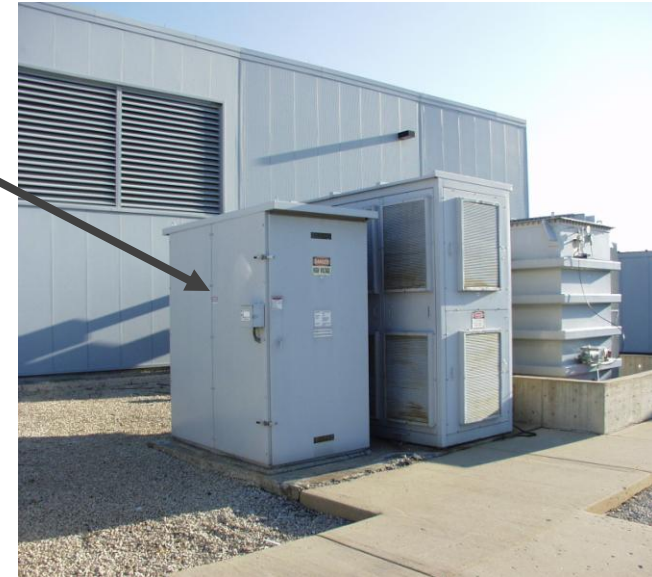
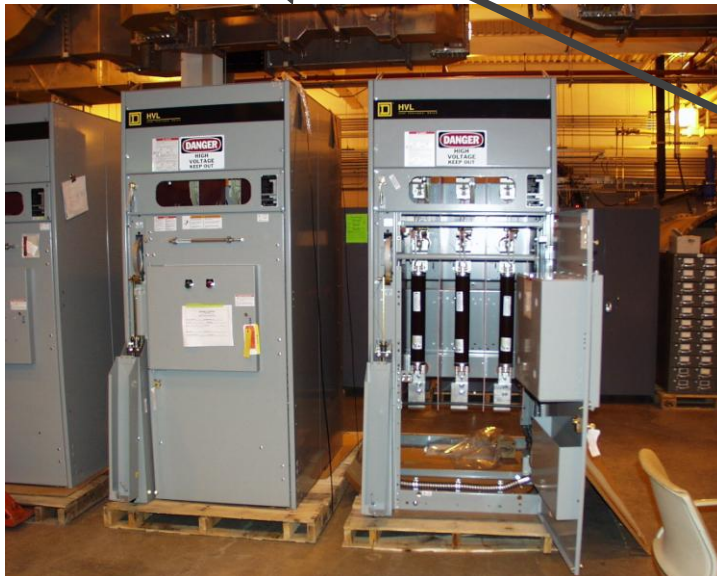
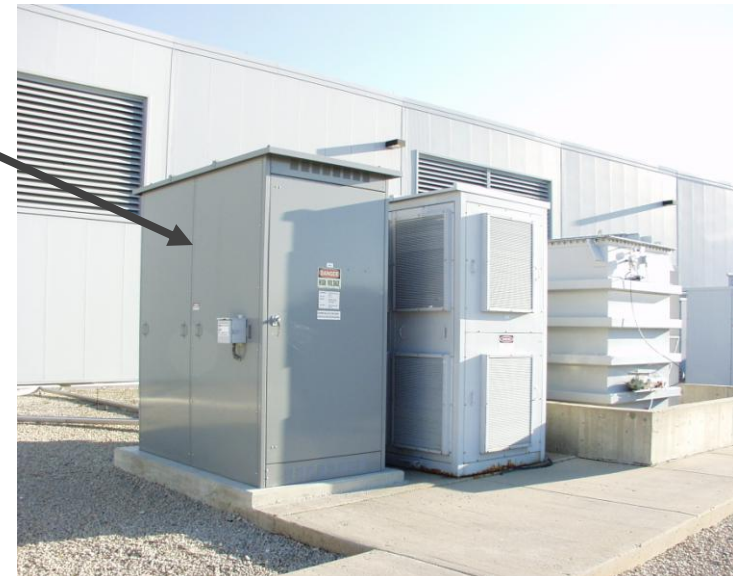
13.2kV Fused-Disconnect Switches

- Original switches *notoriously* unreliable
 - Failure rate as high as once every 10 operations!
 - Would stick in both open and closed positions!
 - Switch was obsolete at time of installation....1992!

- Replaced by new switch that is more robust and easier to maintain, with improved personnel safety features

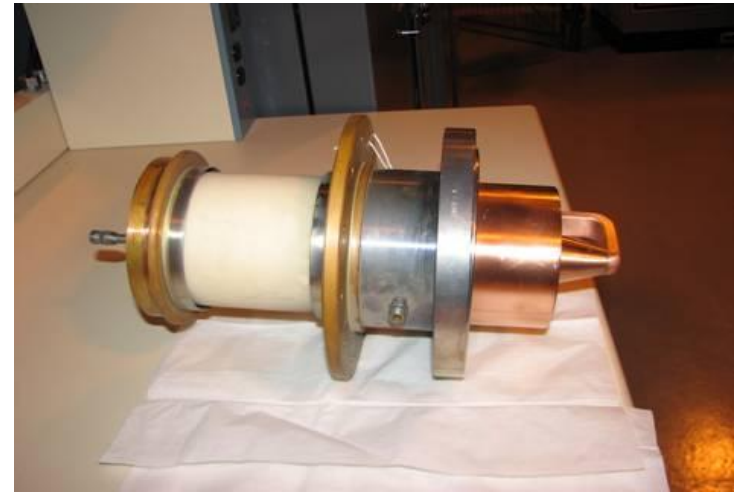
FAILED BOOSTER C1 COUPLER

- **Four coupler failures in the last two years:**
 - 3/22/08 – Booster C1 -- sudden pinhole leak in ceramic
 - 4/25/08 – S40/C2 – intermittent vacuum trips
 - 6/04/08 – S40/C2 – new coupler destroyed by overpower accident during beam studies
 - 6/17/09 – S40/C2 – sudden pinhole leak in ceramic
- **Operating data before failure and post-mortem analysis did not find a definite cause for ceramic pinhole leaks**

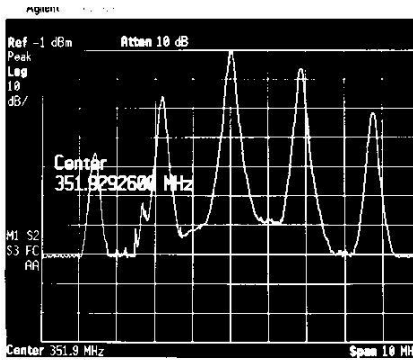
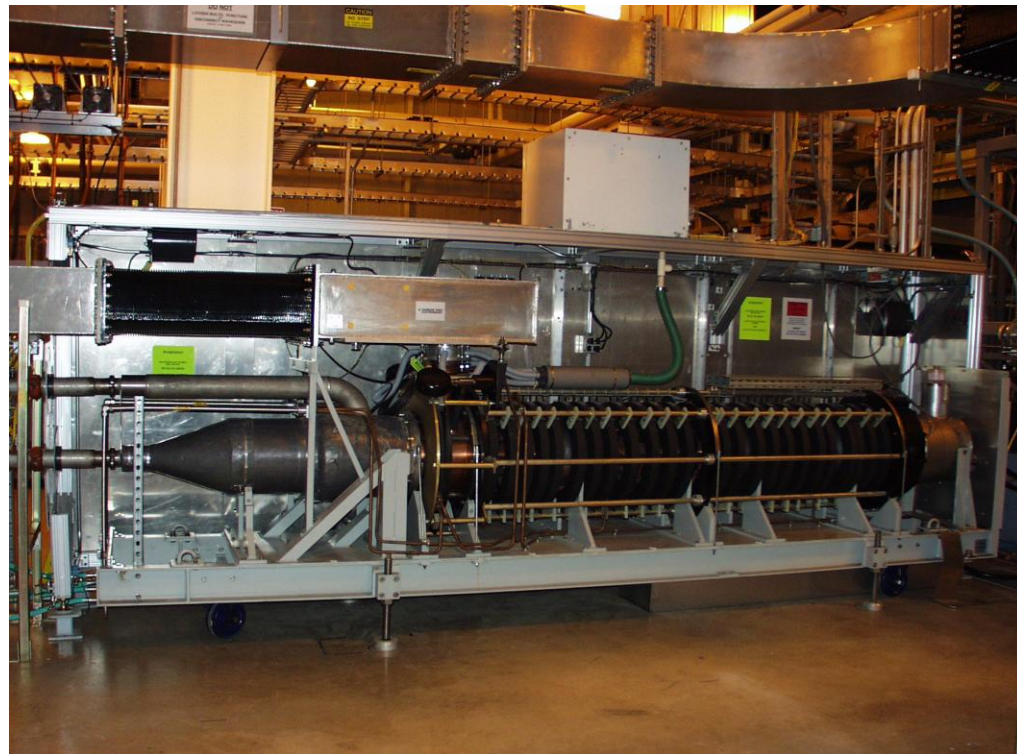
Klystron Instabilities

- The common sideband instability seen in the TH2089A results in very strong sidebands spaced $\sim 2\text{MHz}$ from the carrier:

Klystron sidebands can occur without warning and typically result in beam loss during a fill

- Typical remedies:
 - change cathode voltage by 1-3kV
 - adjust circulator bias to increase reflected power in the direction of *slightly lower efficiency*
- In most cases sidebands can be suppressed

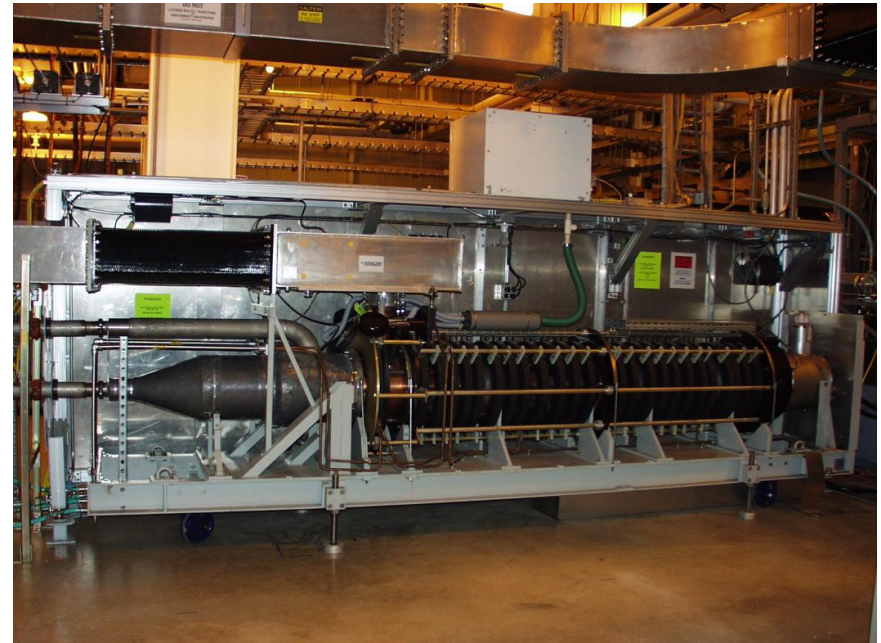
Recent Failure of a Klystron

- TH2089A, s/n 089043, failed after approximately 1,850 hours of operation
- Purchased new in 2001, sat in storage for eight years
- Was installed at RF2 in January of 2010 and ran normally in storage ring service for approximately three months
- On April 6th it suddenly developed severe sideband instability that could not be corrected by normal means
- Preliminary investigation indicates severe dc leakage across mod-anode/cathode ceramic ($\sim 2.5\text{mA}$ at 60kV)
- No crowbar or HV breakdown events were logged

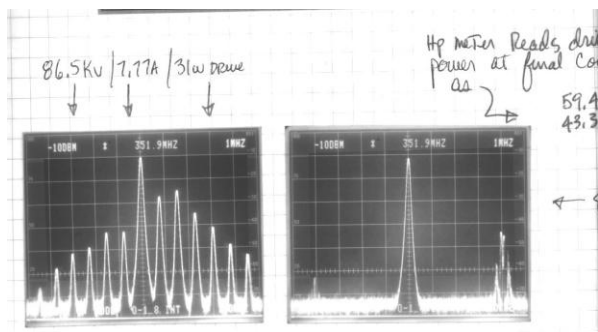
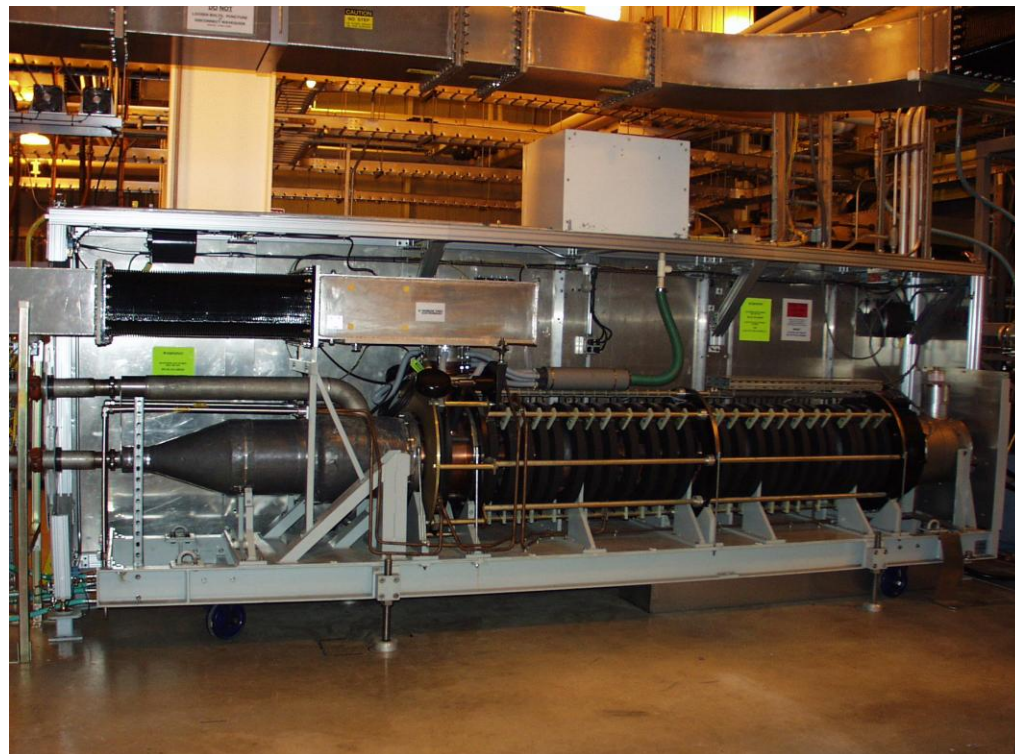
Klystron Instabilities

- Suspected multipactor losses in klystron C1 and/or C2 can result in sudden loss of efficiency and erratic rf power output, and have produced 800kHz sidebands:

C1/C2 multipactor can severely limit useful operating parameter range

- Typical remedy:
 - Adjust rf drive power to avoid multipactor region -- penalty: *loss of efficiency*
- In most cases the instability can be avoided without excessive loss of efficiency
