PSB Report: Week 24

Major Event in PSB 12/06

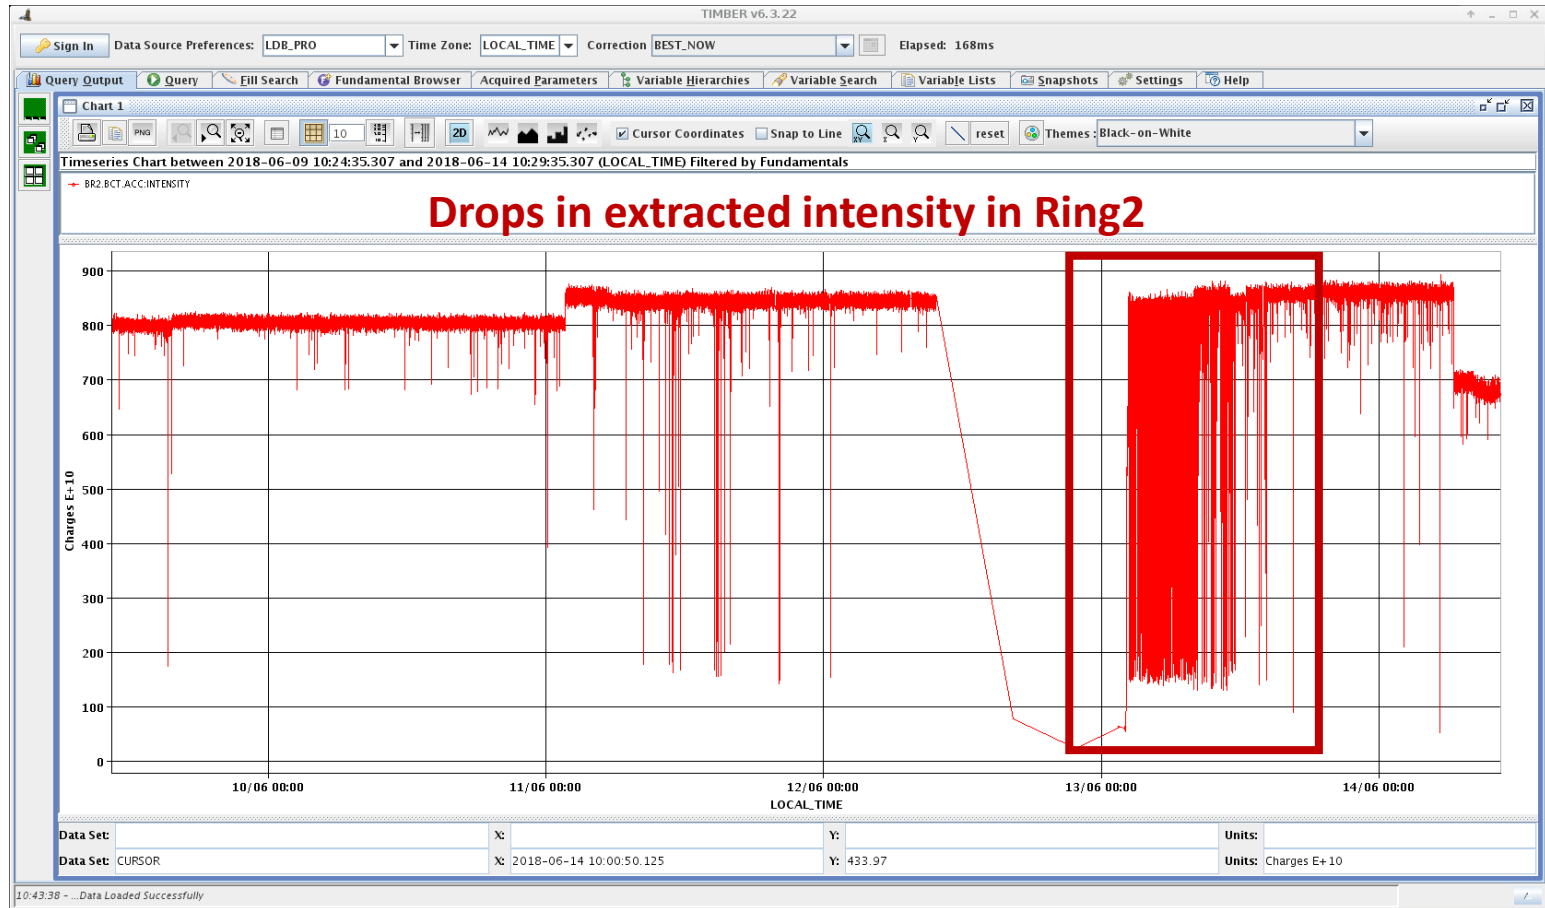
PSB Operation: Issue with TOF (and high intensity beams)

- When the beam was back we noticed issues with TOF beam. Identified issue with one of the TFB **power amplifier broken**. Not due to the issue with the AUG as TIMBER showed occasional losses as well in previous days.
- Situation somehow improving over time (not clear why), nevertheless we **moved the production of TOF from R2 to R3 until ITS1, when the amplifier will be replaced.**
