Summary / Questions

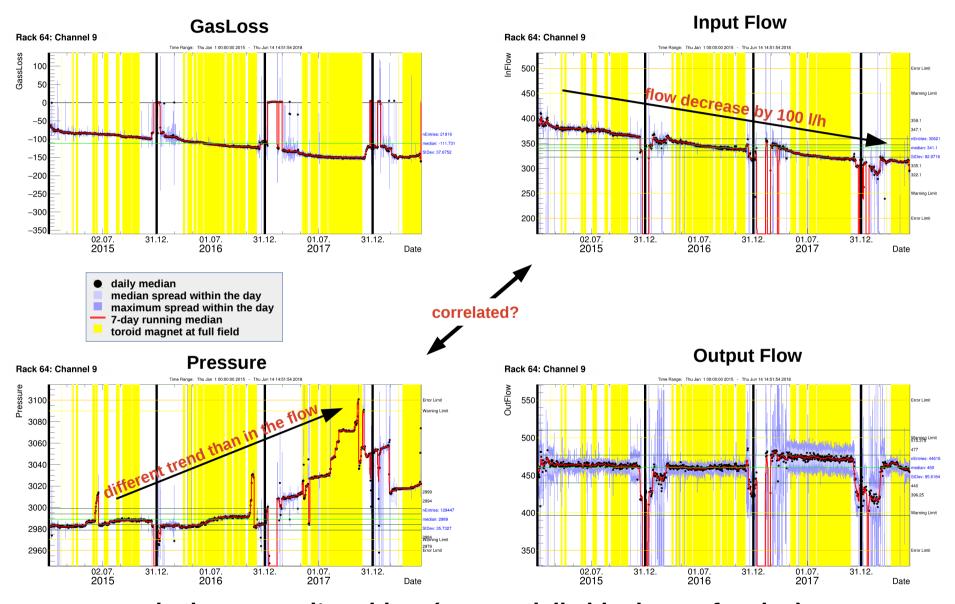
- is there a ,real' problem (e.g. partially blockage of a pipe)
- is this a sensor problem?

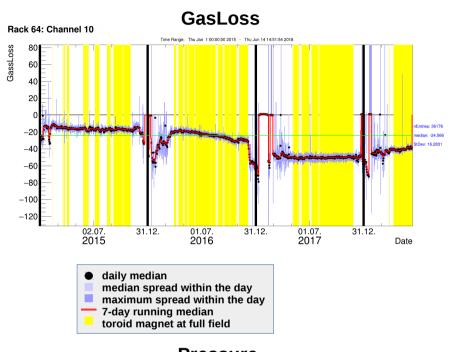
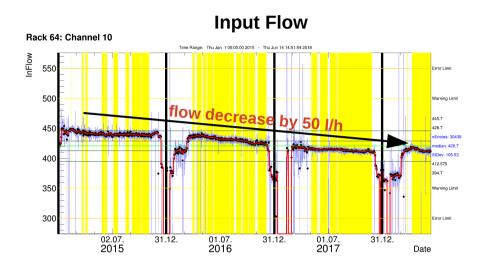
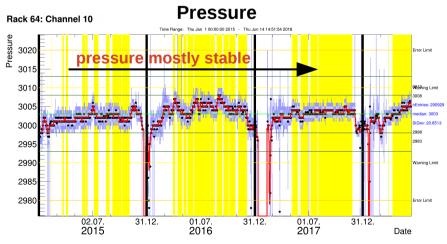
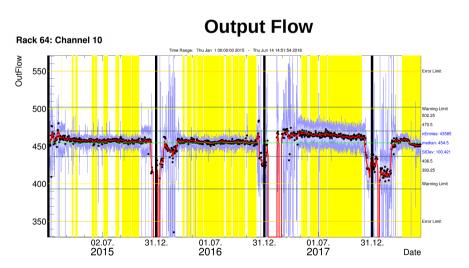
- similar decrease in input flow as in channel 9
- no change of pressure as in channel 9

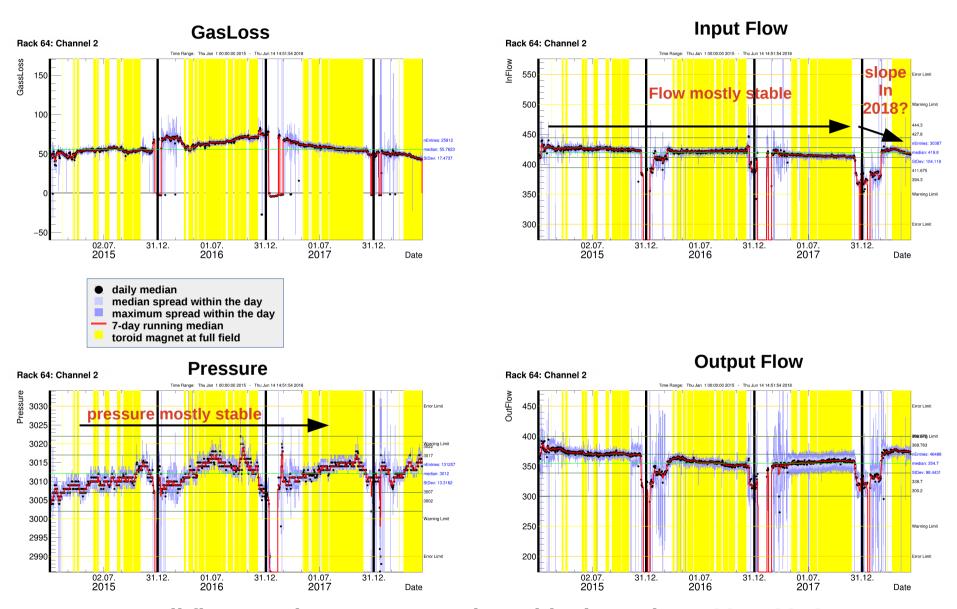
- all flows and pressure mostly stable throughout 2015-2018

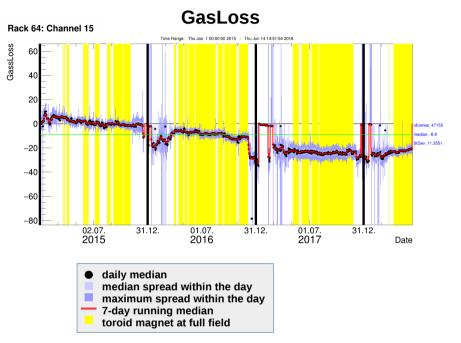
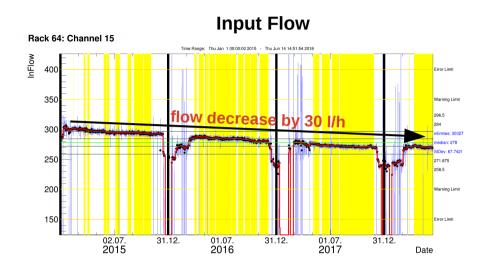
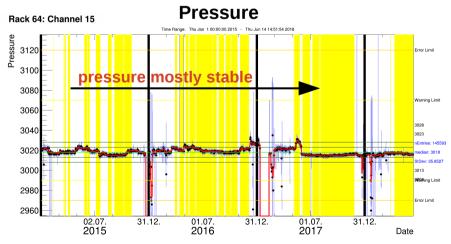
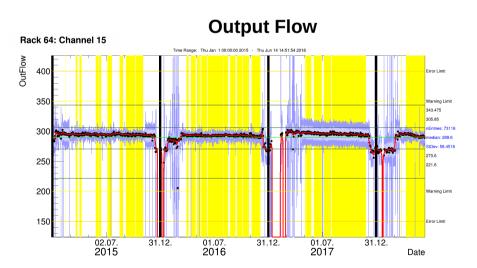
- similar decrease in input flow as in channel 9 (not as steep though)
- no change of pressure as in channel 9

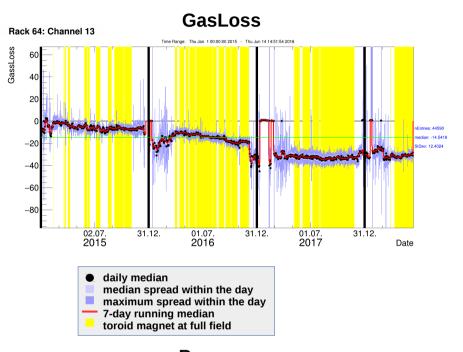
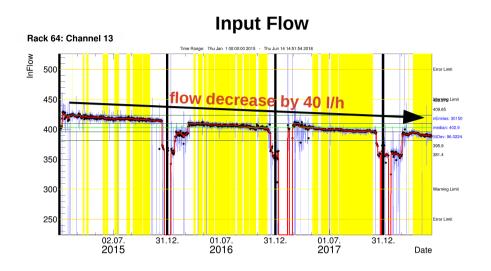
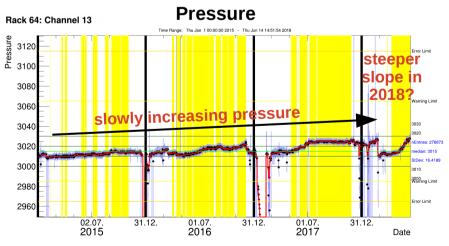
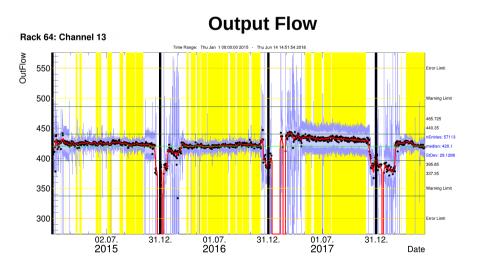
- similar decrease in input flow as in channel 9
- slow increase of pressure by 15 mbar
