Link Monitor Error Analysis Update

Alexander Schmah
University of
Heidelberg
16.07.2018

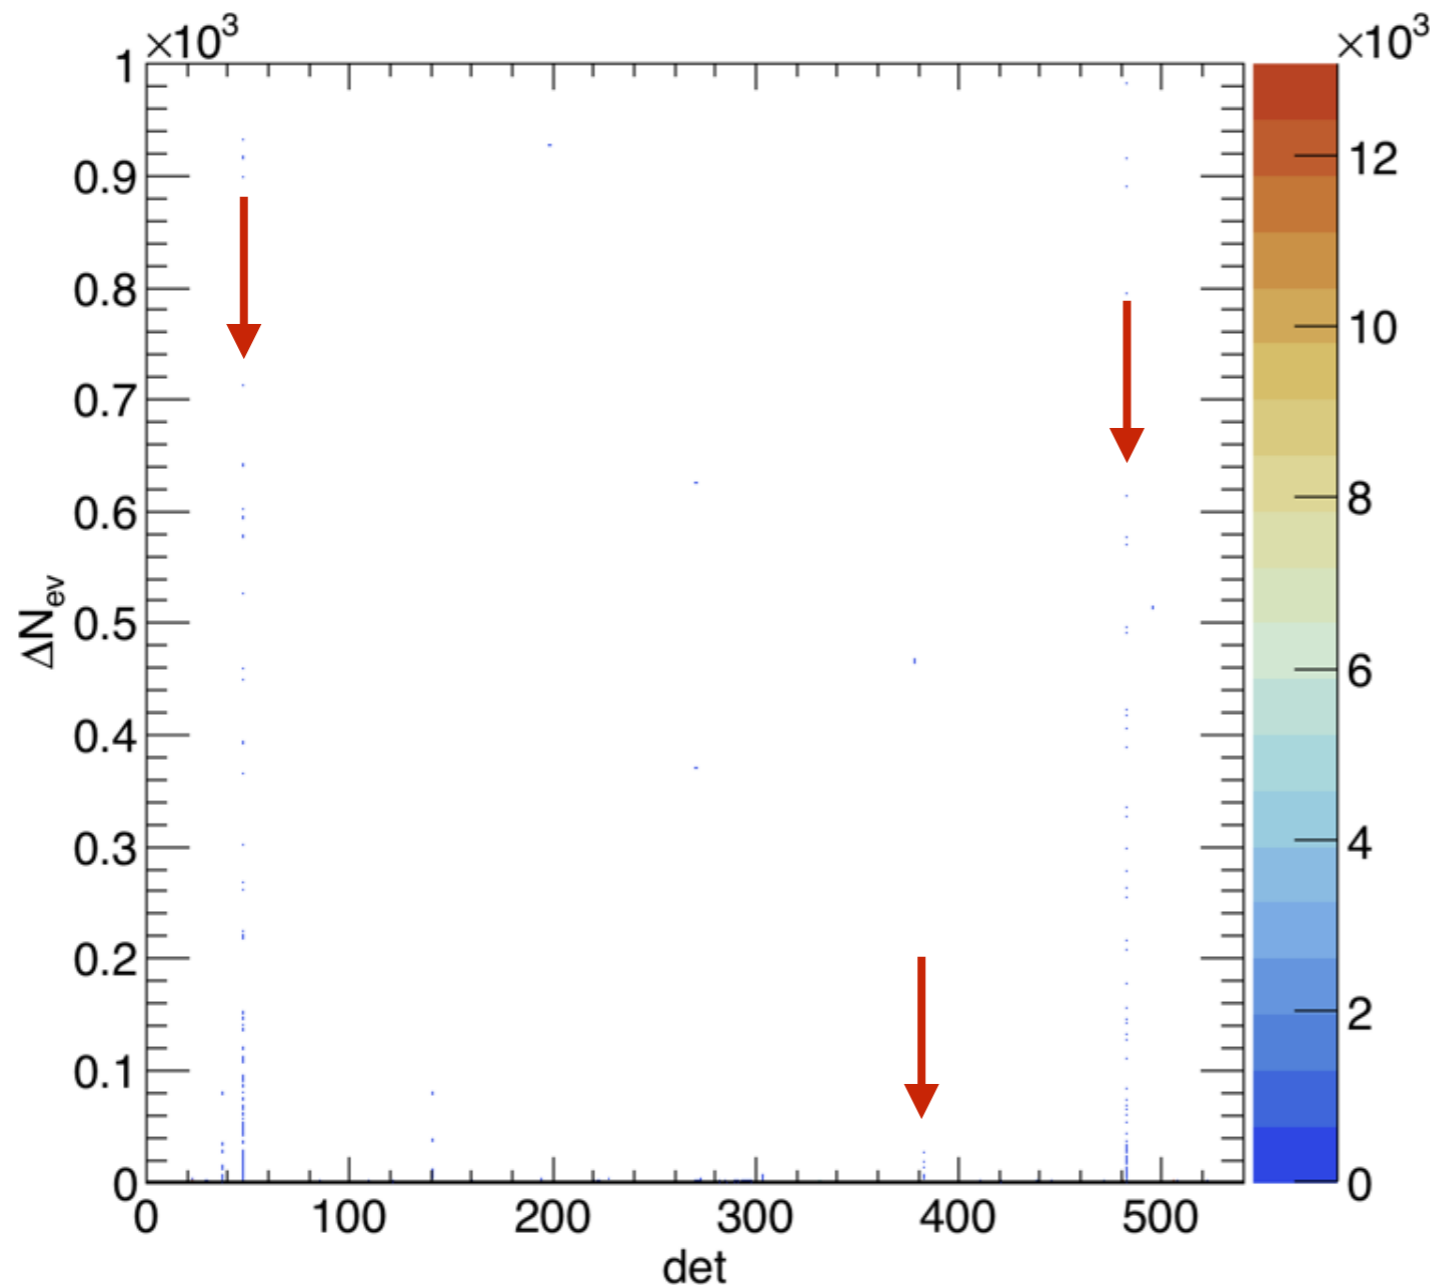
Event when Error Occurred

- Whenever the standard gsm state: 3 has changed between SOR and EOR the difference in event counter is calculated.
- Some detectors show a clear pattern: most errors occur within the first 1000 events.
- Other detectors don't show any pattern (so far).
- See zoom in on the next slides.

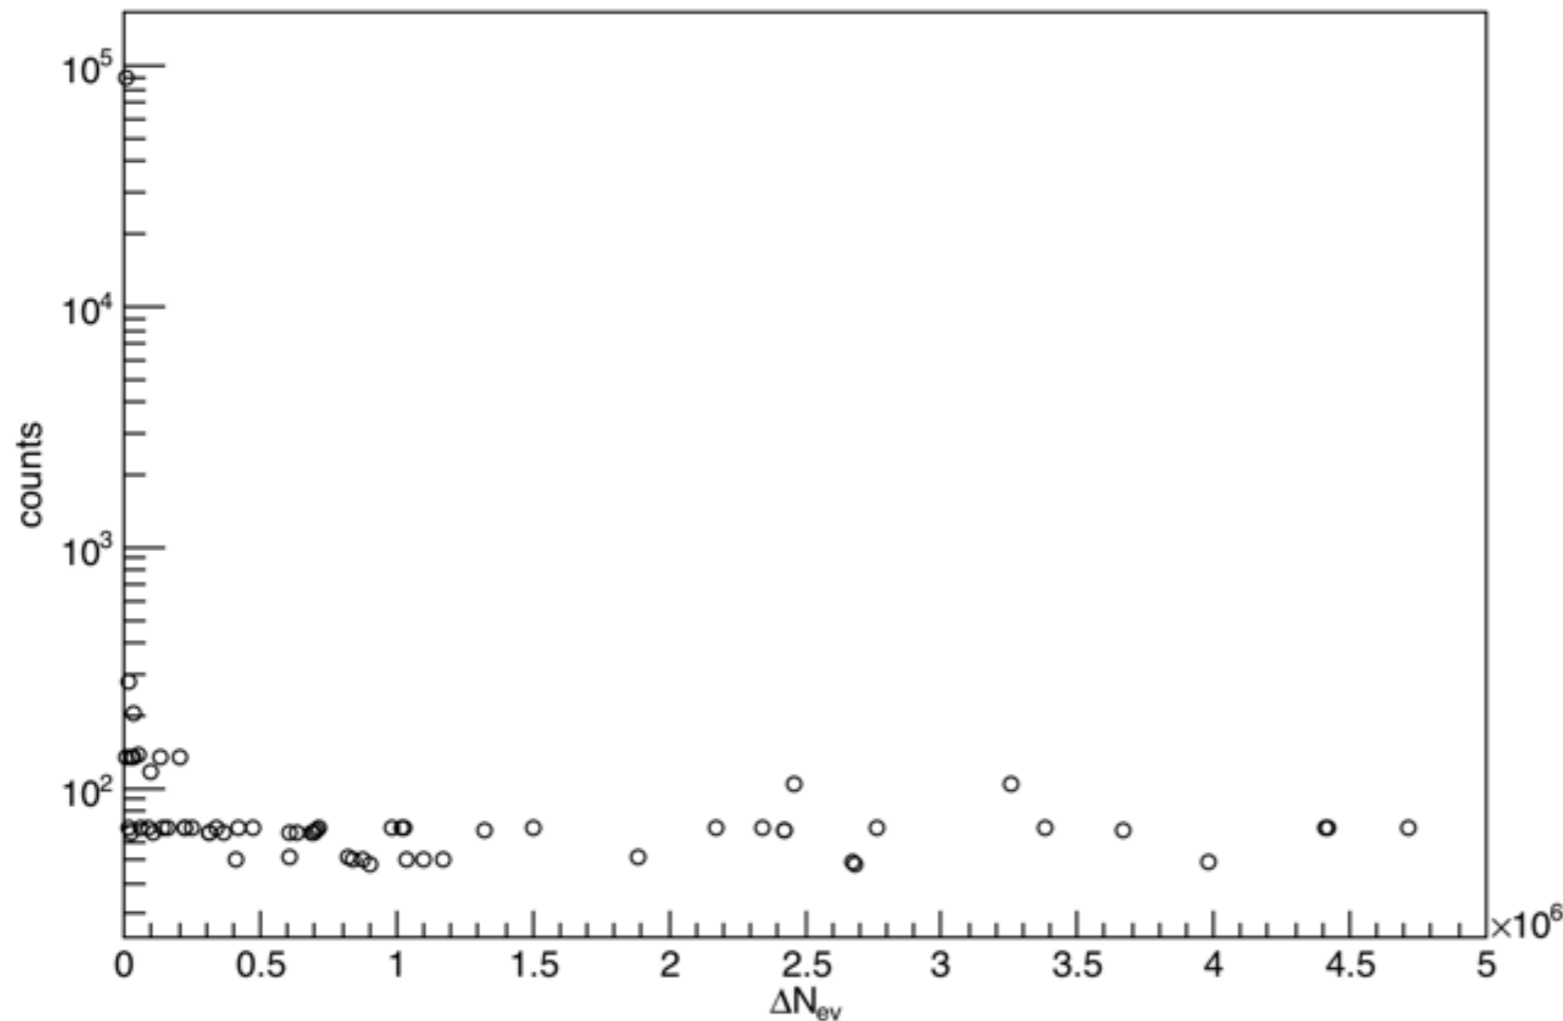
Event when Error Occurred

- Projection for all detectors and larger range (5M).
- Many errors occur during early times, but a few also much later in the run.
→ A MCM has a problem, it will usually show up early.

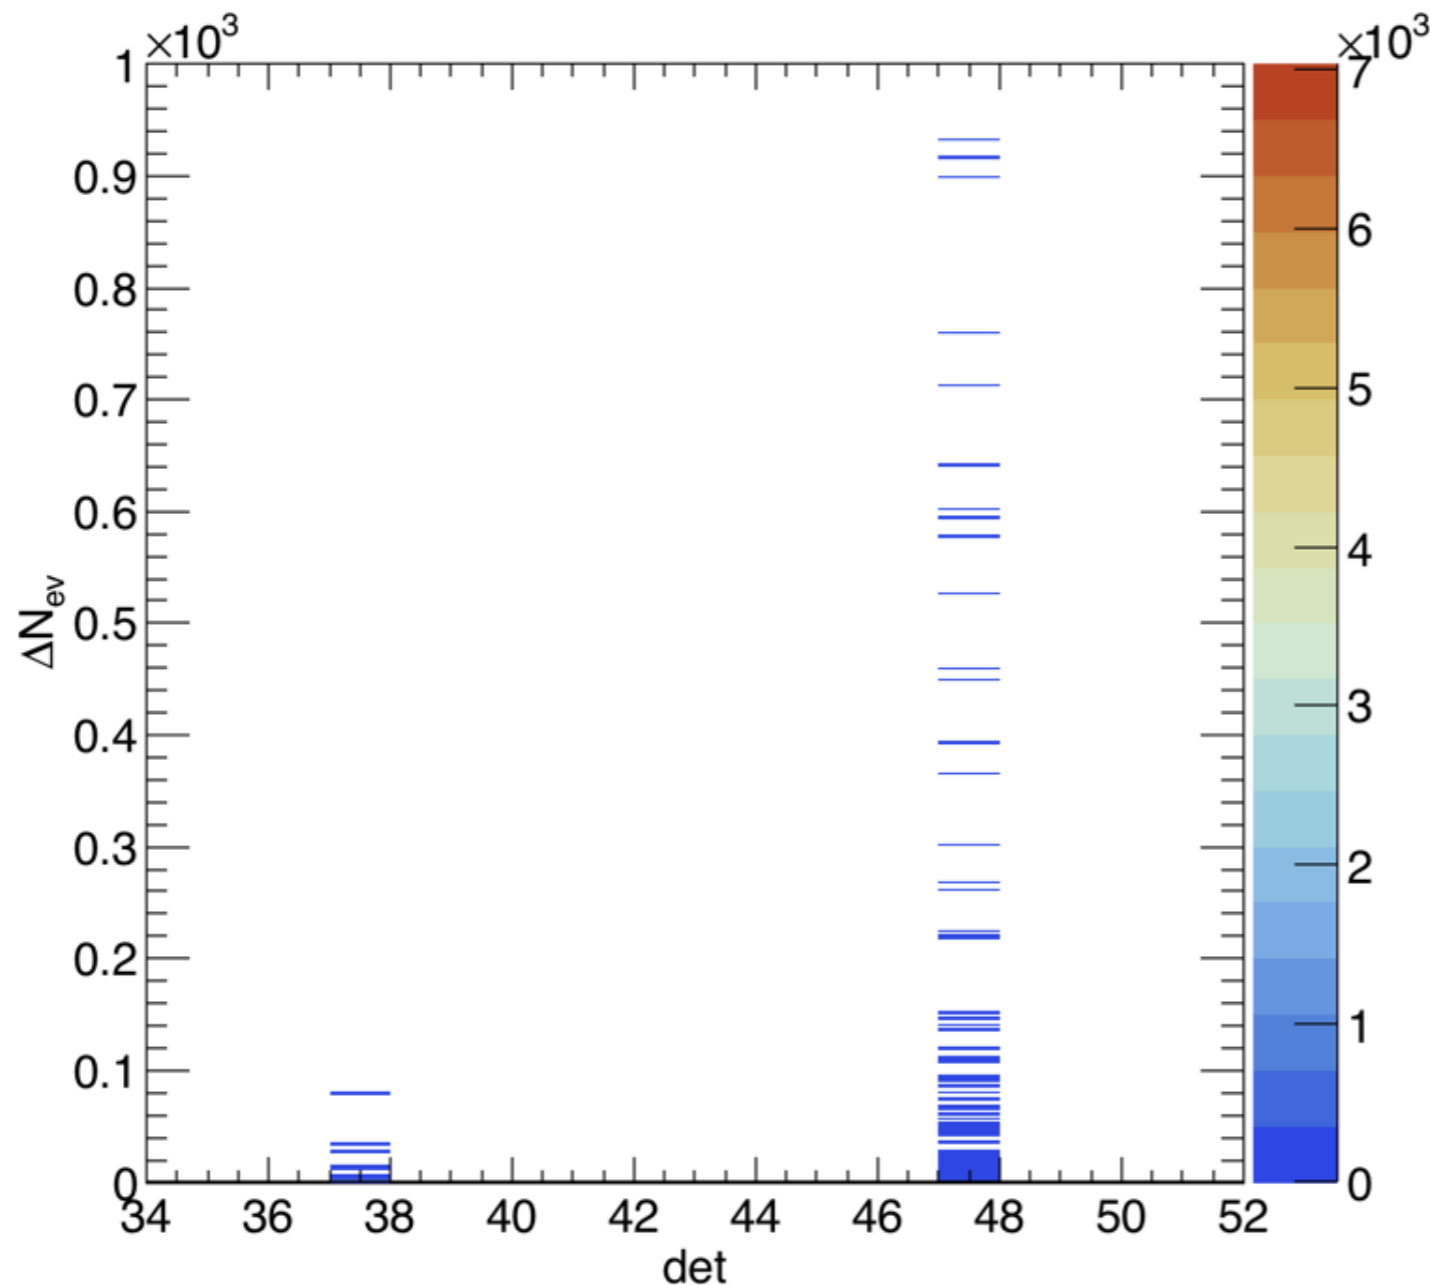
Event when Error Occurred: det. 47

- Whenever the standard gsm state: 3 has changed between SOR and EOR the difference in event counter is calculated.
- Some detectors show a clear pattern: most errors occur within the first 1000 events.
- Other detectors don't show any pattern (so far).

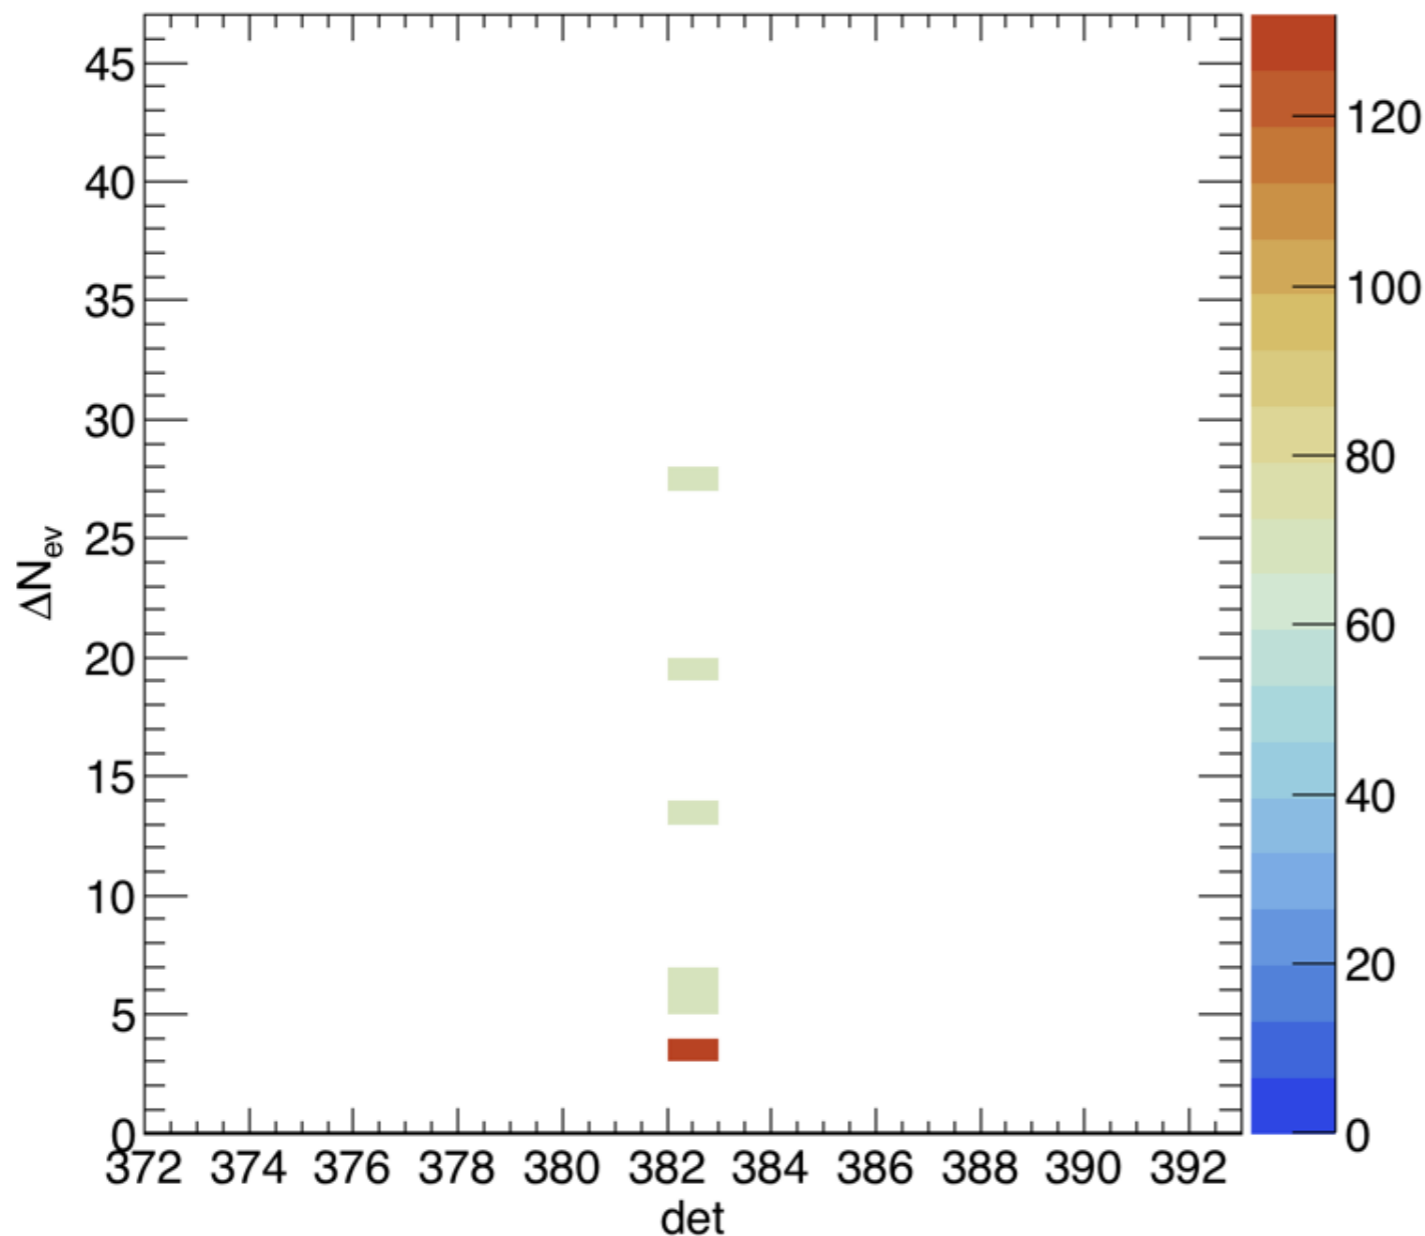
Event when Error Occurred: det. 382

- Whenever the standard gsm state: 3 has changed between SOR and EOR the difference in event counter is calculated.
- Some detectors show a clear pattern: most errors occur within the first 1000 events.
- Other detectors don't show any pattern (so far).

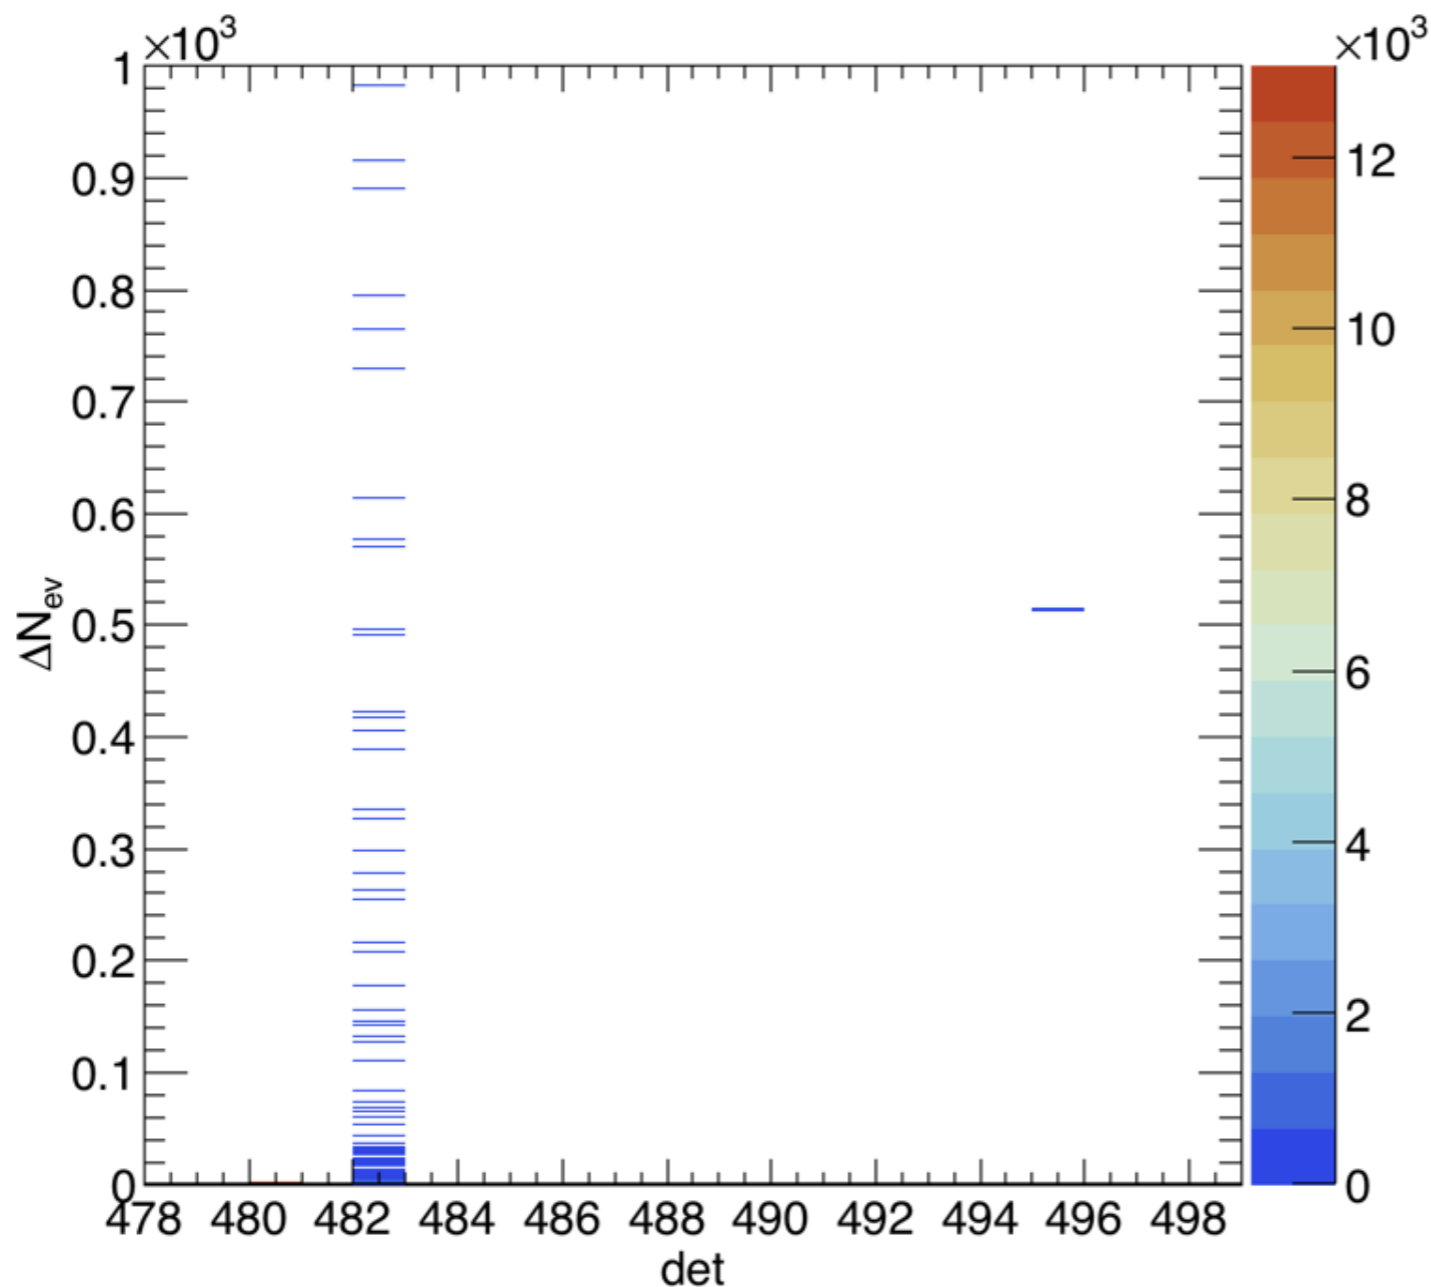
Event when Error Occurred: det. 482

- Whenever the standard gsm state: 3 has changed between SOR and EOR the difference in event counter is calculated.
- Some detectors show a clear pattern: most errors occur within the first 1000 events.
- Other detectors don't show any pattern (so far).

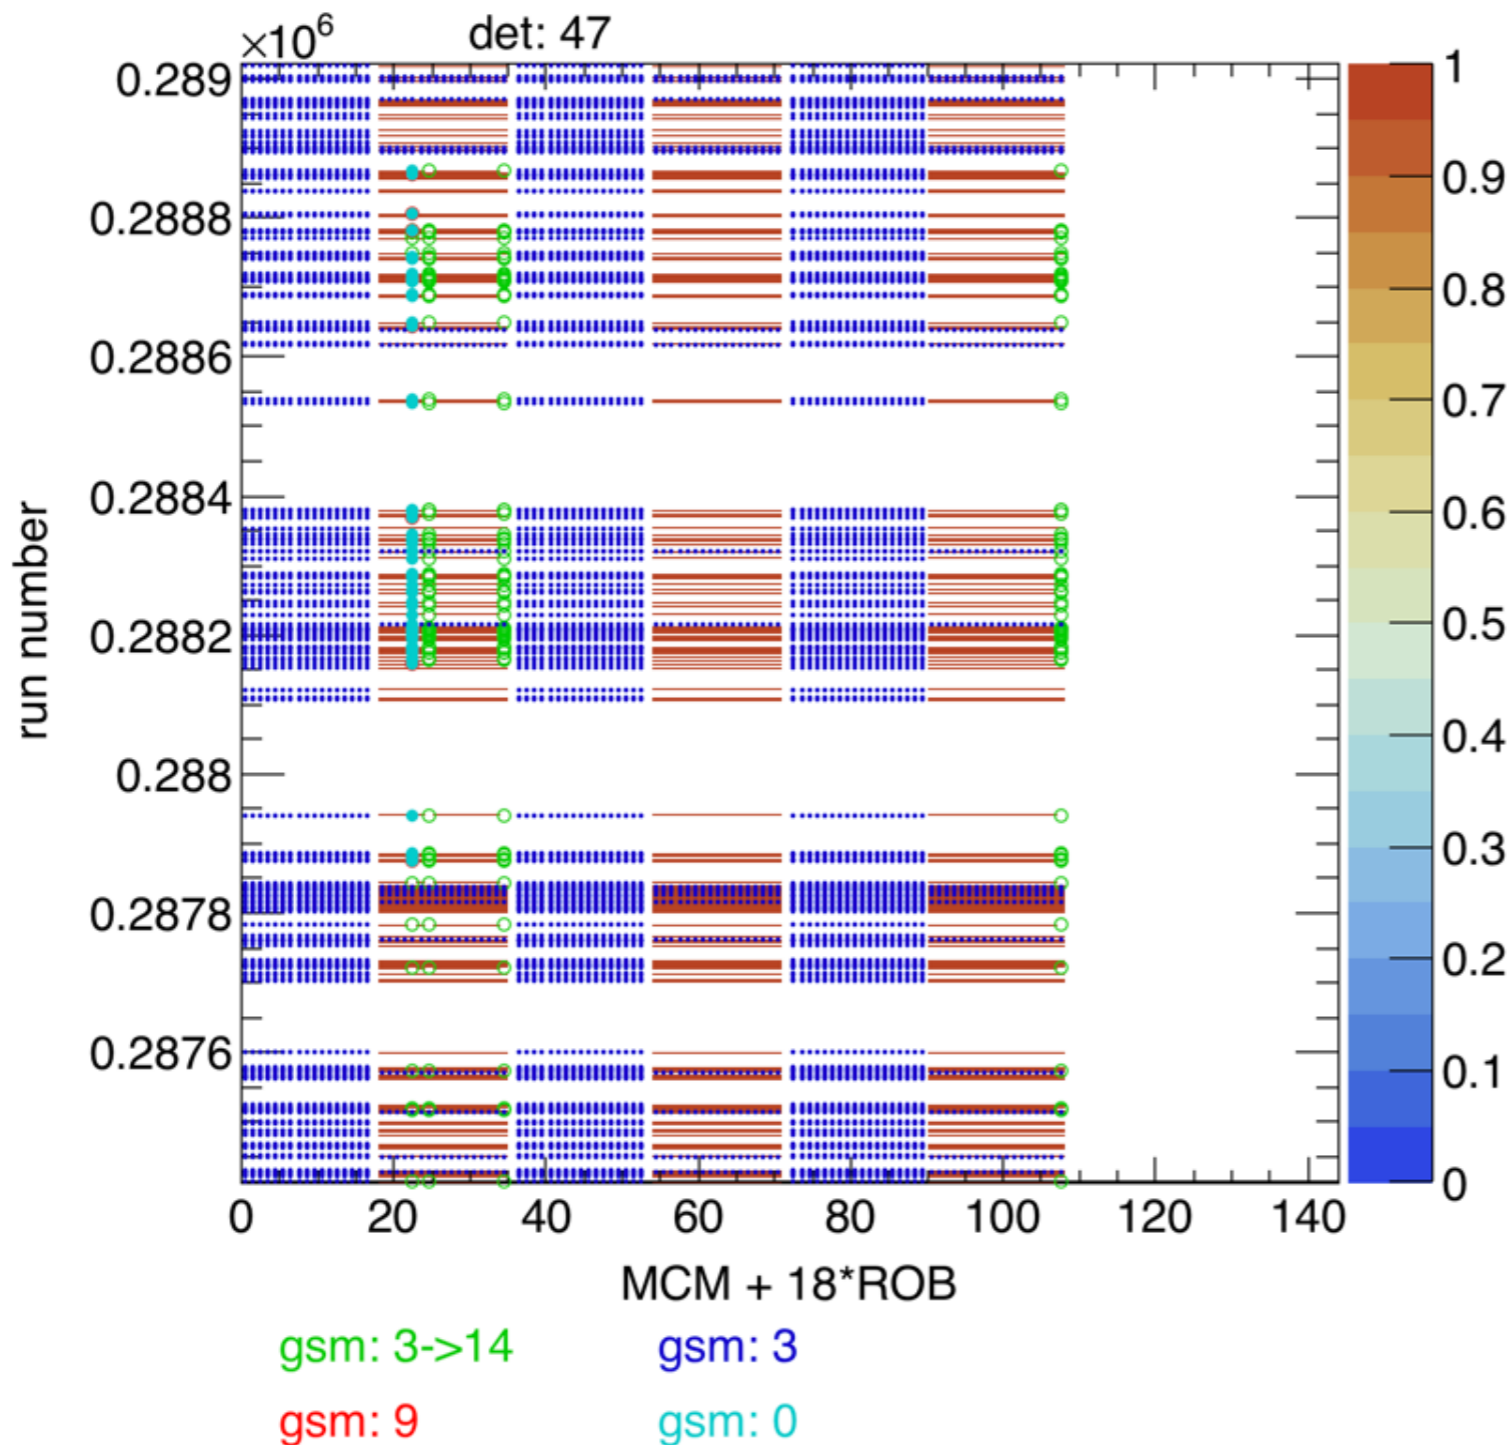
GSM States: TRD det. 47

- Most of the time this (half) chamber has a problem. It is a single MCM, gsm state switch from 3 to 14 (**tracklet send**).
- The whole half chamber switches to mode 9 (**full readout**).
- Board merger and half chamber merger also switch to gsm state 14.

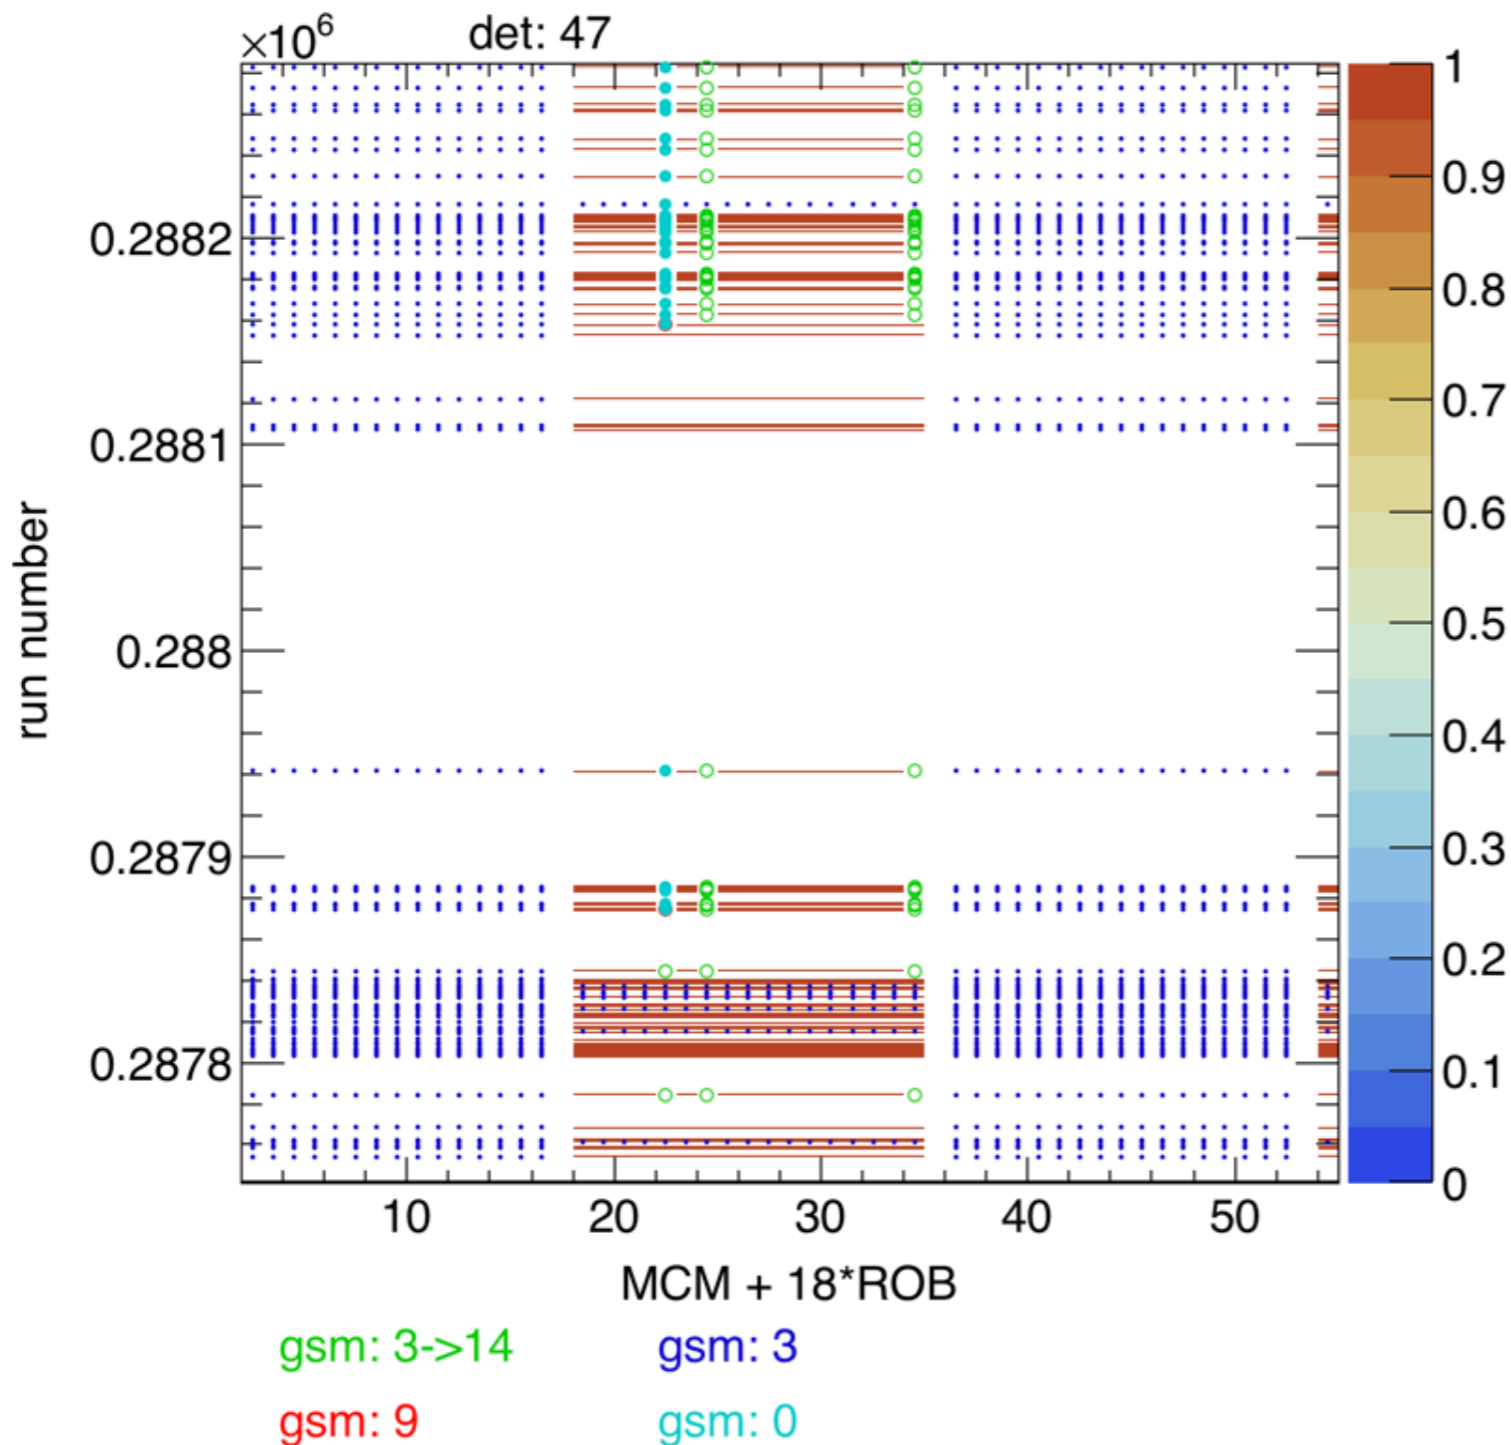
GSM States: TRD det. 47

- Most of the time this (half) chamber has a problem. It is a single MCM, gsm state switch from 3 to 14 (**tracklet send**).
- The whole half chamber switches to mode 9 (**full readout**).
- Board merger and half chamber merger also switch to gsm state 14.
- At some run id the MCM which is causing the problem switches to gsm state 0 (**low power**).
- This does NOT cure the problem.

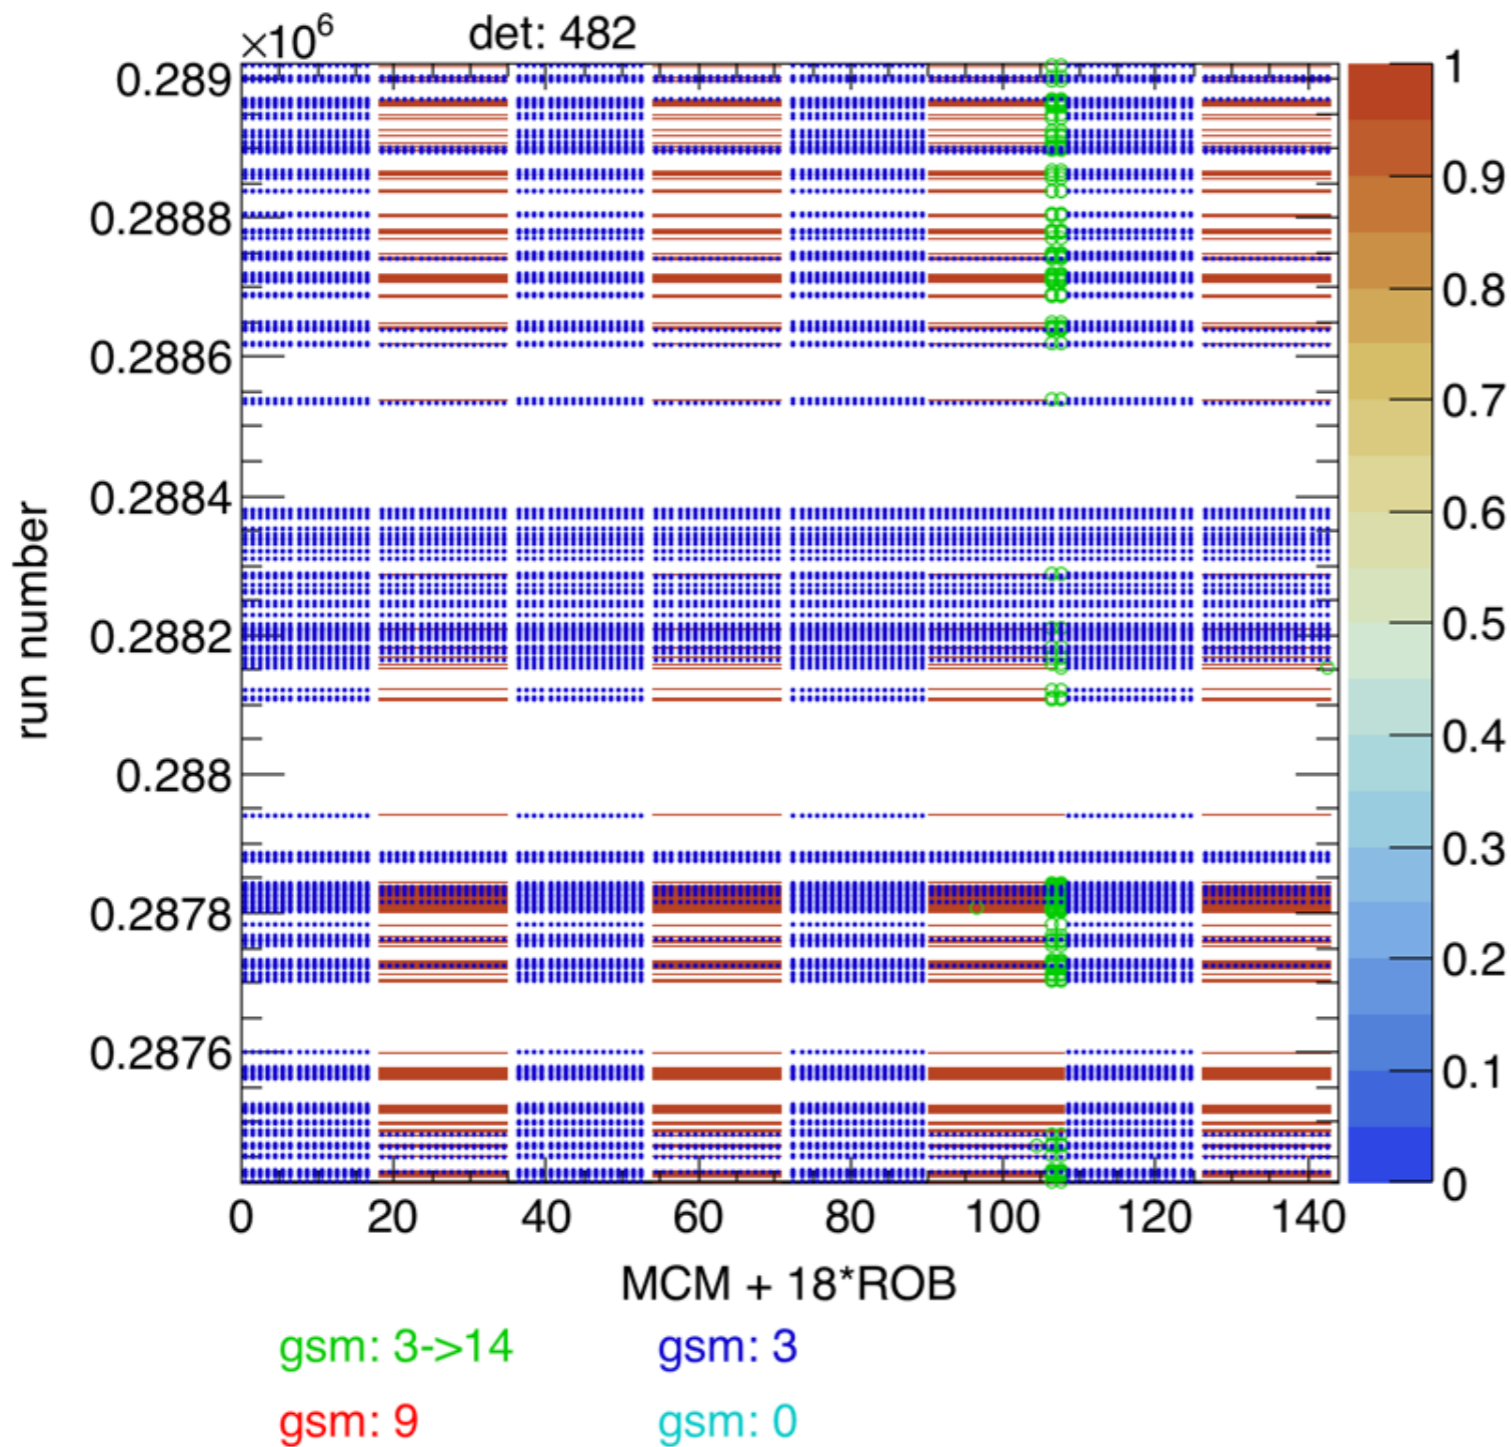
GSM States: TRD det. 482

- For this detector the states are at least sometime good (3).
- Again one MCM is causing the problem, mode 14 but it does not change to gsm state 0.

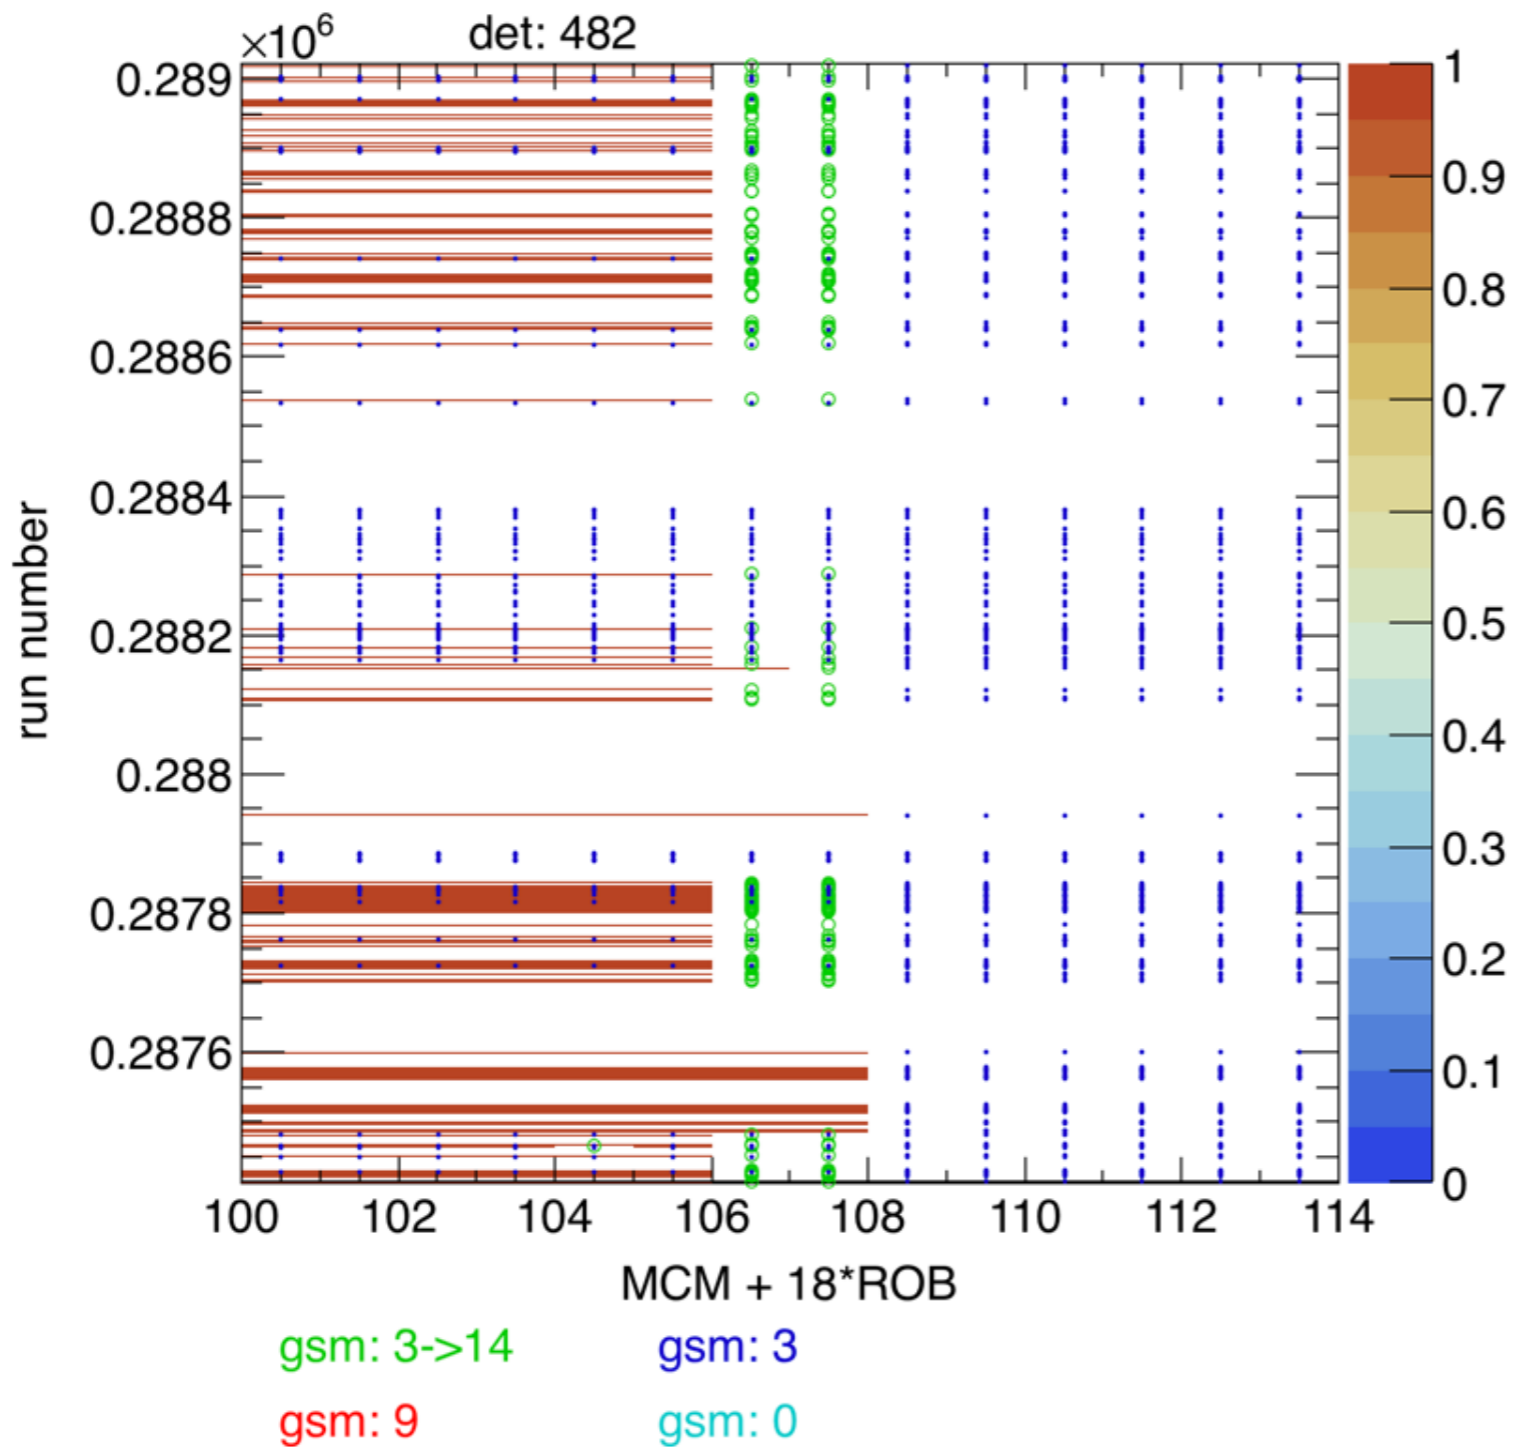
GSM States: TRD det. 482

- For this detector the states are at least sometimes good (3).
- Again one MCM is causing the problem, mode 14 but it does not change to gsm state 0.

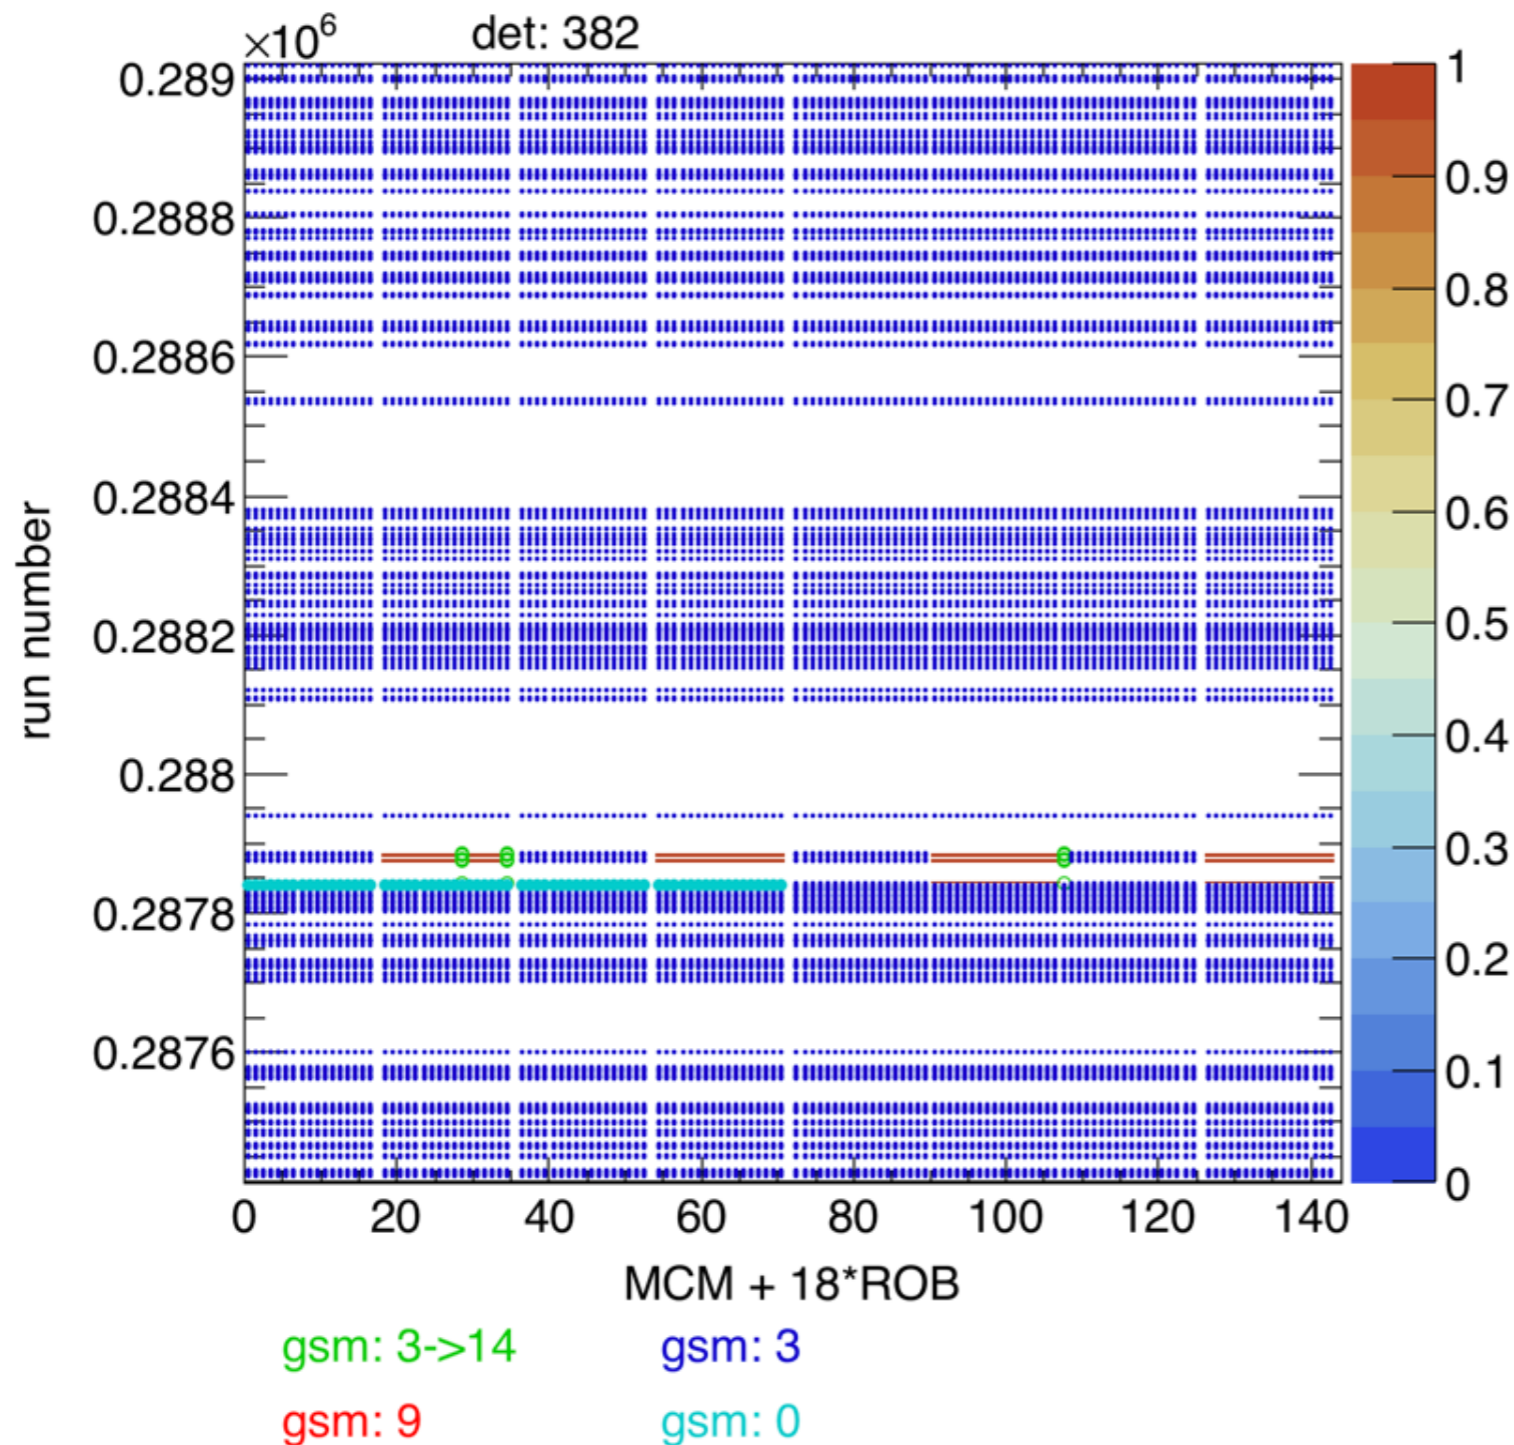
GSM States: TRD det. 382

- This detector shows a really weird error. The event and trigger counters are all fine, then they are both off by exactly one bit (bit 17, not shown here). At this time they are still in mode 3 (wait pre trigger).
- At some point the first 4 ROB switch to gsm state 0 (**low power**), then one MCM within those 4 ROB is causing a problem, gsm state 14 (**tracklet send**), the half chamber then switches to gsm state 9 (**full readout**).
- Later the two counter are again in perfect agreement with ALL other MCMs.
- The 4 ROB are from different half chambers. It is not at all easy to understand how this could happen. Sebastian and I discussed it with Venelin. There might be some possibilities but its not conclusive yet.

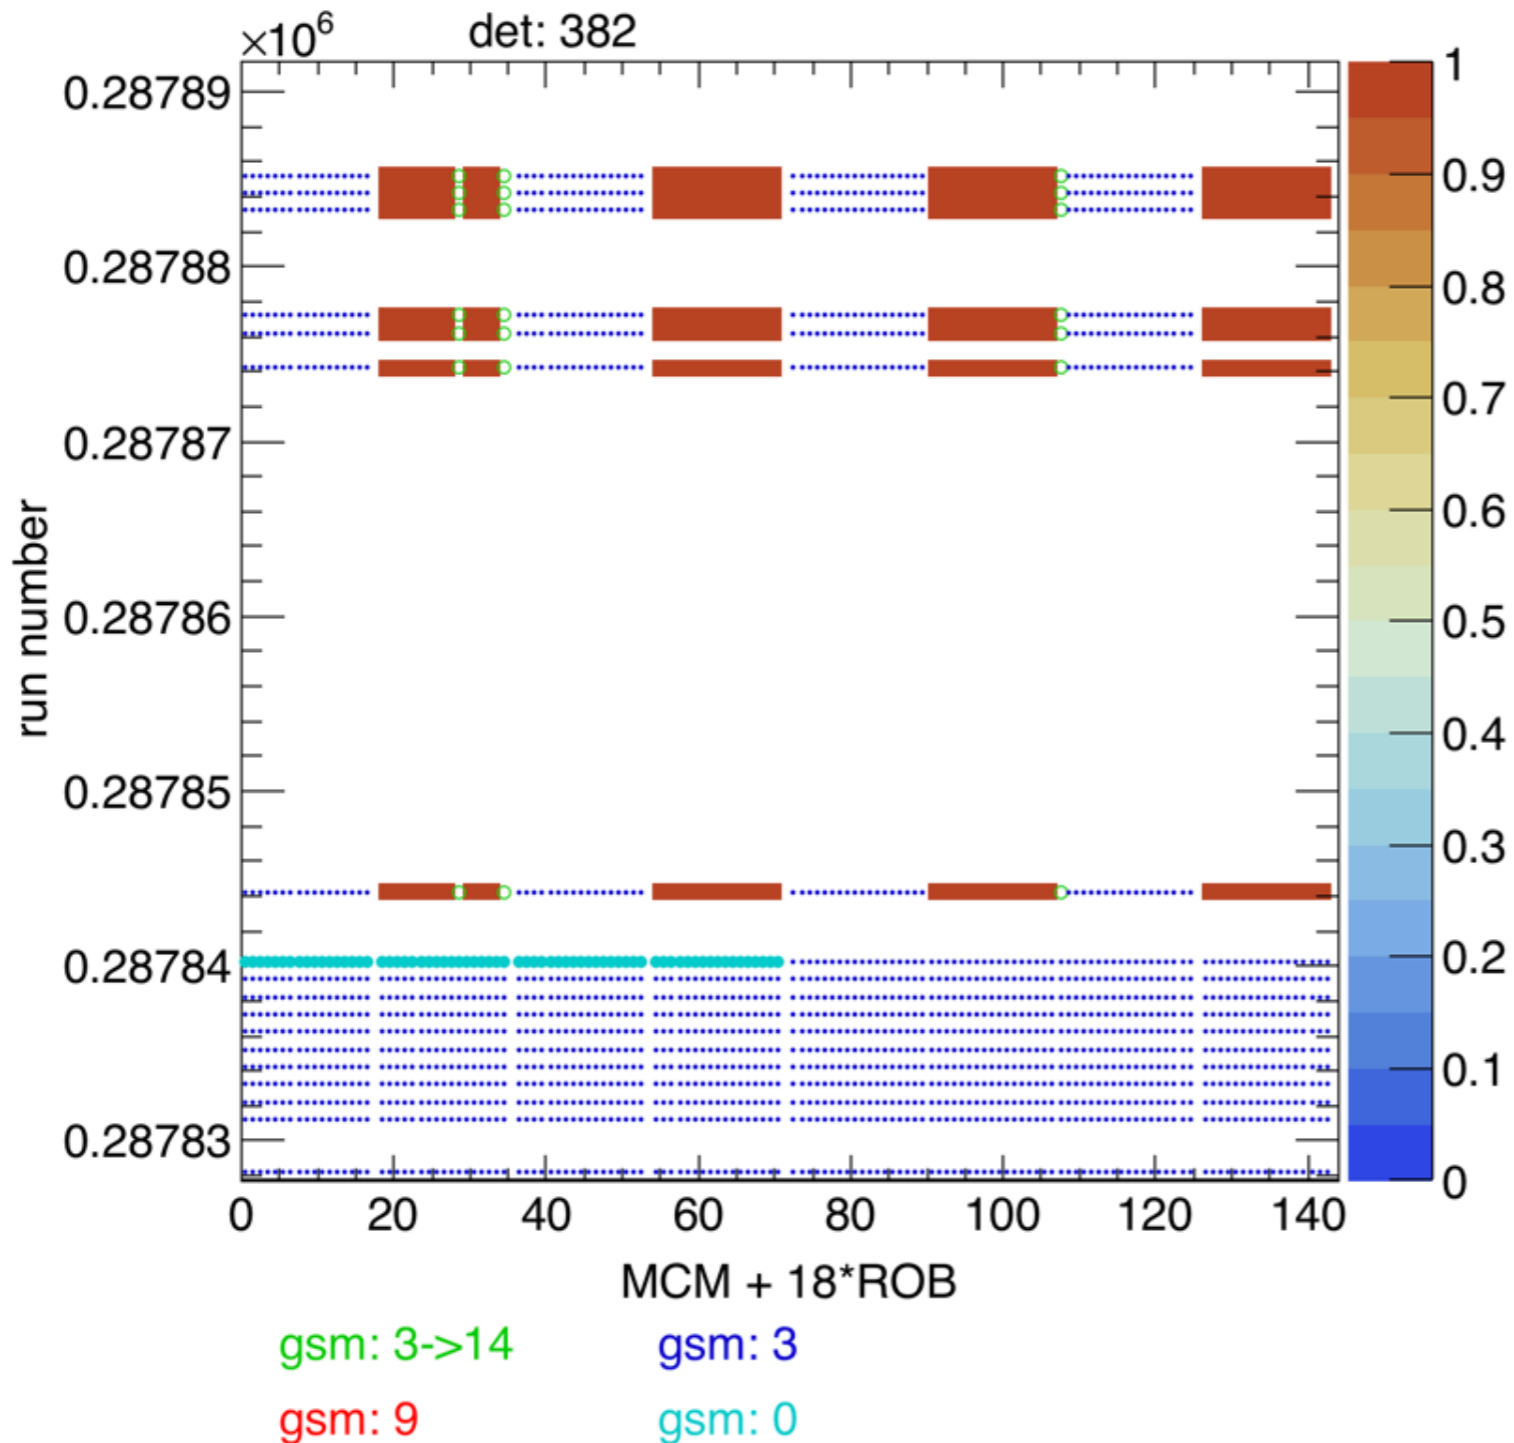
GSM States: TRD det. 382

- This detector shows a really weird error. The event and trigger counters are all fine, then they are both off by exactly one bit (bit 17, not shown here). At this time they are still in mode 3 (wait pre trigger).
- At some point the first 4 ROB switch to gsm state 0 (**low power**), then one MCM within those 4 ROB is causing a problem, gsm state 14 (**tracklet send**), the half chamber then switches to gsm state 9 (**full readout**).
- Later the two counter are again in perfect agreement with ALL other MCMs.
- The 4 ROB are from different half chambers. It is not at all easy to understand how this could happen. Sebastian and I discussed it with Venelin. There might be some possibilities but its not conclusive yet.
