Link Monitor Error Analysis Update

Alexander Schmah
University of
Heidelberg
16.07.2018

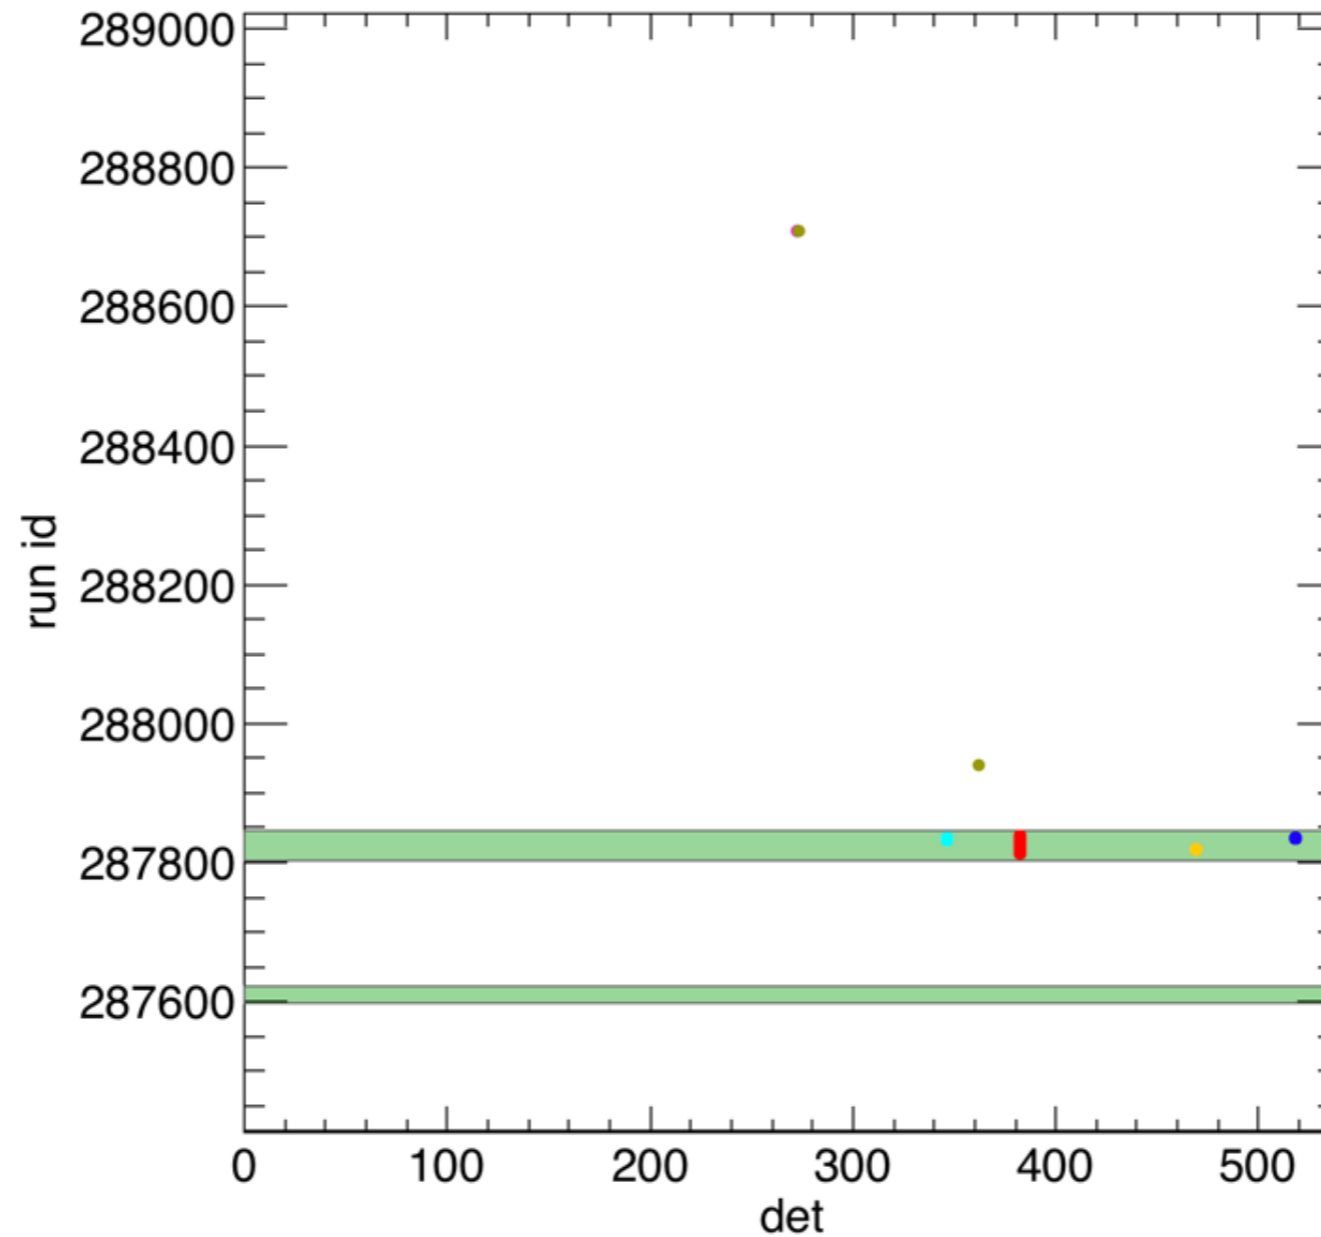
Bit Flips: Run Id vs Detector

- Different color means different bit flipped, bits 0, 1, and 32 are excluded.

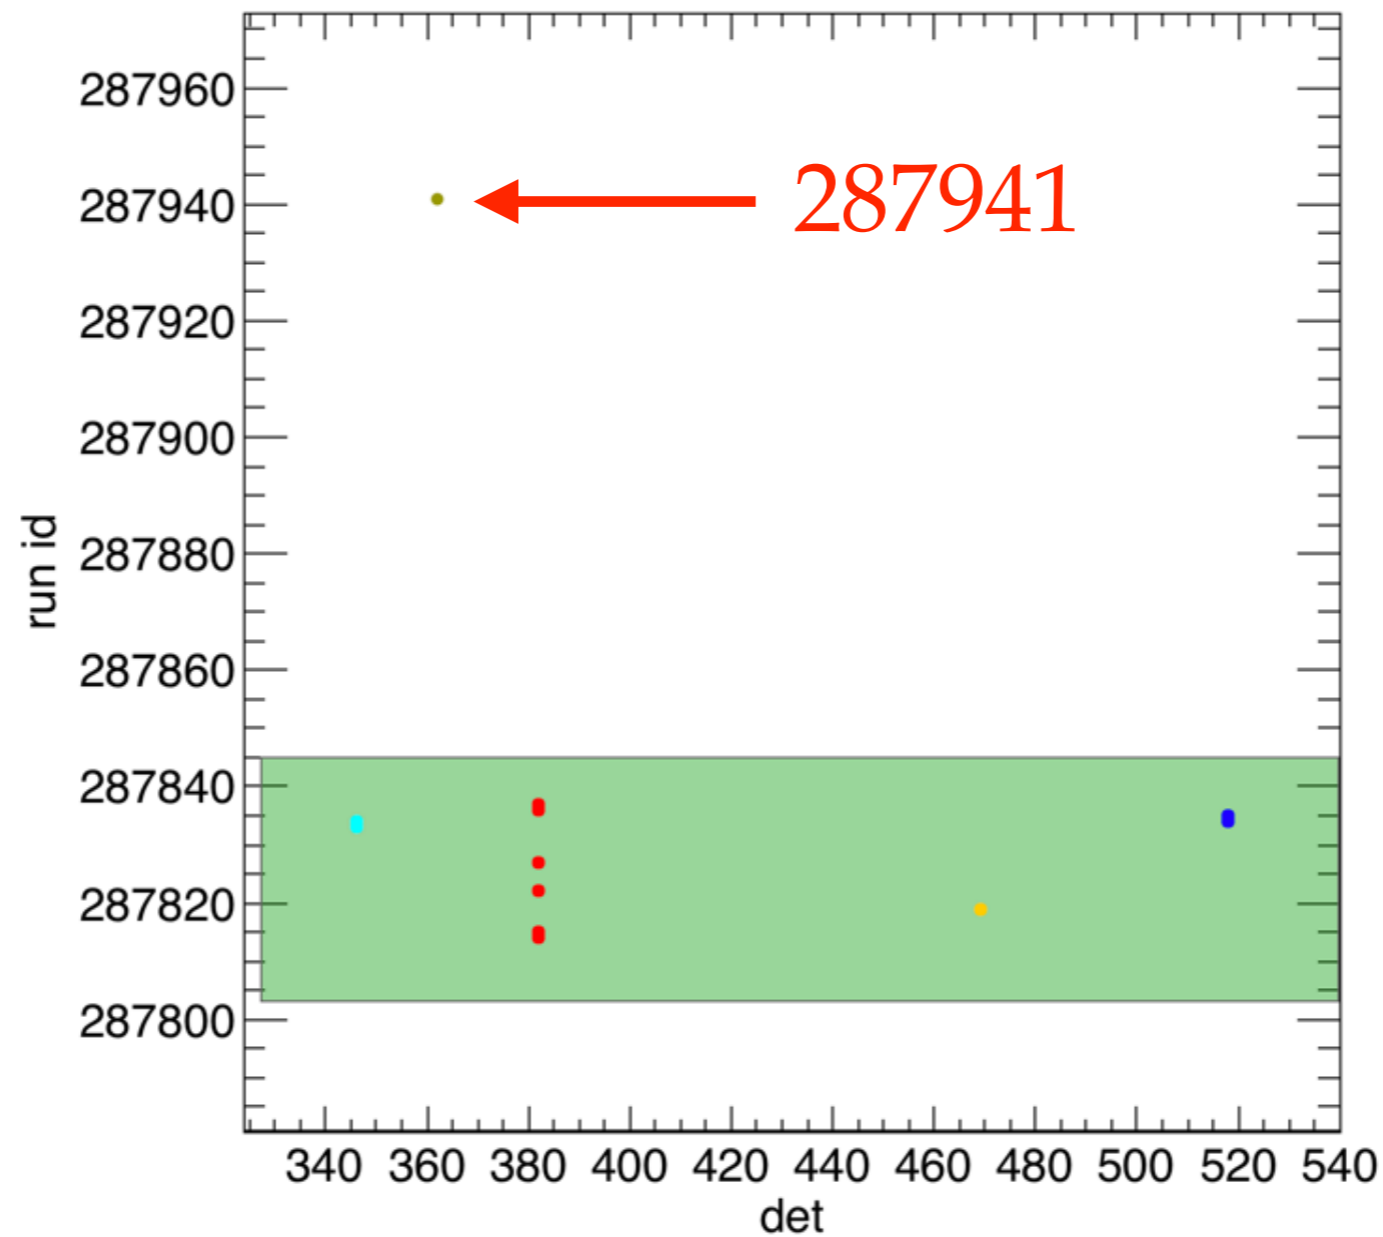
Bit Flips: Run Id vs Detector

- Different color means different bit flipped, bits 0, 1, and 32 are excluded.
- Most of the bit flips occur during the high luminosity run.

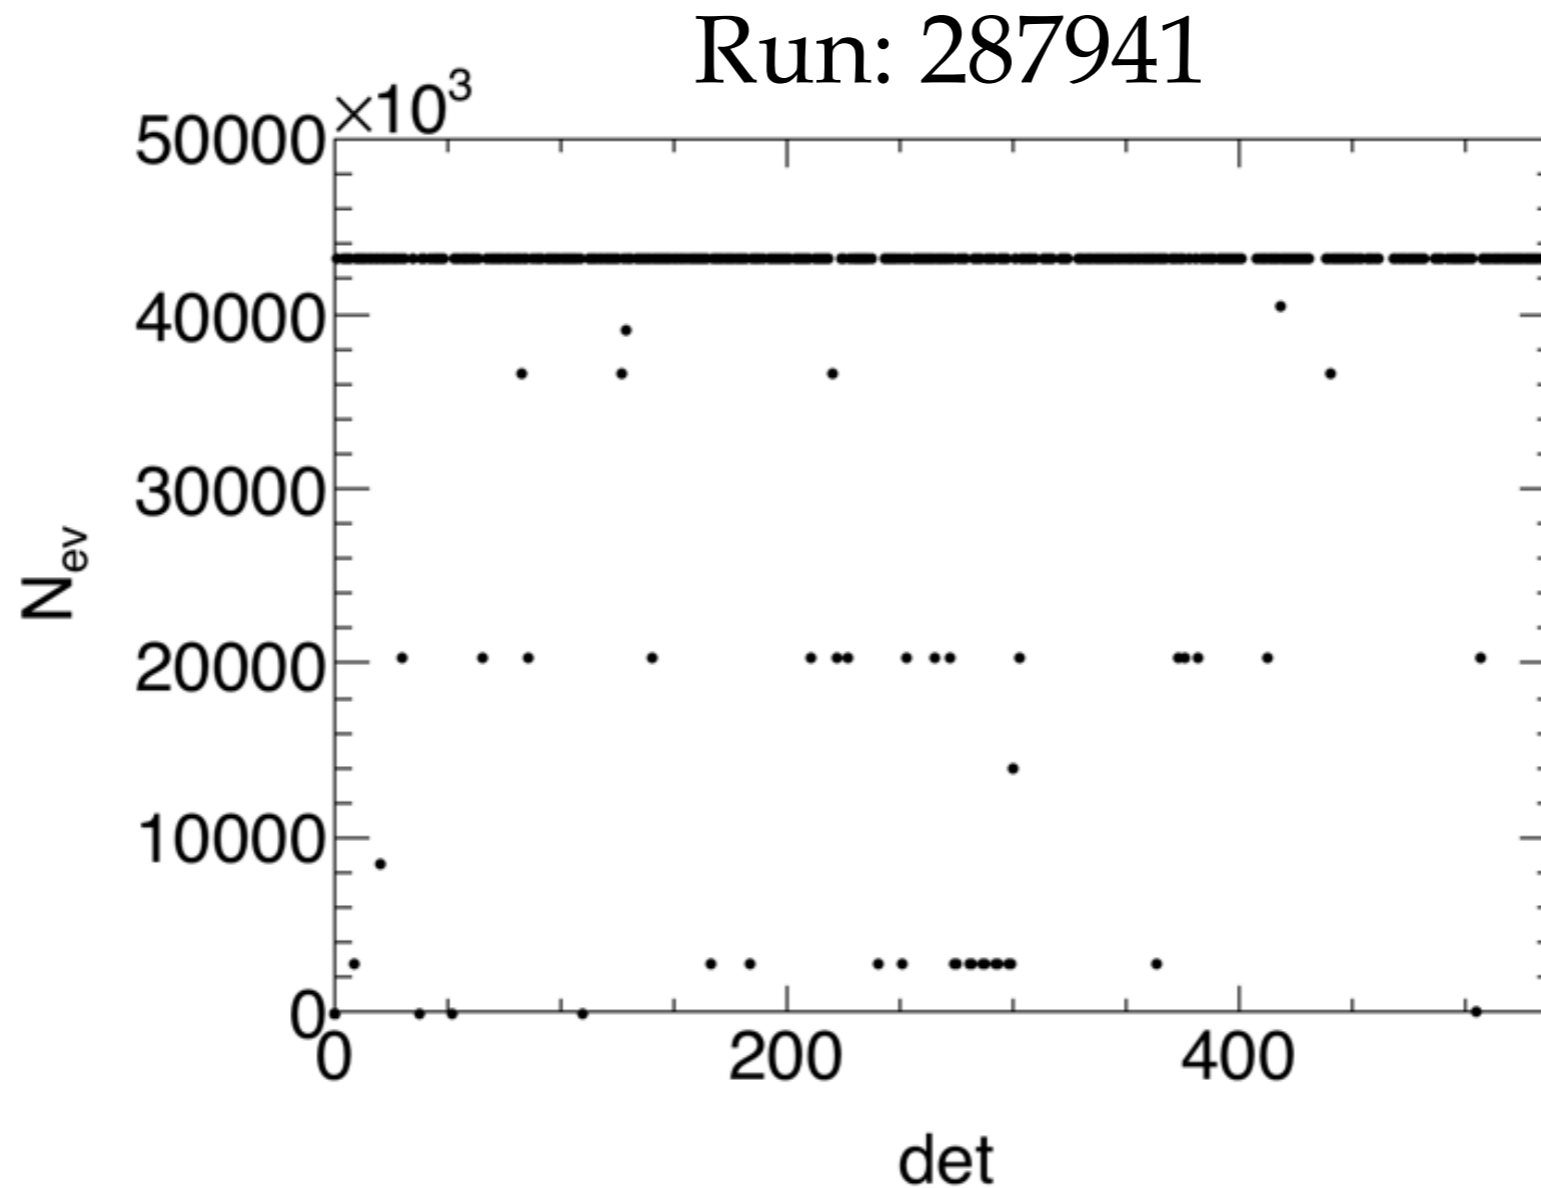
Event Counter vs Detector

- Most of the detector have the same event counter.
- 17 stop simultaneously at an event counter of about 20M.
- At least two more simultaneous stops of event counters for this run.

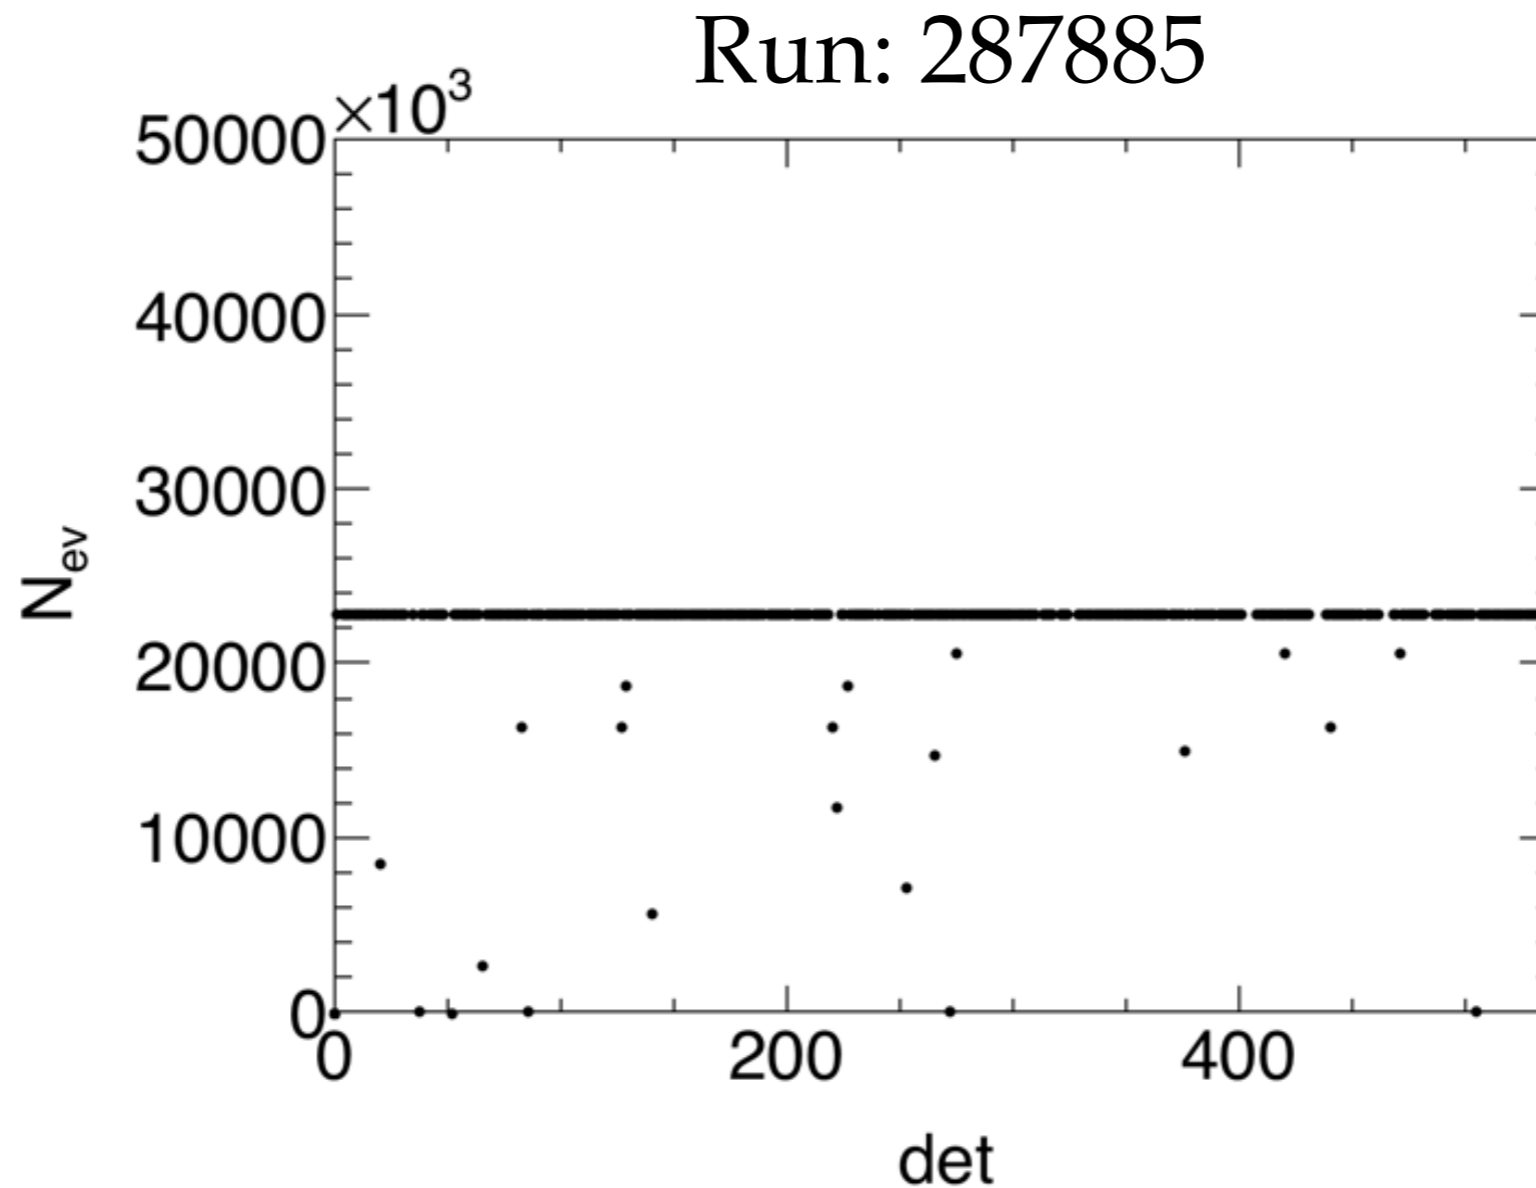
Event Counter vs Detector

- This previous run shows much less simultaneous event counter stops.

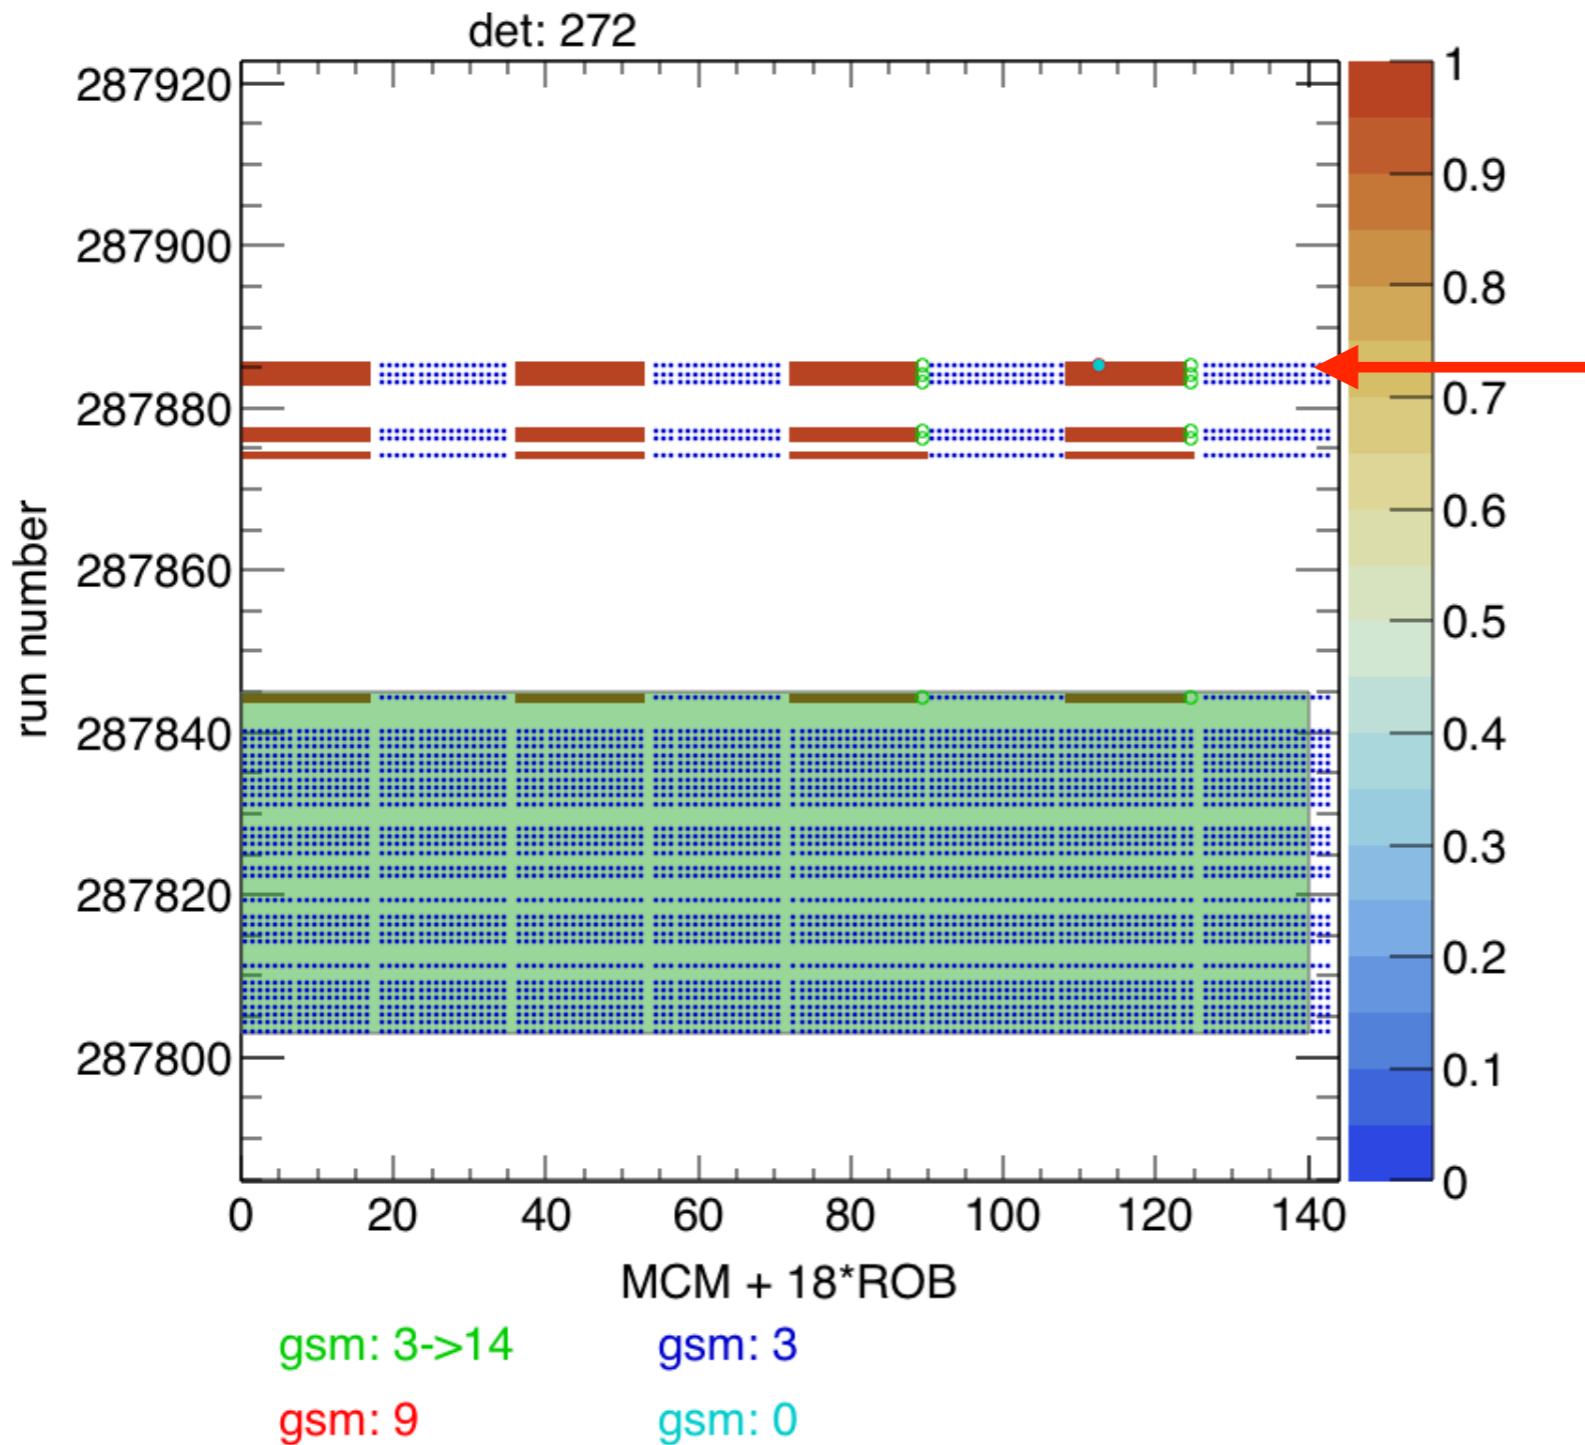
GSM States: TRD det. 272

“Just” gsm state 0

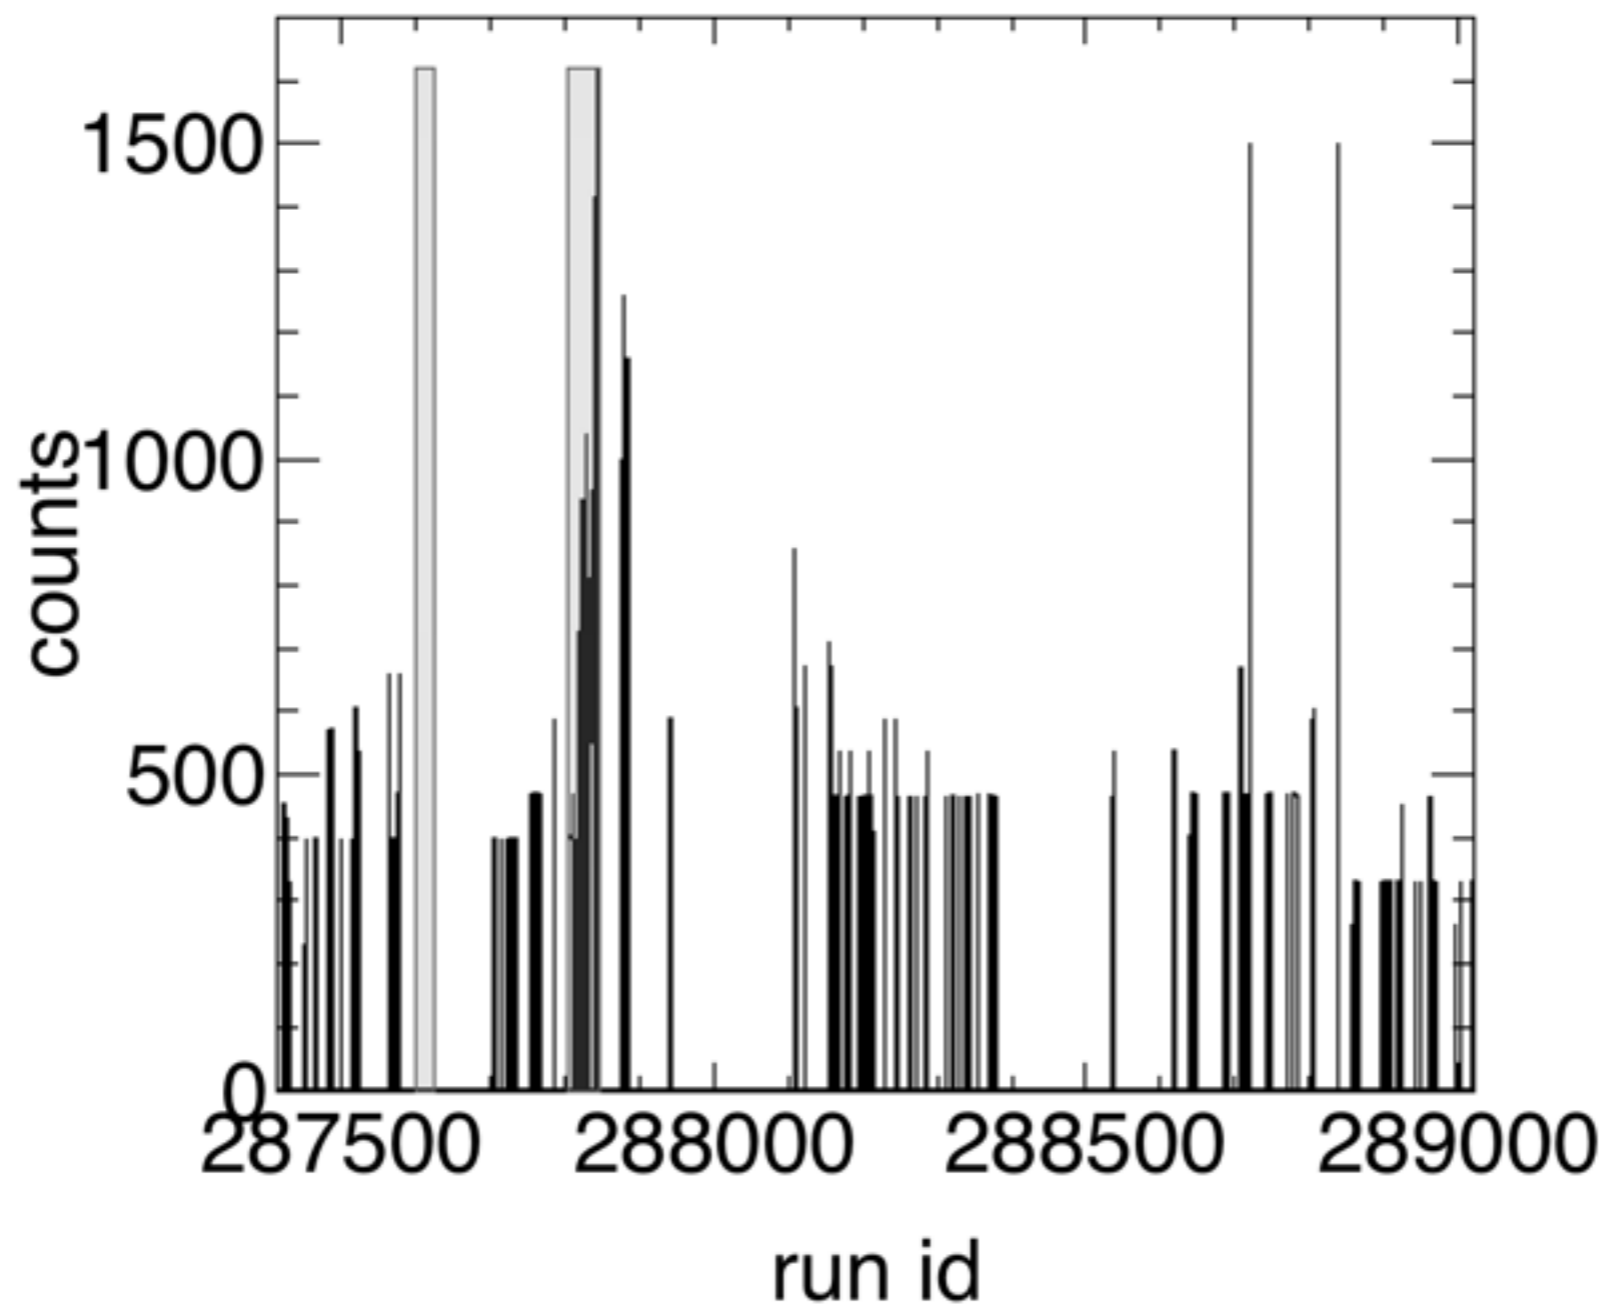
MCM Errors vs Run Id

- Errors seem to be more frequent during high luminosity run (gray shaded areas).

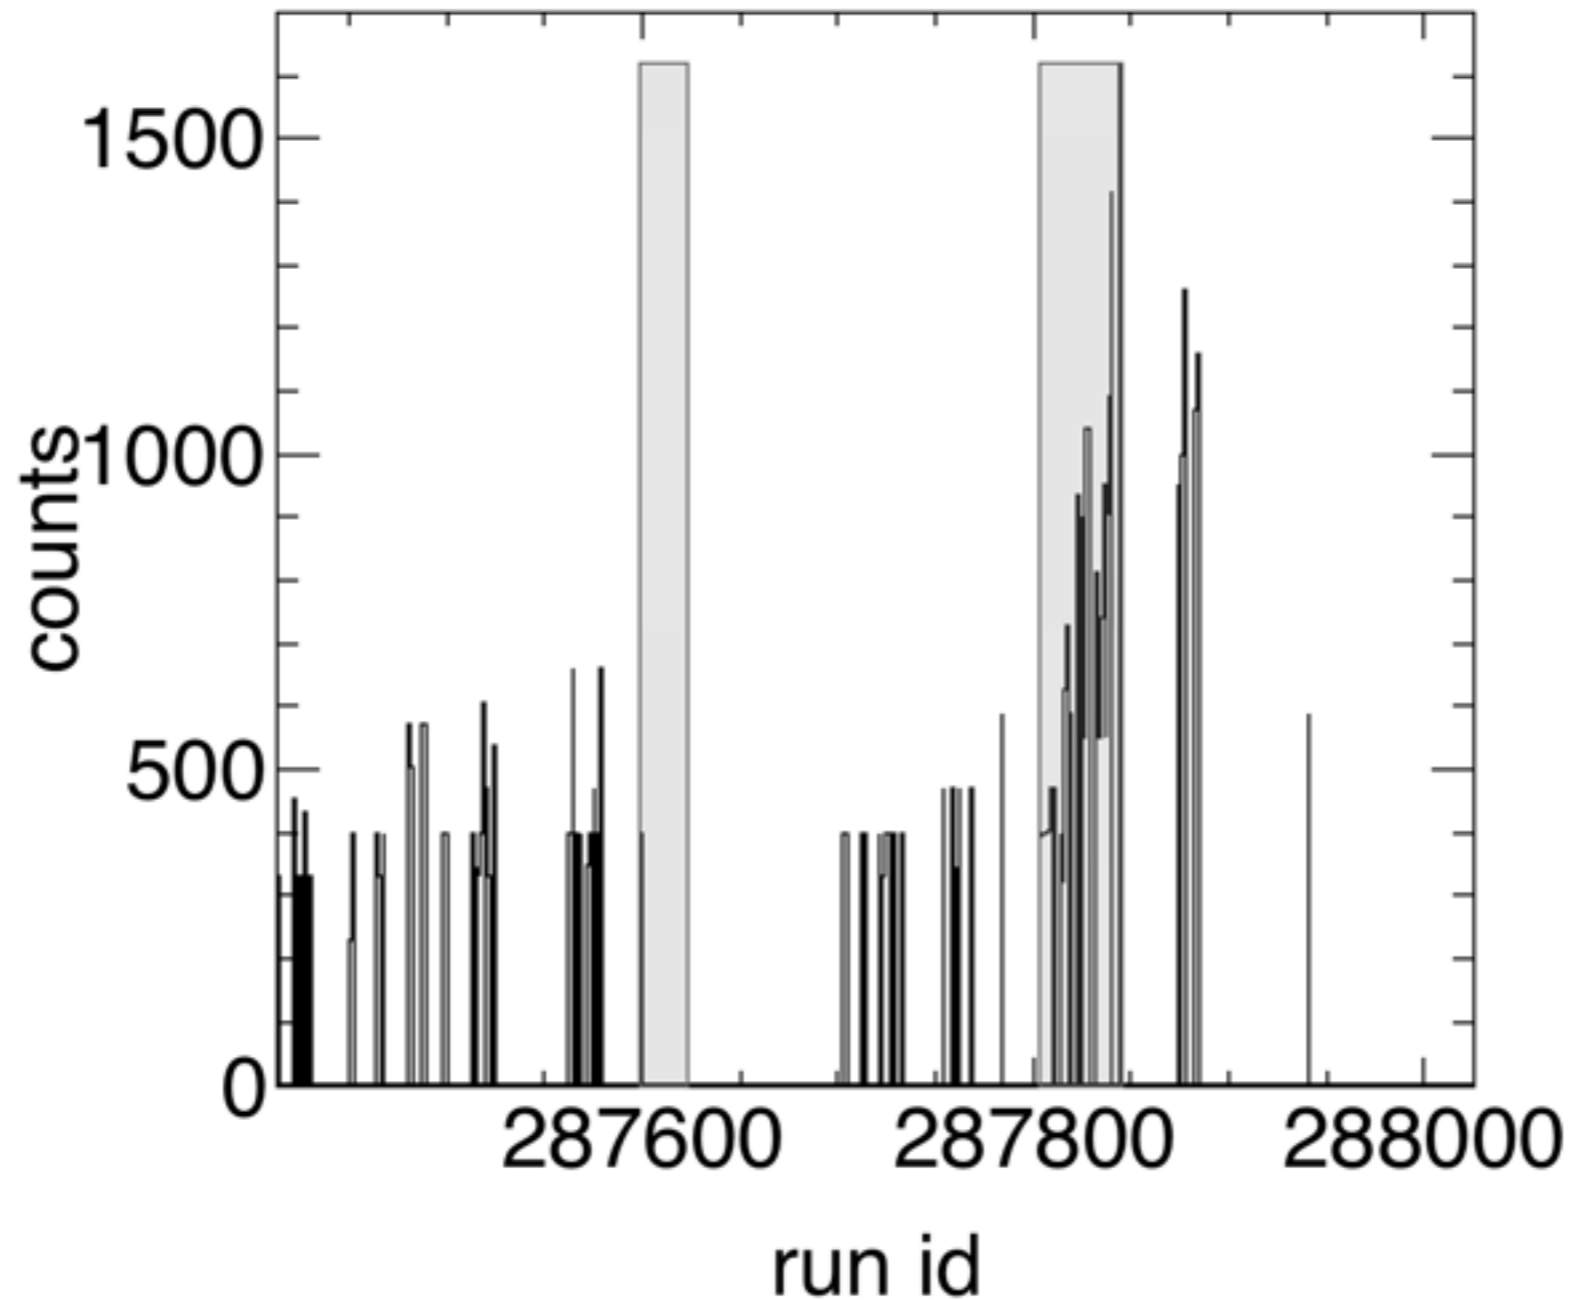
MCM Errors vs Run Id

- Errors seem to be more frequent during high luminosity run (gray shaded areas).
- Similar amount of errors just after second high luminosity run.
