News from the 2018 run

Vincent Andrieux

Technical board meeting
Sep 3rd

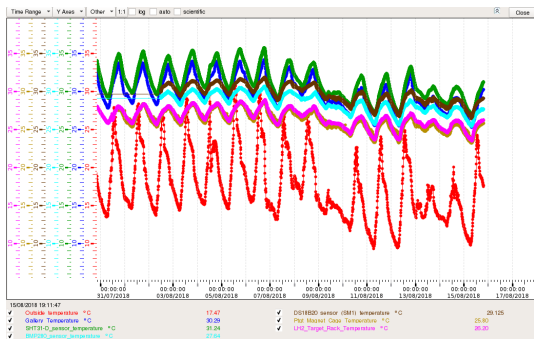
Target: environment temperature monitoring

Christophe connected two temperature probes (2 m and 5 m) from the racks to monitor temperature environment for EP-EPC

Nominal conditions: 25 °C

According to Yves Thurel, the system is not designed to “stand” such environment.

The extra degrees were sufficient to trigger the temperature alarm of the polarity switch.

Temperature can go up to 28 ± 1 °C

- During TS2 (rather UA9)
 - Minor labelling already scheduled couple of month ago
 - Protection of the bus bars
 - Improved cooling of the rack

- During LS2
 - Cooling from the false floor to be discussed between Aziz (EN-CV), Yves (EP-EPC) and us
 - Define space for PSU, polarity switch spares

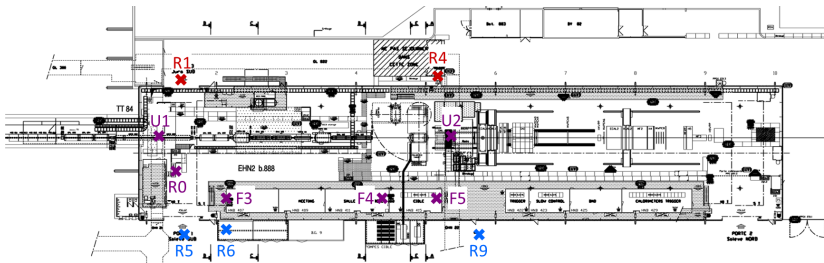
Radiation protection: survey

Supervised * Non-designated * Not classified *

U: underground, R: Ground floor, F: First floor

Statistical uncertainties $\approx 15\%$

Pos.	Wendi-2	IG5		Limit
		Ar	H	
R0	11.2	2.4	14.9	15.0
R1	9.2	2.5	13.3	
R4	44.8	6.6	41.1	
R5	4.2	0.6	4.3	2.5
R6	2.4	0.4	2.4	2.5
R9	2.6	0.3	2.2	2.5
F3	9.3	1.8	11.2	15.0
F4	7.8	1.2	6.4	15.0
F5	6.2	0.9	5.4	15.0
U1	0.3	-	-	15.0
U2	5.6	-	-	-

- Close gallery access door with a padlock to prevent access to Jura side
- Reinforce shielding on Saleve side near the CEDARs with additional concrete blocks
- Repeat measurements on critical locations

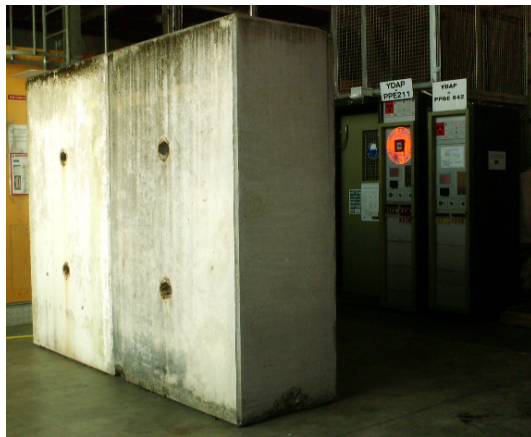
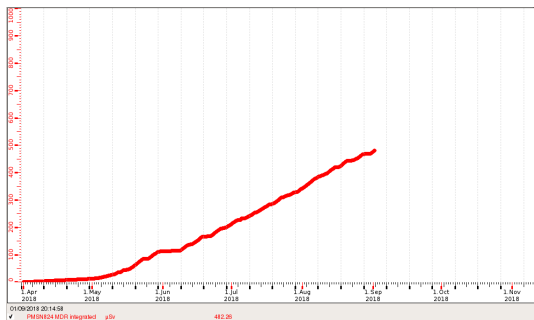
Trend as expected

Limits should not be exceeded
