Jun Lu, Todd Adkins, Iain Dixon (senior IEEE member), and Ke Han, *National High Magnetic Field Laboratory, Tallahassee, FL 32310, USA*  
 Doan Nguyen, *NHMFL Pulsed Field Facility, Los Alamos National Laboratory, NM 87545, USA*

Here we present results of our nondestructive testing (NDT) of Glidcop AL-60 wires using Eddy current testing, ultrasonic testing and x-ray tomography (2D and 3D) methods. The advantages and disadvantages of each method are compared. We have successfully developed the capability for a long length eddy current wire inspection.

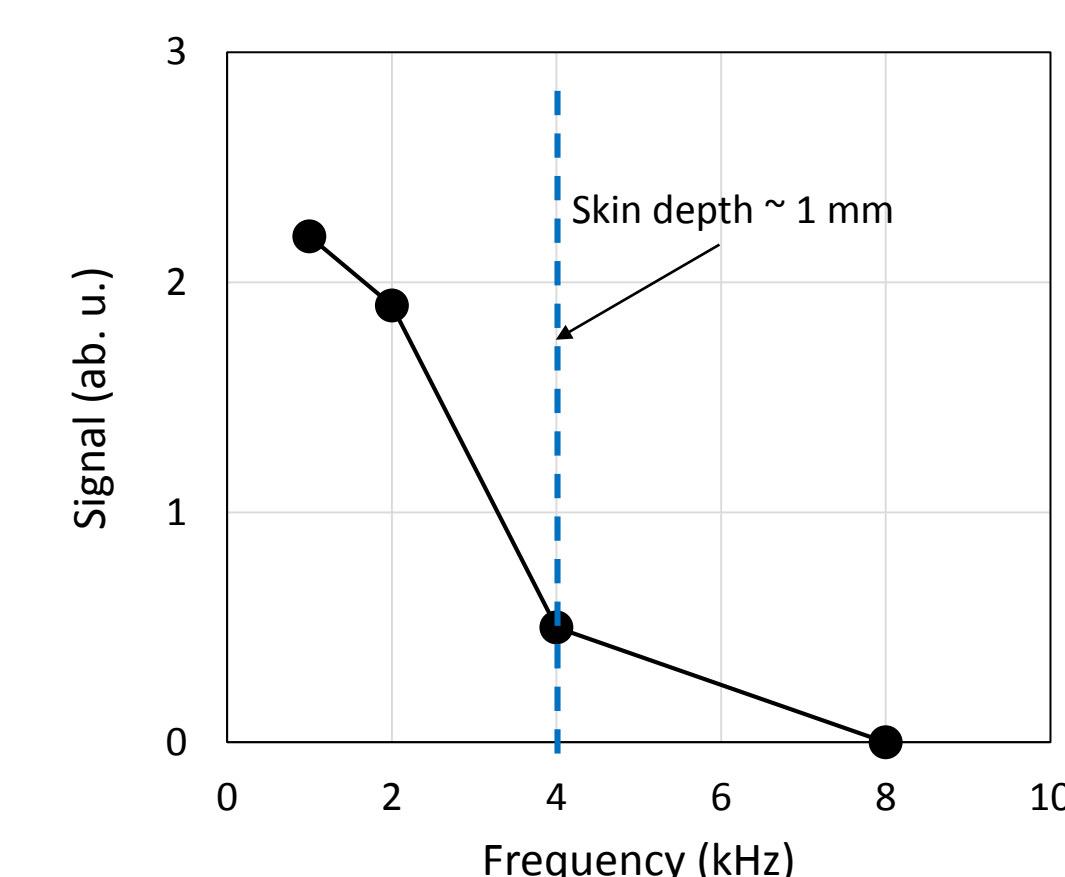
Frequency response of a hole 1 mm from surface. Skin effect prevents detection of deep defects.

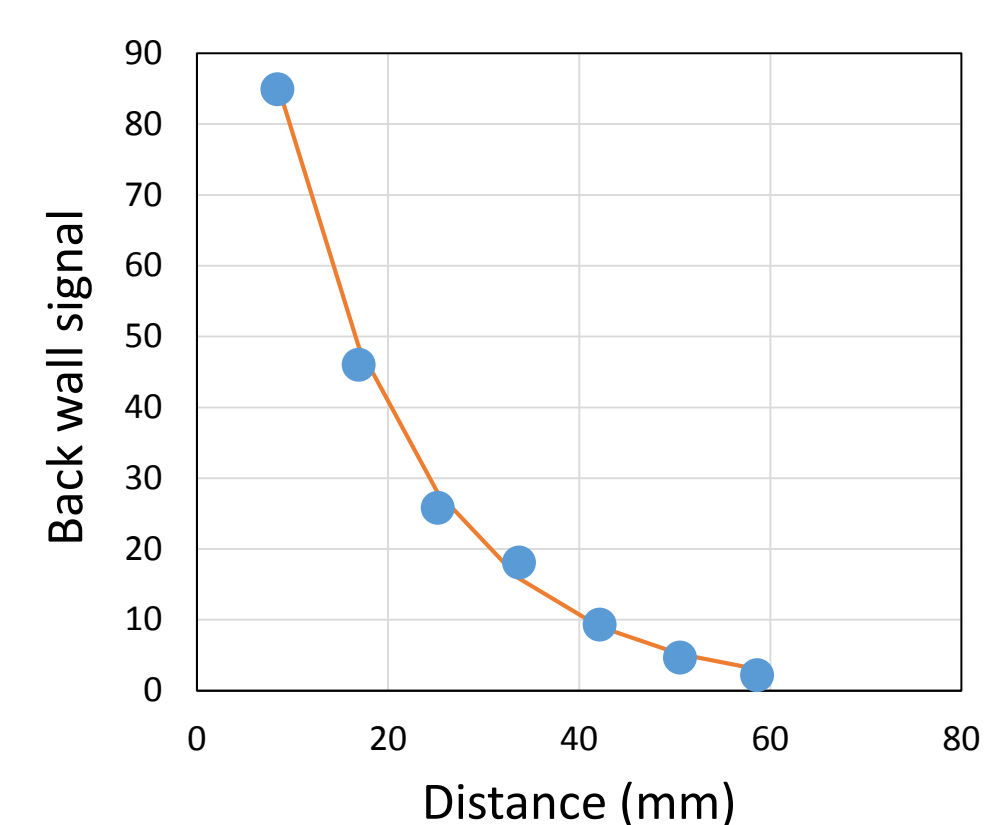
Ultrasonic attenuation limits the detection sensitivity. Characteristic attenuation length is ~ 14 mm.

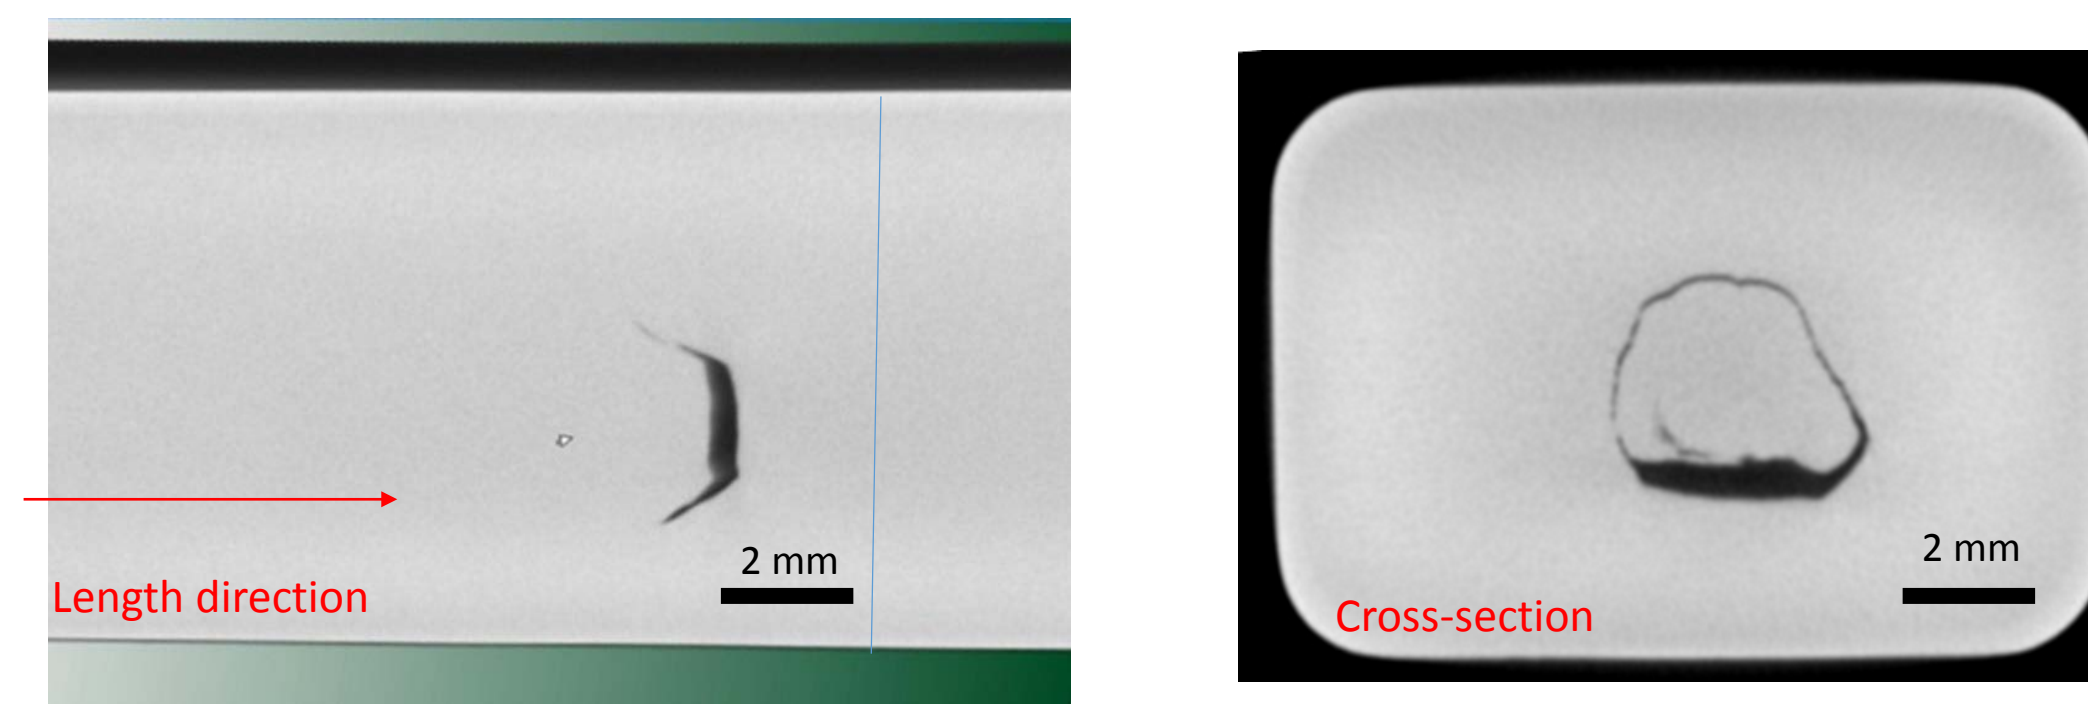
Central bursts or 'chevron' cracks occur in cold drawn wire when lubrication is inadequate, or the drawing die geometry is not optimized. They cannot be seen by visual inspection. We found chevron cracks in Glidcop AL60 wires.

**X-ray CT scan:** a chevron crack in a 12.3 x 8.4 mm² AL60 wire

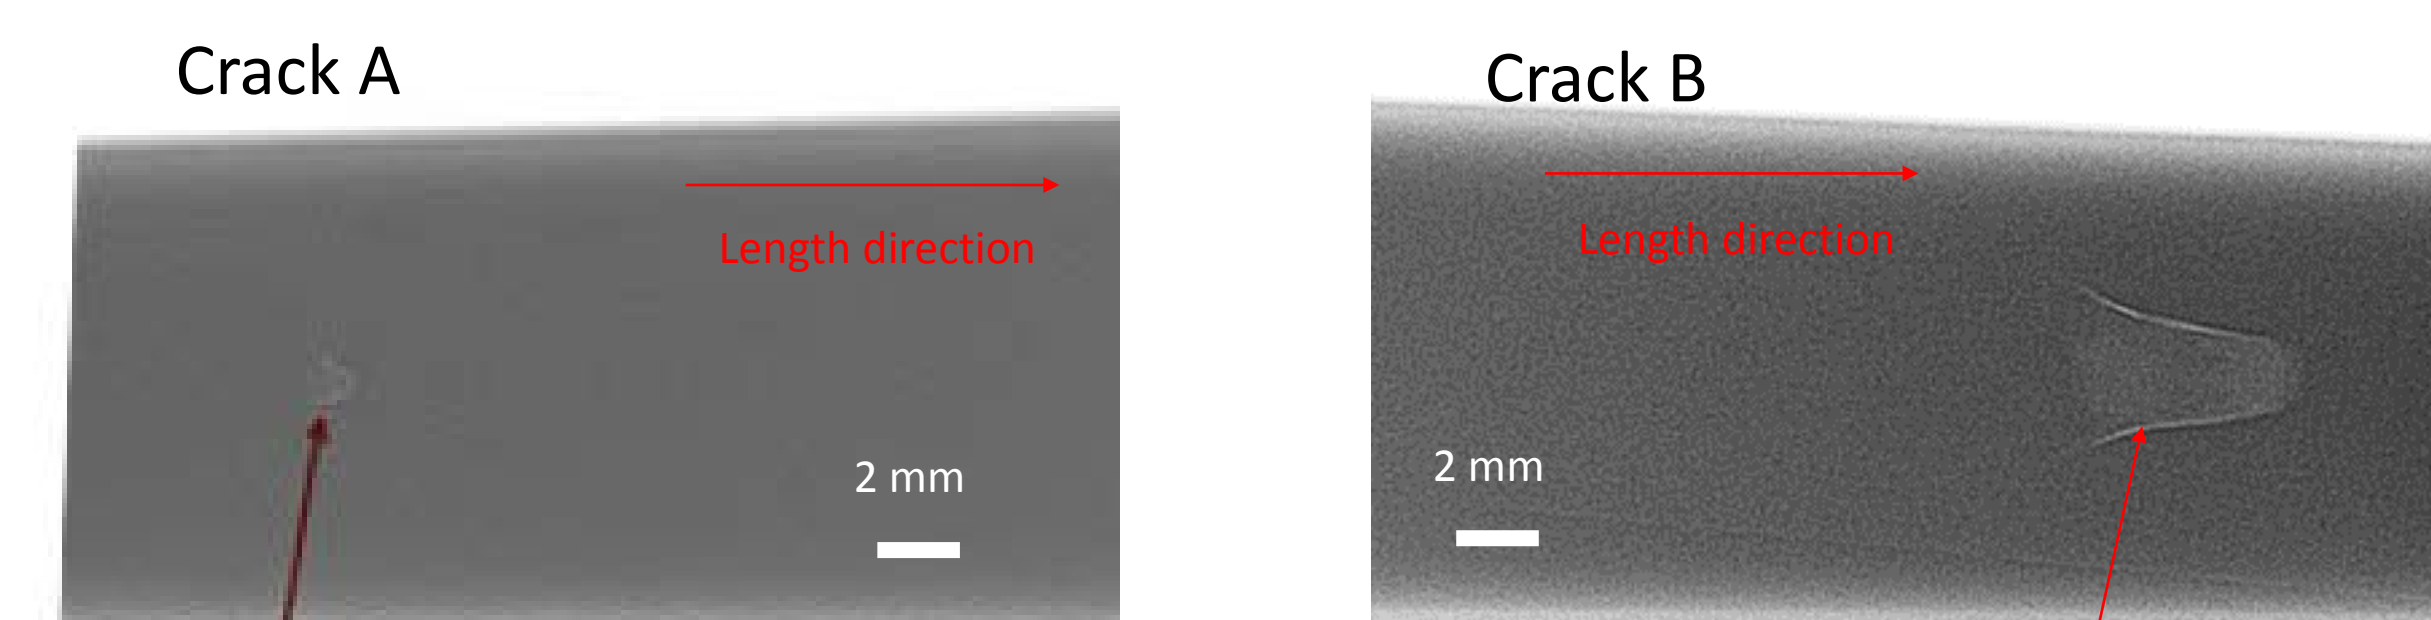
**X-ray 2D scan** also revealed a small crack (A) and large crack (B).

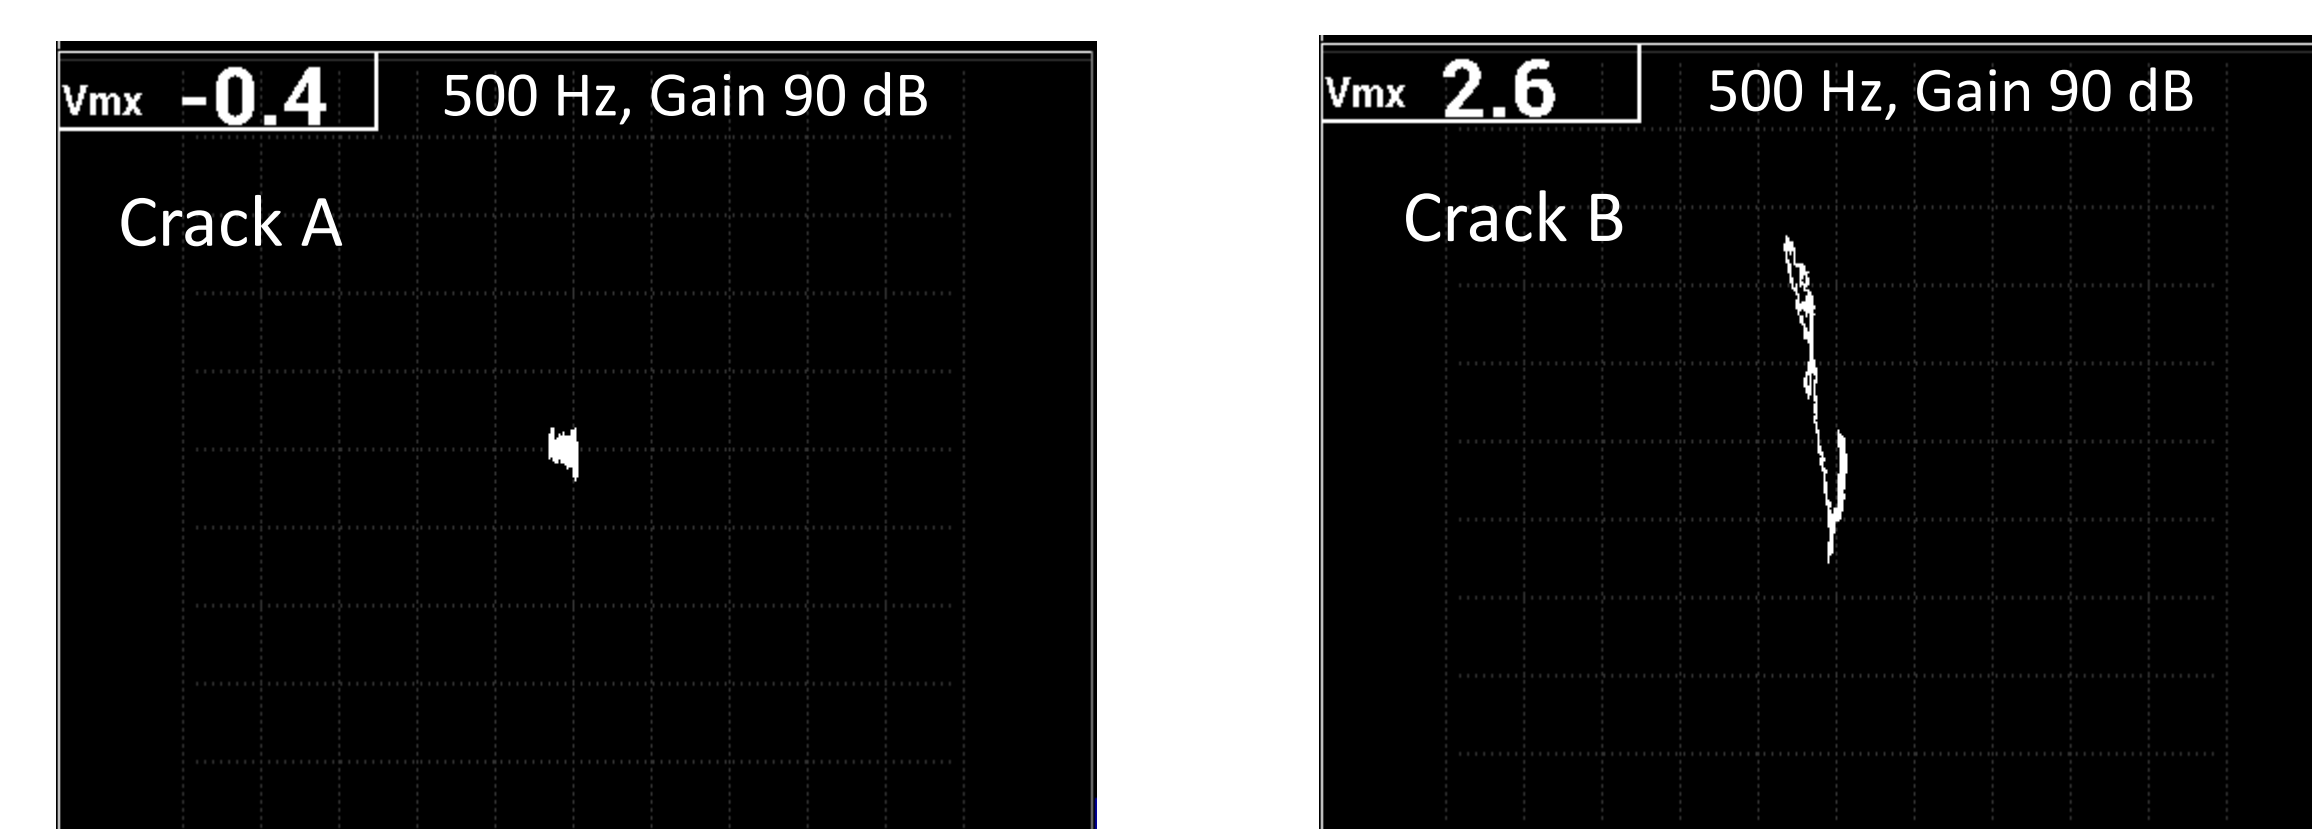
**Eddy current:** at  $f_{min}$  of 500 Hz (skin depth ~ 3 mm), only the large crack B was detected.

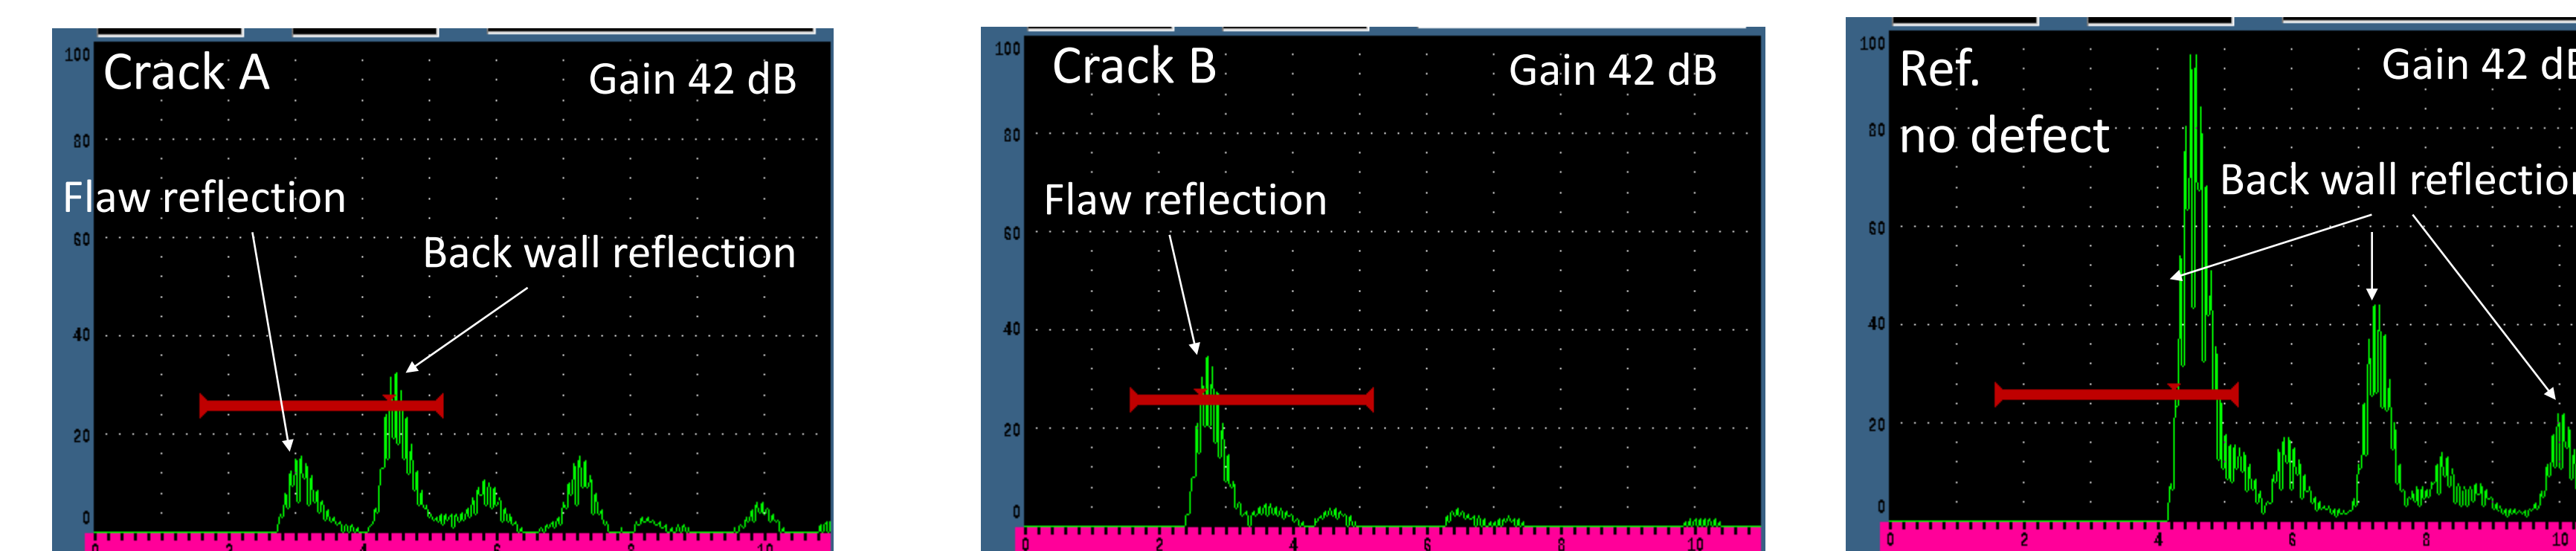
**Ultrasonic:** detected both defects by reflection signal as well reduction in back wall reflections

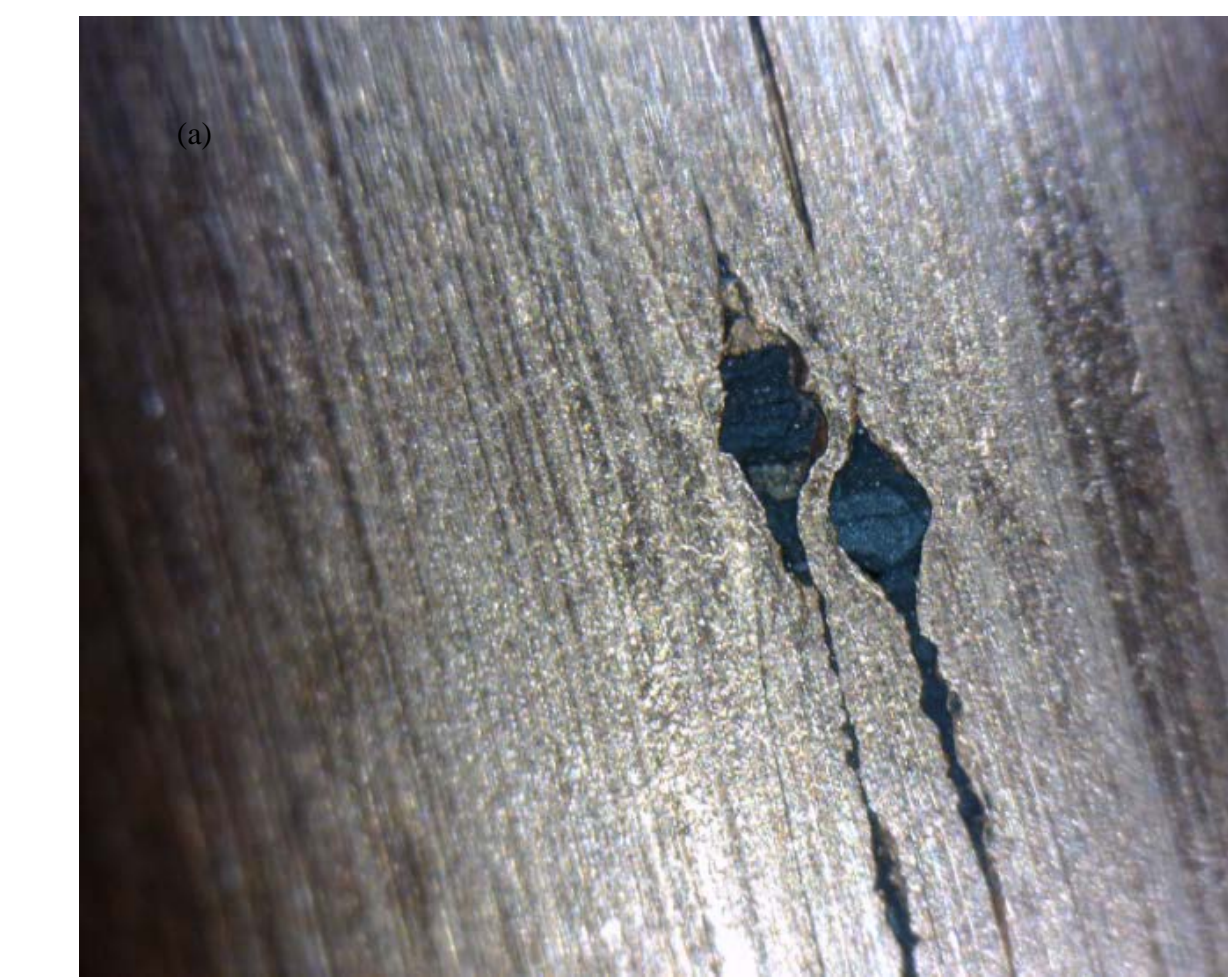
Ferromagnetic surface inclusions

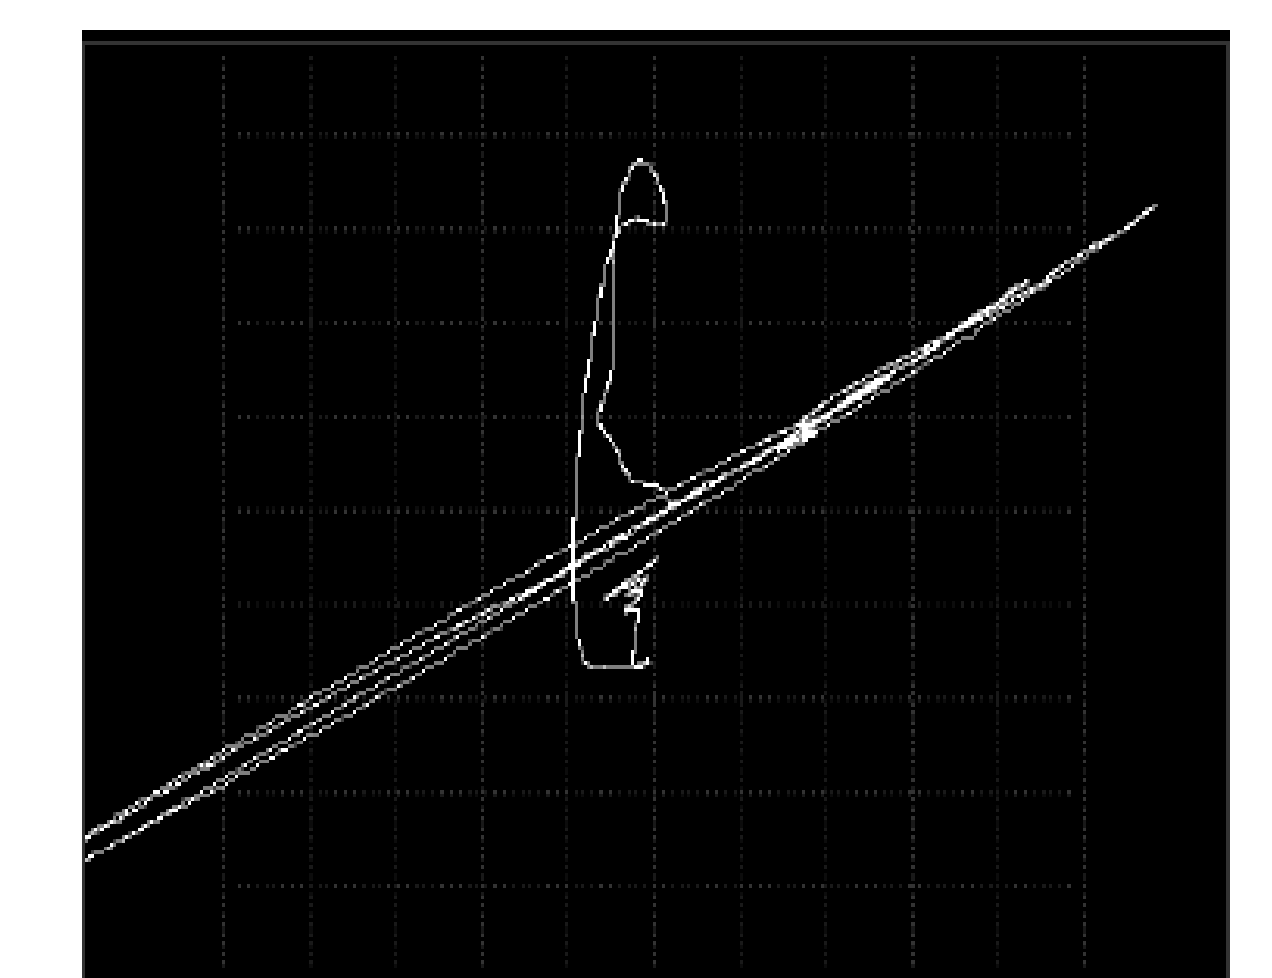
Eddy current signal from surface inclusions
