Tue-Af-Po2.14-08

Post-mortem of No-Insulation Insert (LBC3)

Post-mortem of the Insert Coil

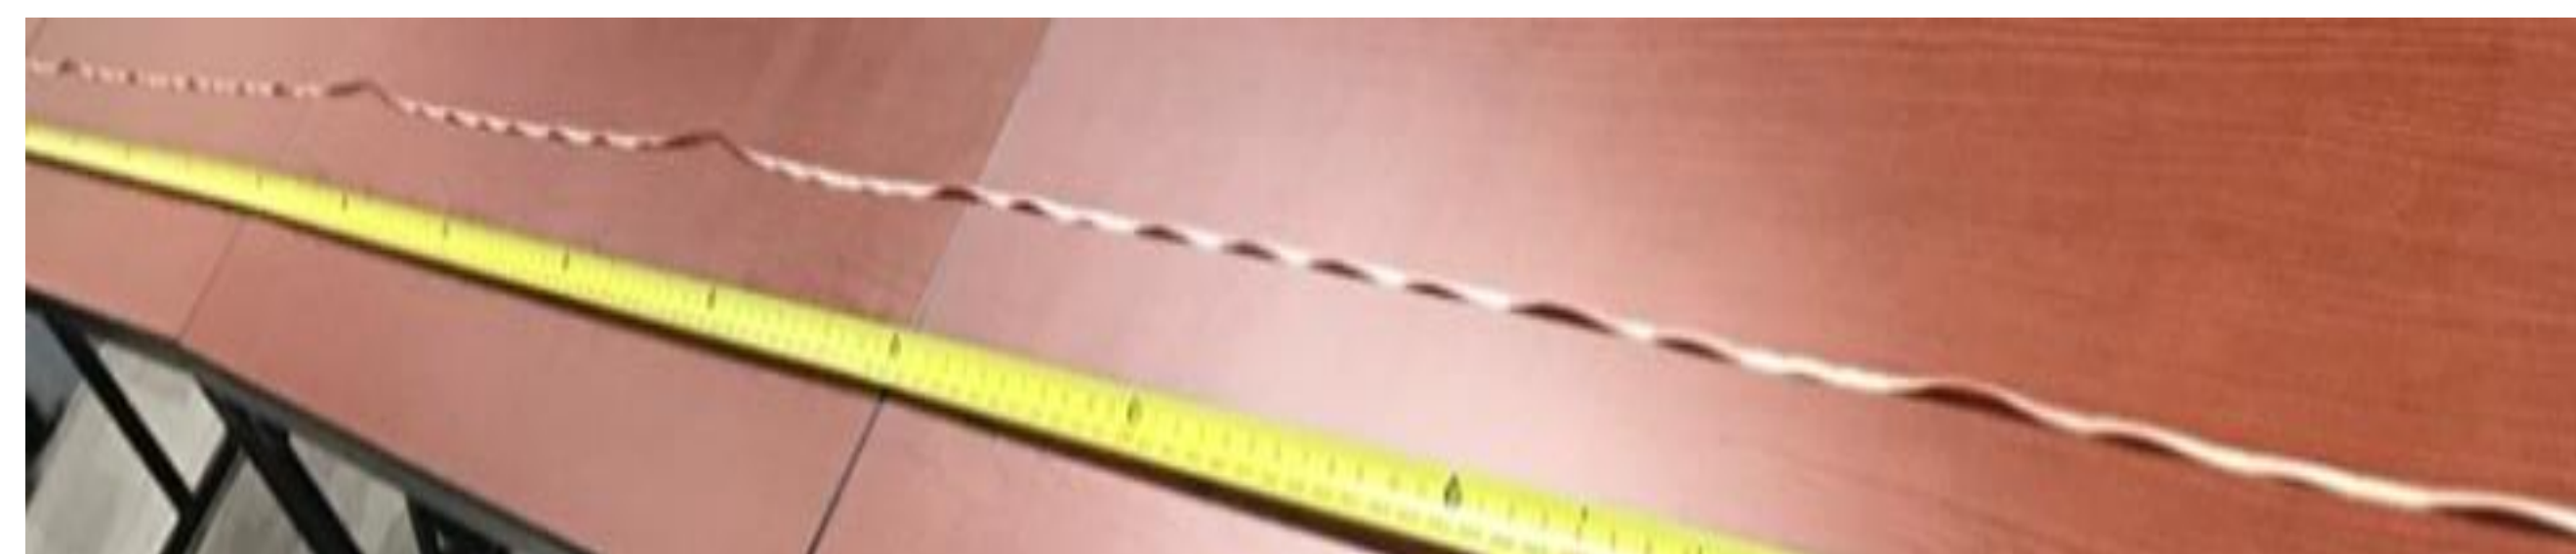
Figure 1. Plastic deformation of the tape.

- After a single quench, the plastically deformed tapes were identified.
- ➔ Due to the over-strain during quenching or the screening current effect during charging?

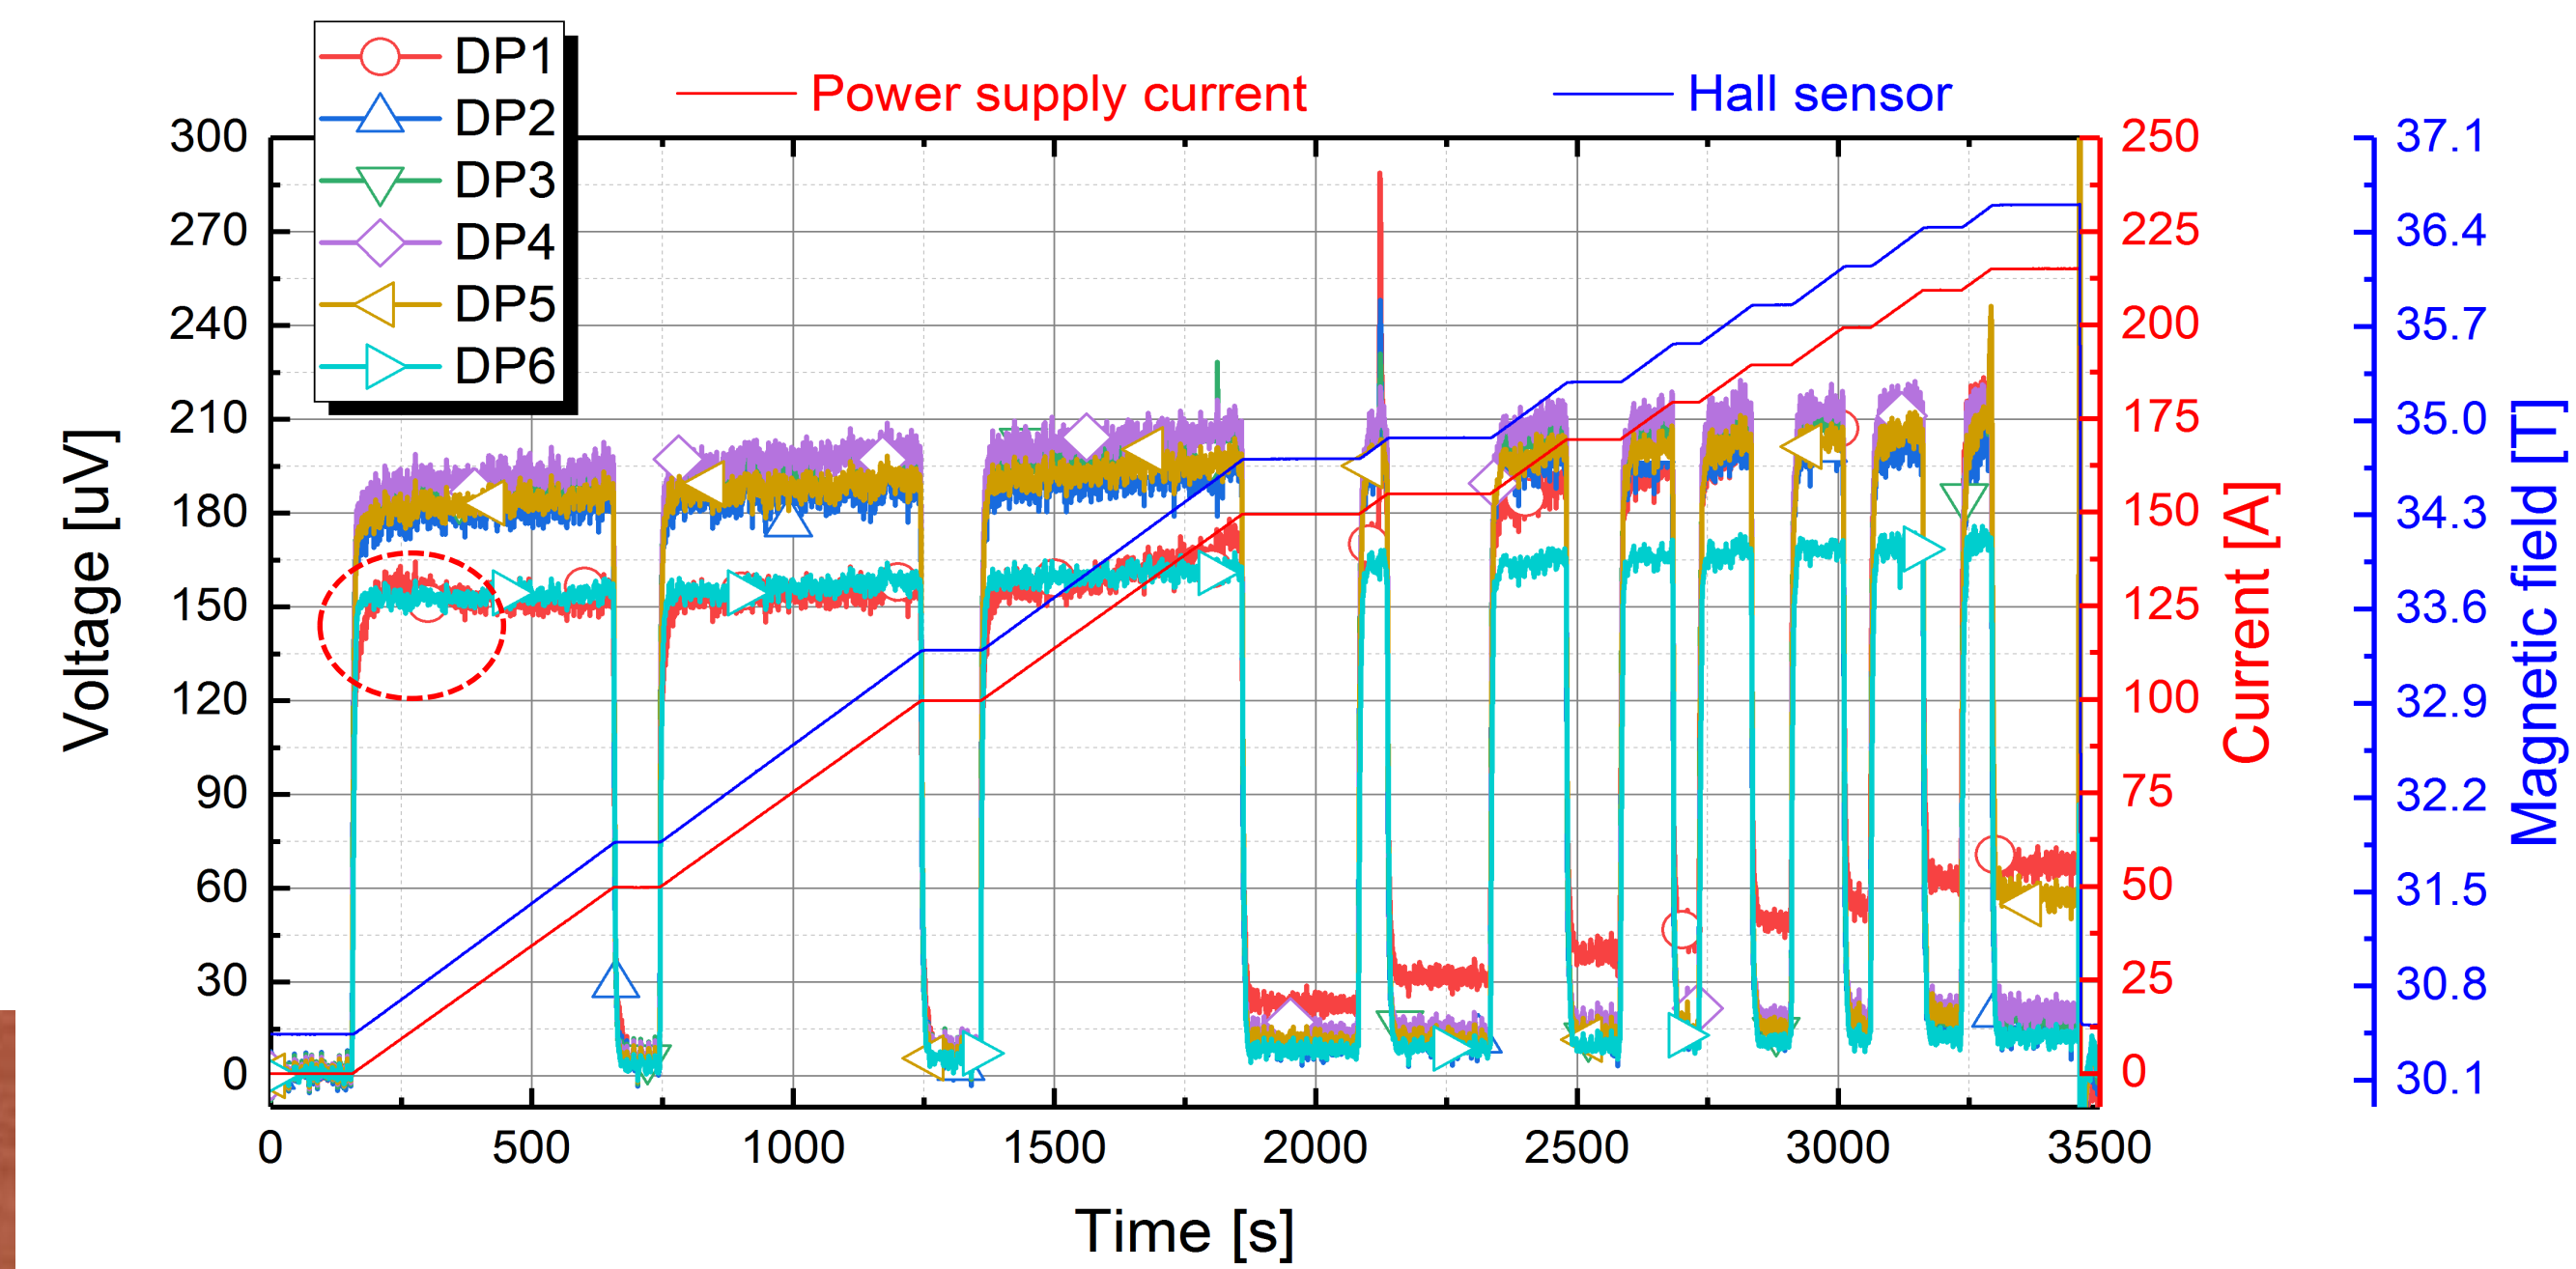
Figure 2. Charging profile of the insert.

- The test coil was charged to 215 A in a 30.5 T background field (ramp rate: 0.1 A/s).
- Voltage overshoot was observed at double pancake 1 (DP1) at the beginning of the charging (red circle).

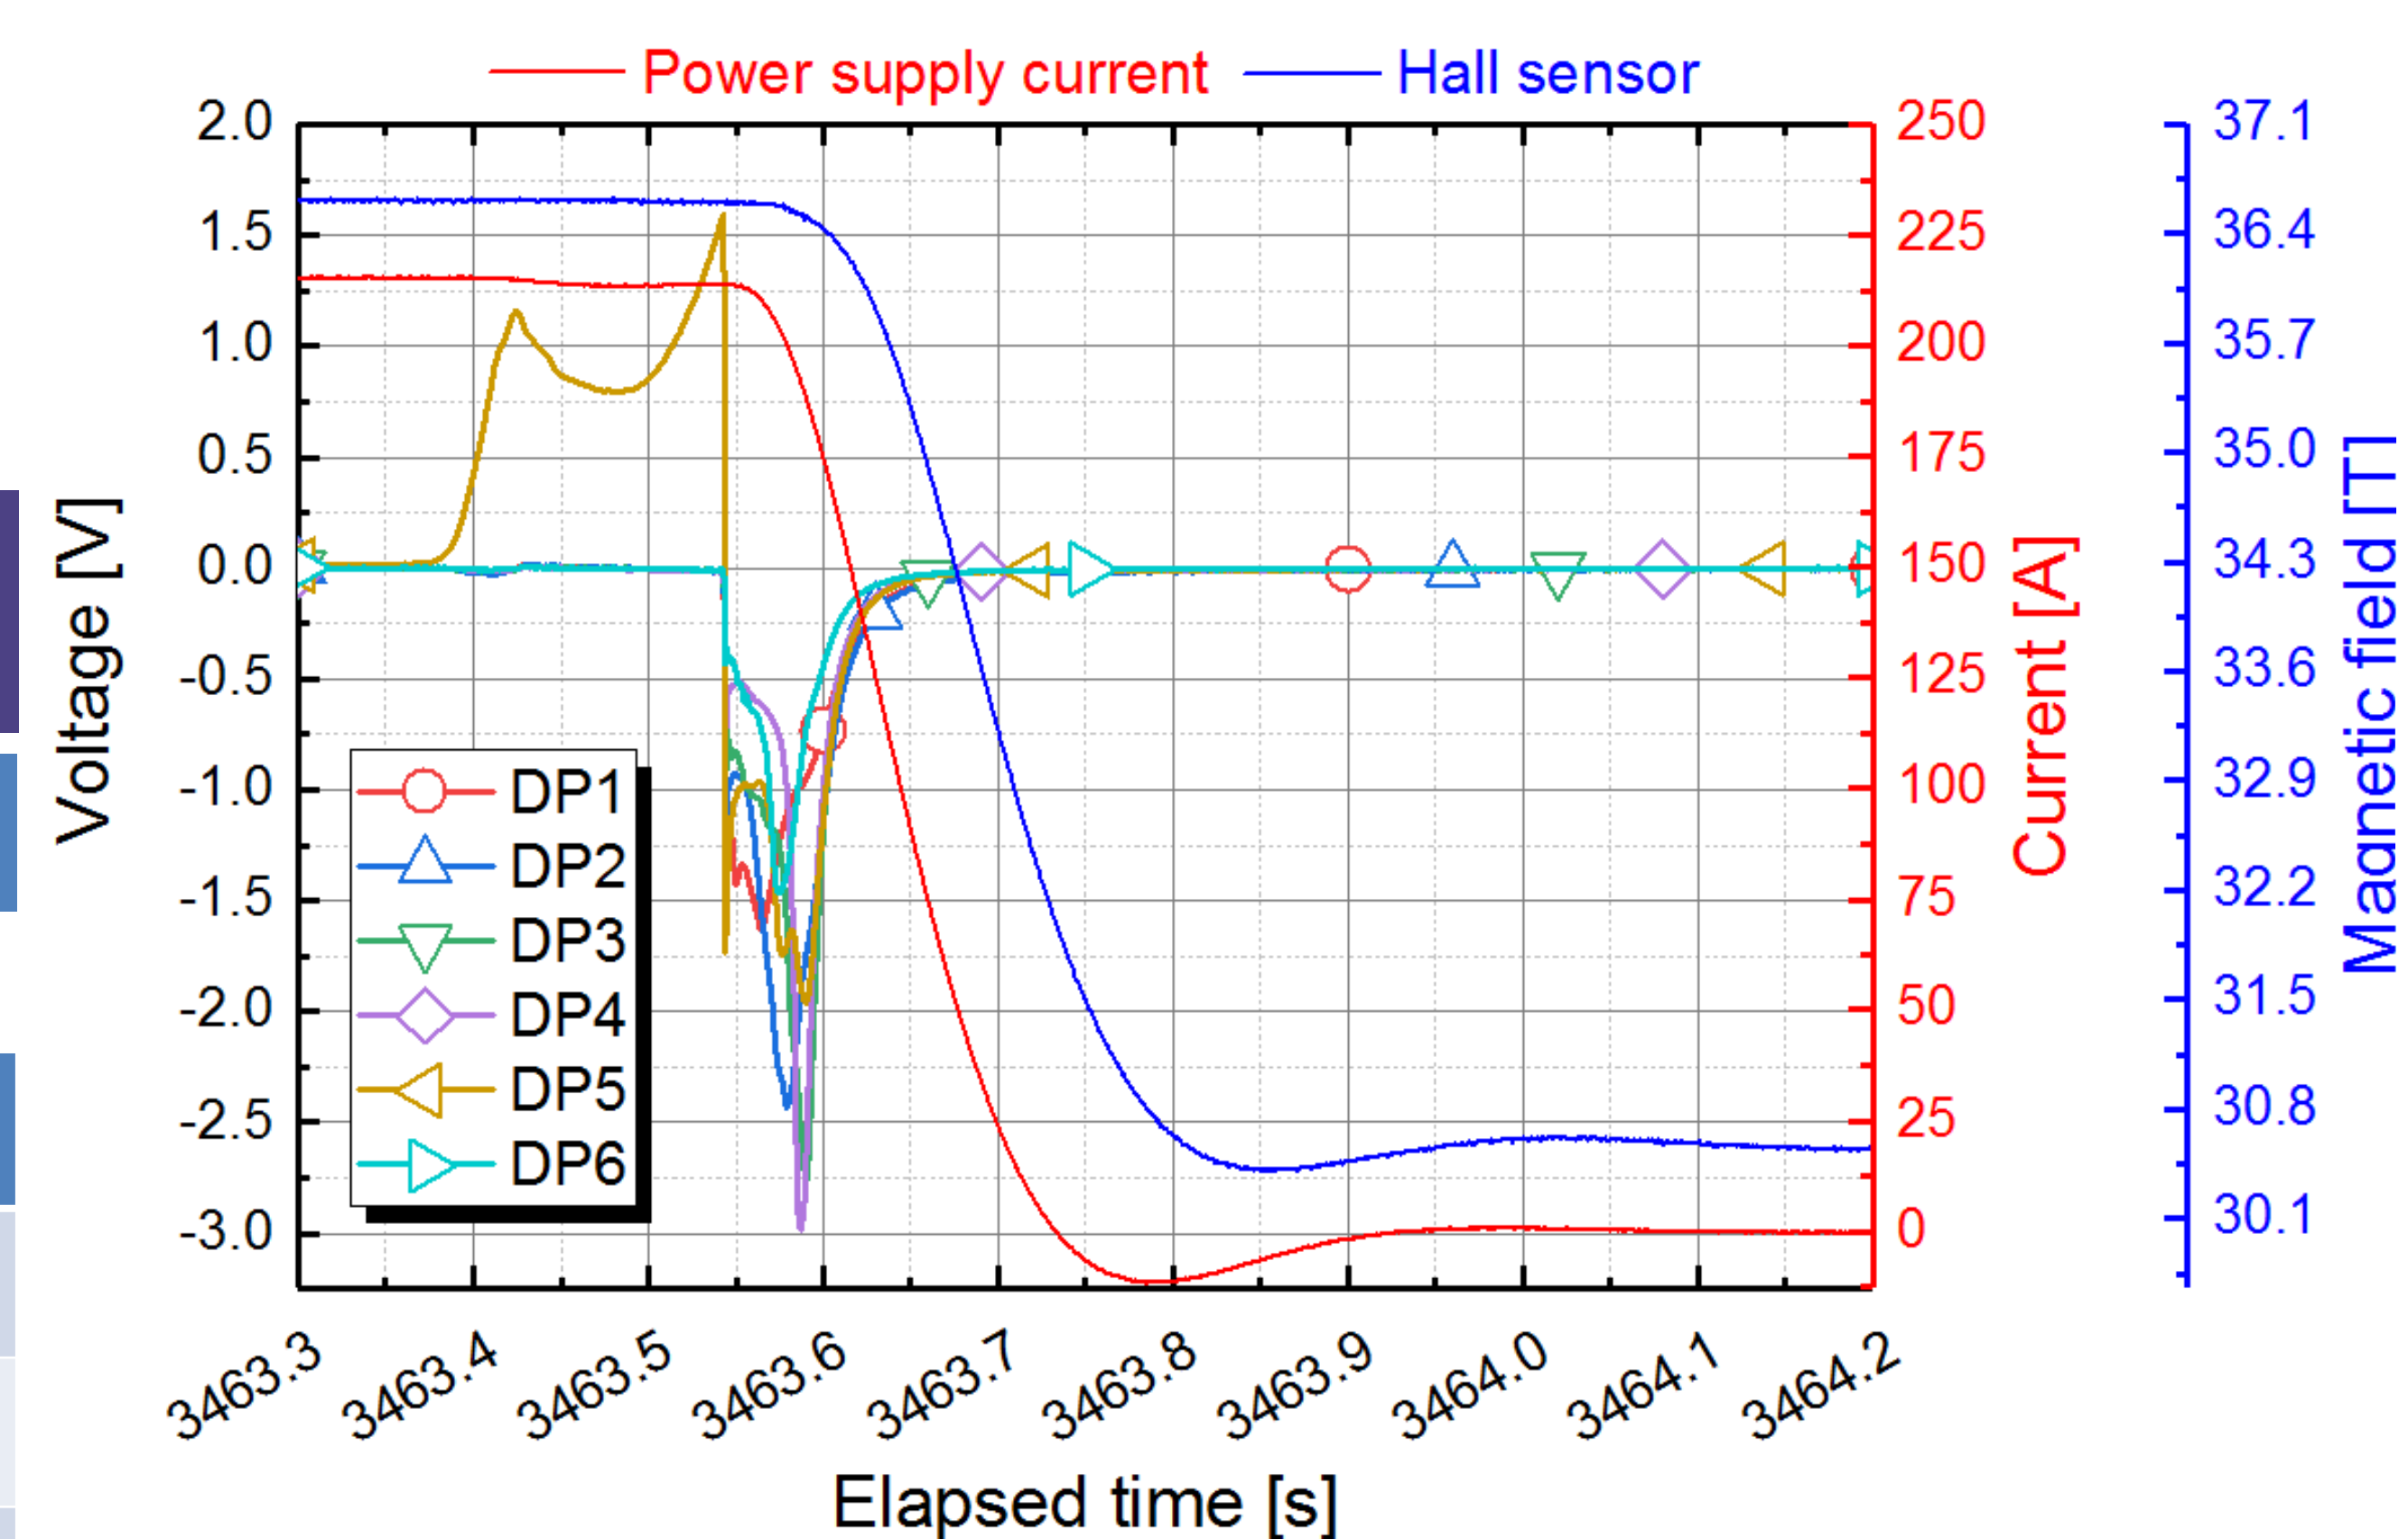
Figure 3. Enlarged view of quench moment.

- Quench was initiated at DP5. However, unlike the previous LBC3, the quench detection box had been operated (trigger voltage: 0.5 V) before the quench started to propagate.

➔ Test coil didn't experience full quenching.

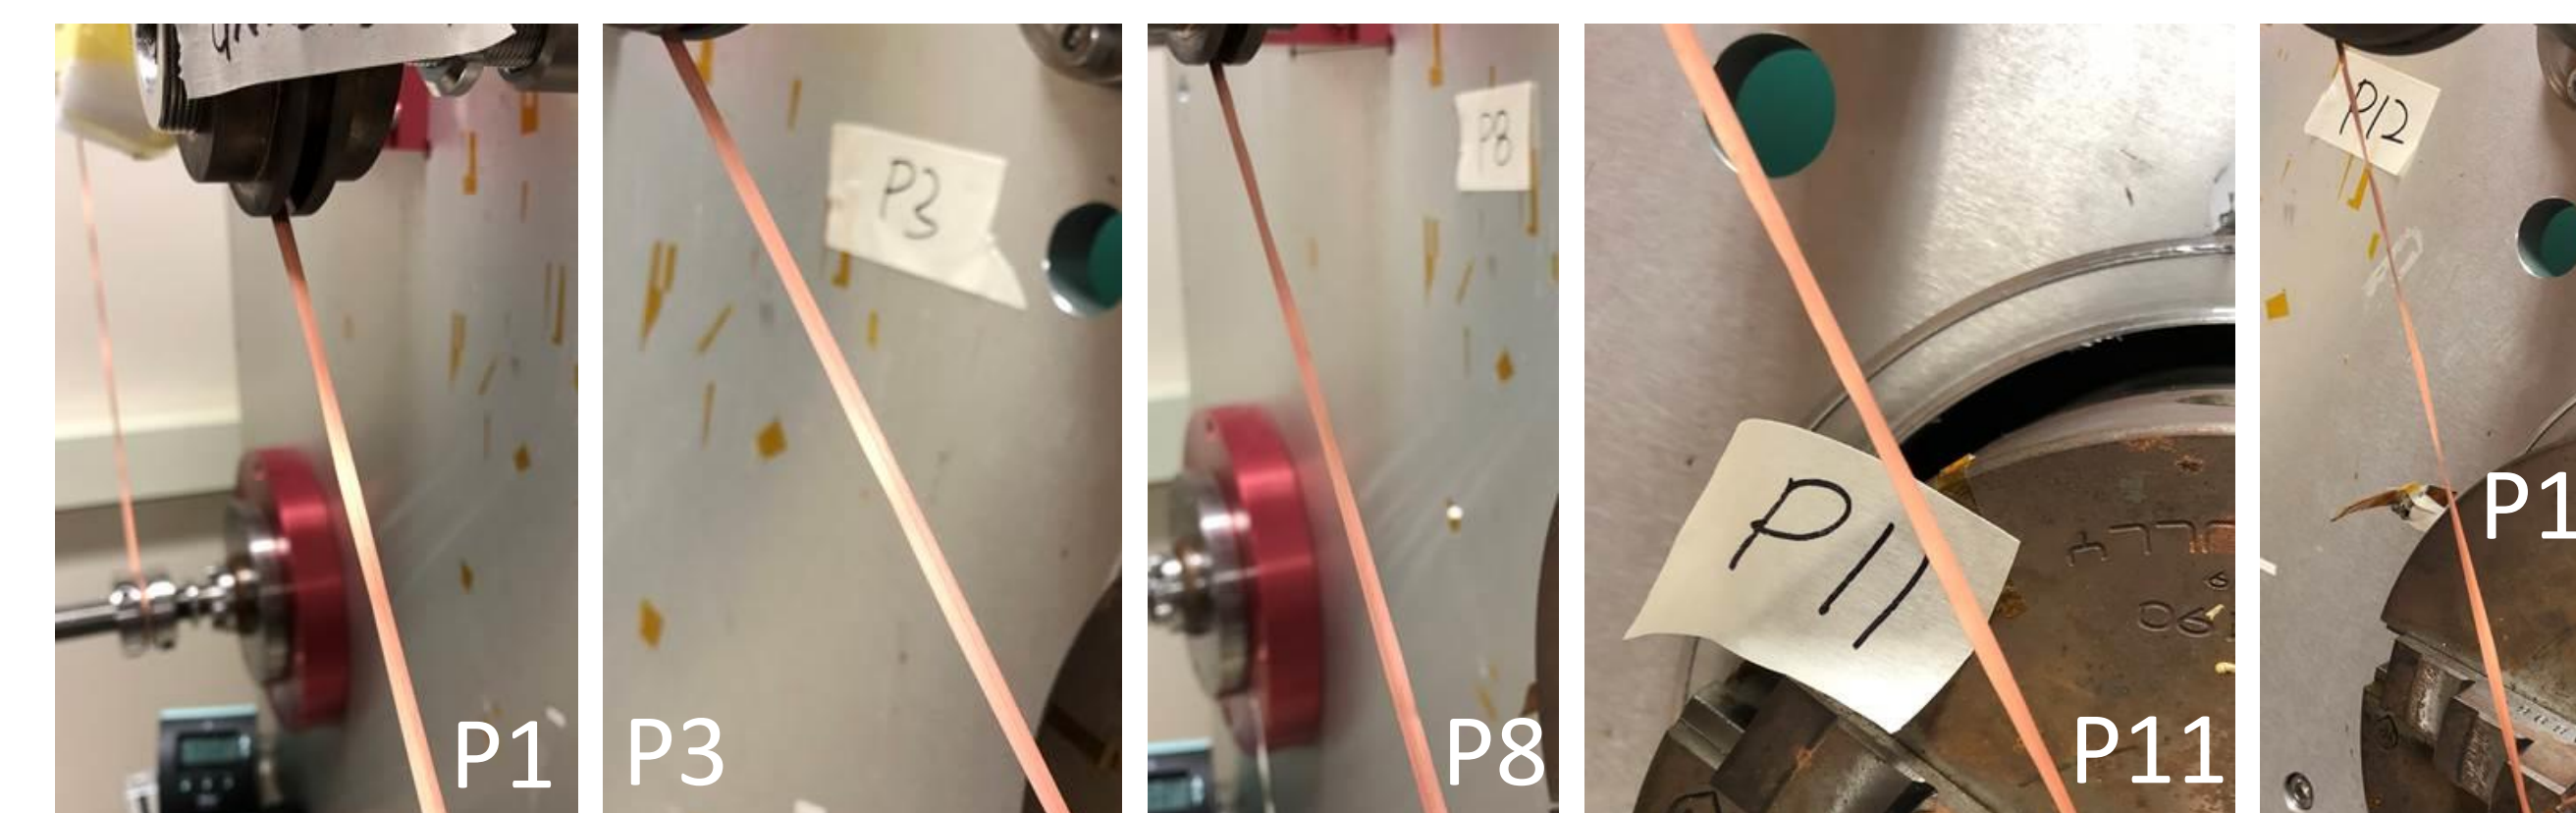
Figure 4. Plastic deformation confirmed.

- Two post-mortems (visual inspection and YateStar measurement) confirms the plastic deformation of the tape.

- Plastic deformation was confirmed at the tape from near the coil ends. According to the calculation results based on the critical state model*, the maximum local hoop stress is not at the end pancakes.
- Identification of current distribution in the tape sample is in progress.

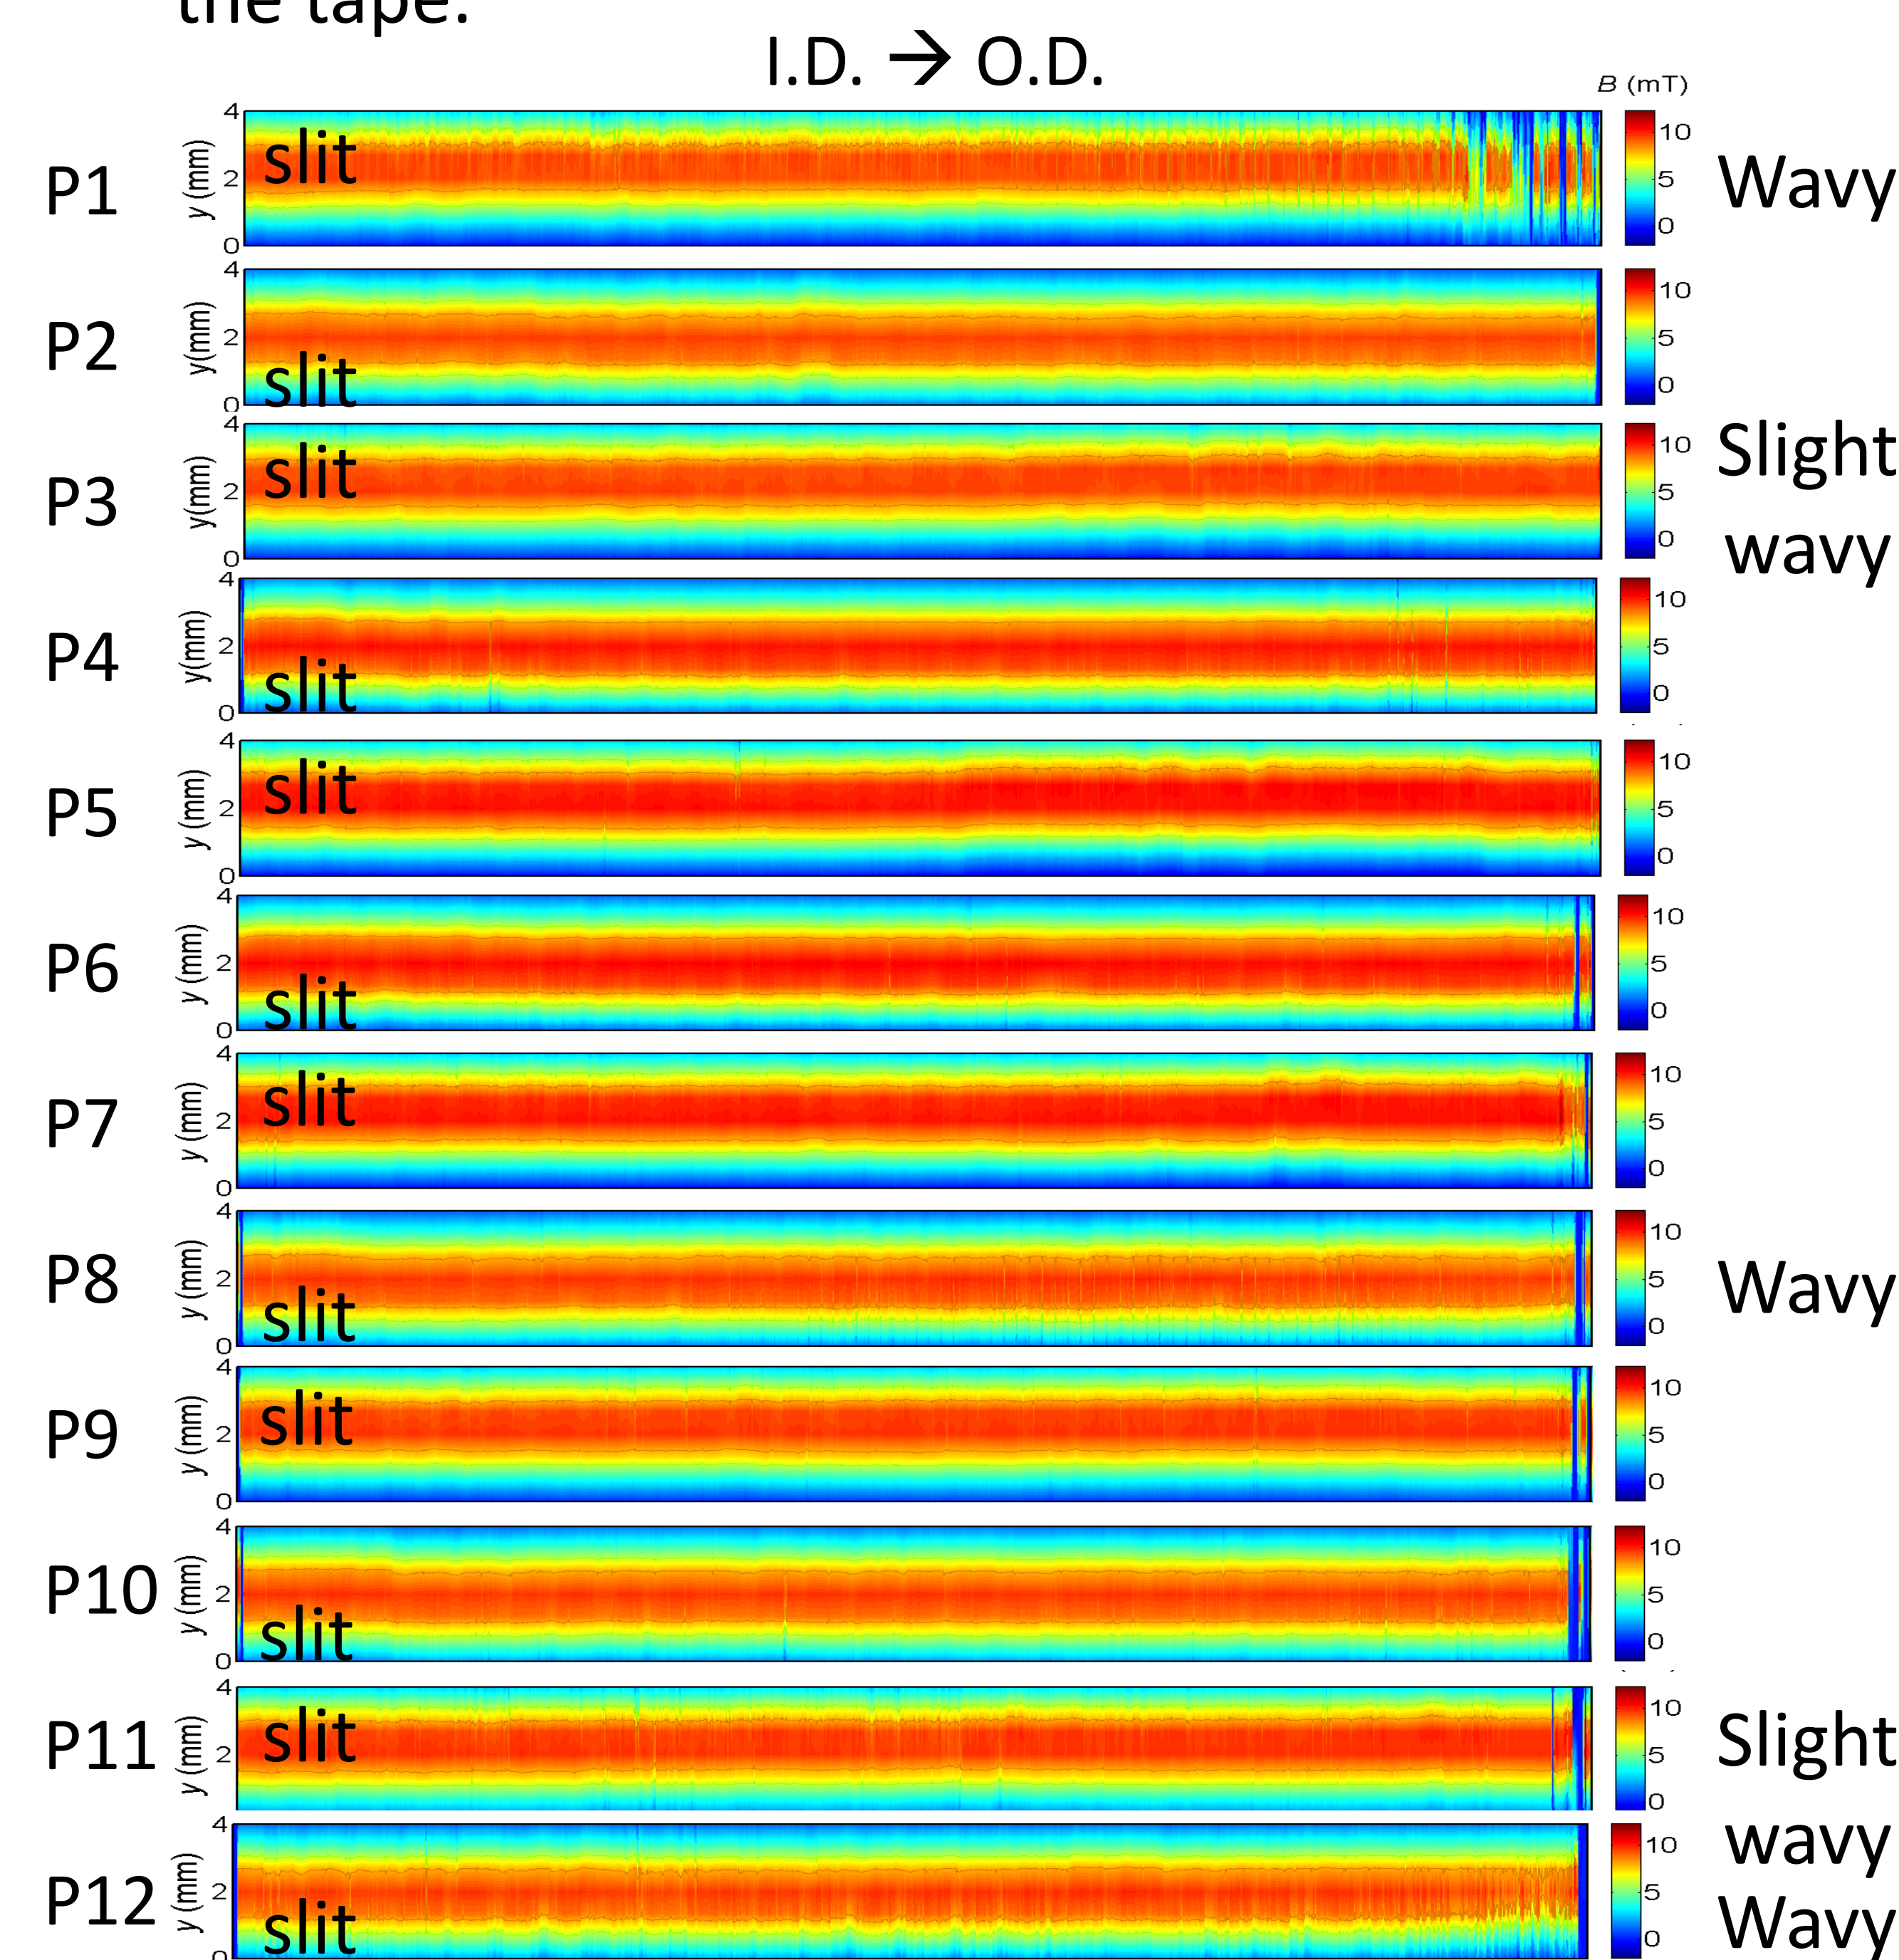
Figure 5. YateStar measurement results.

- DP5 (P10-11), quench initiated pancake, doesn't show the tape degradation.
- ➔ Quench possibly caused by the inner crossover.

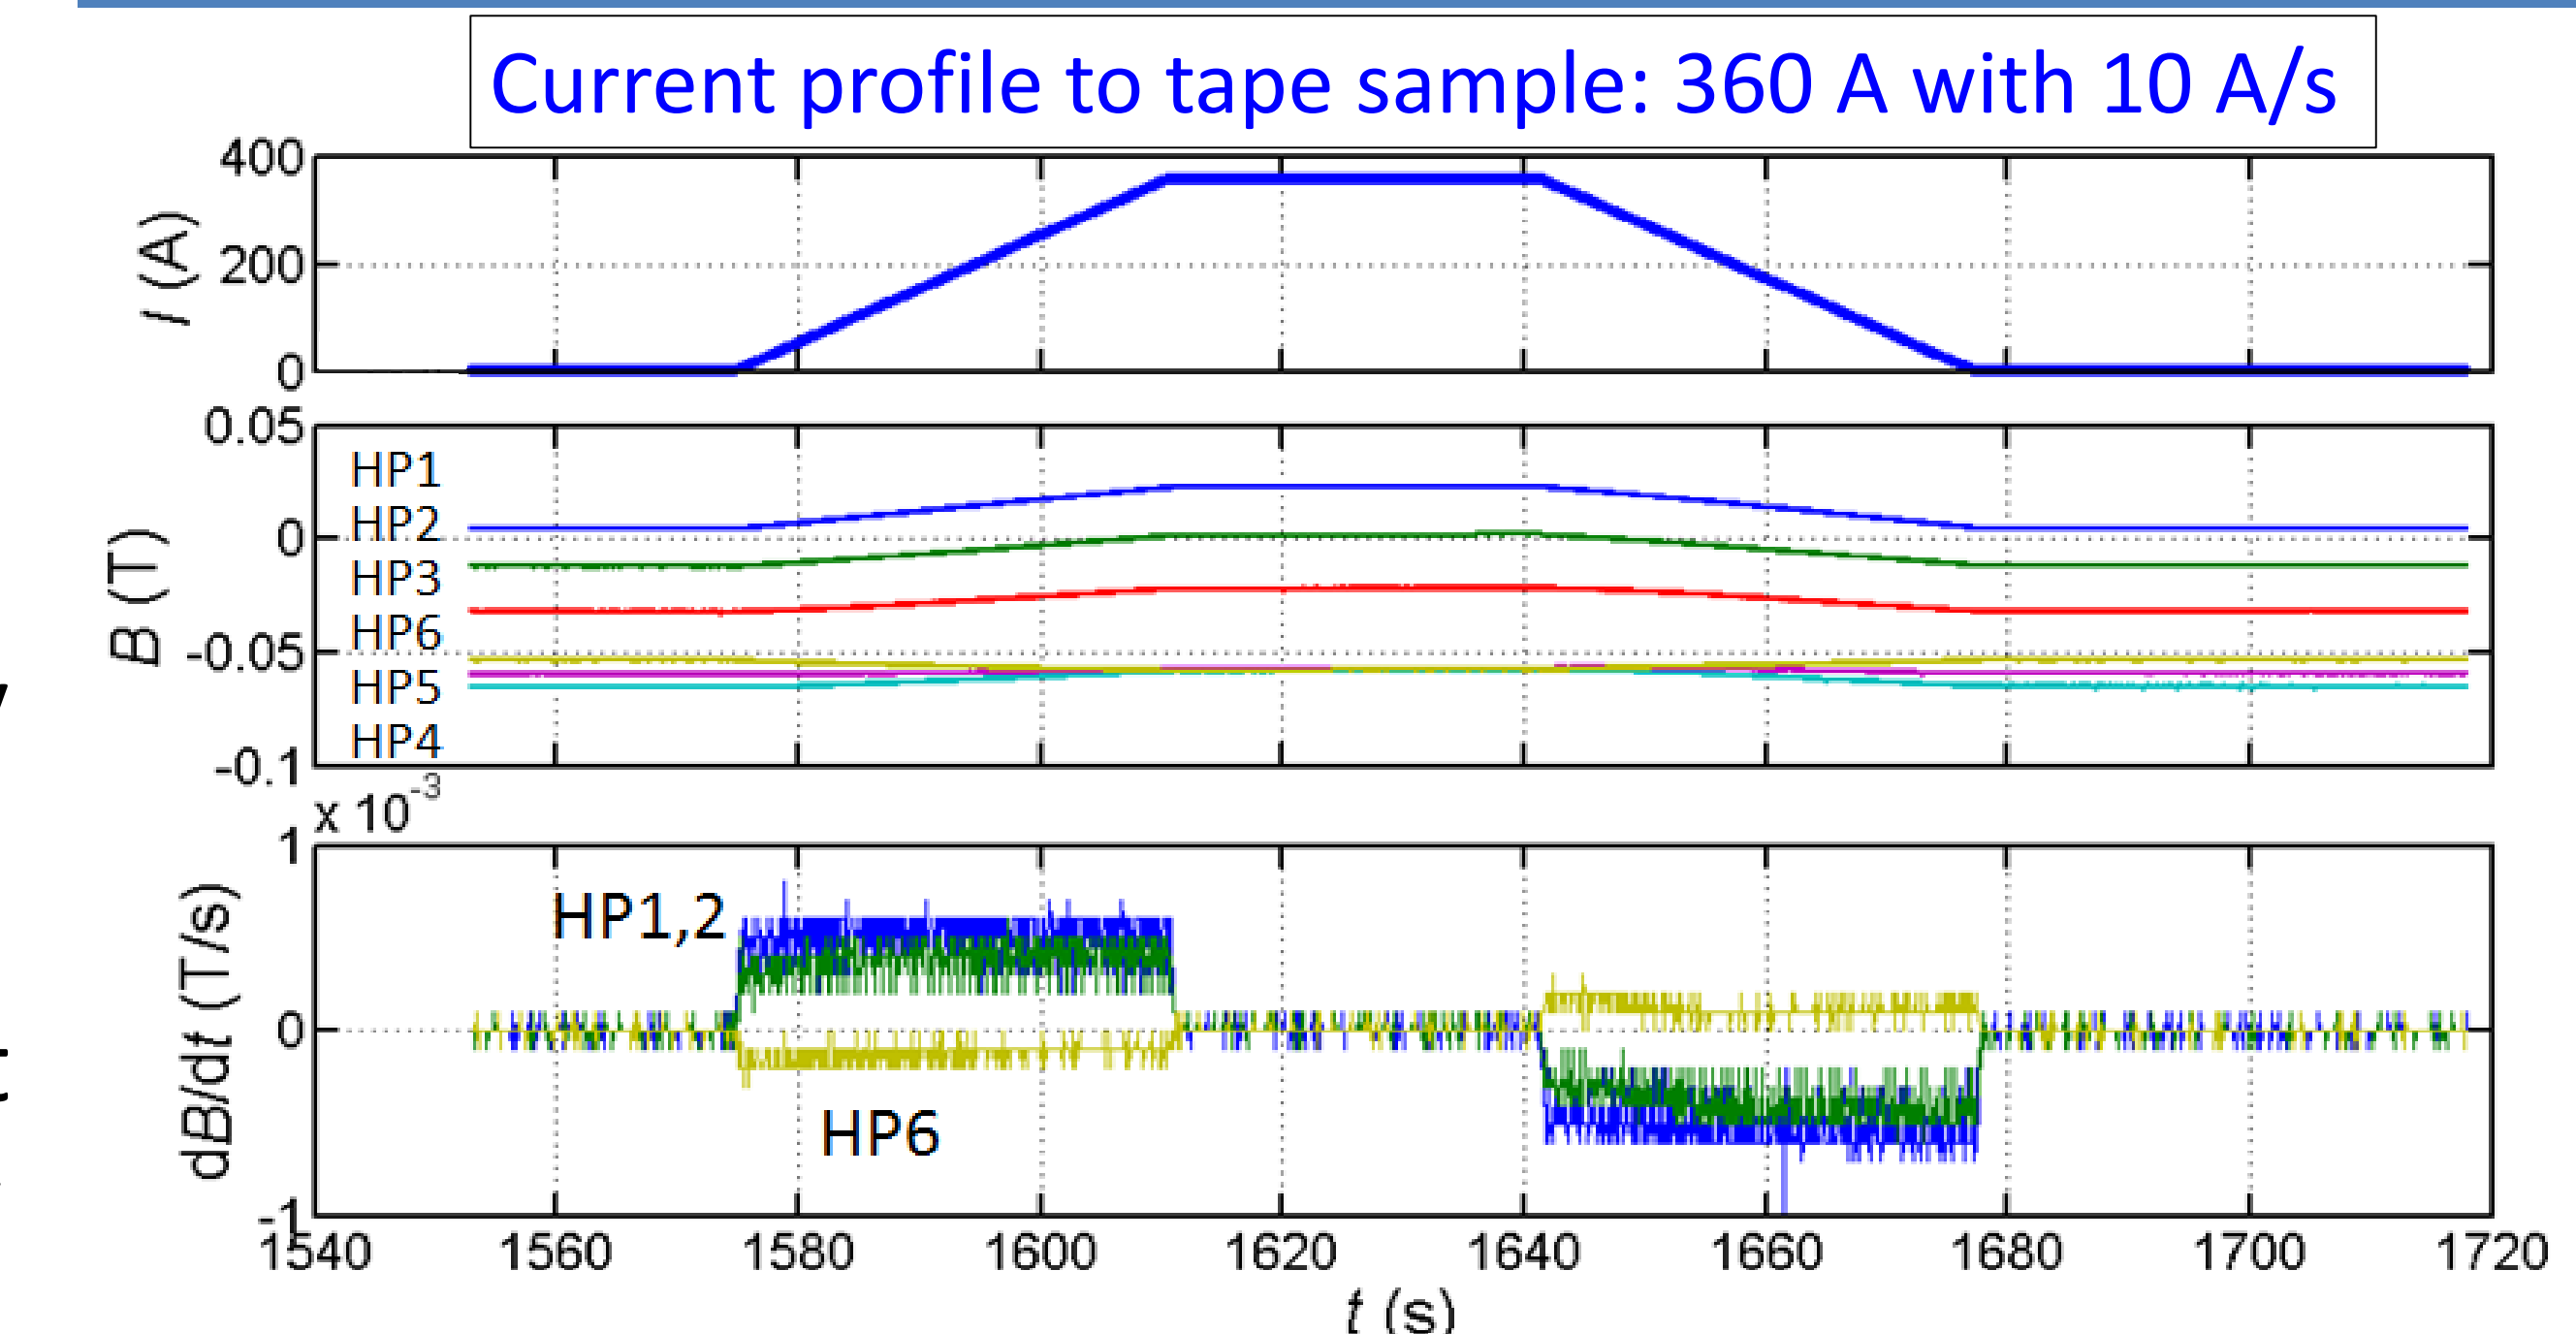
Figure 7. Obtained profiles at background field = 1 T.

- Field changed faster at HP1 which located on the non-slit edge of the sample. Electrical center seems to shift toward HP6.

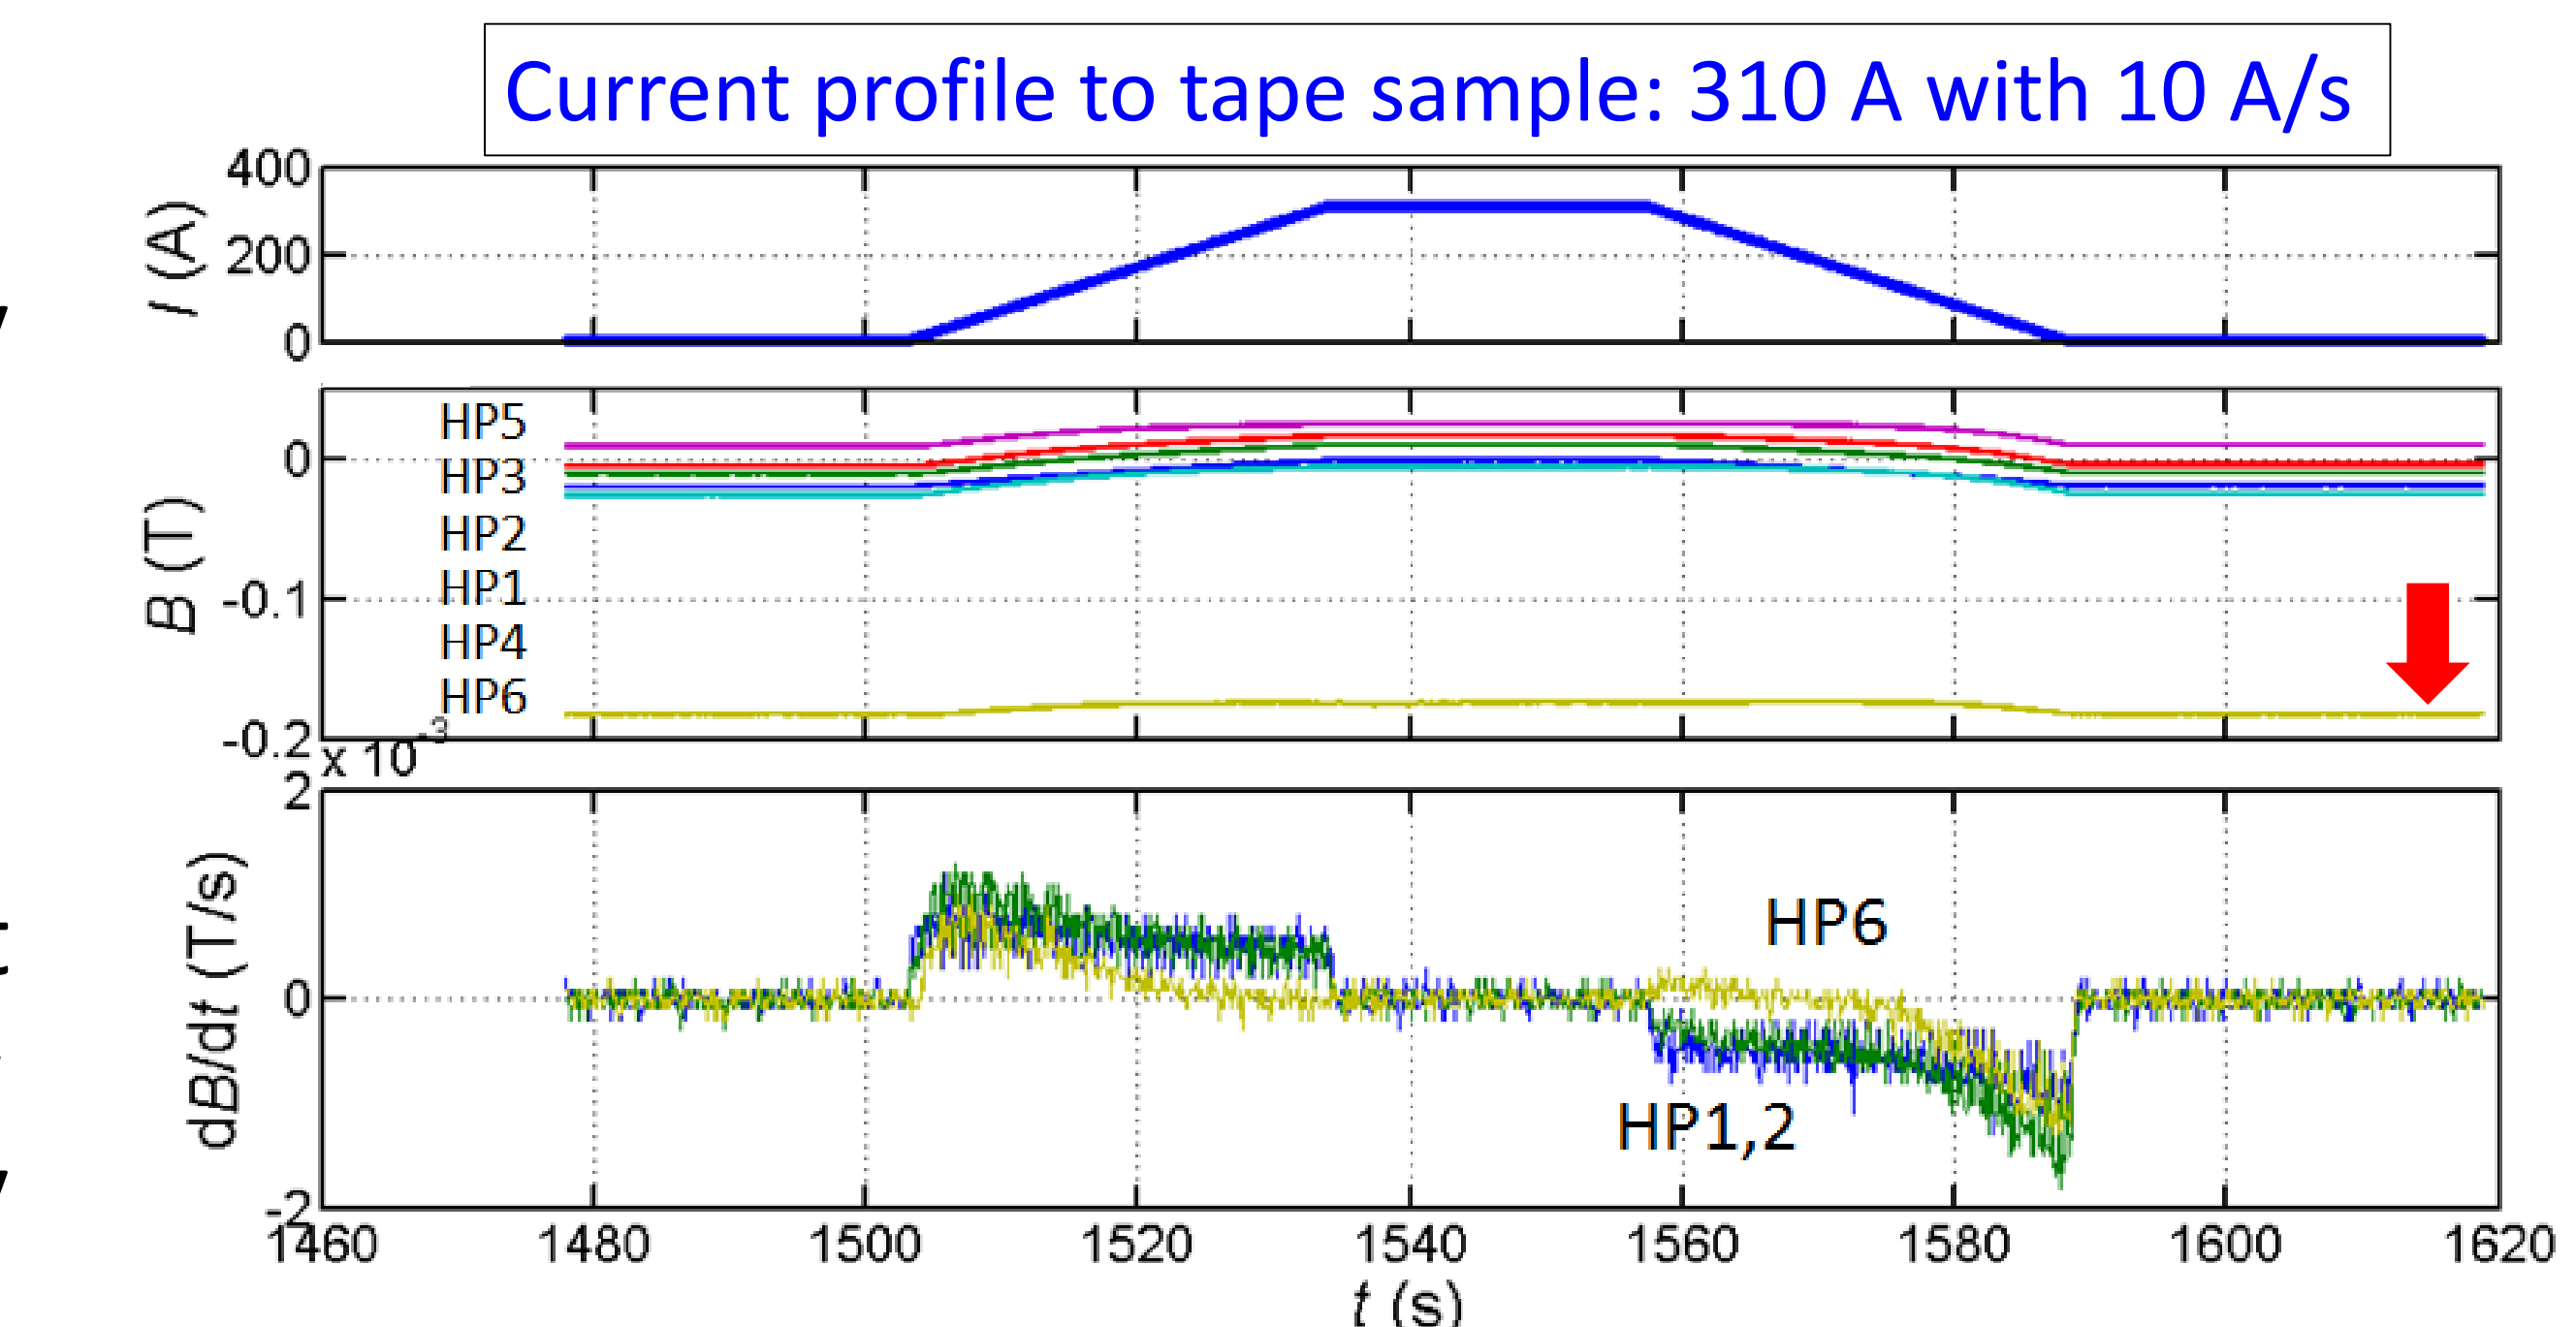
Figure 8. Obtained profiles at background field = 5 T.

- HP6 shows slower increasing rate than HP1. Field increases asymmetric unlike previous case. In both cases, negative dB/dt was confirmed at HP6.
