#### M. Musardo, T. Tanabe, J. Rank, D. Harder, P. Cappadoro, T. Corwin and C. Rhein, Photon Science Directorate, Brookhaven National Laboratory, Upton, NY, 11973 U.S.A

# **Magnetic Field Optimization** of an In-Vacuum Undulator at NSLS-II

**International Conference** on Magnet Technology Vancouver, Canada | 2019

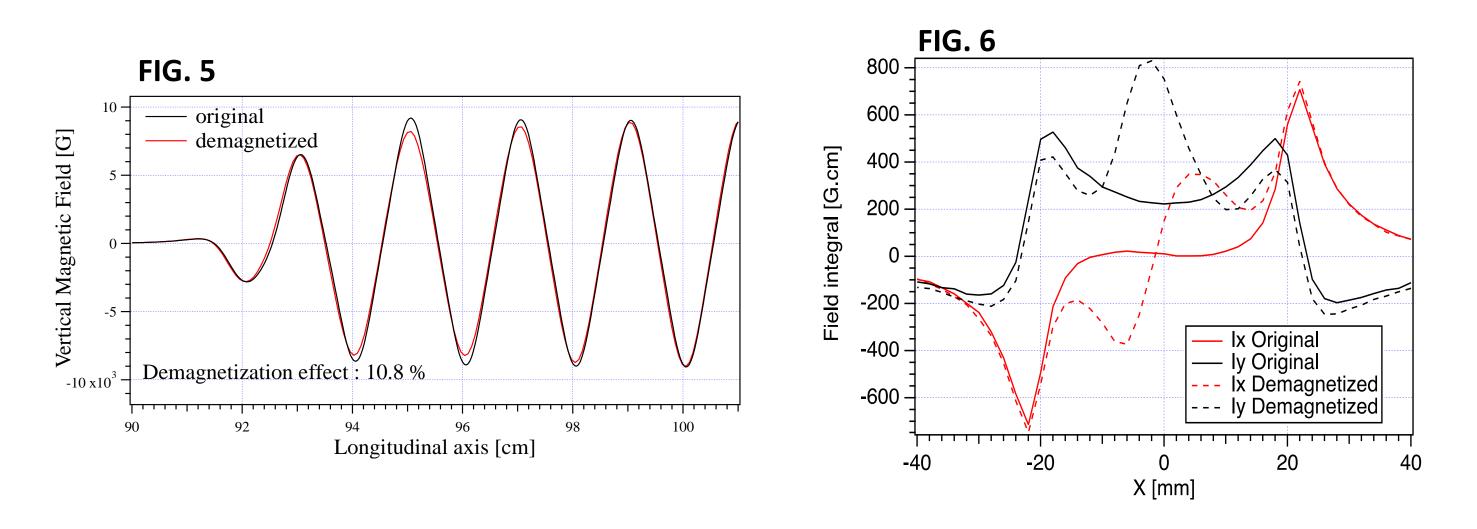
After the mechanical repair was successfully completed, a full set of measurements were performed in order to characterize the magnetic field errors of the device. These measurements revealed that the first 3 upstream periods of the device were slightly demagnetized. The Figure 5 shows a comparison of the vertical magnetic field profile at 6.2 mm gap between the original measurement taken in 2014 and the measurement after the accident. The peak field amplitude of the first 3 upstream The HXN IVU was procured as turn-key device by Hitachi Metal America (Neomax) and installed into periods has decreased by 10% due to these demagnetized modules. The first attempt to restore the magnetic field the storage ring in August 2014 in a short straight section. This device has a period length of 20 mm performance of the device was extract the first 6 demagnetized modules on the top and bottom arrays of the device and and a maximum effective K of 1.83 at 5.2 mm pole gap. The magnetic module consists of a half insert the Neomax spare modules, which were identified according to the Helmholtz measurement data provided by the period unit with two NdFeB magnet blocks of high intrinsic coercivity and one Permendur pole piece. vendor. The magnetization in all three directions of magnets and the N-S magnetic field measurements at a given distance were carefully chosen in order to obtain mutual cancellation of the field errors. A comparison between the magnetic field Figure 1 shows the IVU at the ID magnetic measurement facility (ID-MMF) for magnetic integral of a demagnetized module versus an original module is shown in the Fig. 6. A total of 12 replacement modules were characterization and tuning installed on the magnetic girder on the upstream side of the device.

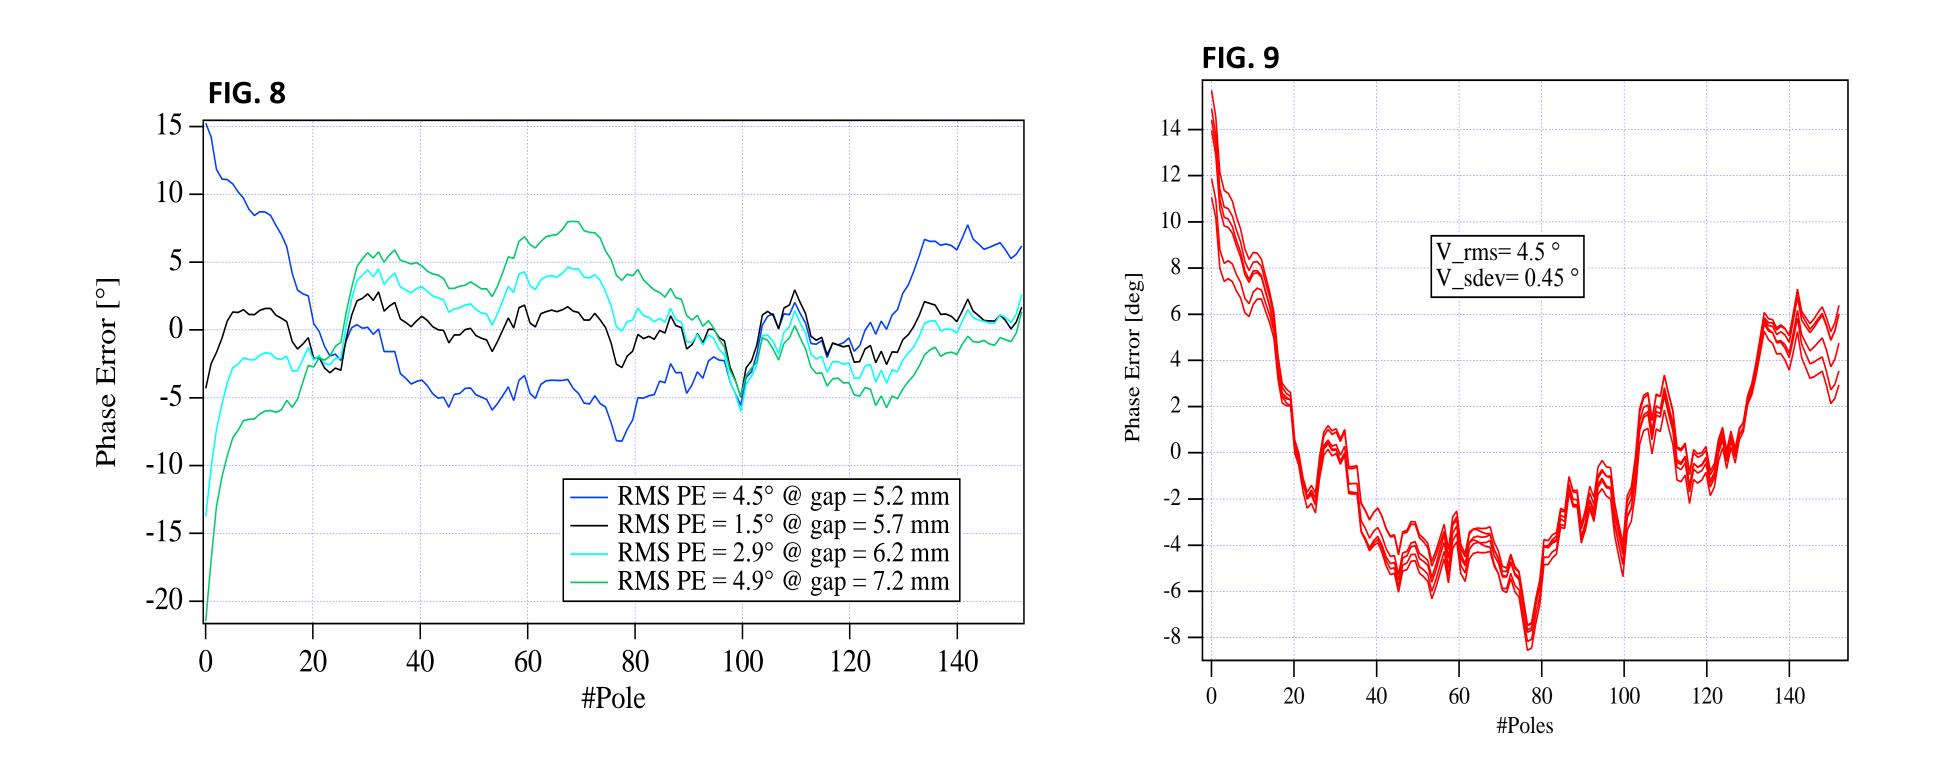
The RMS phase error is used as figure-of-merit to quantify the effect of magnetic errors on the radiation intensity. Therefore, in order to restore the spectral performance of the device a phase shimming technique was implemented. This technique consists of increasing or decreasing locally the on axis peak field along the device without distorting the periodicity of the field. A proper tuning of the peak field advance by using magnetic shims allows the RMS phase error to be minimized. The phase shimming was implemented by placing thin Ni-Cu sheet of 100 µm thickness on the surface of the magnetic array as shown in Fig. 7. The Ni-Cu sheet becomes magnetized under the surrounding nominal field and the additional magnetization can be regarded as a small field source and enhances the field locally. The specific locations, dimensions and number of the shims necessary for the magnetic correction were determined by using an optimization script developed in-house. The shimming procedure is performed based on the measurement data and pre-measured shim-signatures, which describe the magnetic field perturbation induced by the shims located at different longitudinal positions. Given a set of shim-signatures is possible to predict the effect of any shim configuration on the magnetic field distribution and consequently on the optical phase error at a specific gap. The linear superposition of the fields generated by the shims results in the desired magnetic field profile. The phase shimming was capable to improve locally the field quality of the device reducing the phase error to the required values without impacting drastically the total first integral. The phase error distribution at different gaps after the magnetic shimming is shown in Fig. 8. This error contribution is about 0.45 deg. and it is correlated to the mechanical gap repeatability (Fig. 9).

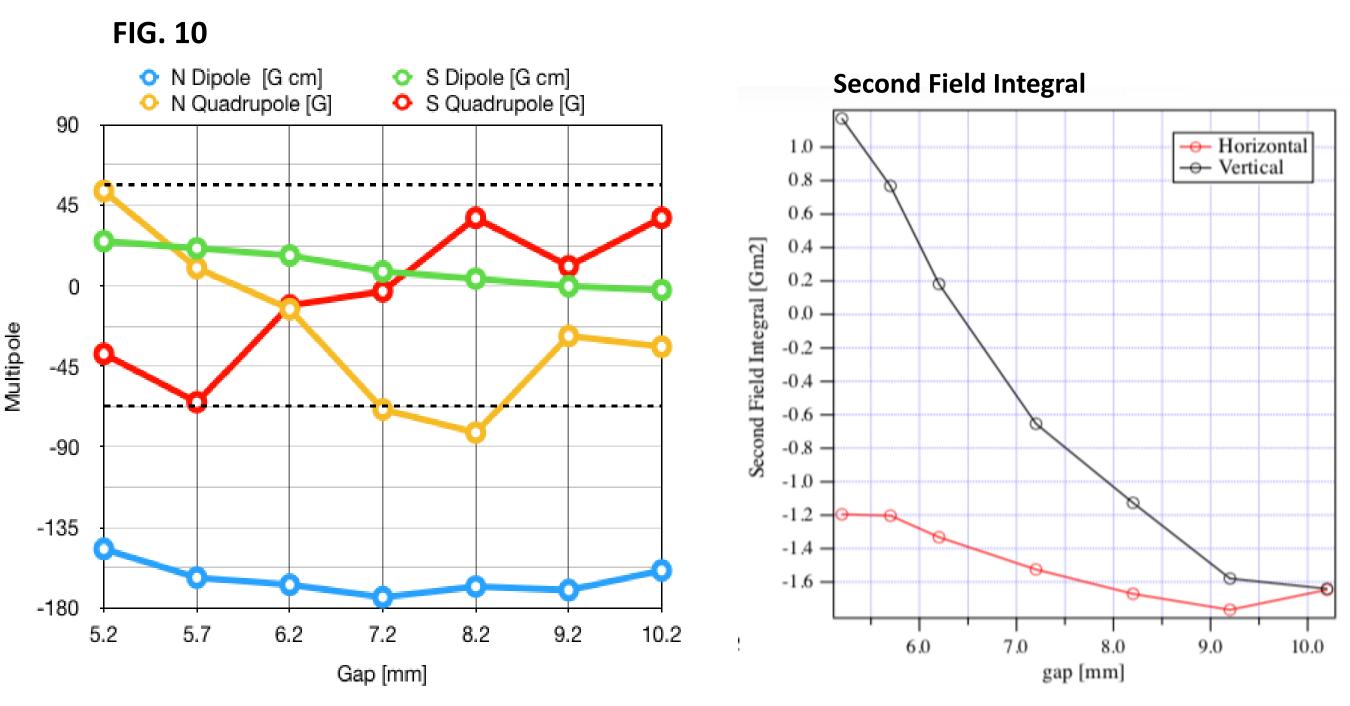
After improving the phase error distribution, the next and final step of magnetic optimization was performed to compensate the remaining normal (N) and skew (S) integrated multipole of the device, primarily to minimize the quadrupole components. This final magnetic optimization was achieved by a rearrangement of the chip-magnets called "magic fingers" inserted into special holders and mounted to both ends of the upper and lower magnet arrays of the device. The magic fingers arrangement is a suitable method to decrease greatly the multipole errors. The final multipole values after the magic fingers tuning at several gaps are shown in Fig. 9. Even though the vertical dipole is out of the optimization range, the steering coils located upstream and downstream of the device can easily correct it.

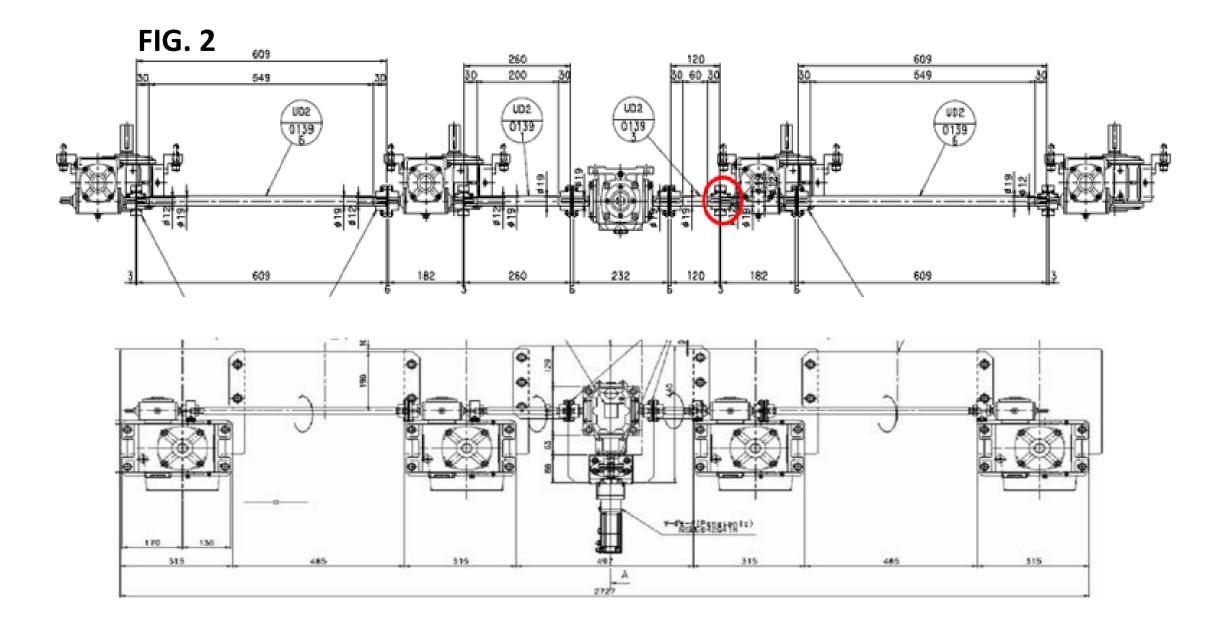
The uncontrolled independent movement of these girders led instantaneously to critical secondary failures. Firstly, the loss of the gap drive synchronization corrupted the once precise relative parallelism of each magnet plane. Ring extraction, with realignment and magnetic field optimization in the ID-MMF was inevitable. Secondly, a shear failure of the copper water lines integral to the in-vacuum cooling platens breached the IVU vacuum chamber. Thankfully, its large rectangular seal could not keep the containment but rather acted to relieve the rising internal pressure (albeit onto the tunnel floor). Forensic inspection and survey of the horizontal drive train uncovered gross misalignments at the junctions of interconnecting shafts and distortion even within shaft segments. Subsequently, data from accelerometers that had been attached to the shipping container revealed the HXN IVU had experienced higher than expected accelerations, particularly along its long axis. Finite element analyses of the IVU subject to such sensor-recorded loads shows deflected shapes of the structural frame and drive shaft that closely resemble post-mortem survey data as shown in Fig. 4. Furthermore, an in-situ survey performed at the sister CHX IVU of identical construction revealed similar misalignment errors that are, in fact, of even greater magnitude at certain points in the drive train. Various measures were proposed by committee to address this serious concern (e.g., structural reinforcement with "Girder Bridge", water detection sensing, passive pressure shut-off valves, etc. The HXN IVU was extracted immediately over a long weekend and transported to the ID magnetic measurement facility. Replacement right-angle gearboxes were ordered, not just for the failed unit, but for all four vertical axes. Upon receipt, careful bench QI by CMM measurement indicated to varying degrees, a poor alignment between the horizontal input shaft and vertical output shaft on all new units. Yielding to operation demands, these new gearboxes were nevertheless installed while taking careful measures to "average out" those misalignments with existing flexible couplers, especially at critical high-stress points to minimize possible further fatigue.

Once the drive train was assembled and aligned as best afforded by our compressed schedule, measurements and shimming magnetic operations looked to return the IVU to its original magnetic performance. Discussion of outcome of those measurements followed. Meanwhile, in parallel, the failed Cooling System (Figure 3) was reworked, this time with stainless tubing rather than copper, and including specially designed weldable re-entrant vacuum feed-throughs. This new Cooling System is expected to be more reliable benefitting from increased resistance to shear and fatigue, remaining always below the now higher material strengths and fatigue limit. To date, the thermal performance has proven to be equally efficient relative to the original copper system.
