RF performance and operational issues

The LHC RF team
reported by A. Butterworth

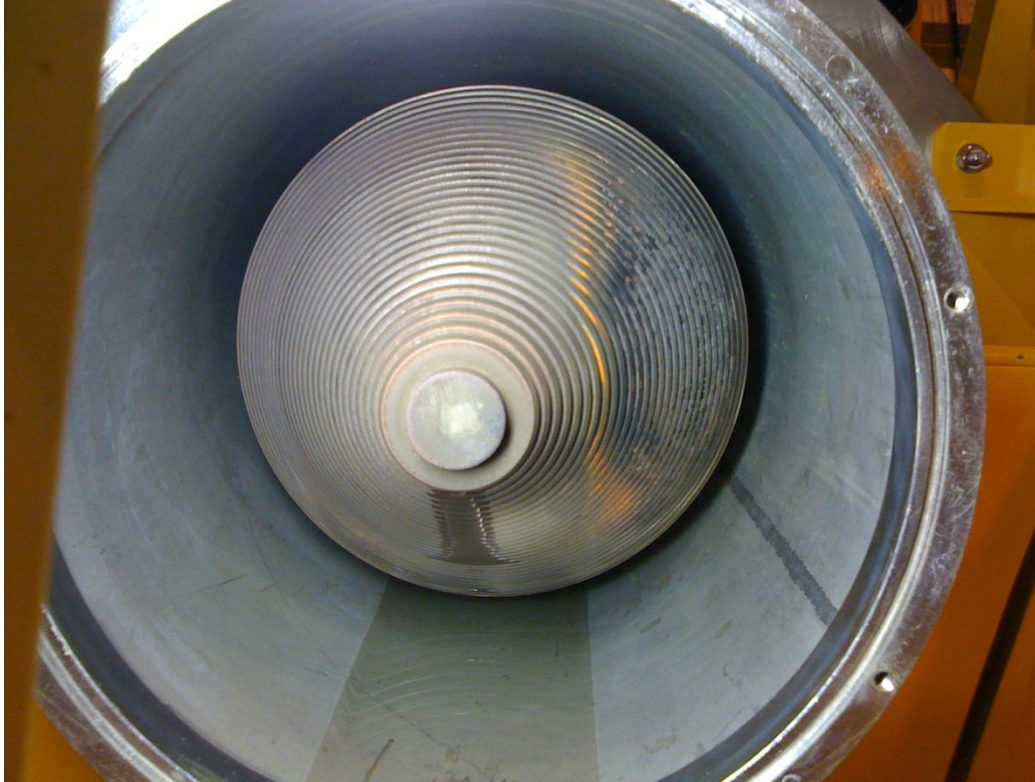
Collector opened 15/01/10

Potential concern - under investigation.

- Mitigation: reduce collector power:
 - fewer cavities with higher voltage per cavity
 - higher RF power per klystron → reduced collector power (below 450 kW)
 - 4 cavities @ 2 MV, many RF trips
 - cavities had de-conditioned during 2 weeks of running at injection level
 - eventually +/- reliable with 5 cavities @ 1.6 MV
- Other measures:
 - Automatically switch power system to READY when RF OFF
 - reduced current, $P_{\text{collector}} \approx 100\text{kW}$

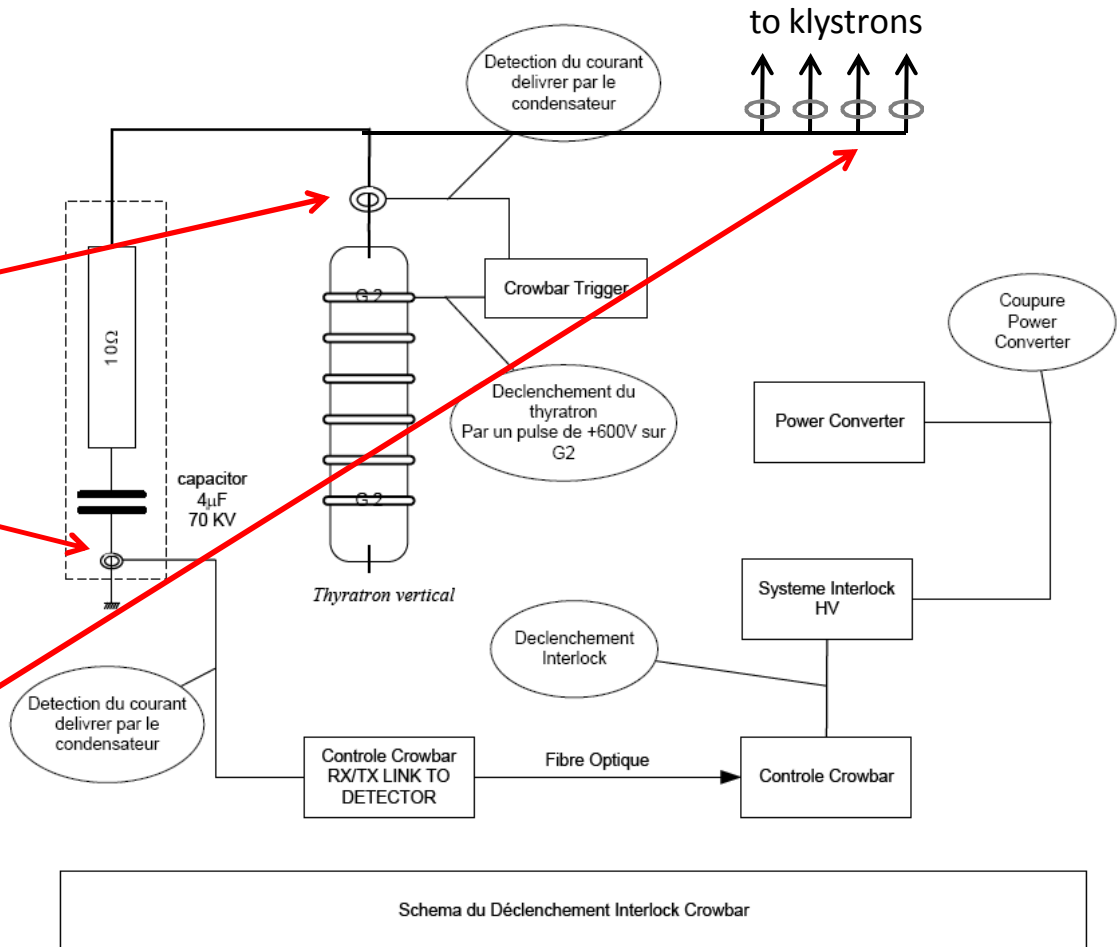
- Many crowbars when starting/raising HV
 → Reduce HV power converter ramp rate

- Crowbar triggers do not come from klystrons

- 1 coil to fire thyatron
- 1 coil to generate power converter interlock
- 1 coil for each klystron: used for interlock diagnostics
- no triggers seen on klystron channels

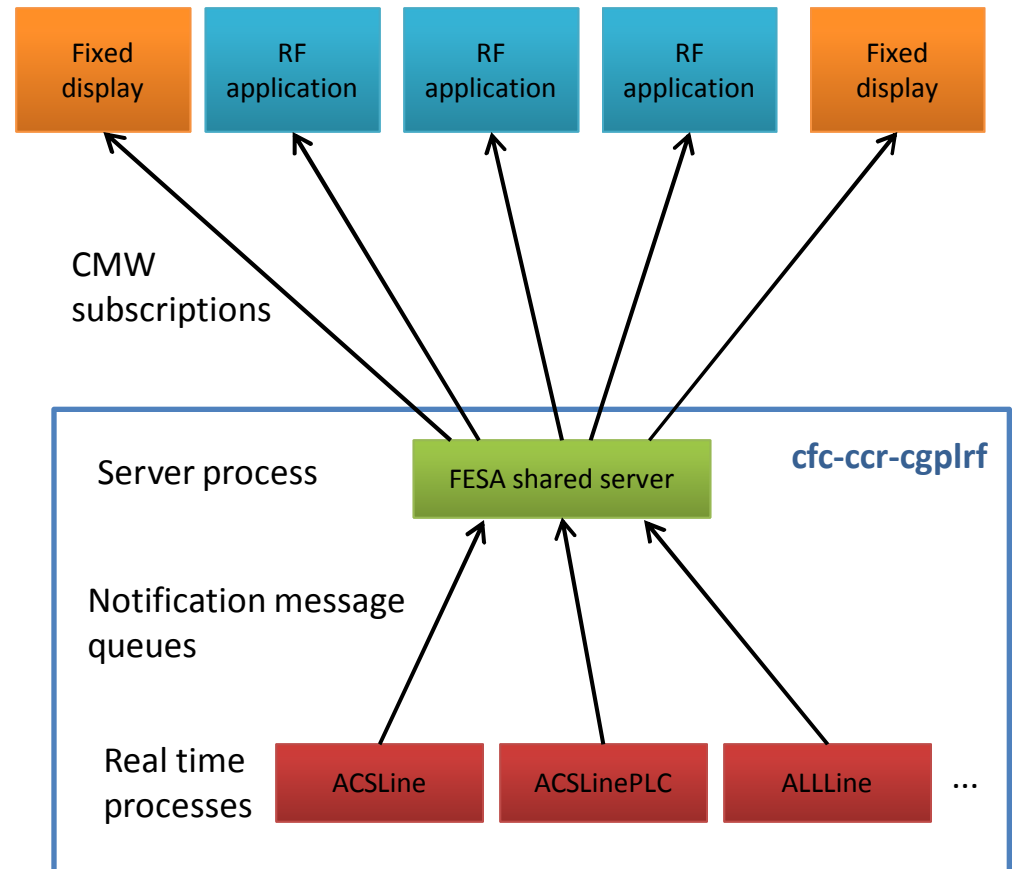
- many subscriptions: machine starts to overload
- notification message queue between FESA RT and Server becomes full
- FESA surveillance mechanism notifies server via signal
- signal caught by any random thread
- FESA crash... application “blocks”
- only hope of restart is to kill all clients and reboot

Bug found, fixed & tested (thanks to FESA team)

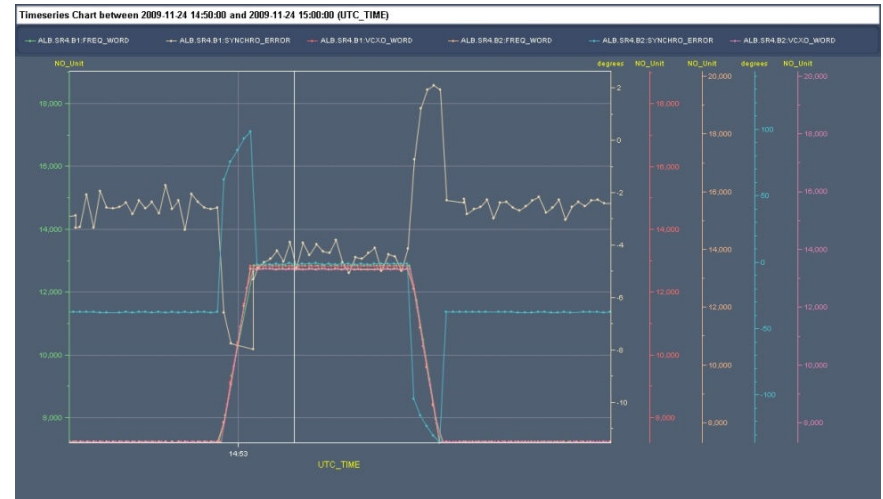
Synchro loop error (blue) during 855Hz trim

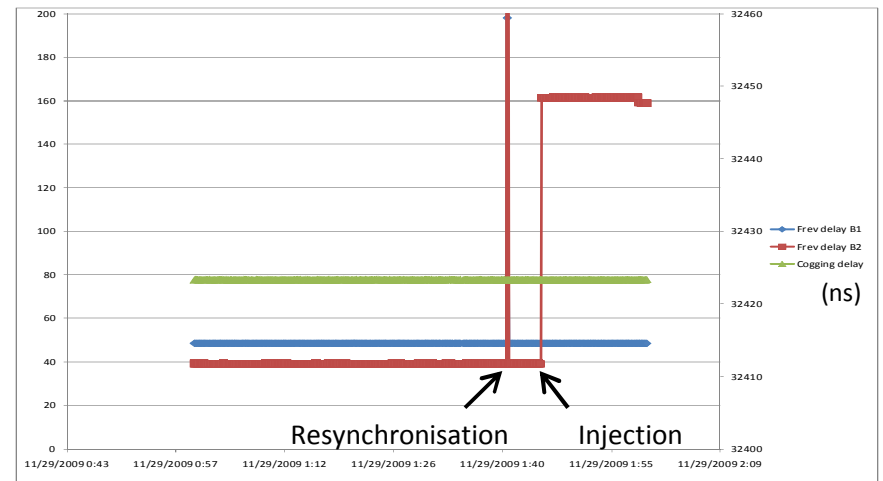
Synchro loop unlocking at injection

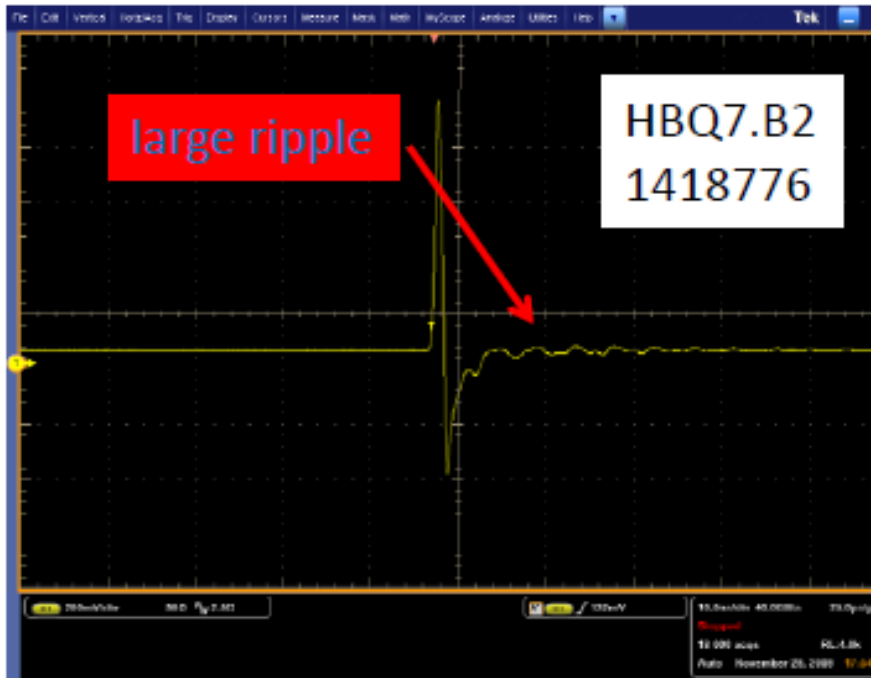
Signal from single bunch as measured on the surface; the large ripple is due to a periodic perturbation on the cable

Two cables being replaced during the technical stop

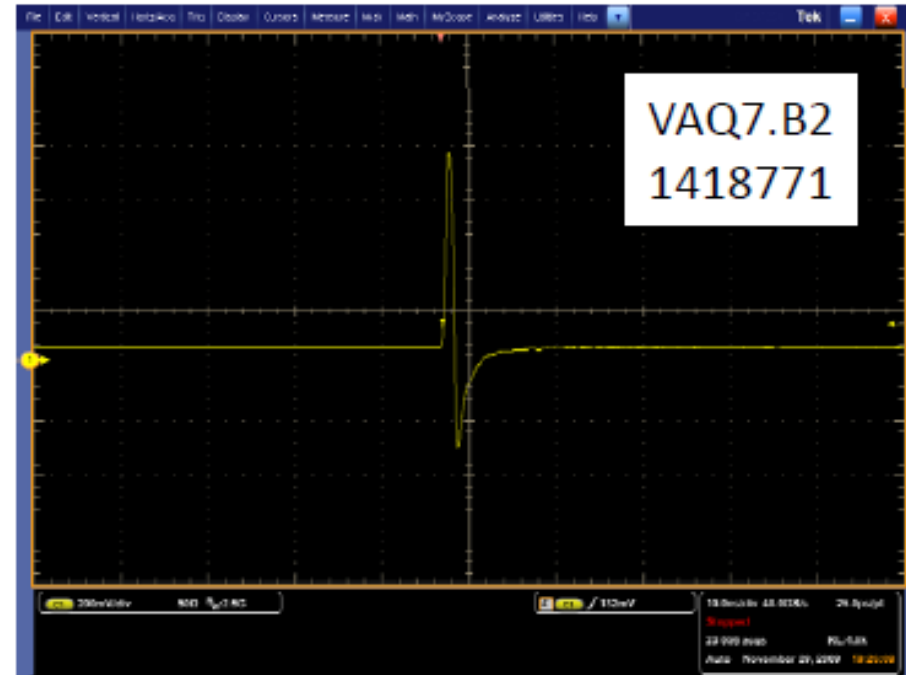
Good cable for comparison

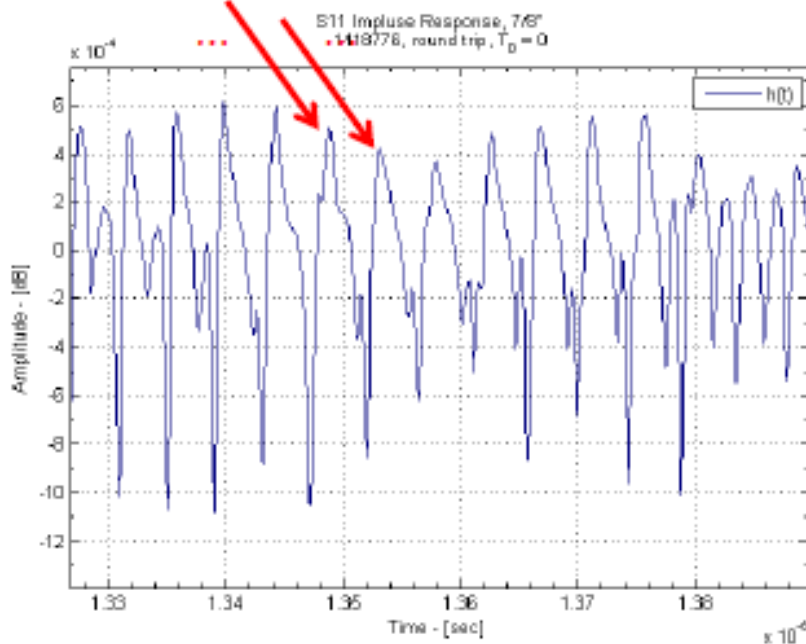
Periodic perturbation visible in reflectometry, compatible with pitch of ladder (attachment every 60 cm = 2 x 30 cm)

periodic reflections at $\Delta t = 5$ ns

Zoom into the time domain S_{11} data of damaged cable

reconsider pick-up signal processing if necessary (all cables show some signs of this problem)

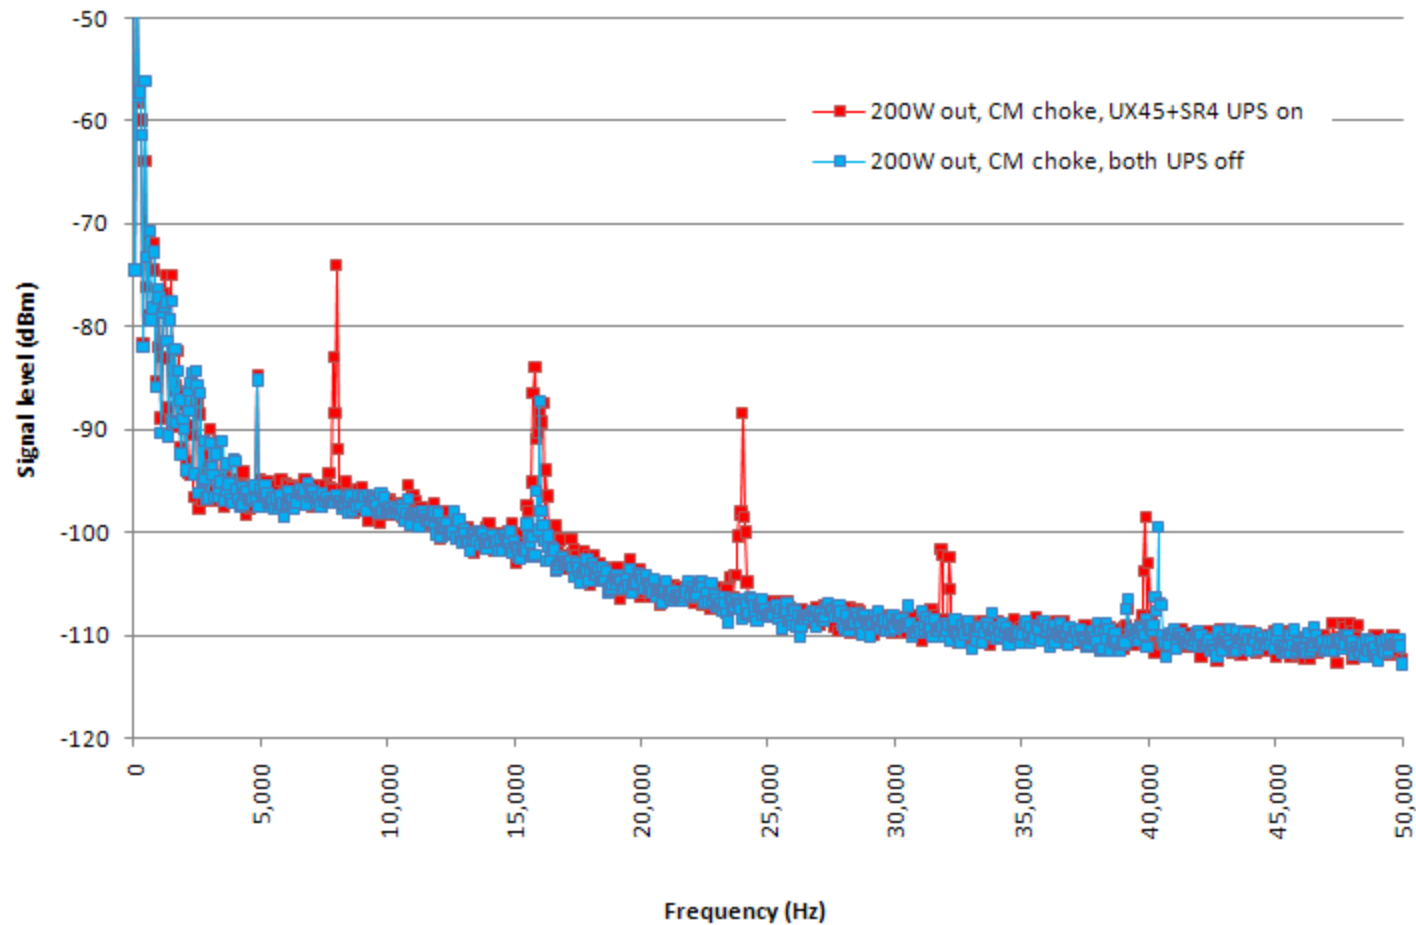
Disappearance of 8 kHz line in damper spectrum when UPS' in UX45 and SR4 are bypassed
line at 16 kHz probably caused by another ground loop involving other UPS or equipment

Splitting predriver output spectrum, both UPS (UX45, SR4) ON

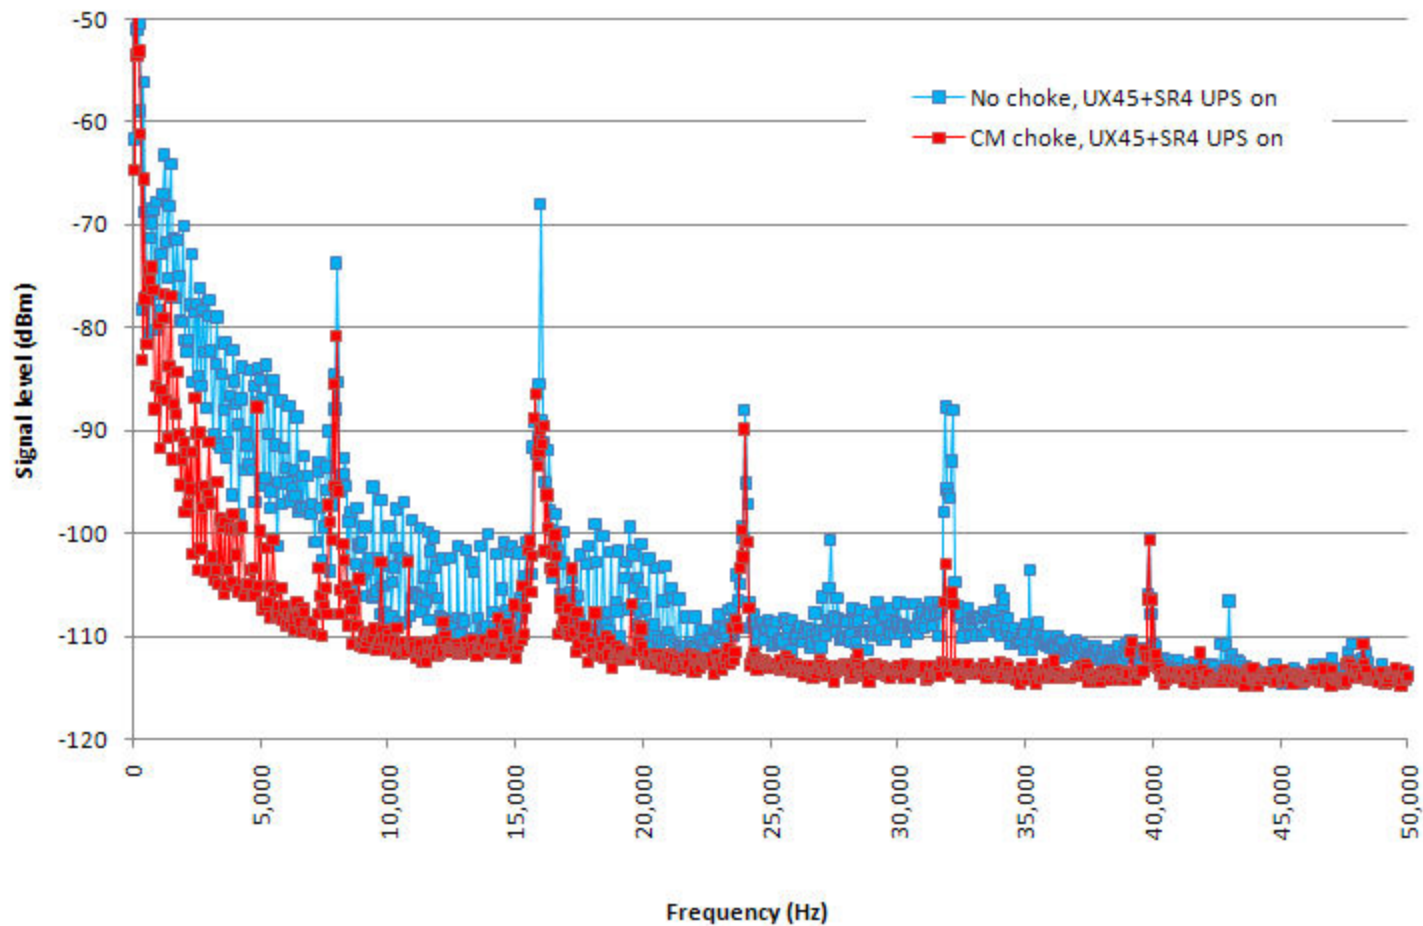
Reduction of damper noise at 8 kHz by common mode choke in UX45
choke will be improved, measurement shows that problem is a ground loop

- For 2010 a scheme to suppress the noise is to install common mode chokes at the input of the damper equipment in UX45
 - 10 dB suppression shown already

- chokes with more windings will be constructed for better suppression
 - if problem persists, another solution would be to move some equipment from the surface to UX45

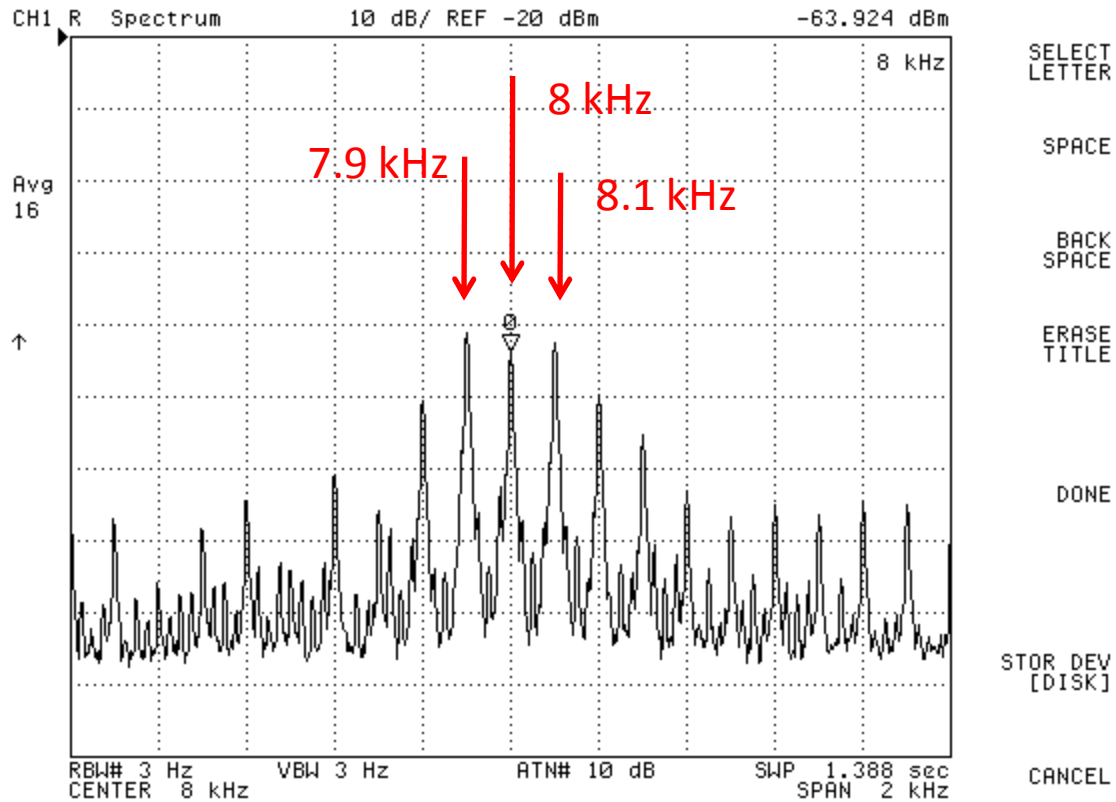
Details of spectrum; 8 kHz + lines spaced 100 Hz

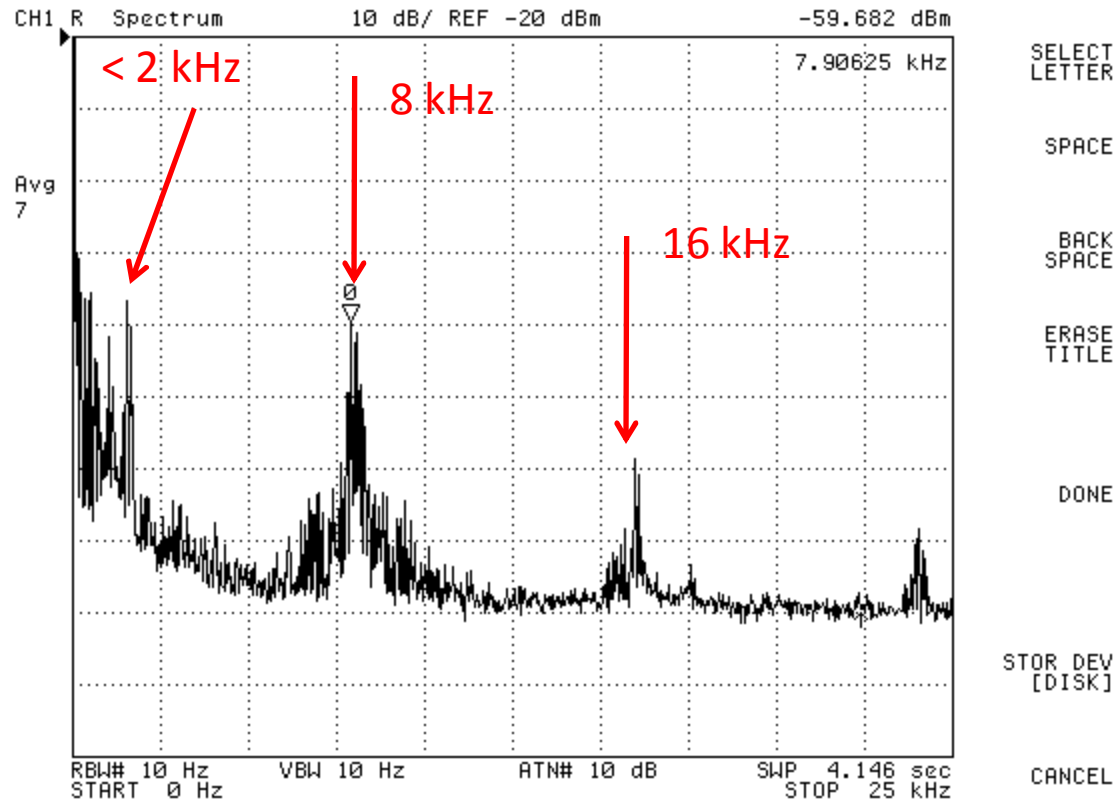
Spectrum of 230 V perturbation in a rack supplied by UPS;
main contributions: < 2 kHz, 8 kHz, 16 kHz
one phase in damper racks (SR4) to neutral

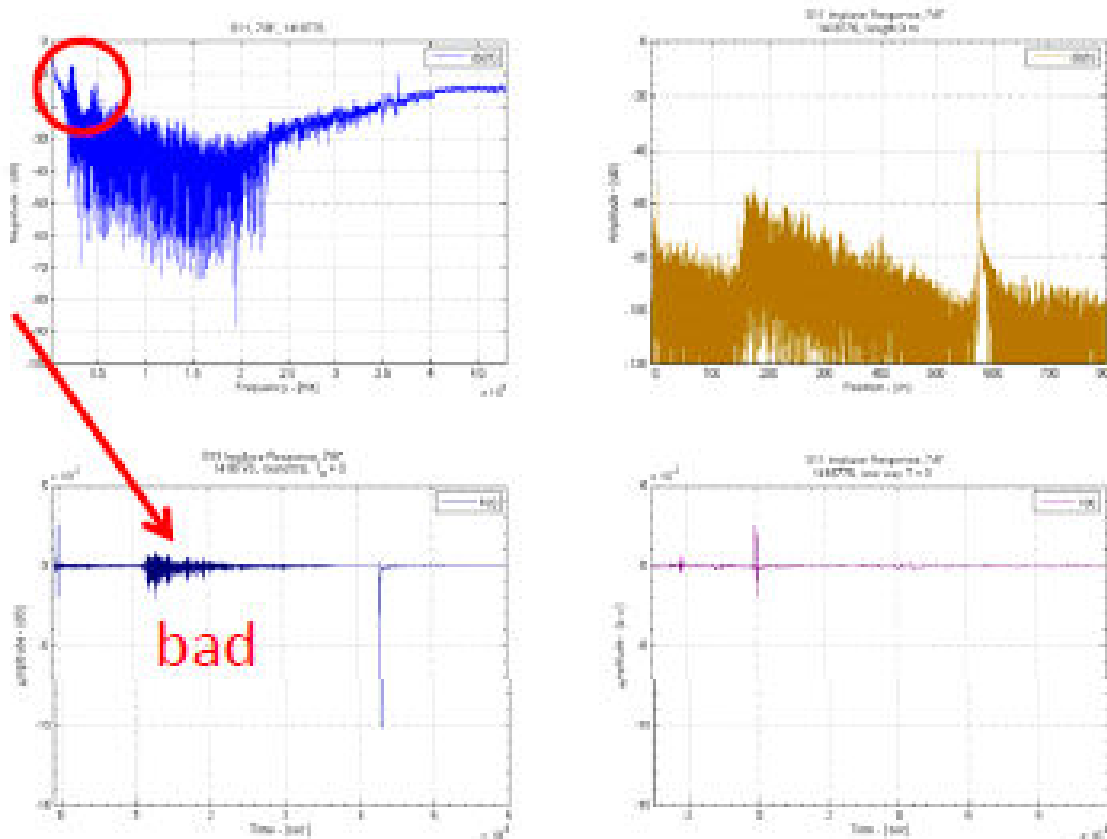
Seems to be due to the way the cables are attached in the vertical part of the pit going down

Reflection from cable in vertical part (in the pit) is high, periodic perturbation in frequency domain at approximately 200 MHz and 400 MHz (unfortunately)

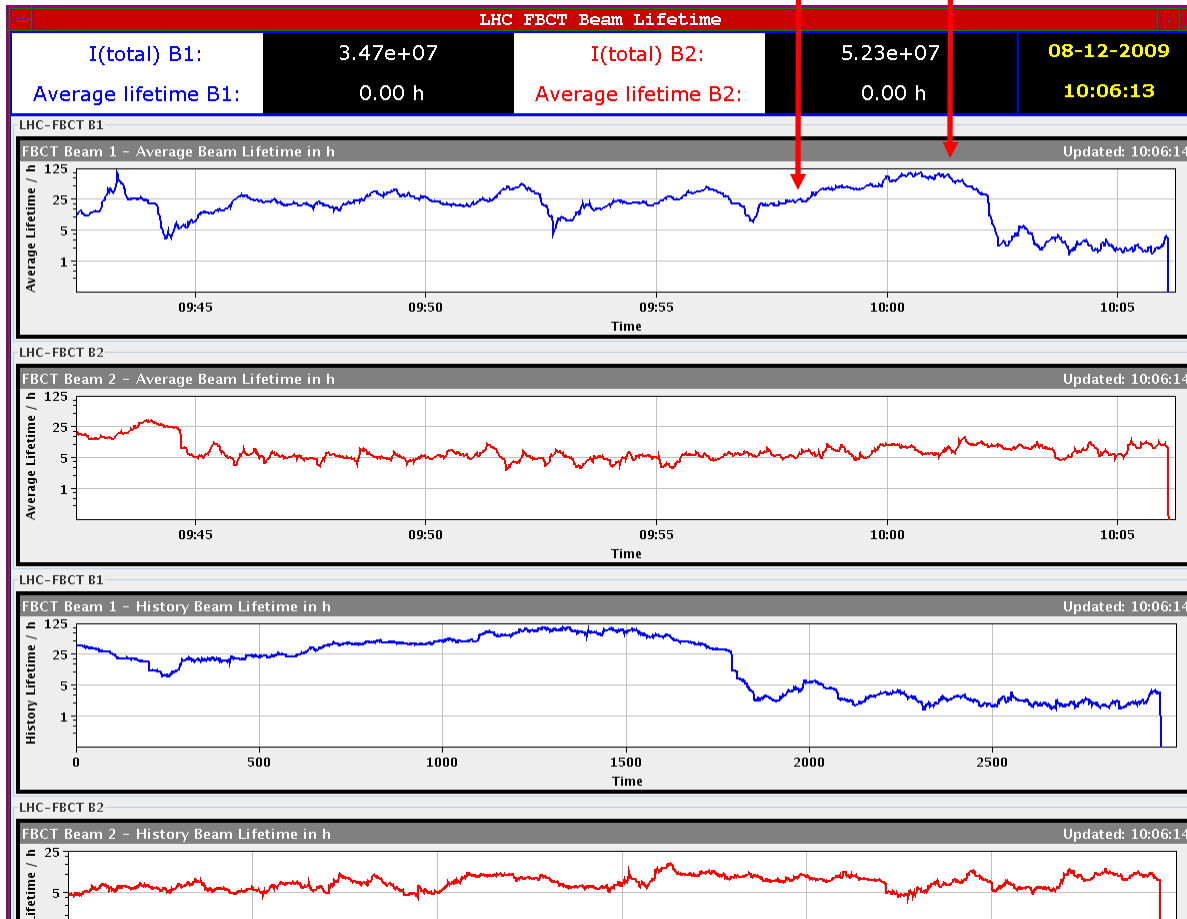
8.12.2009

damper level 3 on
without BI signal
9:58

BI signal on
(via switch and timing on RF side)

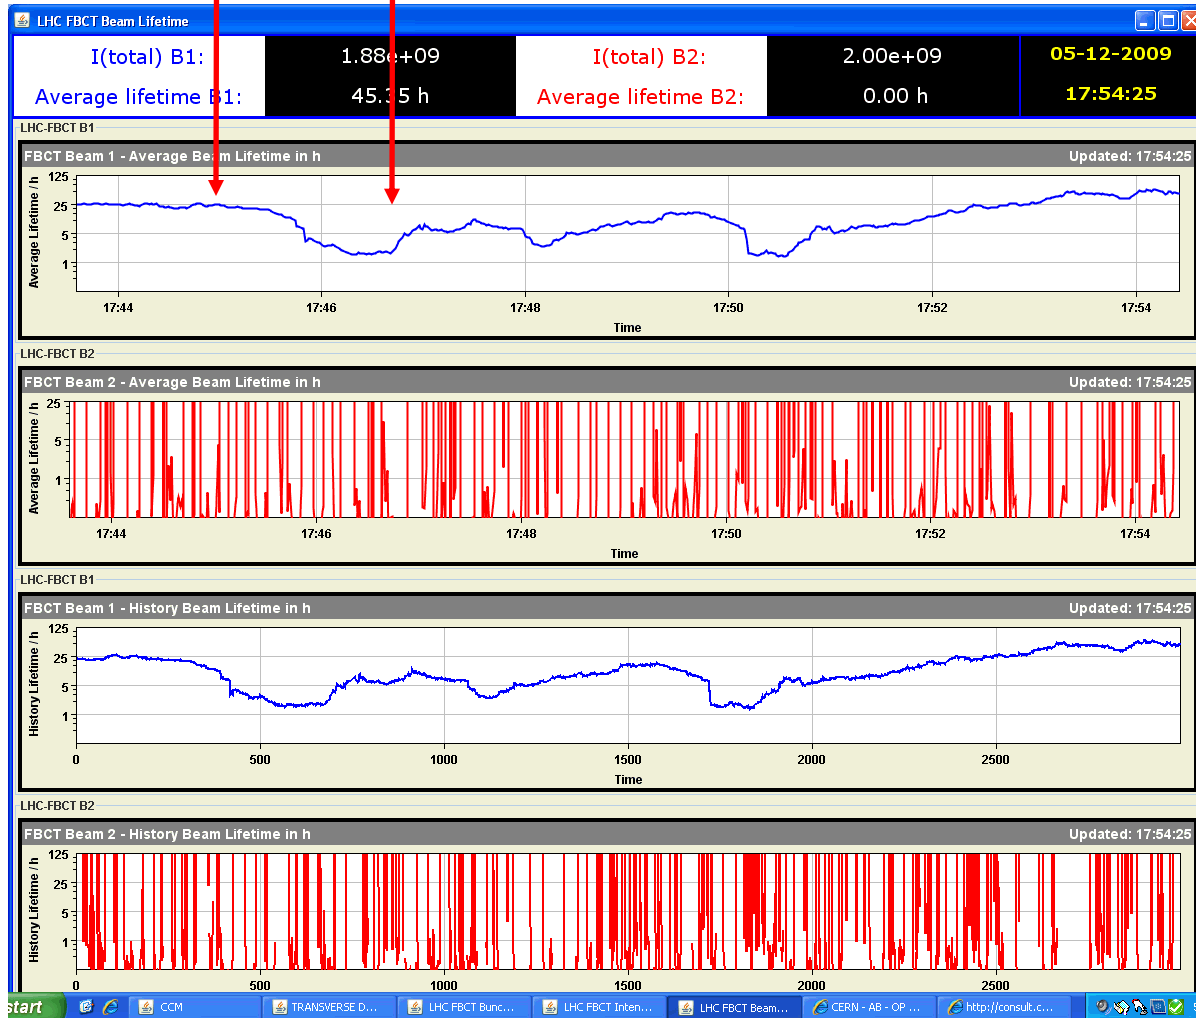
5.12.2009

damper level 3 on
with BI signal
17:45

damper level 3 off
