Cu/Cu Repeater CHARM Radiation test Presentation

Radwg meeting
26 Nov. 2018

Julien Palluel BE/CO/IN
Eva Gousiou BE/CO/HT

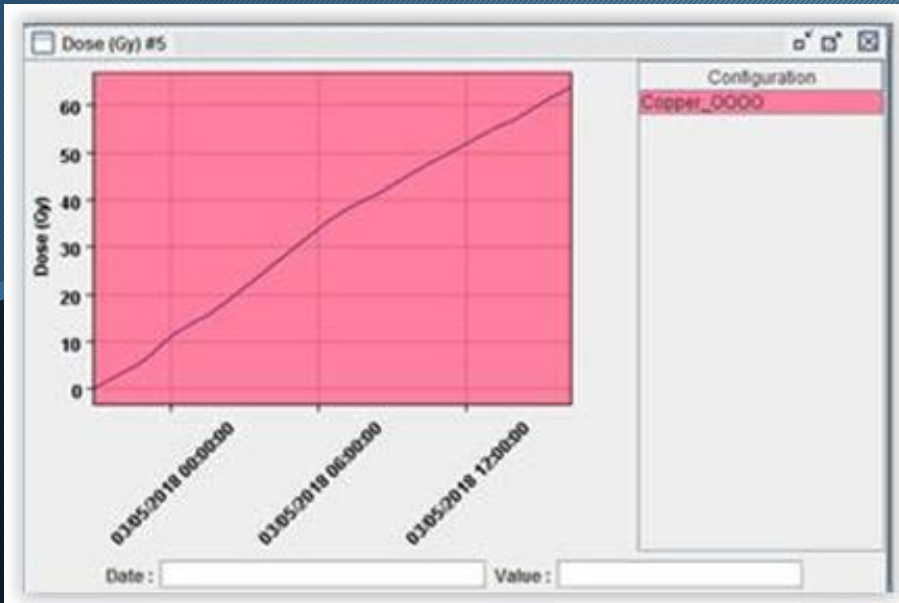
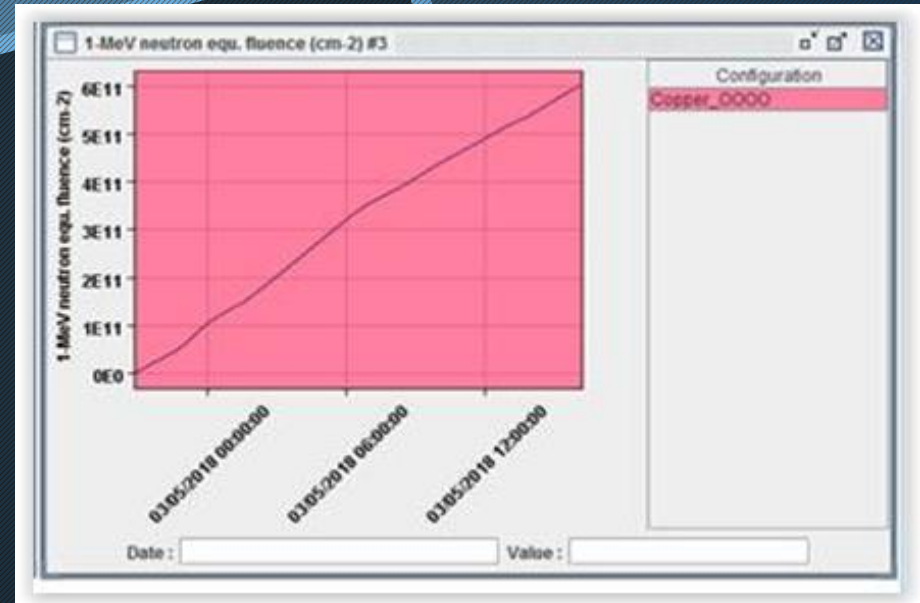
Both DUTs quickly died at 60Gy.

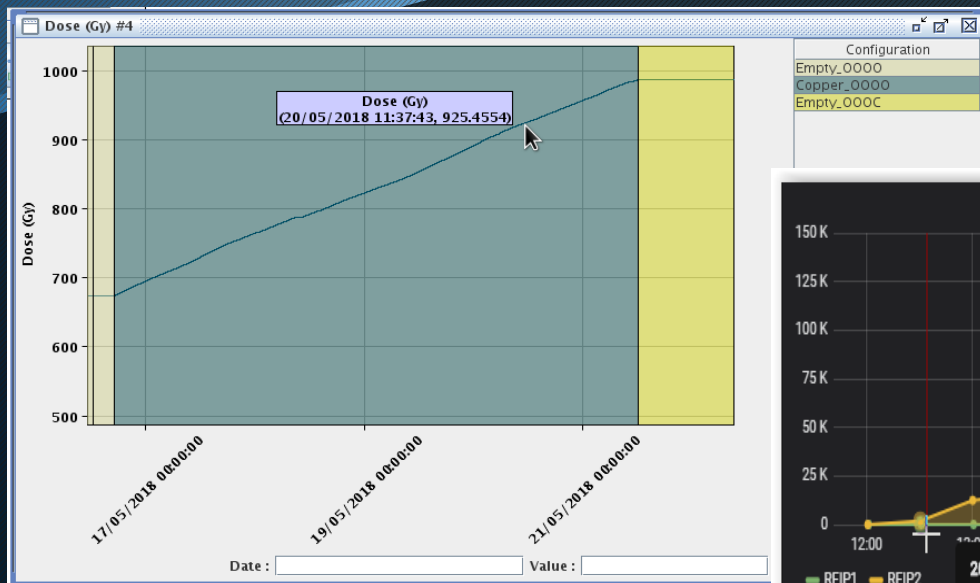
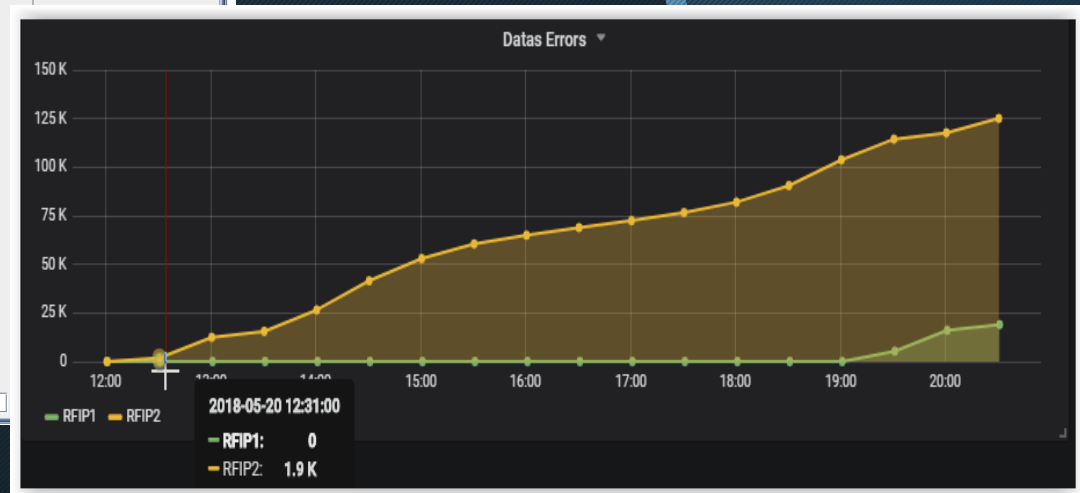
- Suspecting the power mosfet IRFR9220 dealing with the anti-latchup, we shunted it on a repeater and replaced by the SI3443 on the second
 - Rep-01 With no mosfet (short circuit)
 - Rep-03 With new mosfet SI3443
- Both DUTs showed errors at 250Gy.

According to CHARM tool, it took $925 - 675 = 250$ Gy

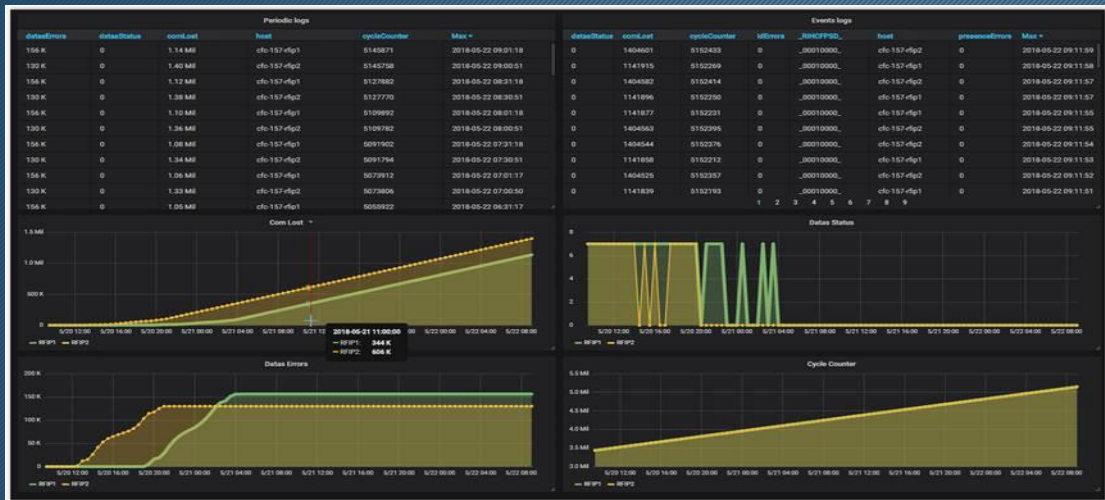
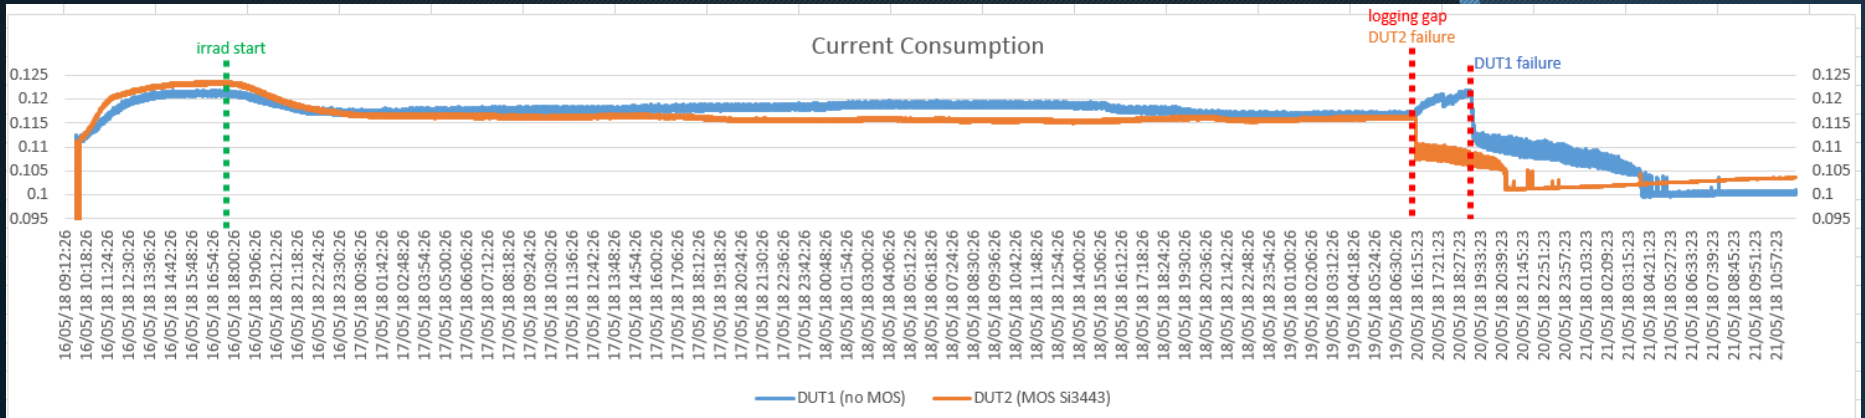
20Gy after first errors, both repeaters did not respond anymore. Power reset did not help more

We are seeing a small current consumption increase exactly before the data failures and then a gradual decrease.

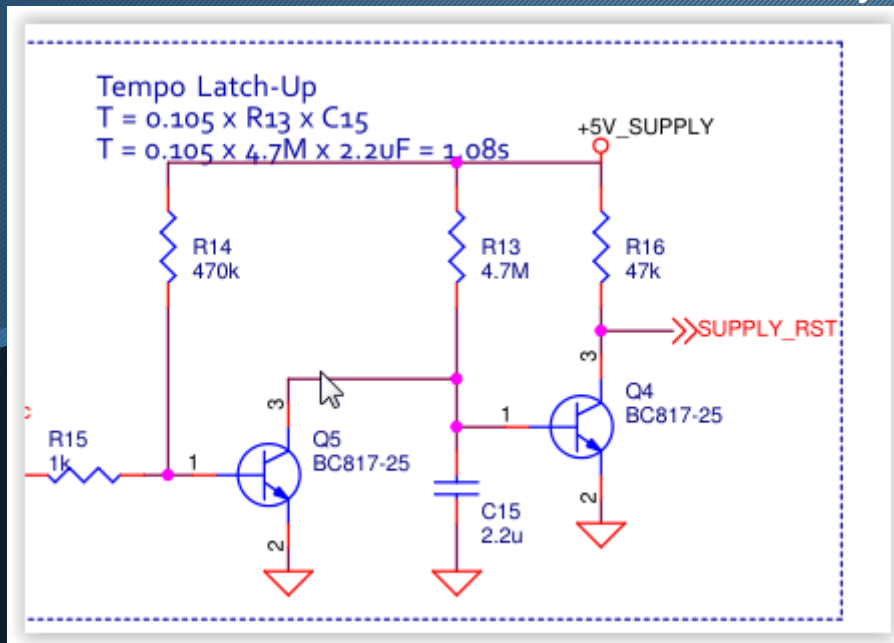
- We confirmed that IRFR9220 TID was very low 60 Gy
- We confirmed that Si3443 is a good replacement for IRFR9220
- We found that BC817 TID was 250 Gy and needs to be replaced

SUPPLY_RST line in a wrong state

- Si3443 instead of IRFR9220
- FMMT419 instead of BC817

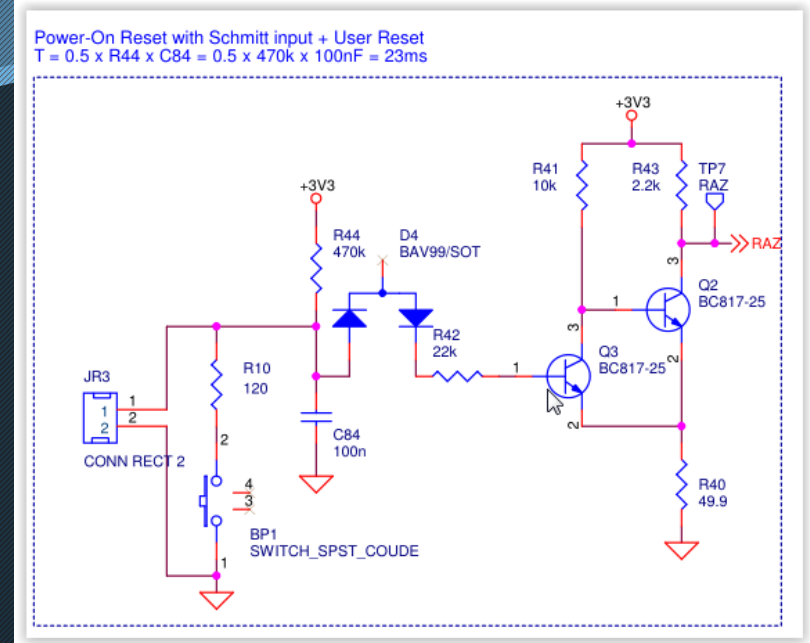
RAZ stuck low
