# HPTPC hardware report

A. Deisting

Royal Holloway, University London

22<sup>th</sup> of November, 2018

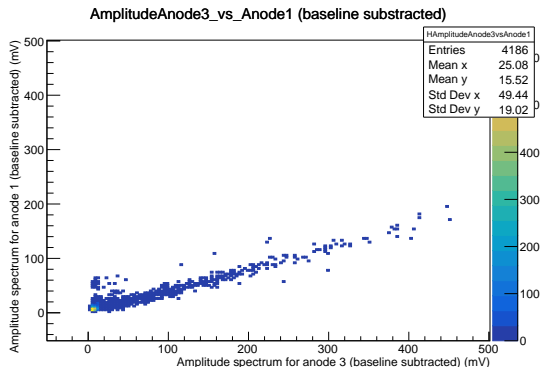
- ▶ Most of the anode 2 signals were not correlated with the anode 1 and anode 3 signals
- ▶ Only at the highest voltages there are correlated signals over all three anodes
- ▶ Basically all anode 1 and anode 3 signals were correlated
- ▶ During ramping and sparking the anode 2 HV channel showed now abnormal behaviour
- ▶ No capacitance measured between anode 2 and the other anodes

### Correlation between the signal amplitudes on different anodes

- ▶ We opened the TPC yesterday and checked the anode 2 connection
- ▶ There was a loose connection, but a connection → This is fixed
- ▶ Capacitances look reasonable now
- ▶ Given that the ramping and sparking looked normal on anode 2 – and the light as well as correlated charge pulses seen – the data we took during the last days may still usable
  - ▷ Hypothesis: Uncorrelated anode 2 signals are due to some “micro” discharges between the cable and the connection tab
- ▶ There are few runs with no anode 2 signals at all – these would be the bad runs. (There may be a more obvious mistake though, this is still to check.)

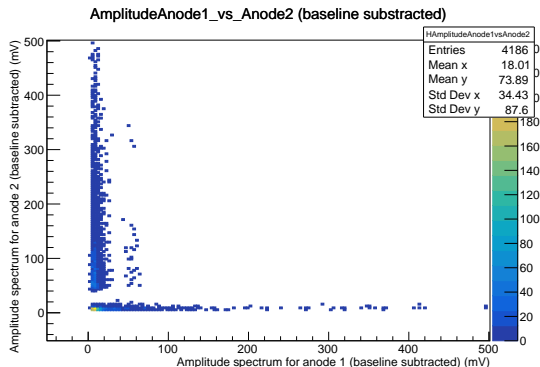
- ▶ Most of the anode 2 signals were not correlated with the anode 1 and anode 3 signals
- ▶ Only at the highest voltages there are correlated signals over all three anodes
- ▶ Basically all anode 1 and anode 3 signals were correlated
- ▶ During ramping and sparking the anode 2 HV channel showed now abnormal behaviour
- ▶ No capacitance measured between anode 2 and the other anodes

Correlation between the signal amplitudes on different anodes

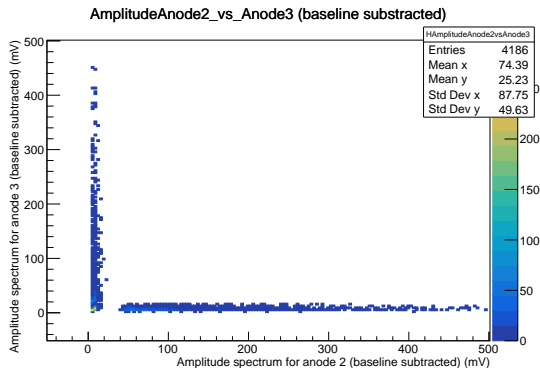
- ▶ Most of the anode 2 signals were not correlated with the anode 1 and anode 3 signals
- ▶ Only at the highest voltages there are correlated signals over all three anodes
- ▶ Basically all anode 1 and anode 3 signals were correlated
- ▶ During ramping and sparking the anode 2 HV channel showed now abnormal behaviour
- ▶ No capacitance measured between anode 2 and the other anodes

Correlation between the signal amplitudes on different anodes
