# Results on Stripping Foil Tests

C. Bracco, L. Jorat, R. Noulibos, P. Van Trappen and **W. Weterings**

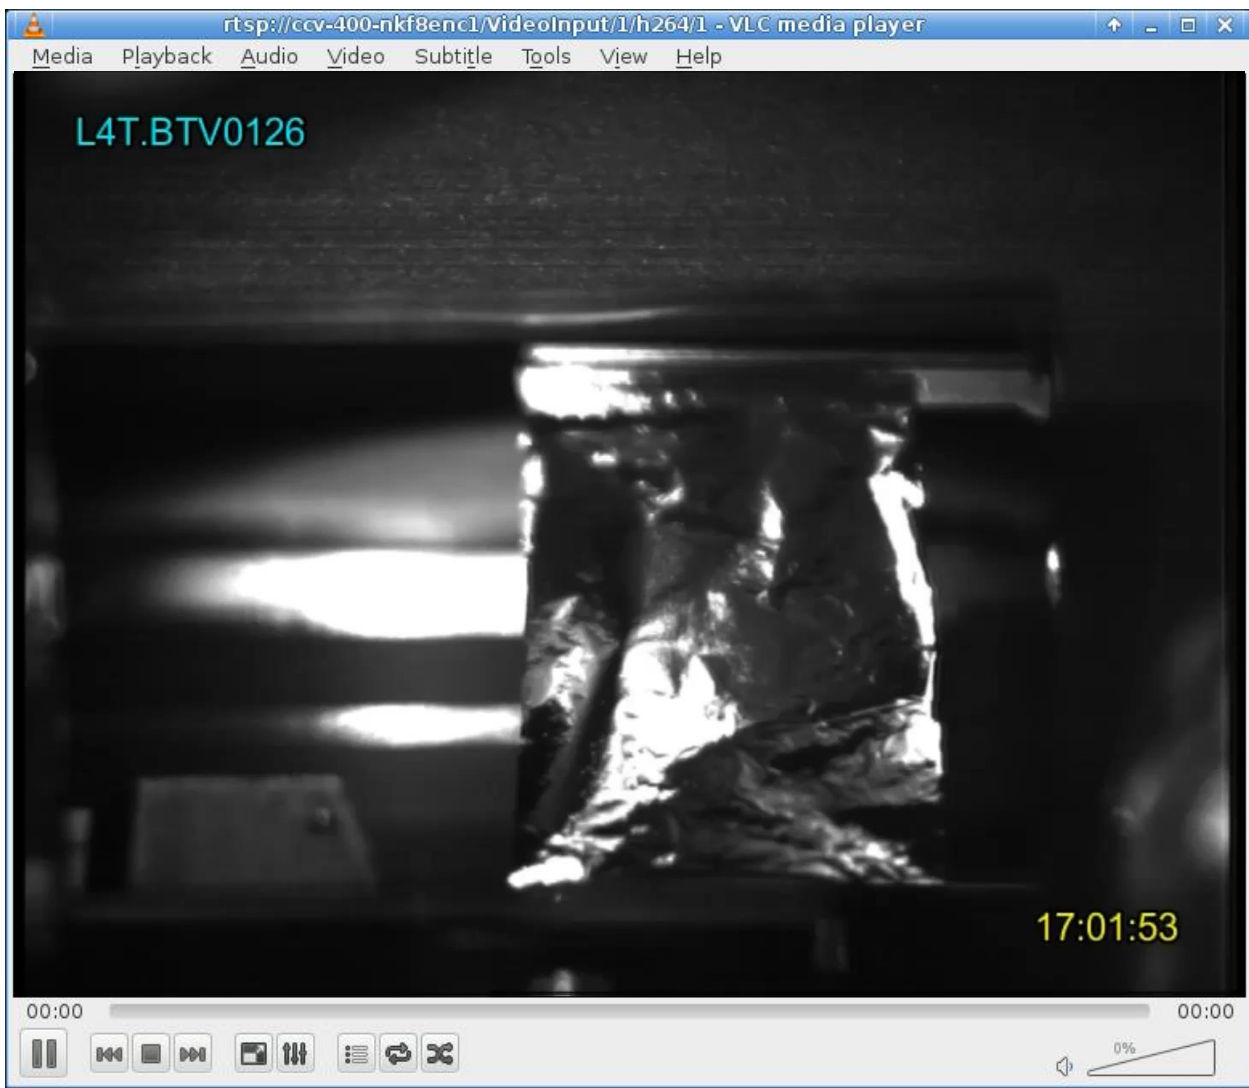
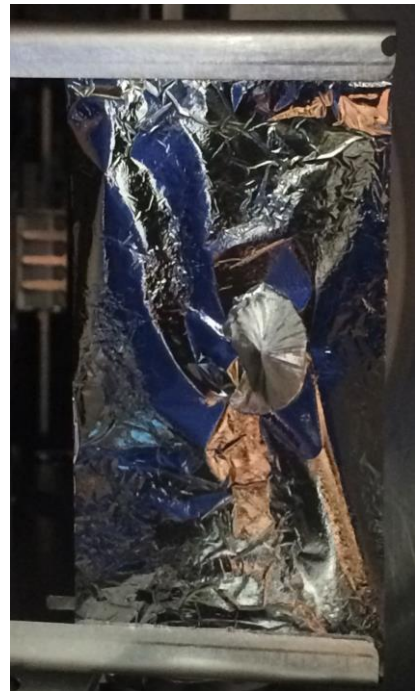
10/11/2017 15:58h  
Foil #5, DLC-23-1000-S,  
movement of the foil is  
observed at every beam  
shot (like a heartbeat).  
Foil in for ~ 5 minutes.  
BCT.LAZ value 100%

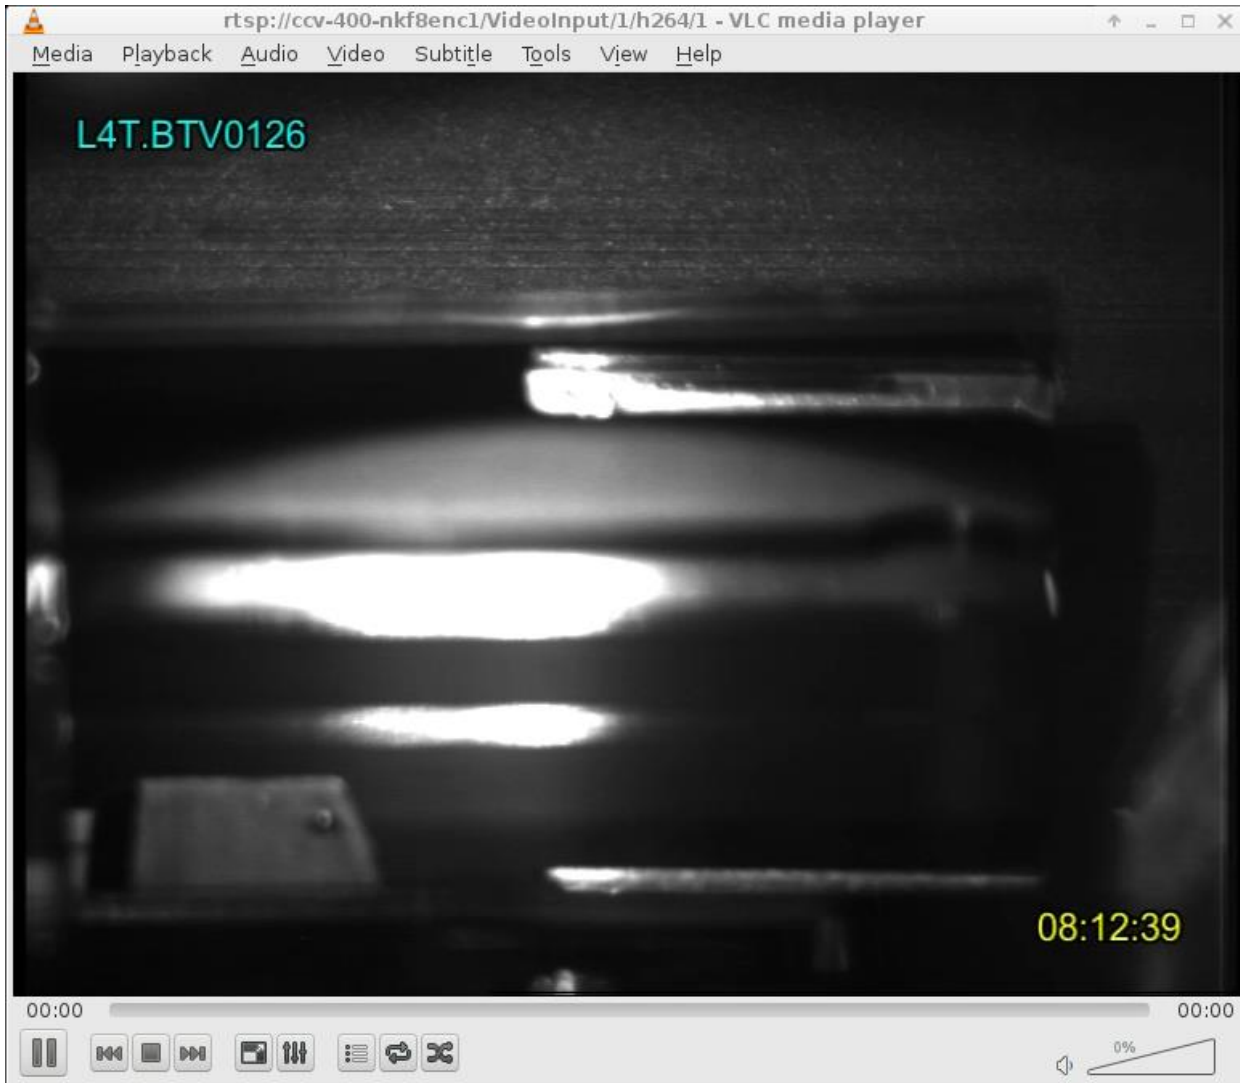
24/04/2018 08:05h  
Removed foil #5 from  
beam, foil visually in  
same condition as last  
night. [WWW], inspection  
of other foils, foil #2,  
DLC-23-1000-S, has  
disappeared from frame....

This foil has not been in the beam position, nevertheless it was completely removed from the foil holder.

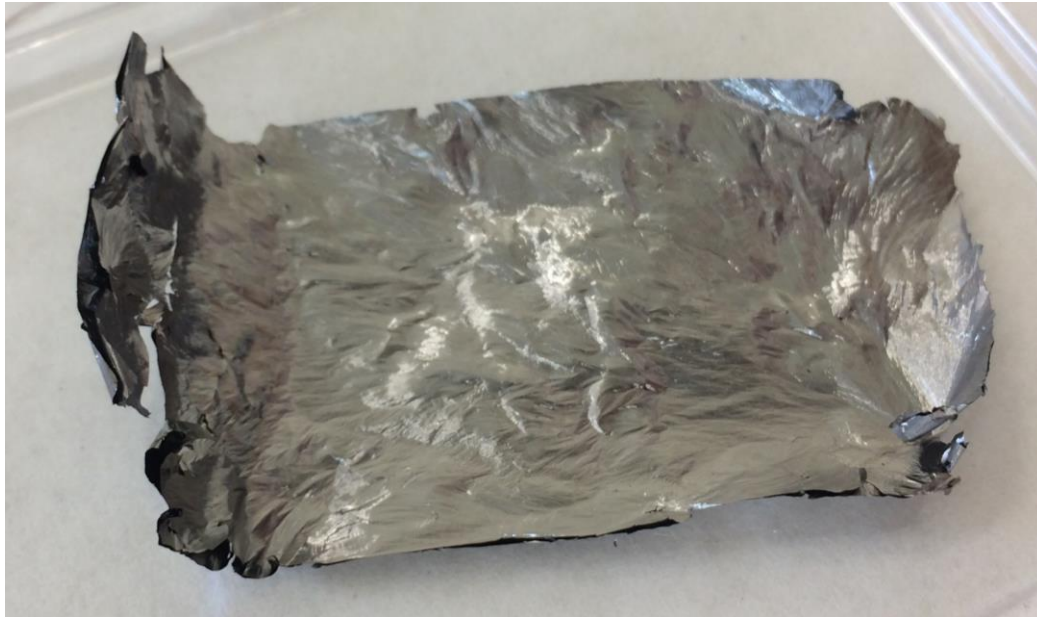
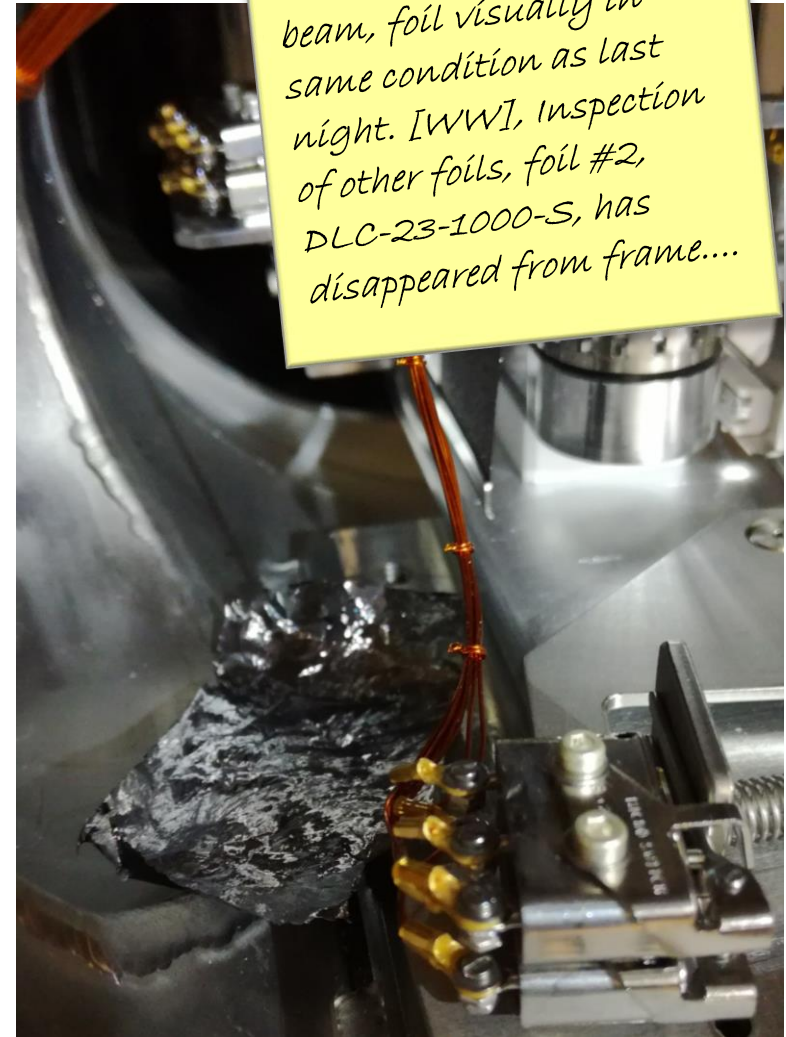
It was found lying inside the vacuum tank and looked completely burnt. We notice delamination of the foil layers at the edge of the foil. The foil holder of this particular foil was very activated,  $> 38 \mu\text{Sv}$  at contact, compared to  $0.1 \mu\text{Sv}$  of all other frames.

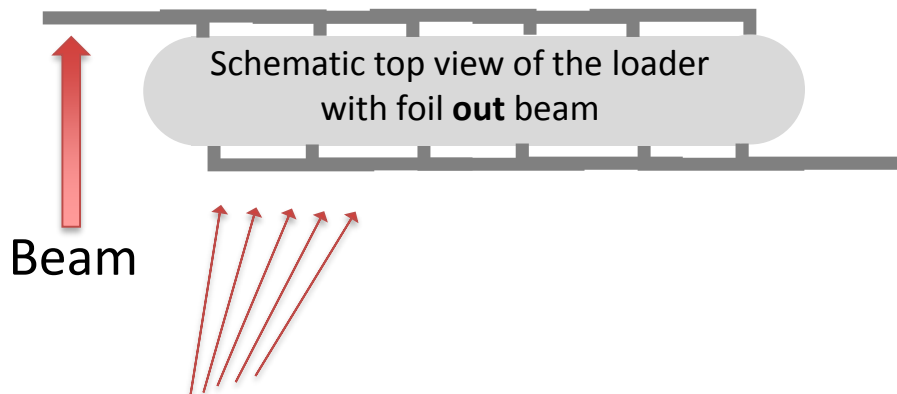
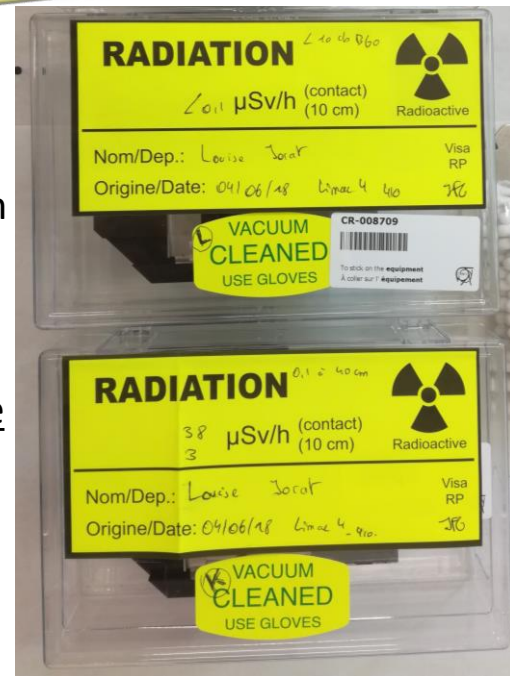
Logbook entries show that during the low energy tuning @ 3MeV, the beam was not properly steered and was lost just upstream of the TKSTR, causing showers on the foil holder. This was confirmed by damage to downstream electronics.

Standard frame  
 0.1  $\mu\text{Sv}$  contact  
 0.1  $\mu\text{Sv}$  @ 10cm

Impacted frame  
 38  $\mu\text{Sv}$  contact  
 3  $\mu\text{Sv}$  @ 10cm

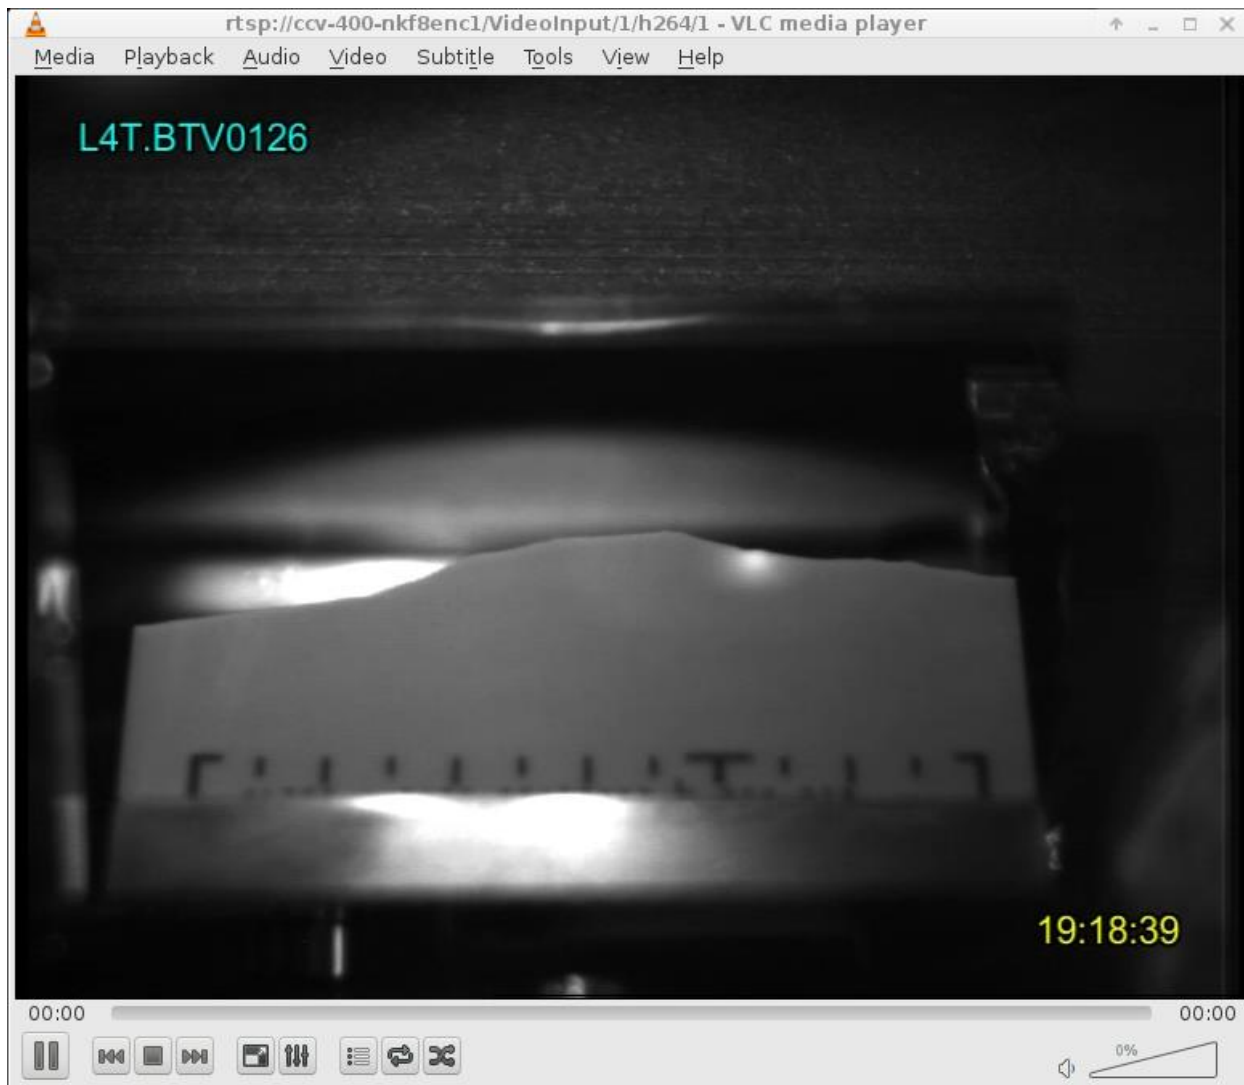
26/09/2018 19:03h  
Preparing stripping foil  
tests. L4T.RQF.021  
disabled. Image of beam  
on screen.  
Unfortunately the screen  
is **BROKEN!**  
Re-enable L4T.RQF.021

Probably due to high stress during tests to check that improved grounding solved issues with broken foils due to BTV charging/movements (~5 minutes with high intensity beams, BTV and foil IN)

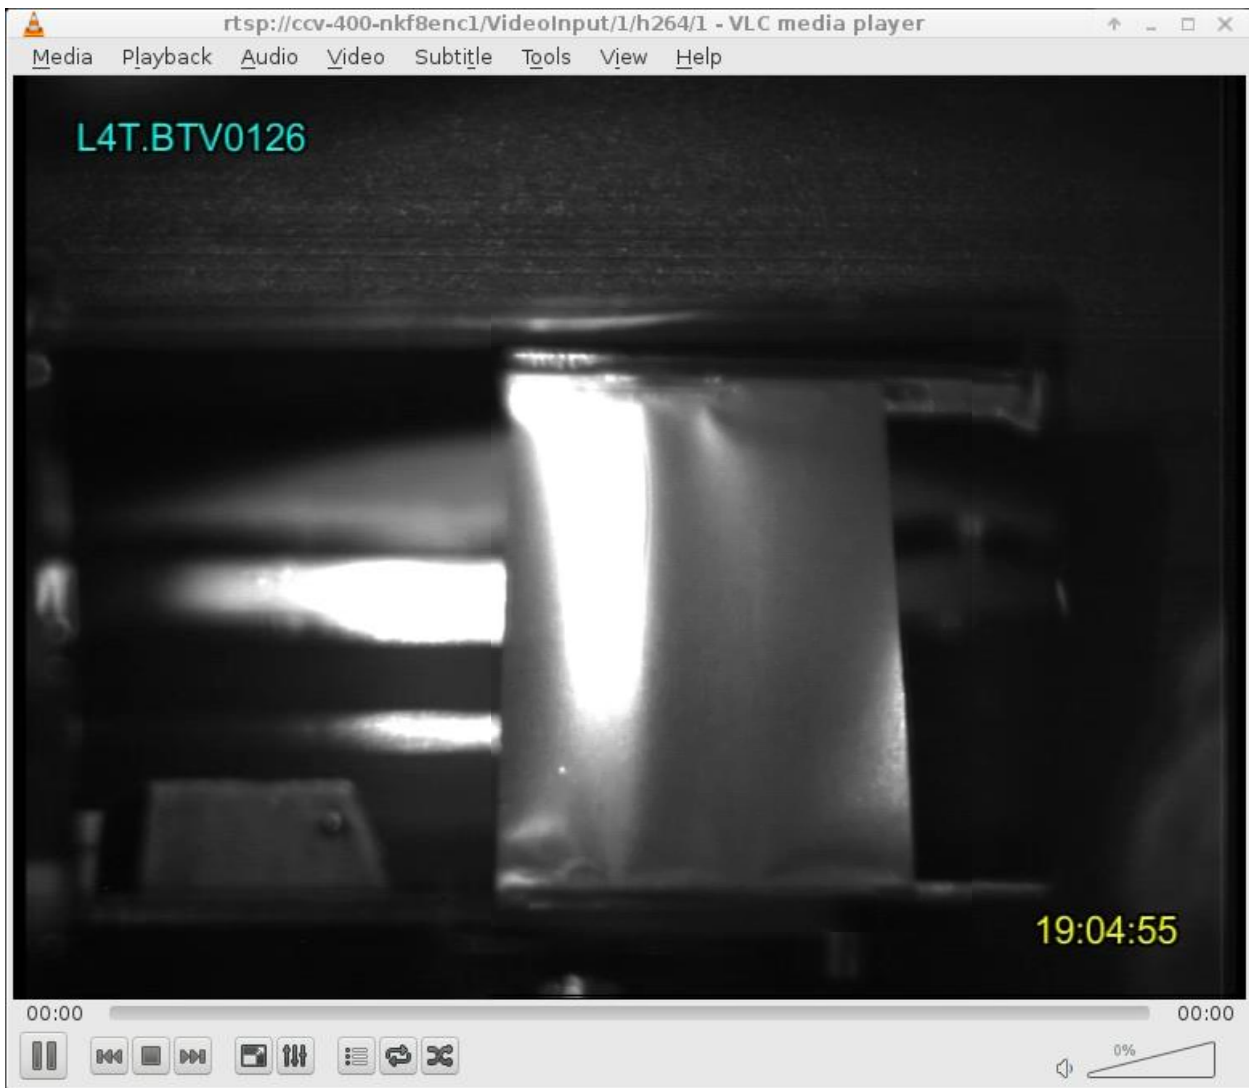
27/09/2018 19:05h  
Foil\_2, GSI\_199. After 1  
beam pulse the foil  
completely changed  
aspect. It looks like the  
foil shrunk, or stressed  
towards the centre.  
Nevertheless, no changes  
in efficiency.

After only one 600 $\mu$ s pulse, 4x150 $\mu$ s @19.7mA, the foil completely deformed. No influence on performance, the foil remained in beam for 12 hours with stripping efficiency of ~99.8%.

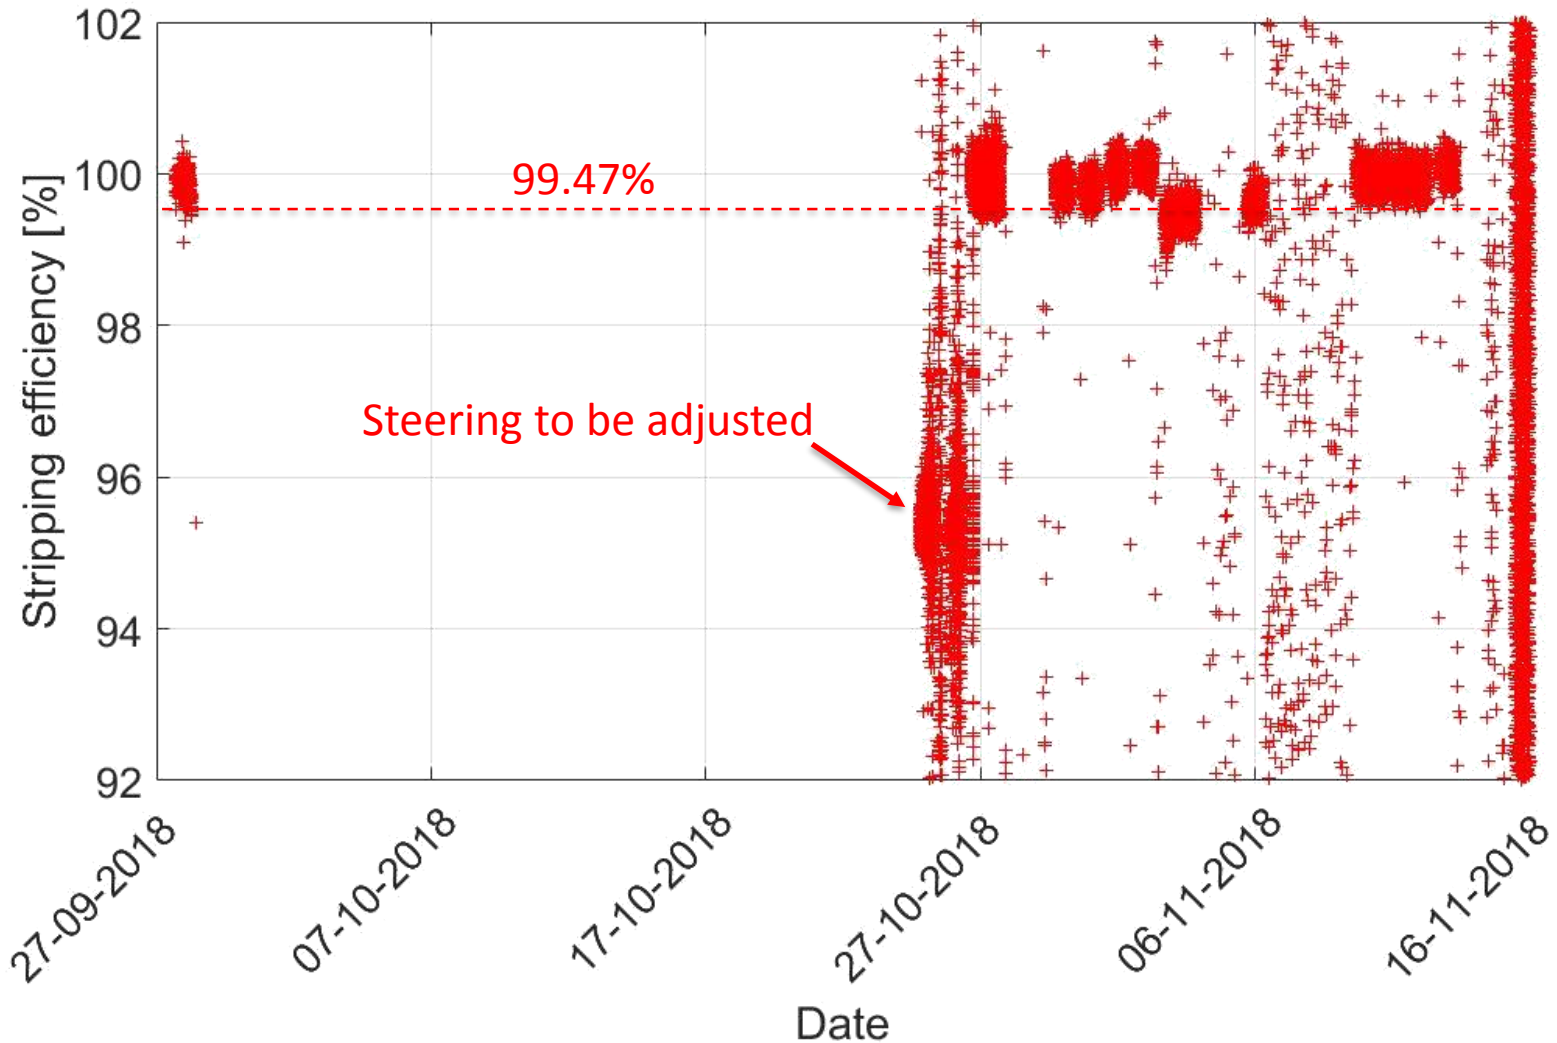
No signs of stripping efficiency degradation despite crater
