# Investigation status of amplitude jumps on Libera electronics

Borut Repič

WWW.I-TECH.SI Grenoble, DEELS 2019

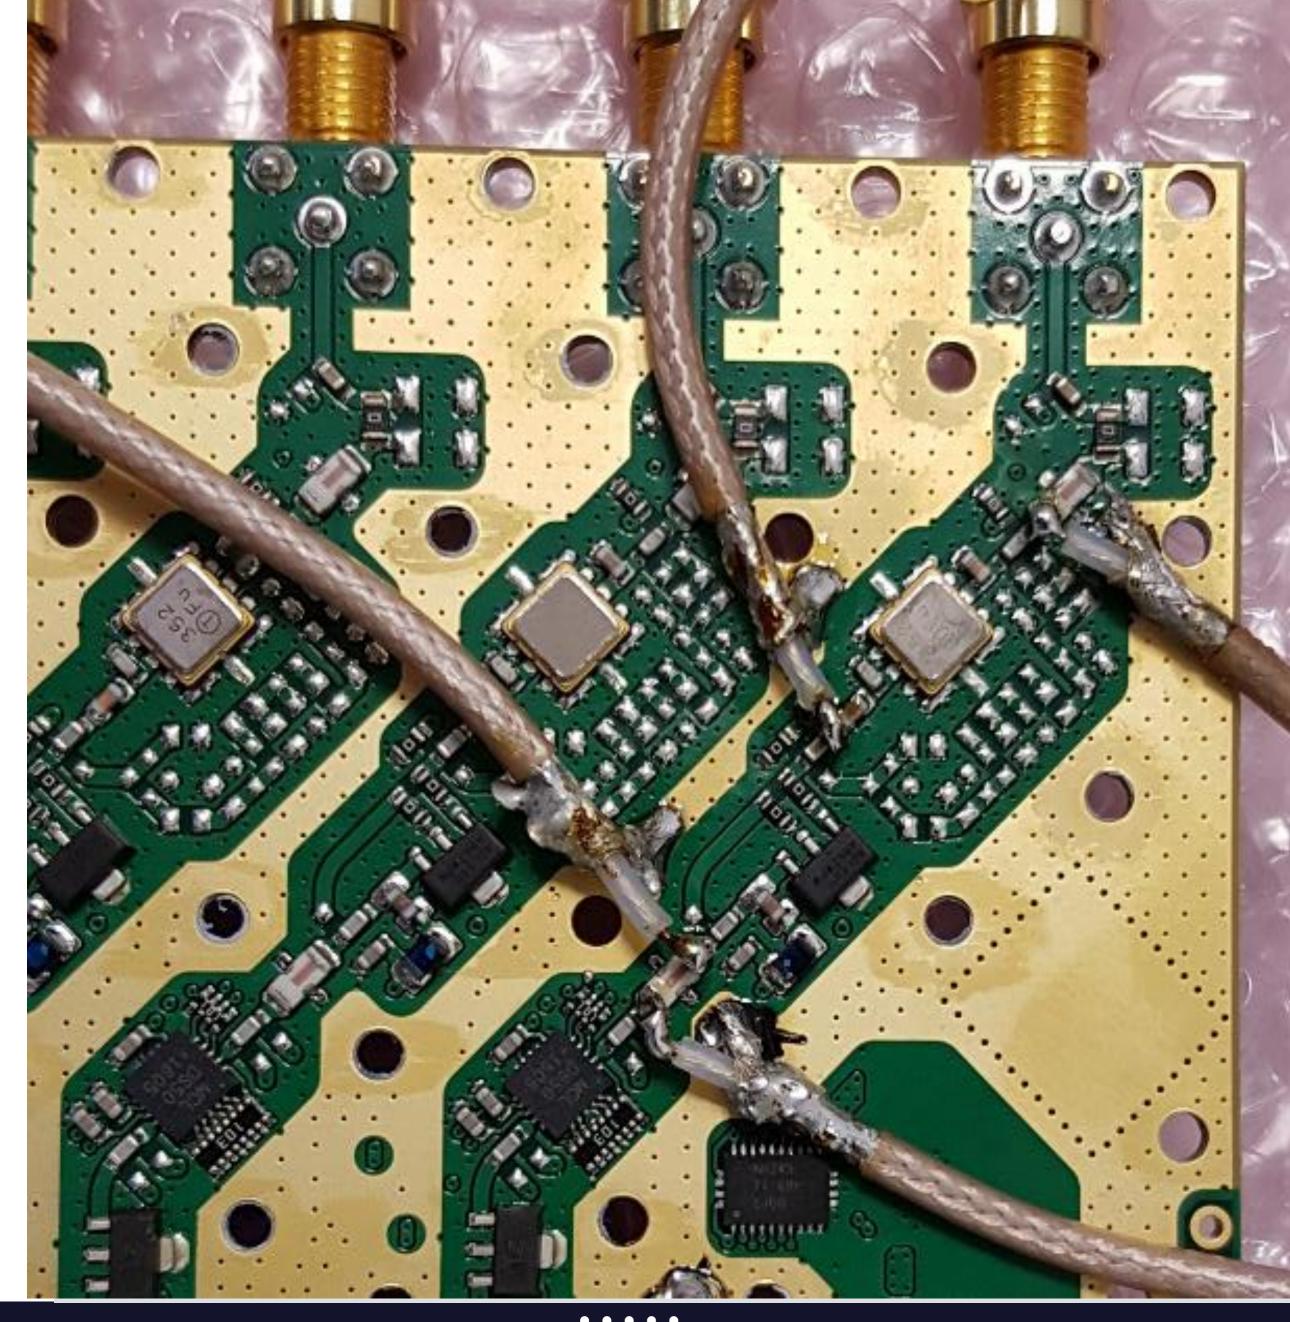
Attaching multiple RF power probes along the signal path to identify critical component.

Low pass filters LFCN from Minicircuits which are commonly used to suppress harmonics of amplifiers were identified as root cause.

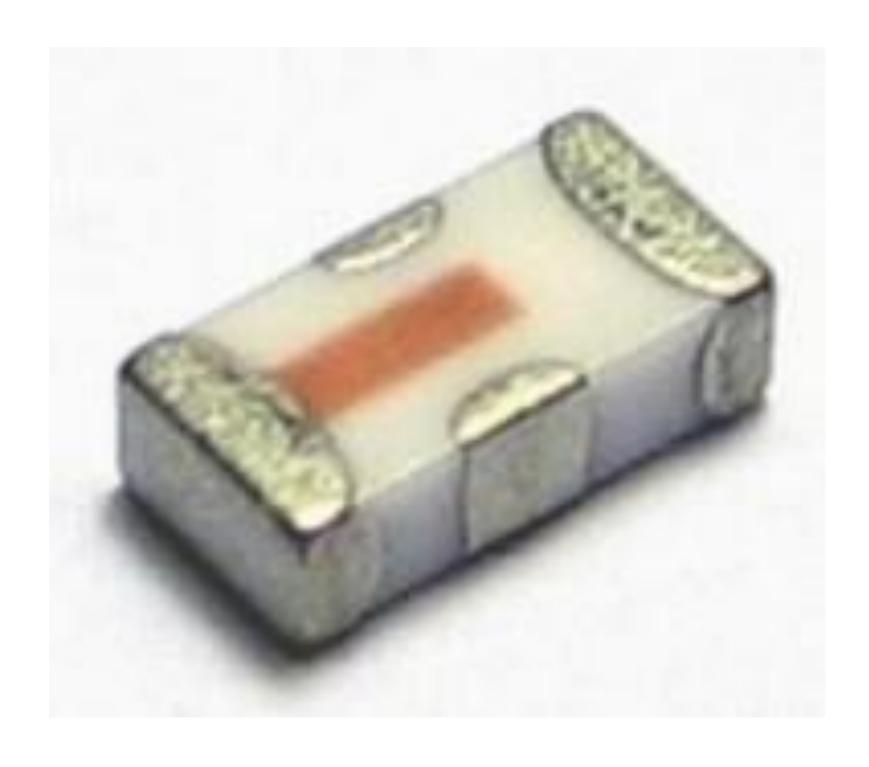
## LFCN low pass filter

- Each channel 3-4 filters → 12-16 pcs/board
- Faulty component was identified on the board.
- Failures found at different positions within signal path.
- RMA towards Minicircuits was opened
- Reflow profile, operating environment, electrical conditions, washing solvents, coating ...

- We found this issue on different boards (with different frequencies), assembled at different EMS plants.
- After such component was resoldered, the problem disappeared → cold joints X
- All faulty samples we got so far were too old (>3 years) for Minicircuits to accept them for analysis.
- Currently we have fresh samples behaving in the same way.
- Impedance behavior discovery
- We just sent complete board (soldering effect) to Minicircuits for analysis.
