THE AD ELECTRON COOLER ISSUES 2018

Lars V. Jørgensen
CERN, BE-BI-EA

The AD electron cooler double failure

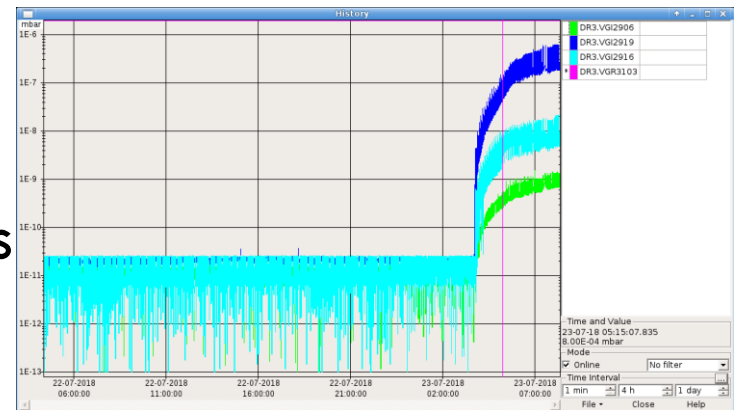
- First failure:
- Large vacuum leak in July from Collector water cooling circuit to vacuum.
 - ▣ Started 23 July
 - ▣ Fixed by switching collector to spare and bake-out of electron cooler section.
 - ▣ Beam back 10 August
 - ▣ Info: The spare collector was last used 12 years ago.

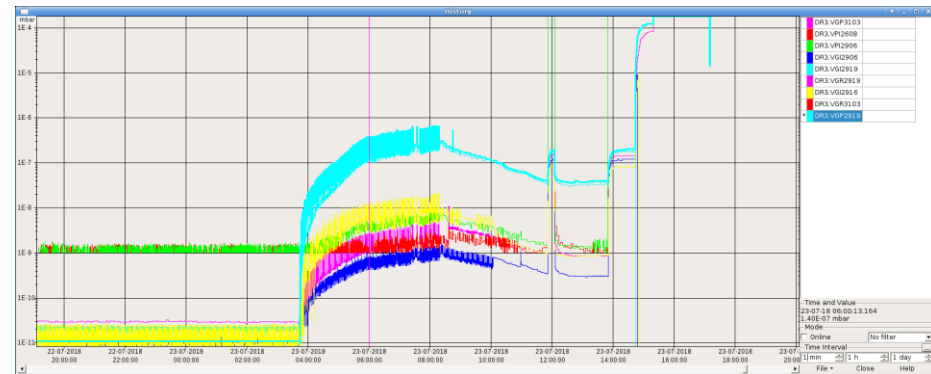
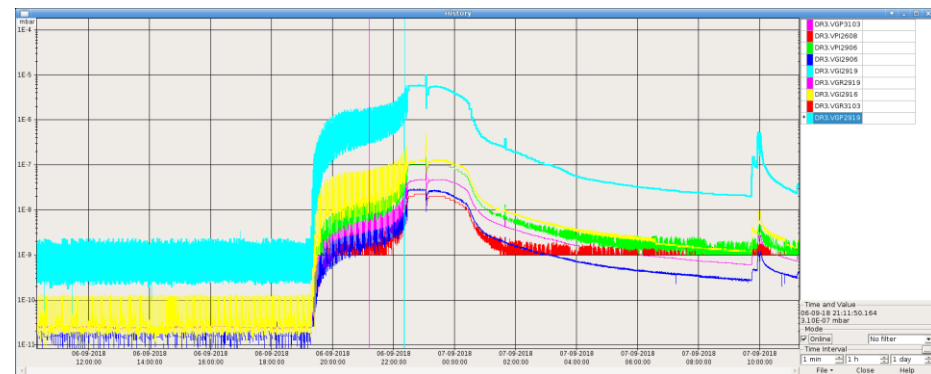
- Started Sept. 6
- Problem in Collector water cooling system again.
- Leak much smaller this time.
- After pumping on the collector cooling system vacuum levels in the ring go back to normal.

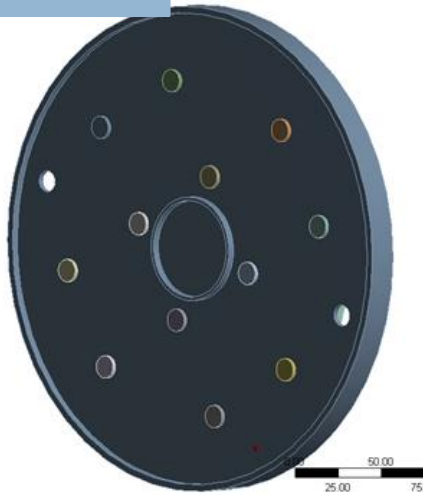
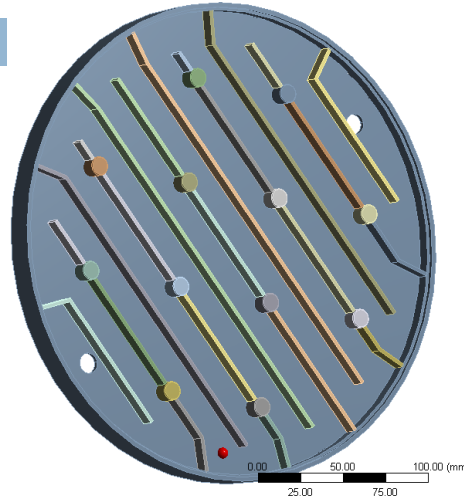
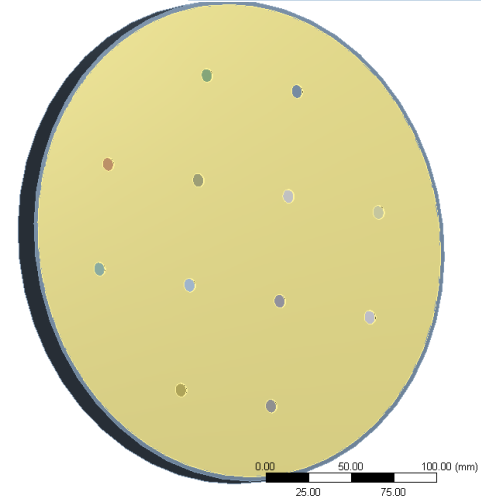
Collector design: end cover

- Two-walled cover, walls made of 316LN, welded circumferentially
- Cover is water cooled, at a pressure of 3.2 bar
- Cylindrical stiffeners added by electron welding to decrease stresses and deformations on the two walls

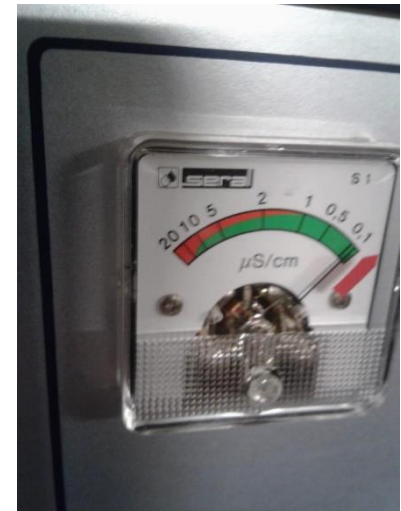
- N. Roget informed us that the conductivity of primary AD cooling circuit is about 0.2 $\mu\text{S}/\text{cm}$
- We decided to make multiple purges of the system to get the conductivity down.
- Recently re-charged cartridge is installed after the purges.
- Conductivity reduced to 0.1 $\mu\text{S}/\text{cm}$
