# KFA10 Vacuum tank

Status vacuum leak

# Beam Transfer (BT) line

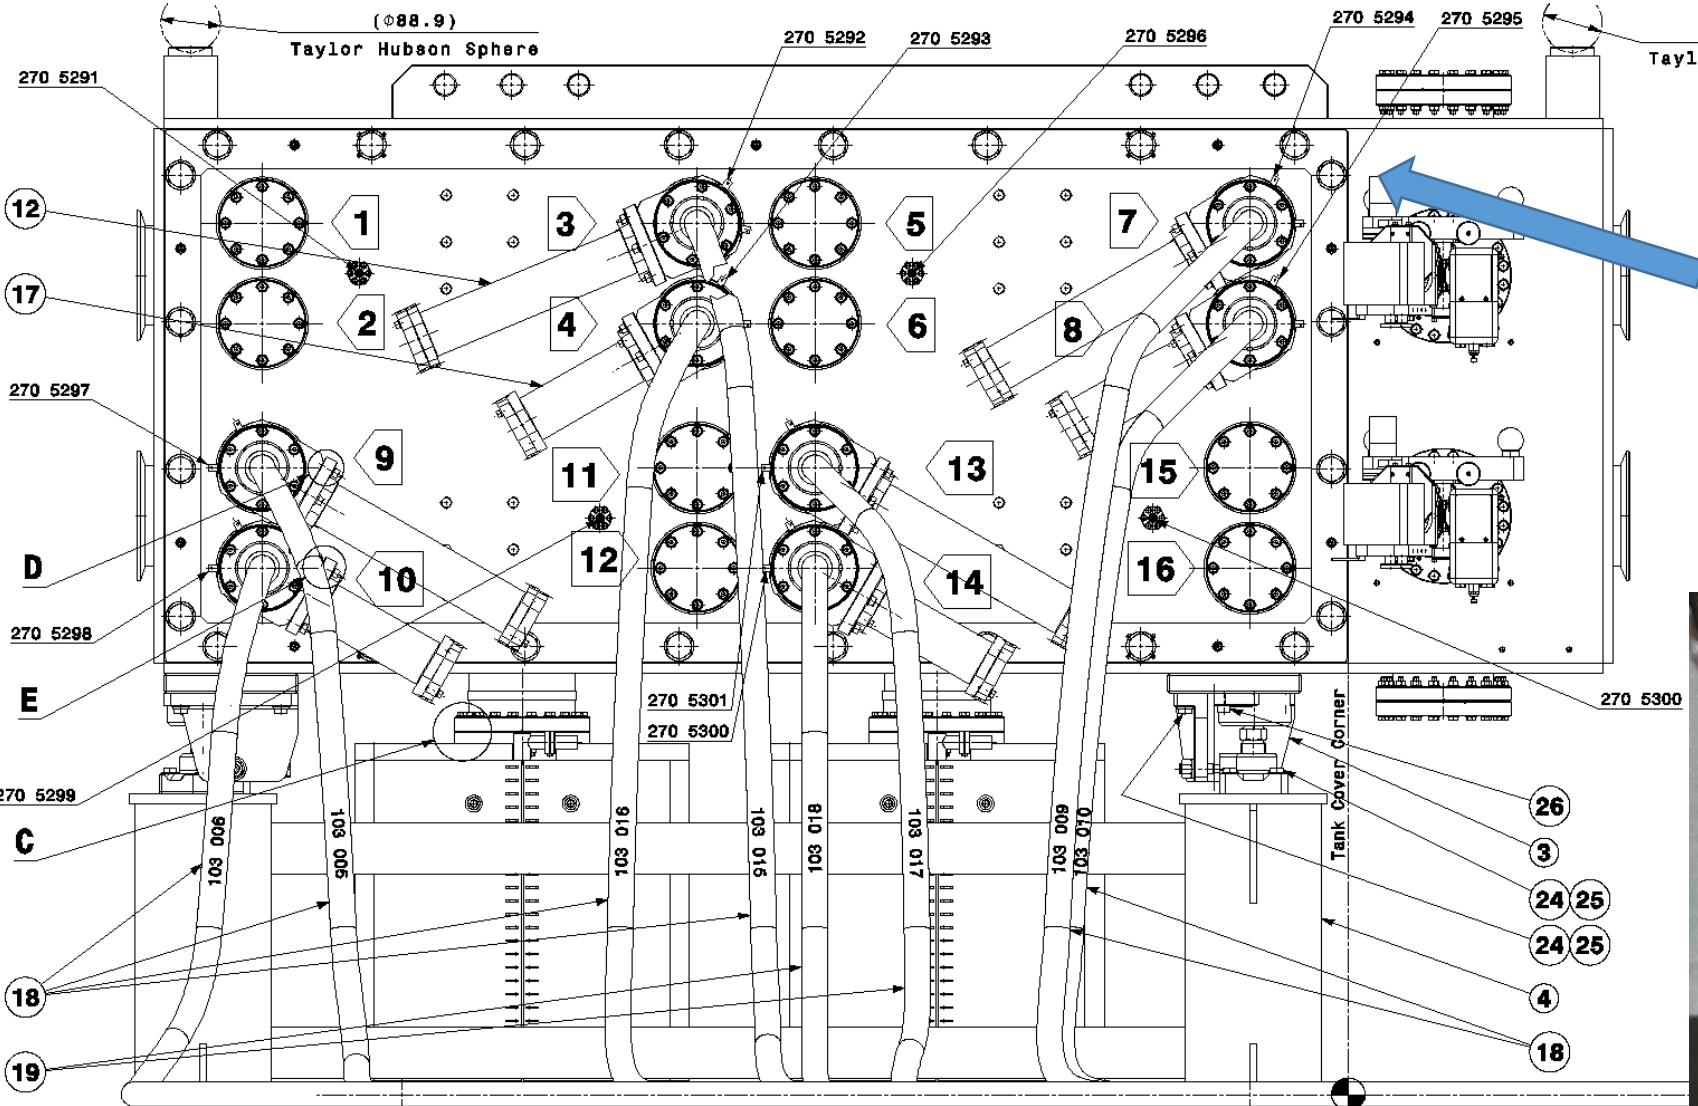
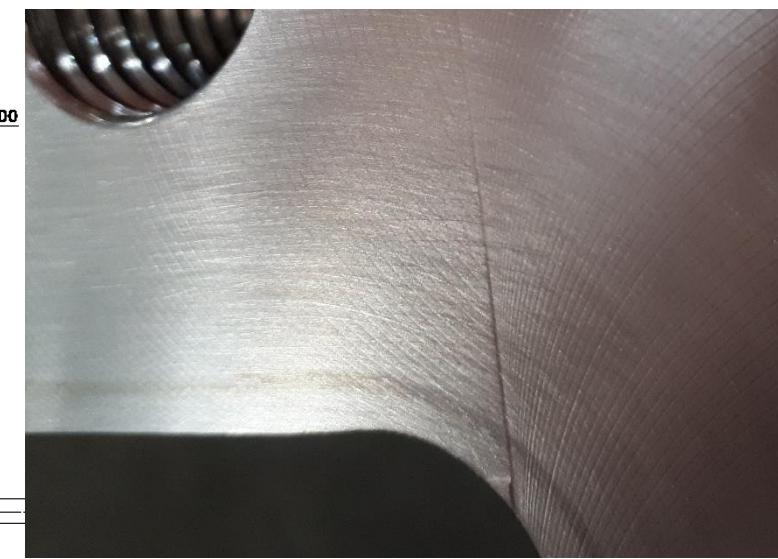
# After repair still leaking & RGA

- Avant resserrage de la porte (180-200Nm) le taux de fuite sous poche à saturation était de  $5.6 \times 10^{-7}$  mbar.l/s
- Après resserrage de la porte à 300Nm, nous sommes à  $4.2 \times 10^{-7}$  mbar.l/s
- La fuite la plus importante soit dans l'angle en haut à droite. Ce qui ne veux pas dire qu'il n'y ai pas de fuite plus petite autre part.

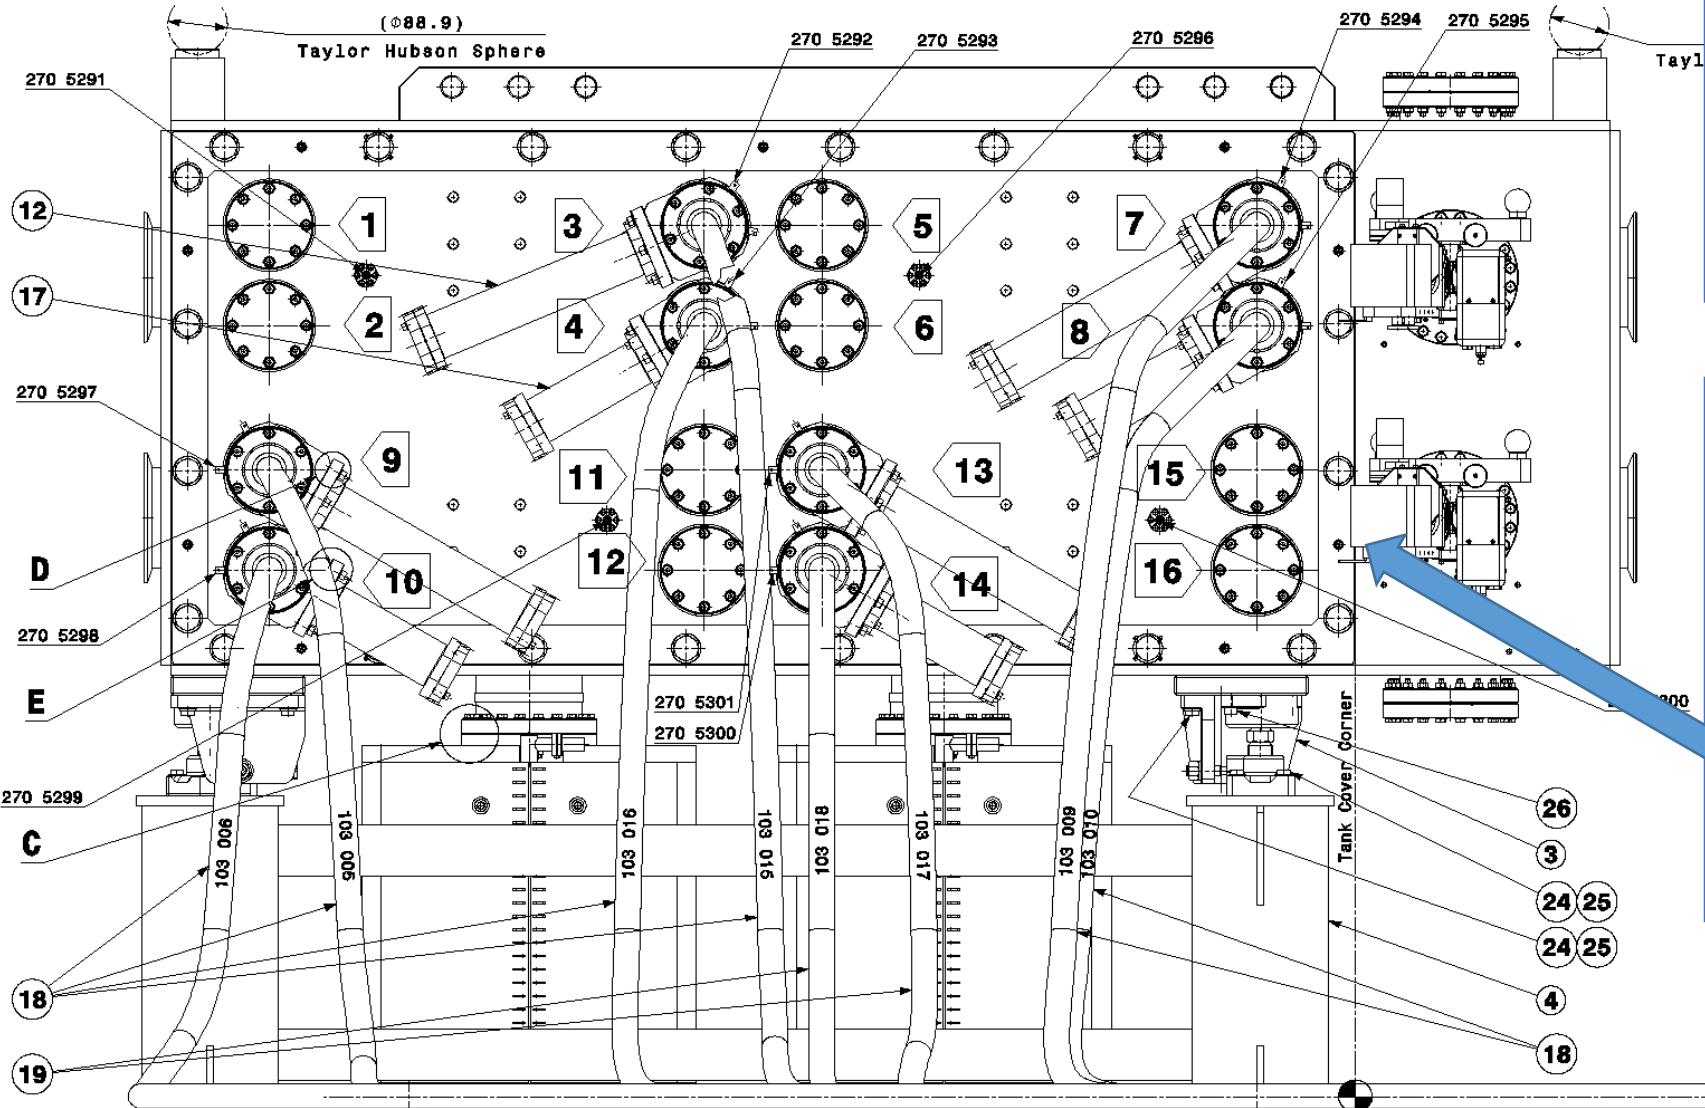
# After repair still leaking & RGA

- 2 :  $2 \times 10^{-8}$  mbar.l/s
- 3 :  $7 \times 10^{-10}$  mbar.l/s
- 5 :  $4 \times 10^{-8}$  mbar.l/s
- 8 :  $6 \times 10^{-10}$  mbar.l/s
- 11:  $5 \times 10^{-9}$  mbar.l/s
- 12:  $2 \times 10^{-9}$  mbar.l/s

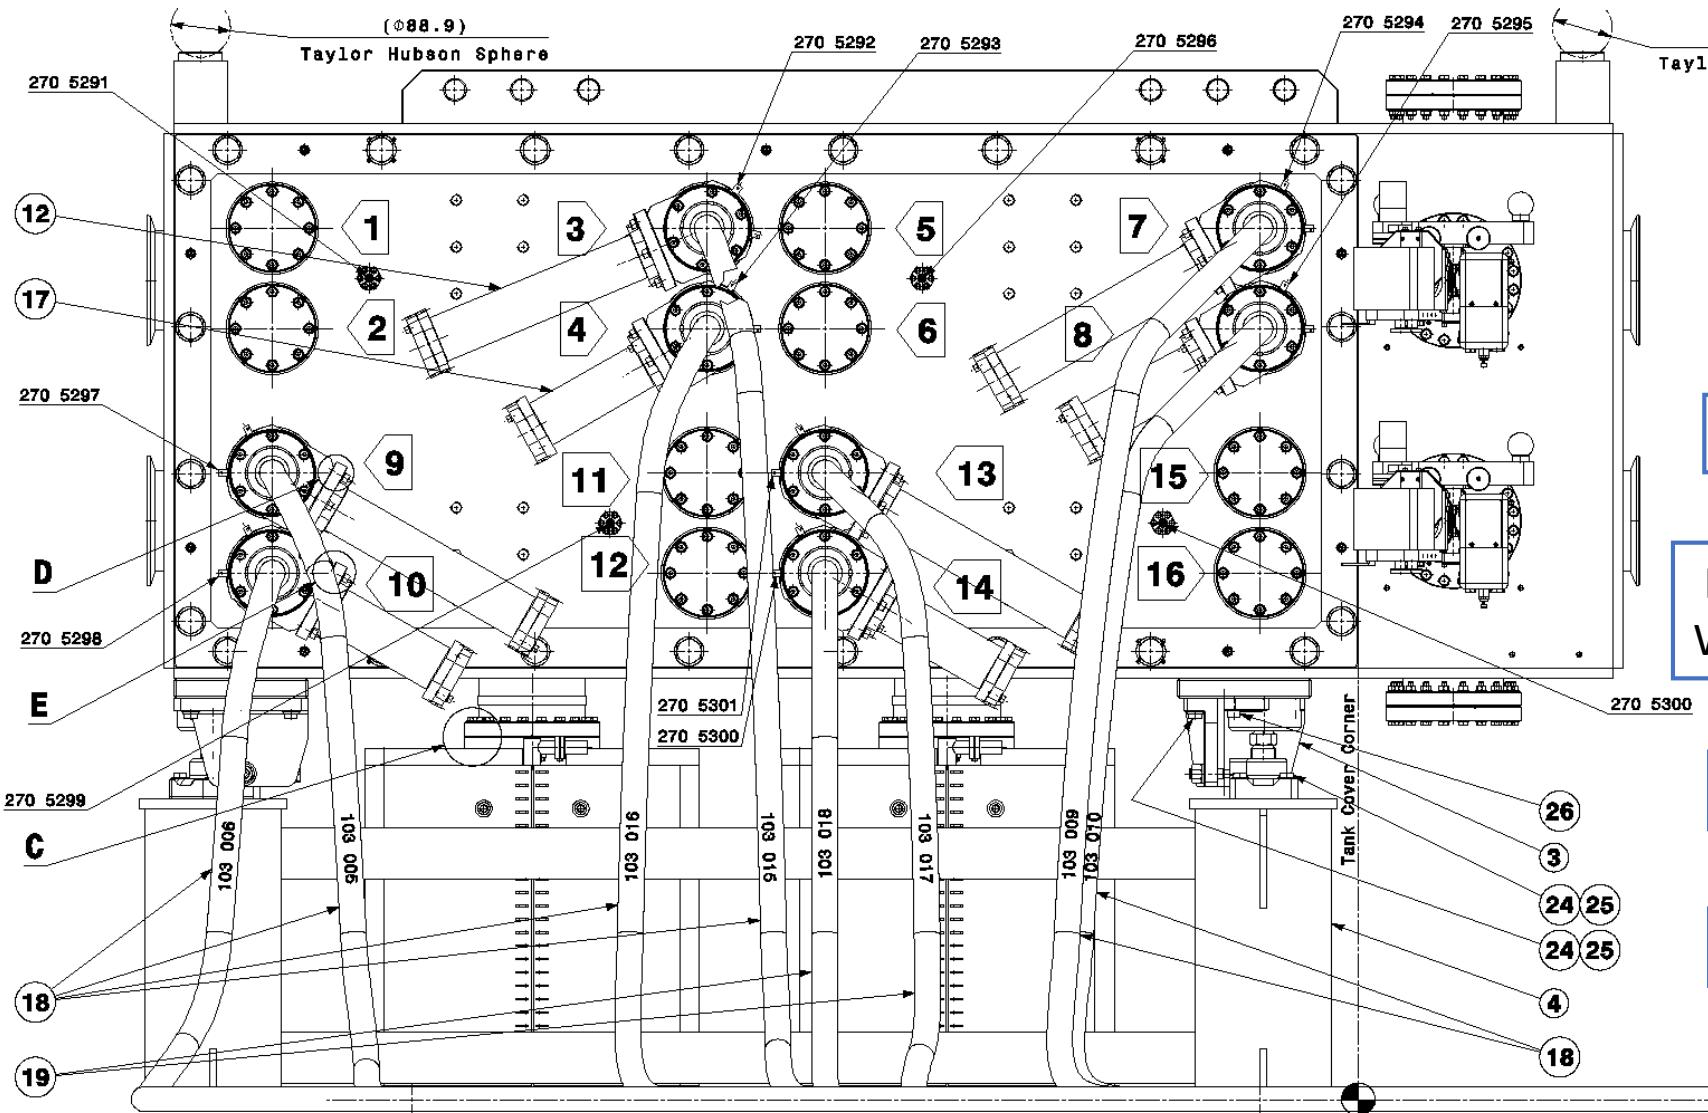
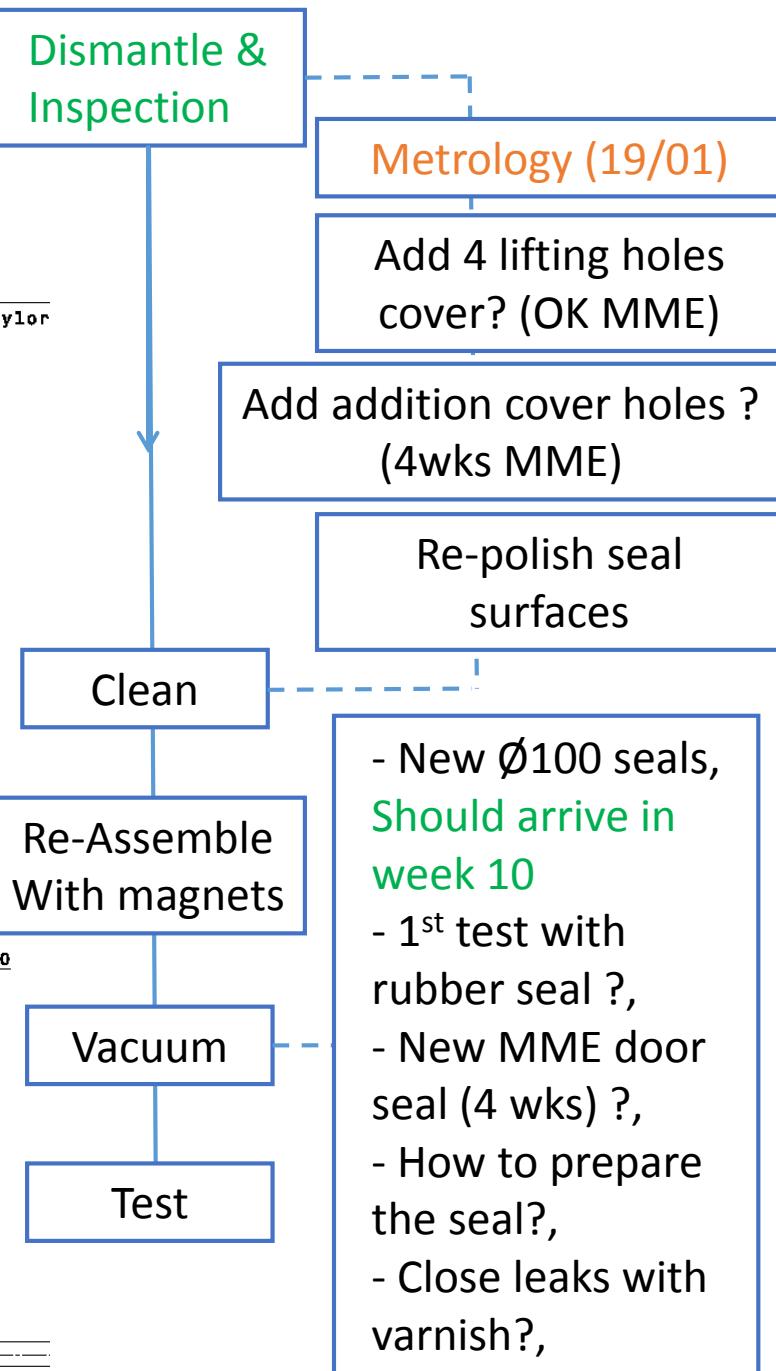
- Inspection showed machining marks → Dismantle & Inspection
- Fixation of magnets tested on the doors
- Circular seals have been re-polished
