The lonely perpetrator in the DCDC FEAST2 case

How an individual transistor threatened the operation of the CMS pixel detector

F.Faccio, CERN, EP-ESE

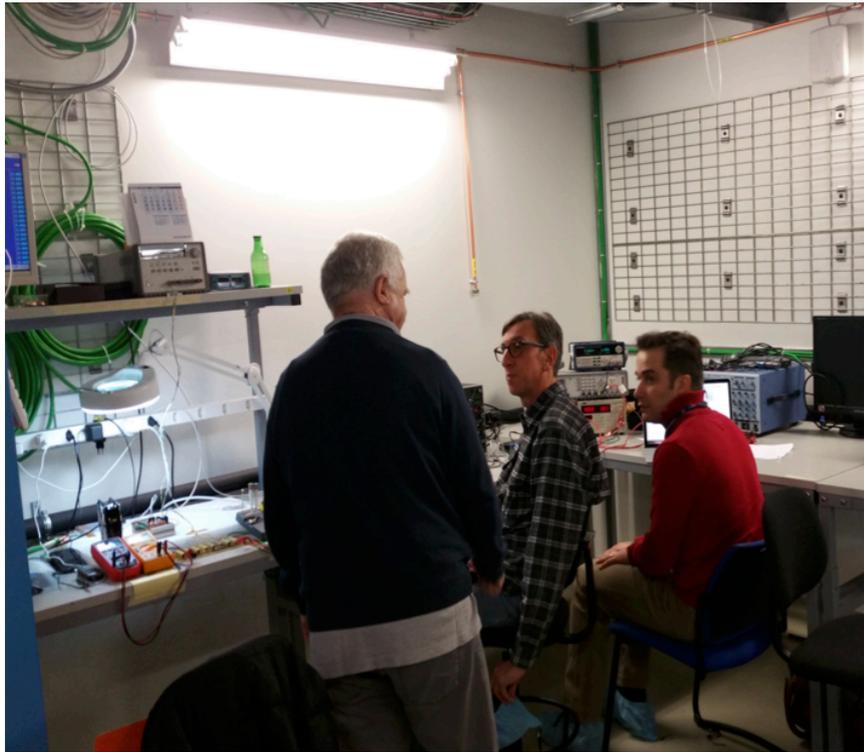
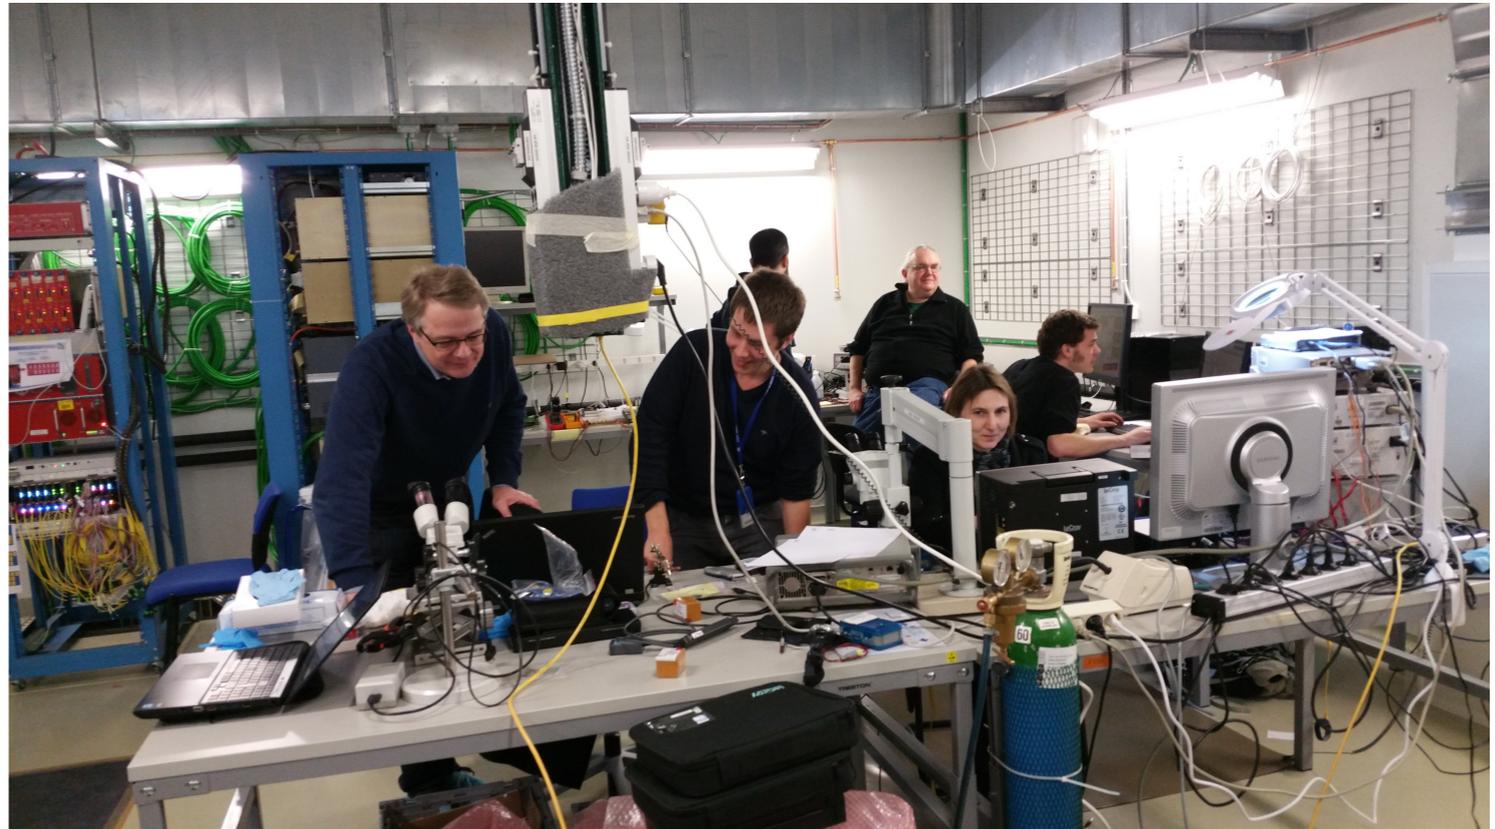
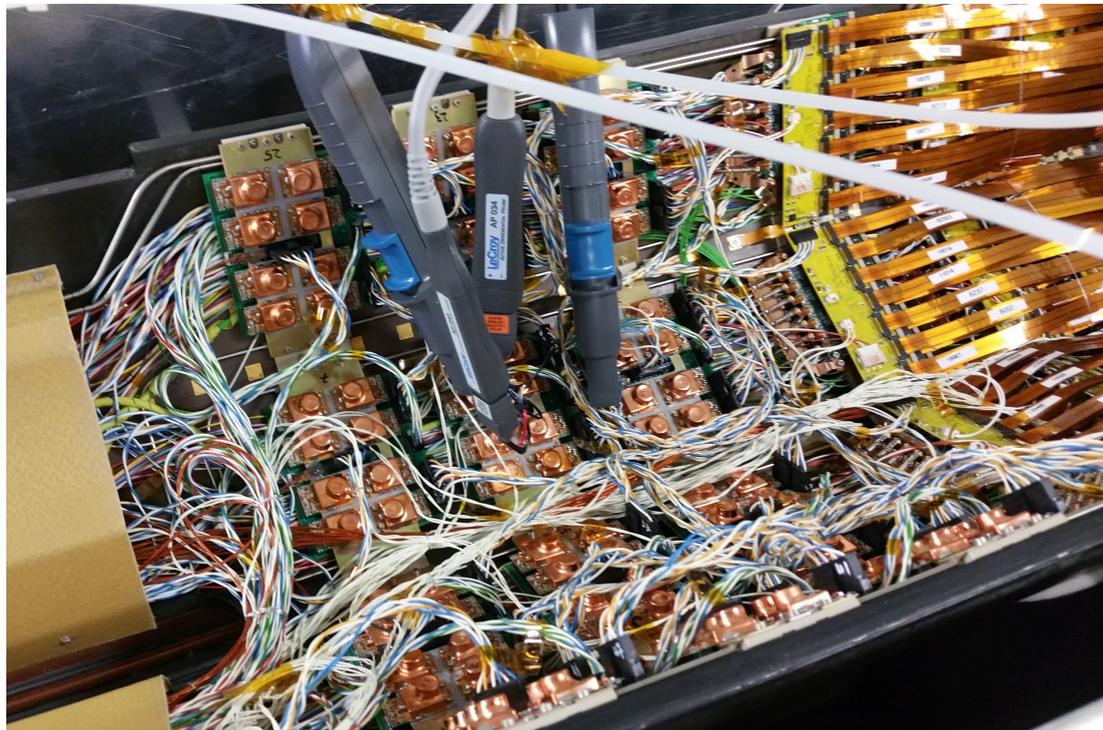
Photo memories from the 2017 Christmas Break

FEAST2 modules in the CMS experiment were found to present 2 distinct types of damage

- “Broken” samples failed to provide any output voltage
- “High-current” samples were perfectly functional, but were found to have an excessive current below UVLO

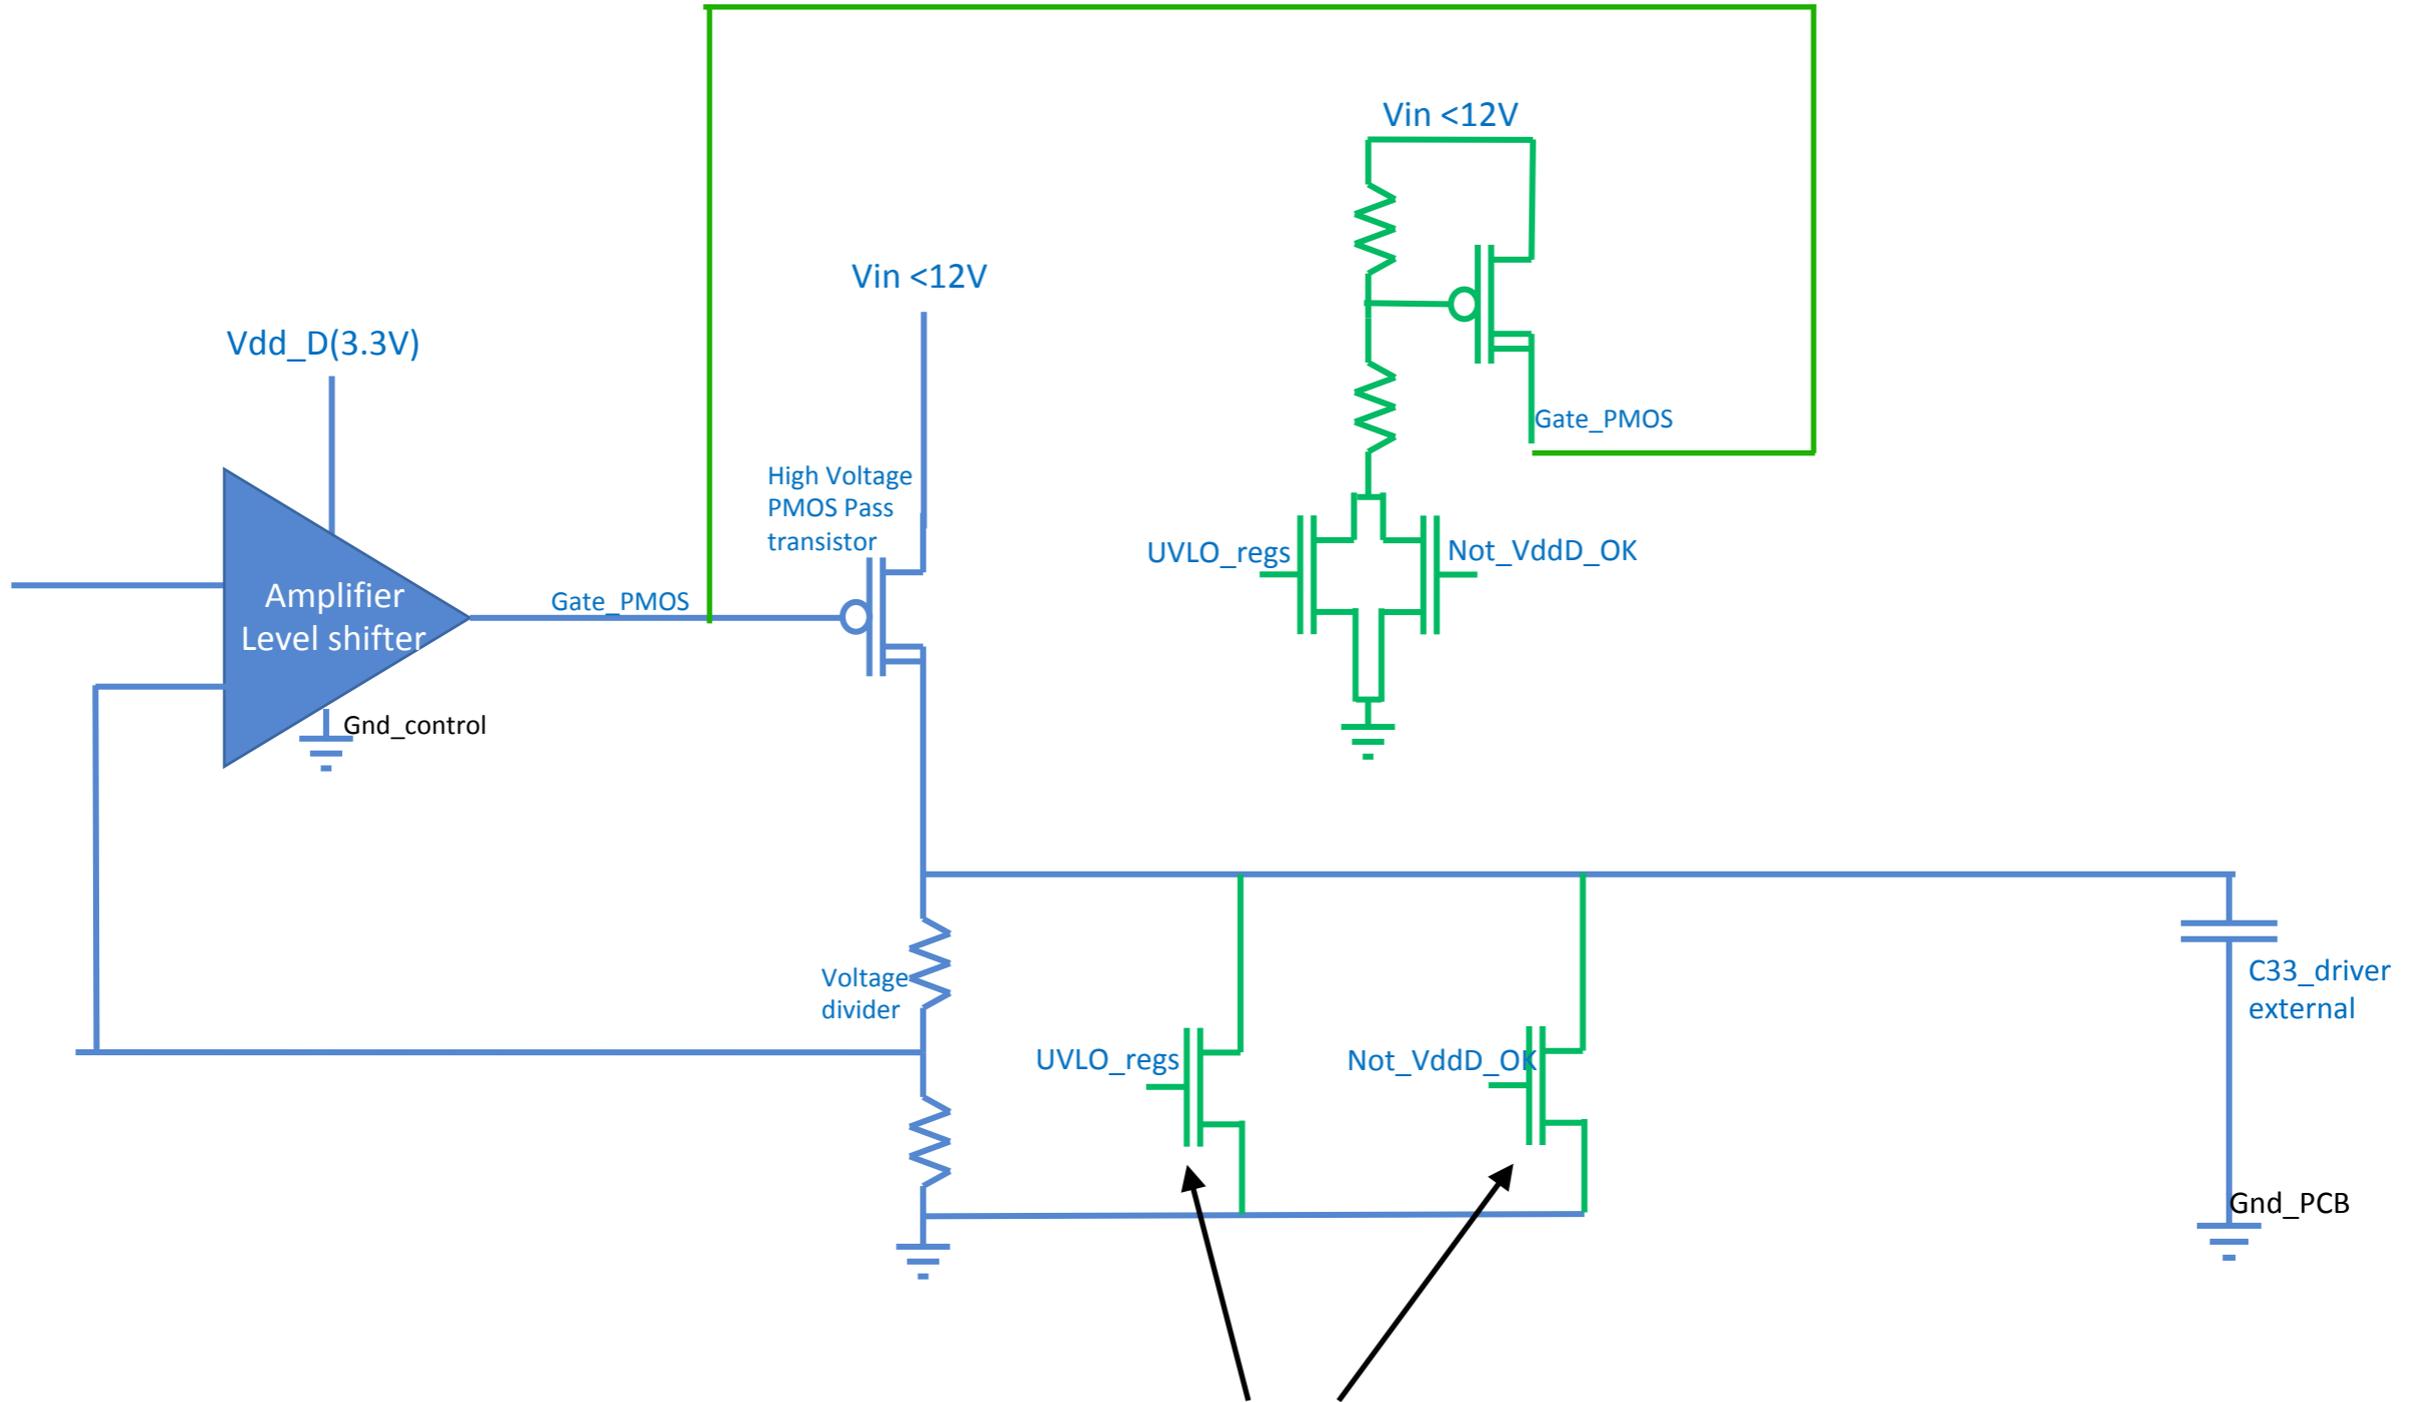
**Clamp transistors for soft-start procedure
(transistors rated to 3.3V)**

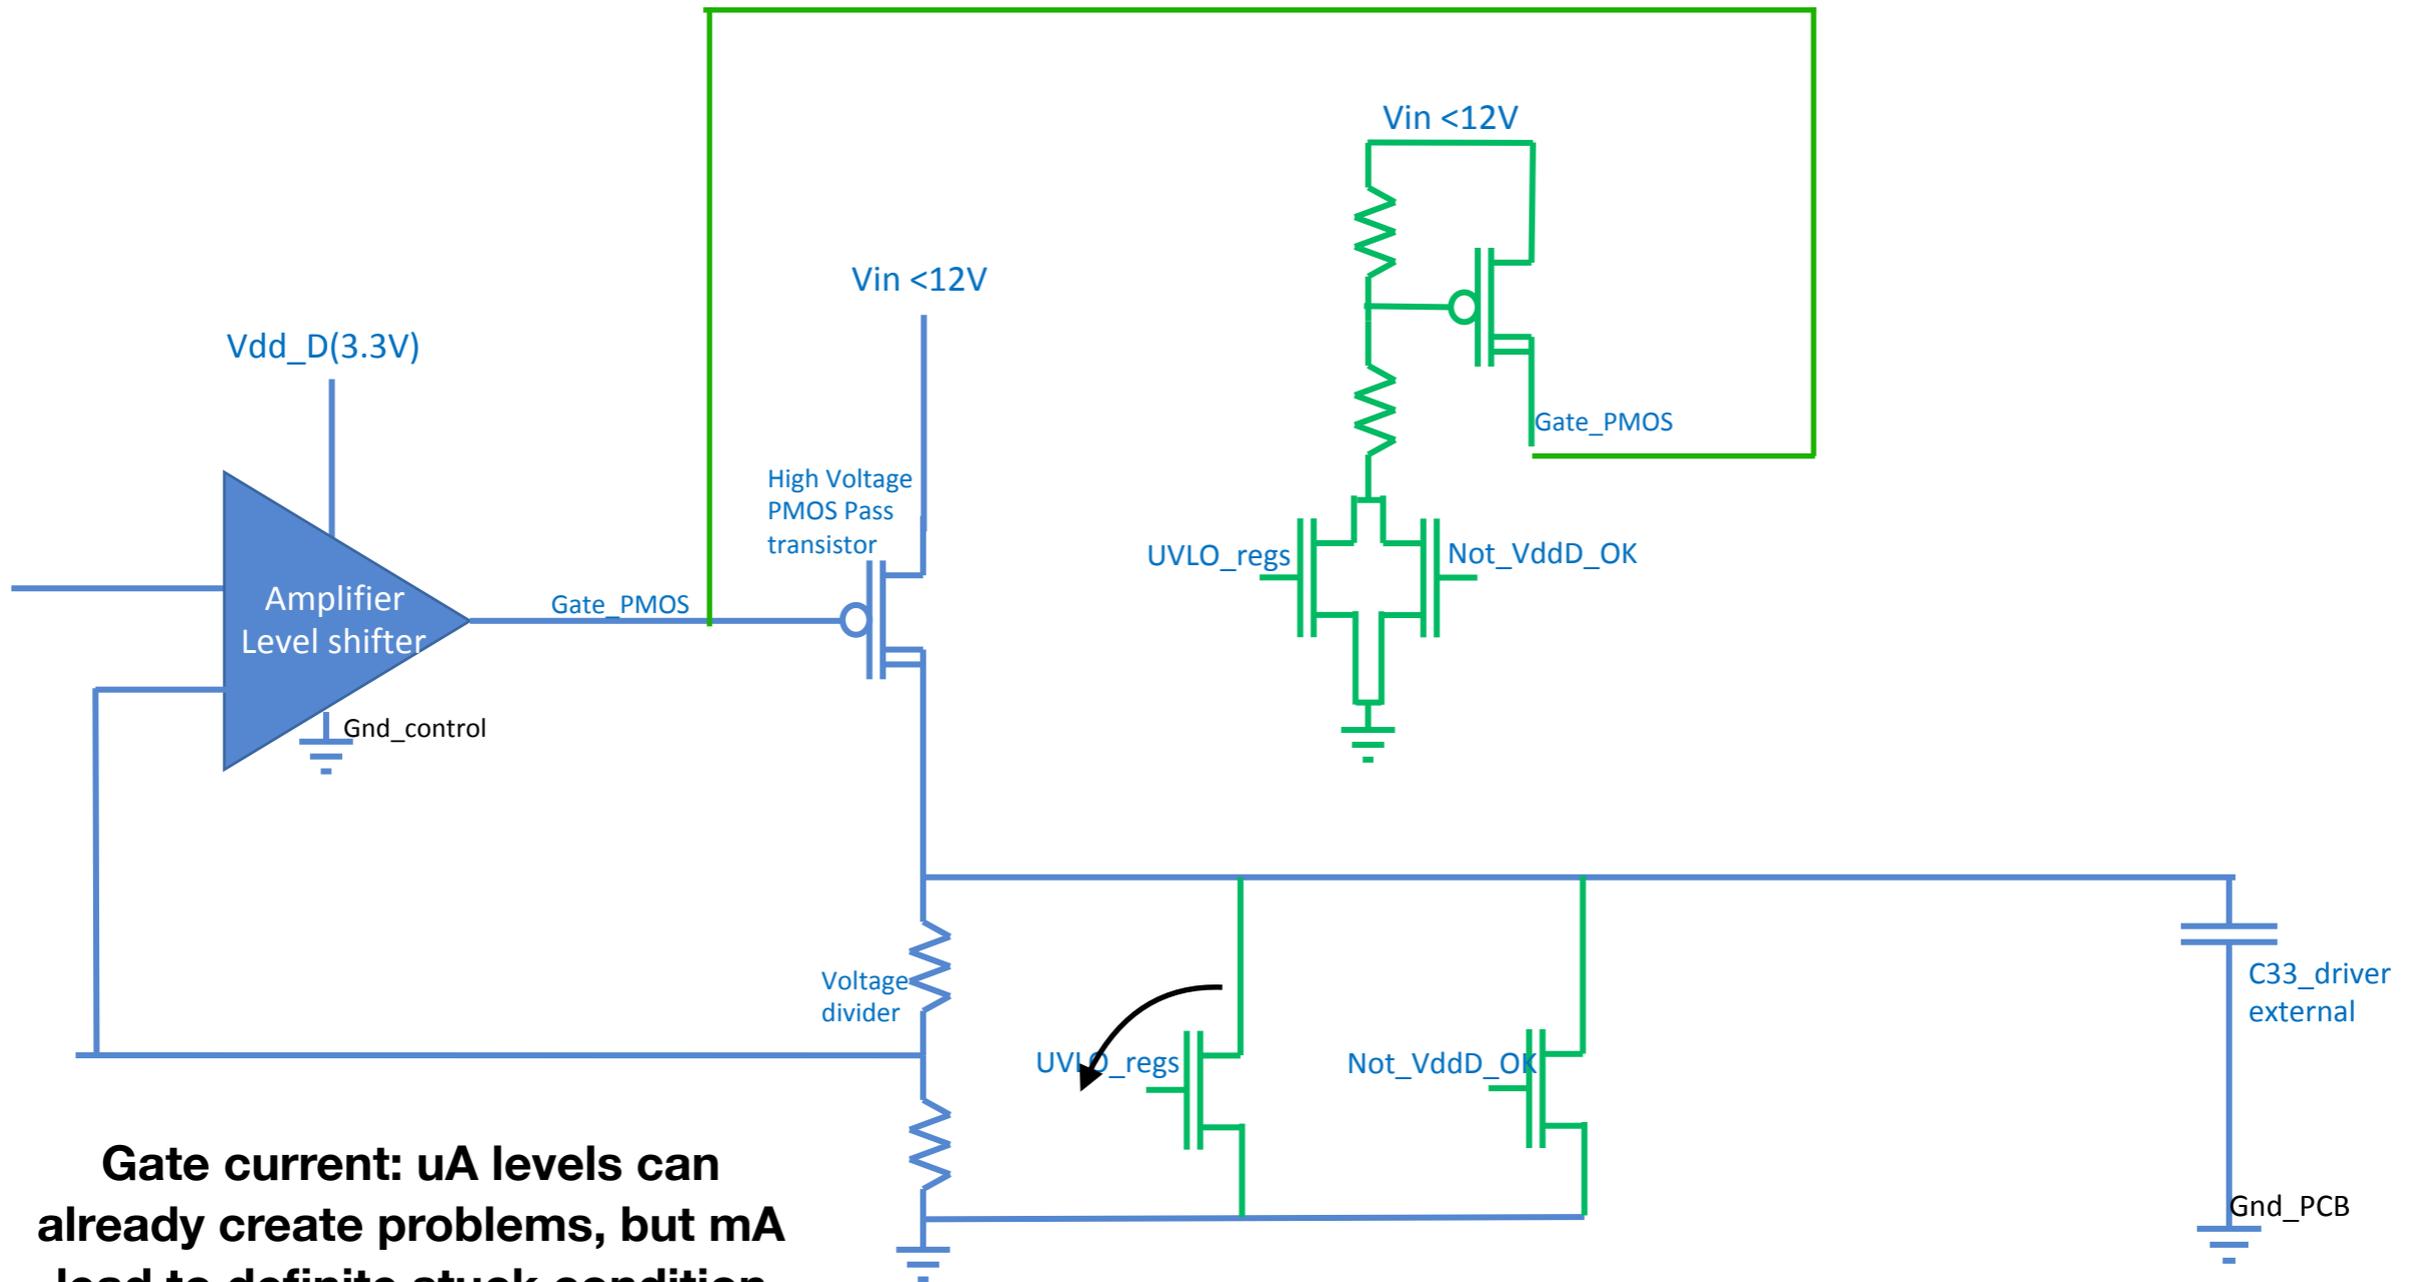
What happens if the clamp transistors are damaged?

Gate current: μA levels can already create problems, but mA lead to definite stuck condition

This also disrupts the correct value of the $UVLO_regs$ voltage, hence preventing the UVLO from working correctly

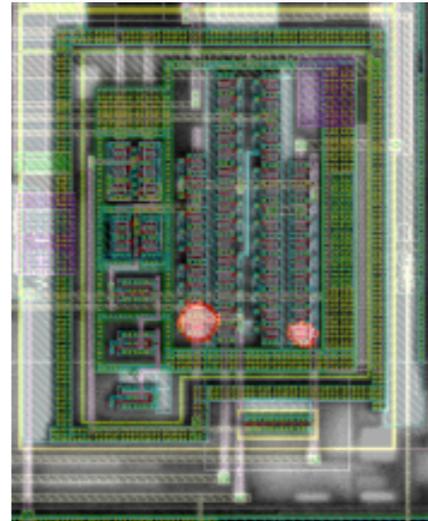
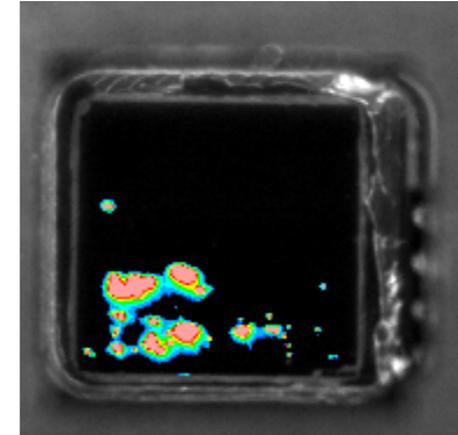
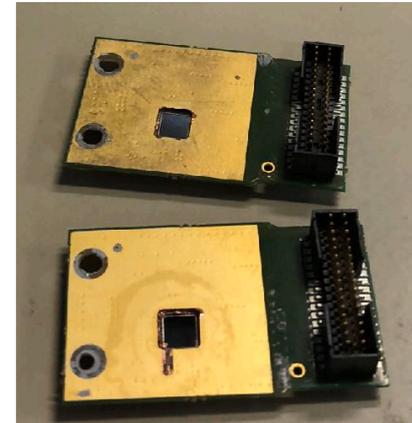
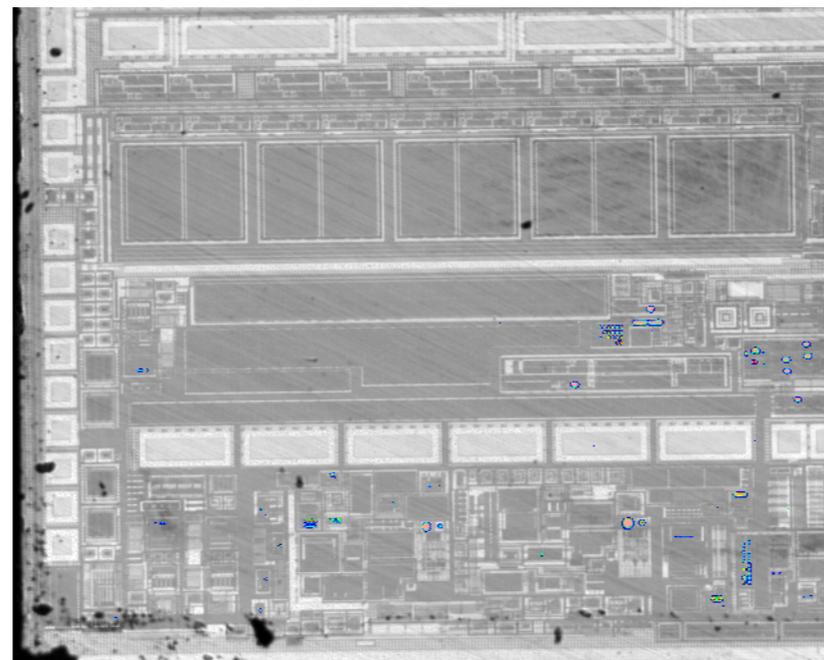
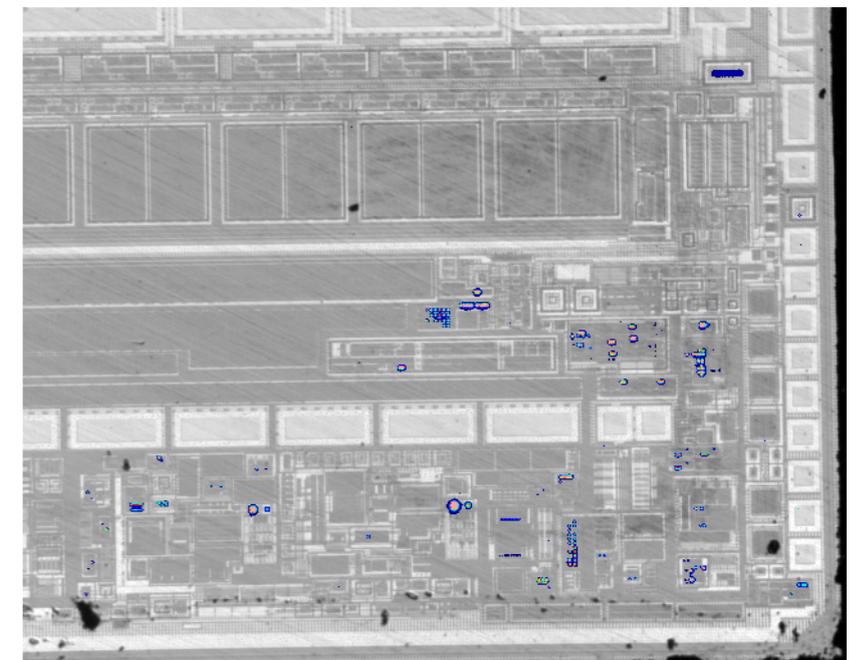
During OBIRCH a laser beam selectively illuminates the metal lines, altering their resistance. The consequent input current change is measured, allowing the mapping of current paths. In broken FEAST2 samples, current flows to the clamp transistors.

Emission images are based on the detection of photons generated from hot carriers (therefore only conducting NMOS transistors are well visible). "Broken" or "High-current" FEAST2 samples showed different current paths.

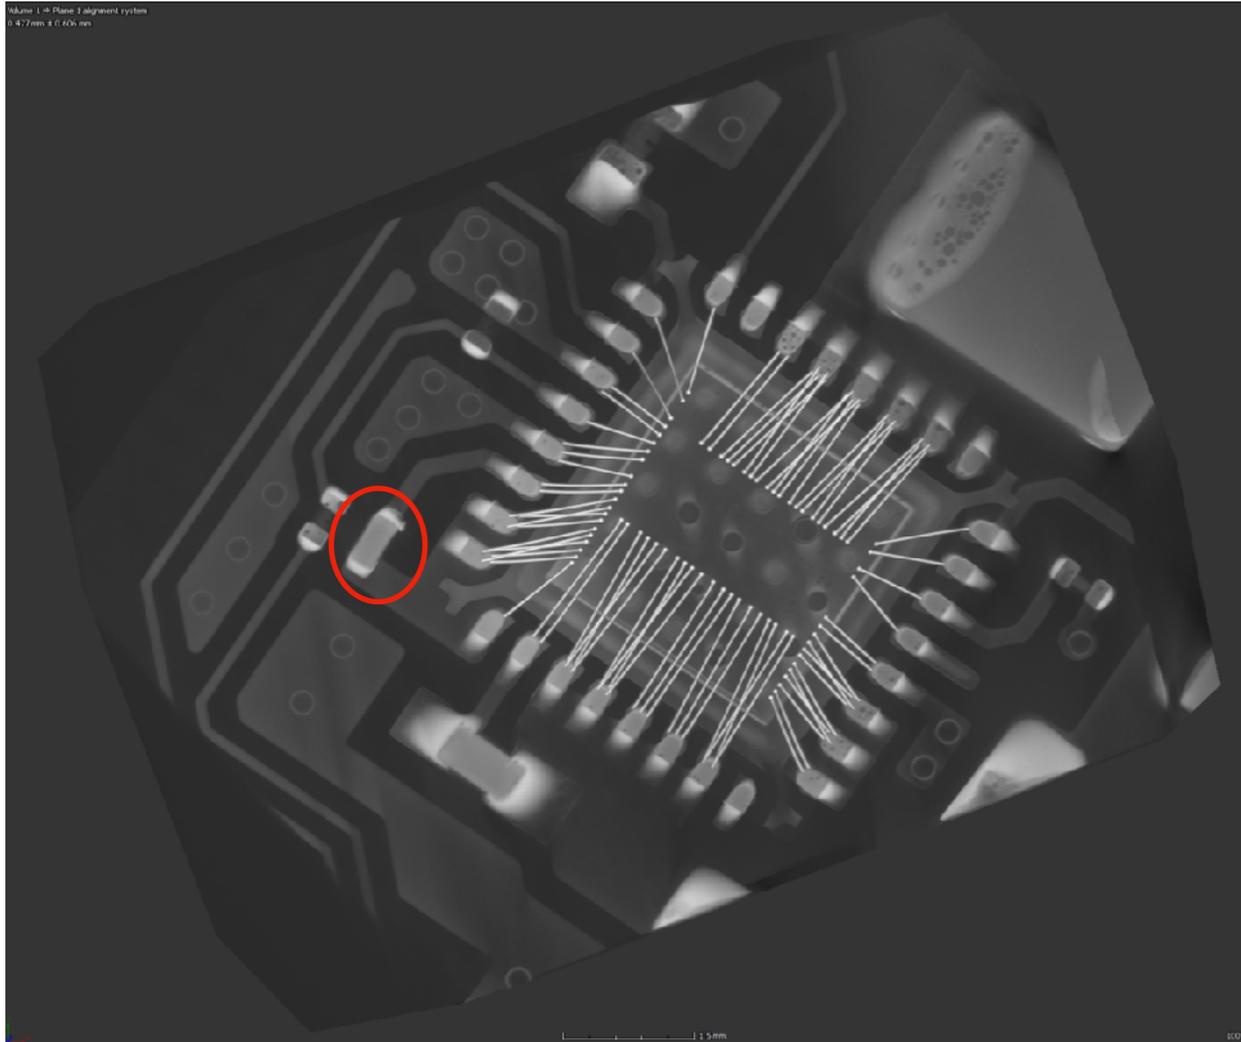
Faulty capacitor, or intermittent contacts of the capacitor in the PCB generated a stress that produced somewhat similar damage

3D X-ray imaging of the module to inspect the quality of the soldering of the capacitor to the PCB

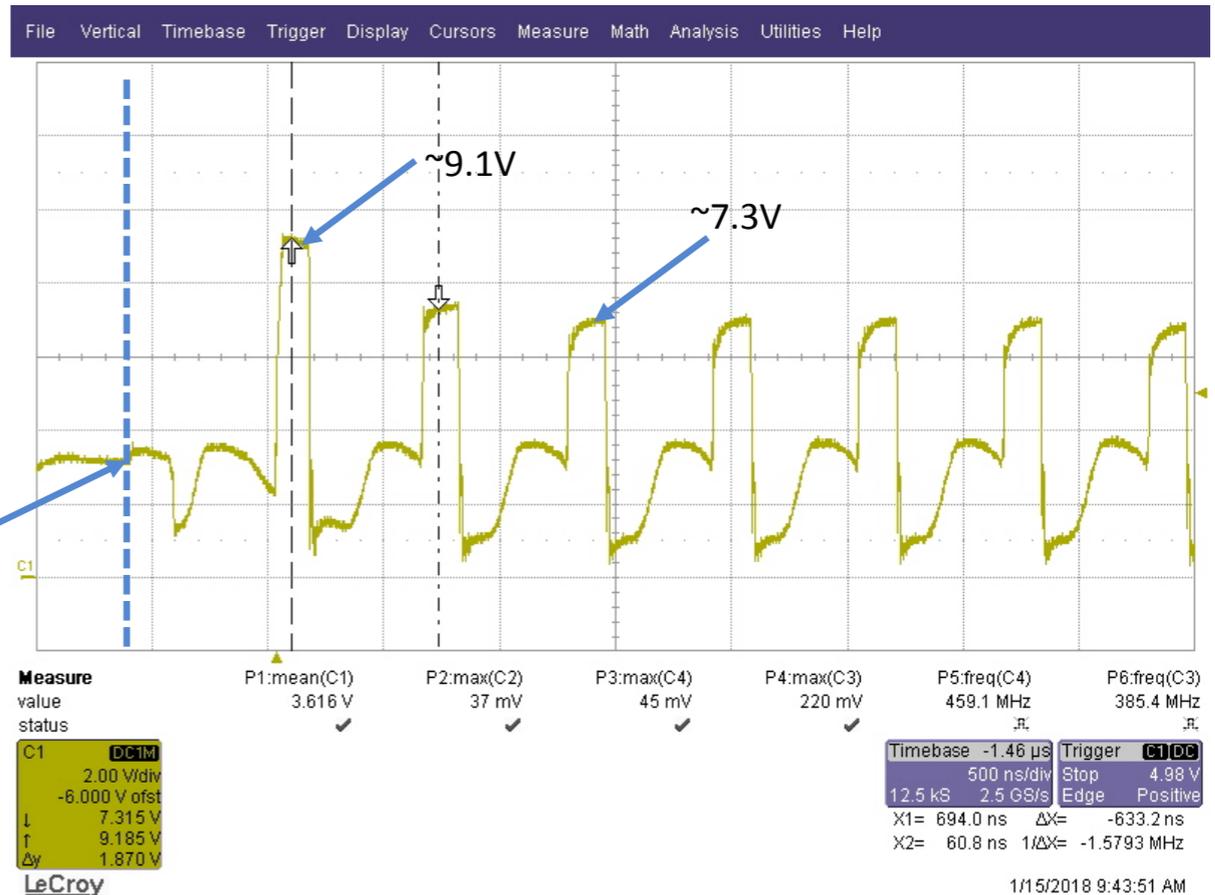
Waveform of the V33Dr node when the capacitance has intermittent contacts to the PCB

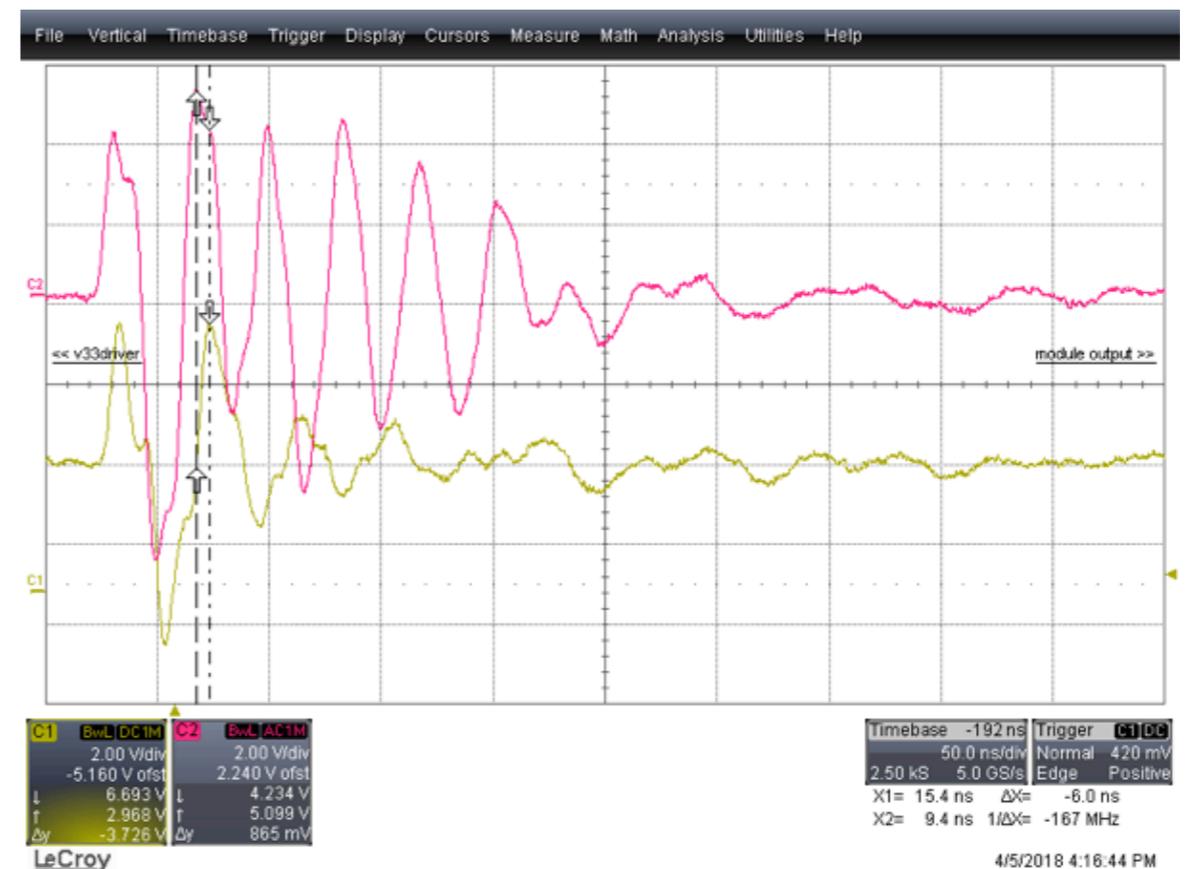
AC-observation of the effect of a 3kV (!) pulse with 50ns duration on V_{in} and V_{33Dr} . The peak is several V above the DC (V_{33Dr} reaches 8V)!

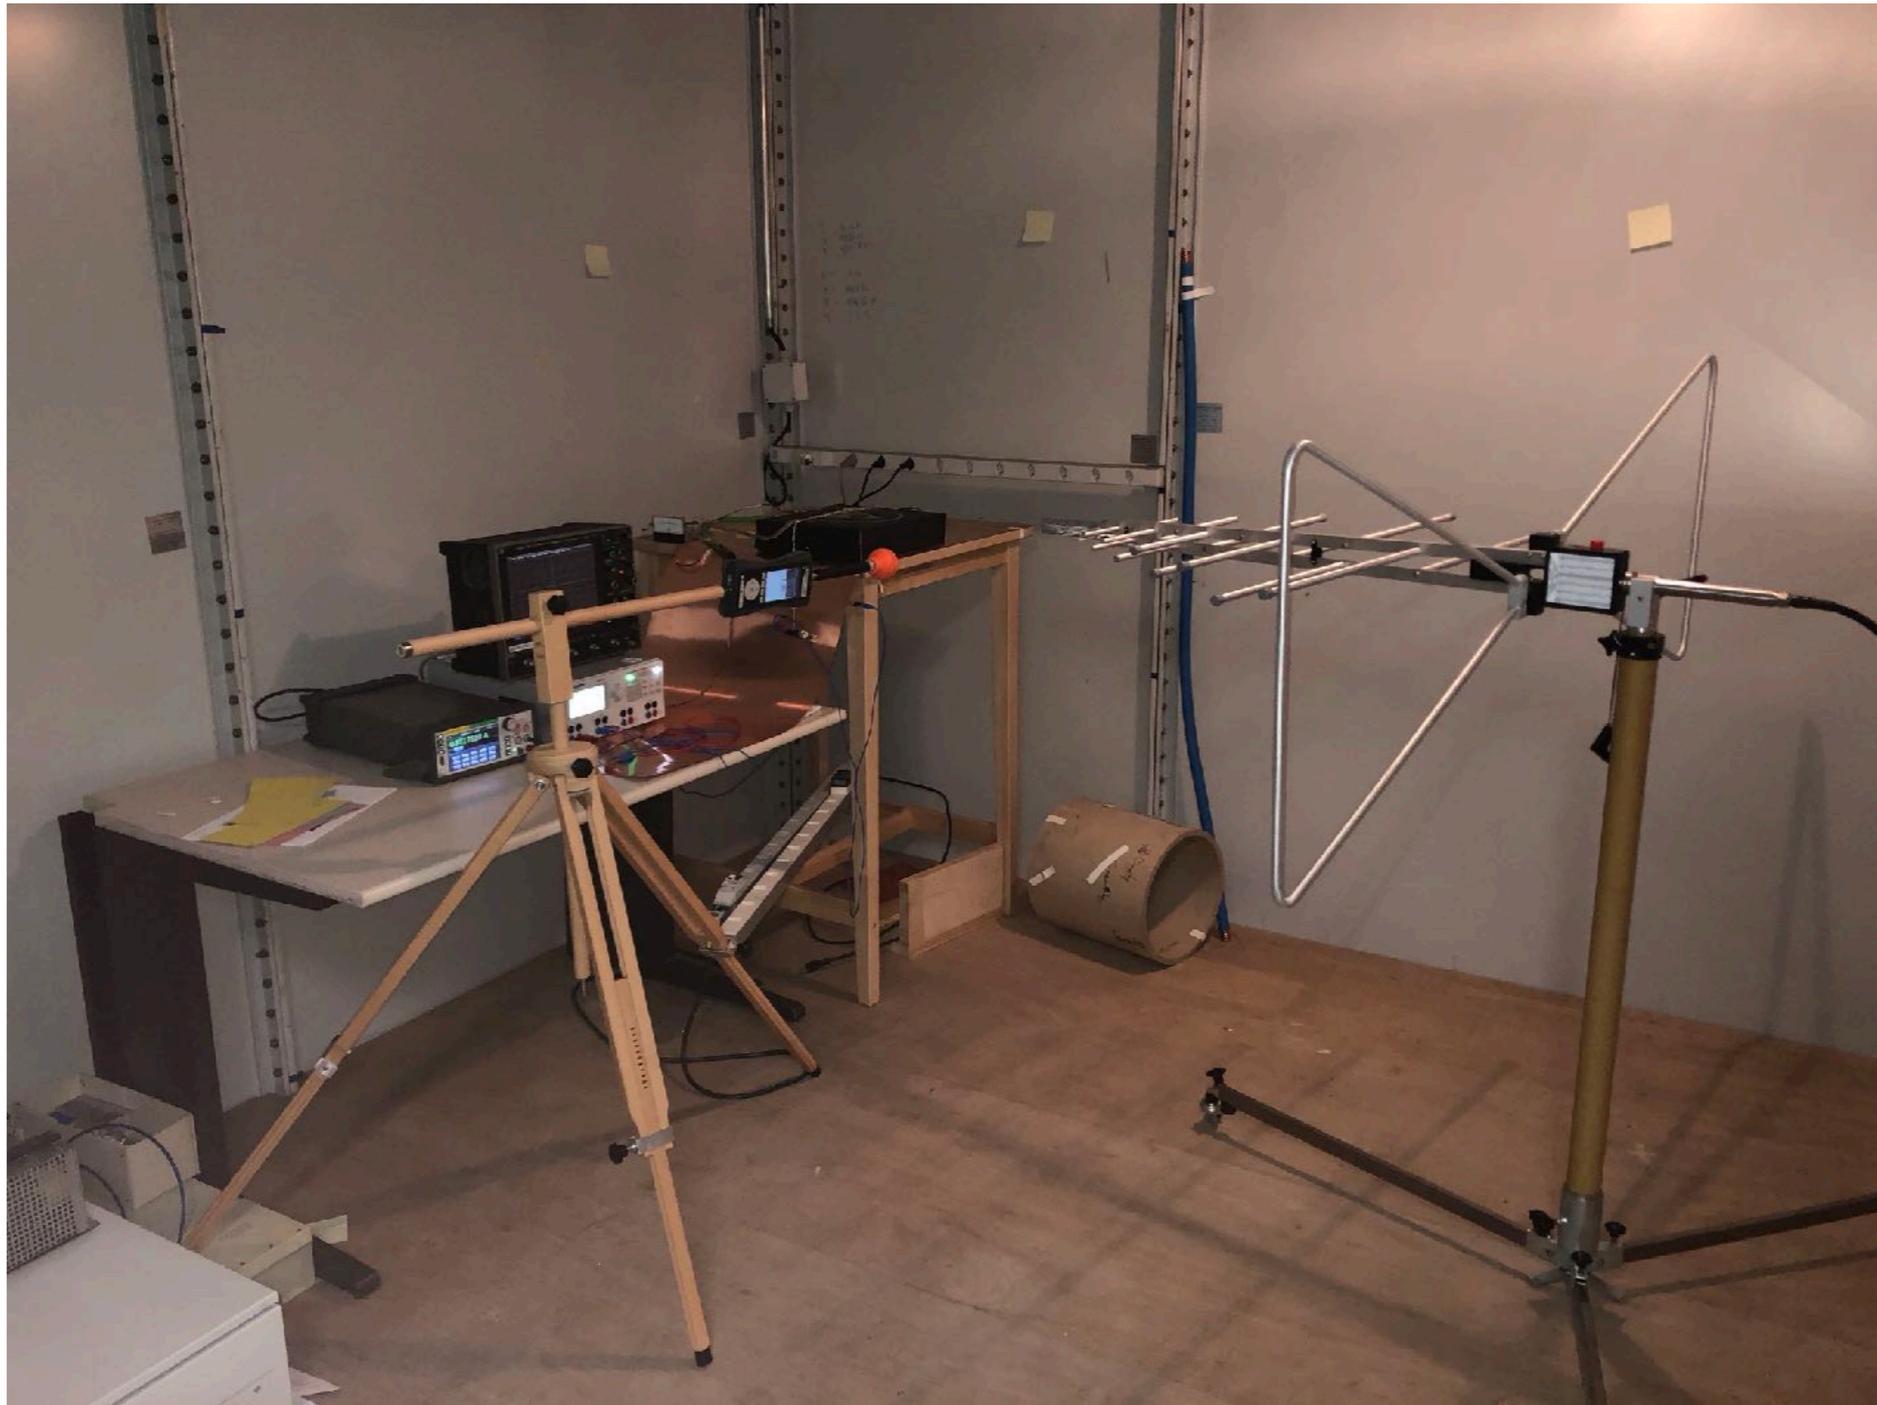
High frequency (GHz) and high power transient pulses are injected via an antenna in a special chamber in CERN Prévessin. At very large power, the ASIC can be damaged but the signature is different than in samples failing in CMS. Coupling is through the long enable line.

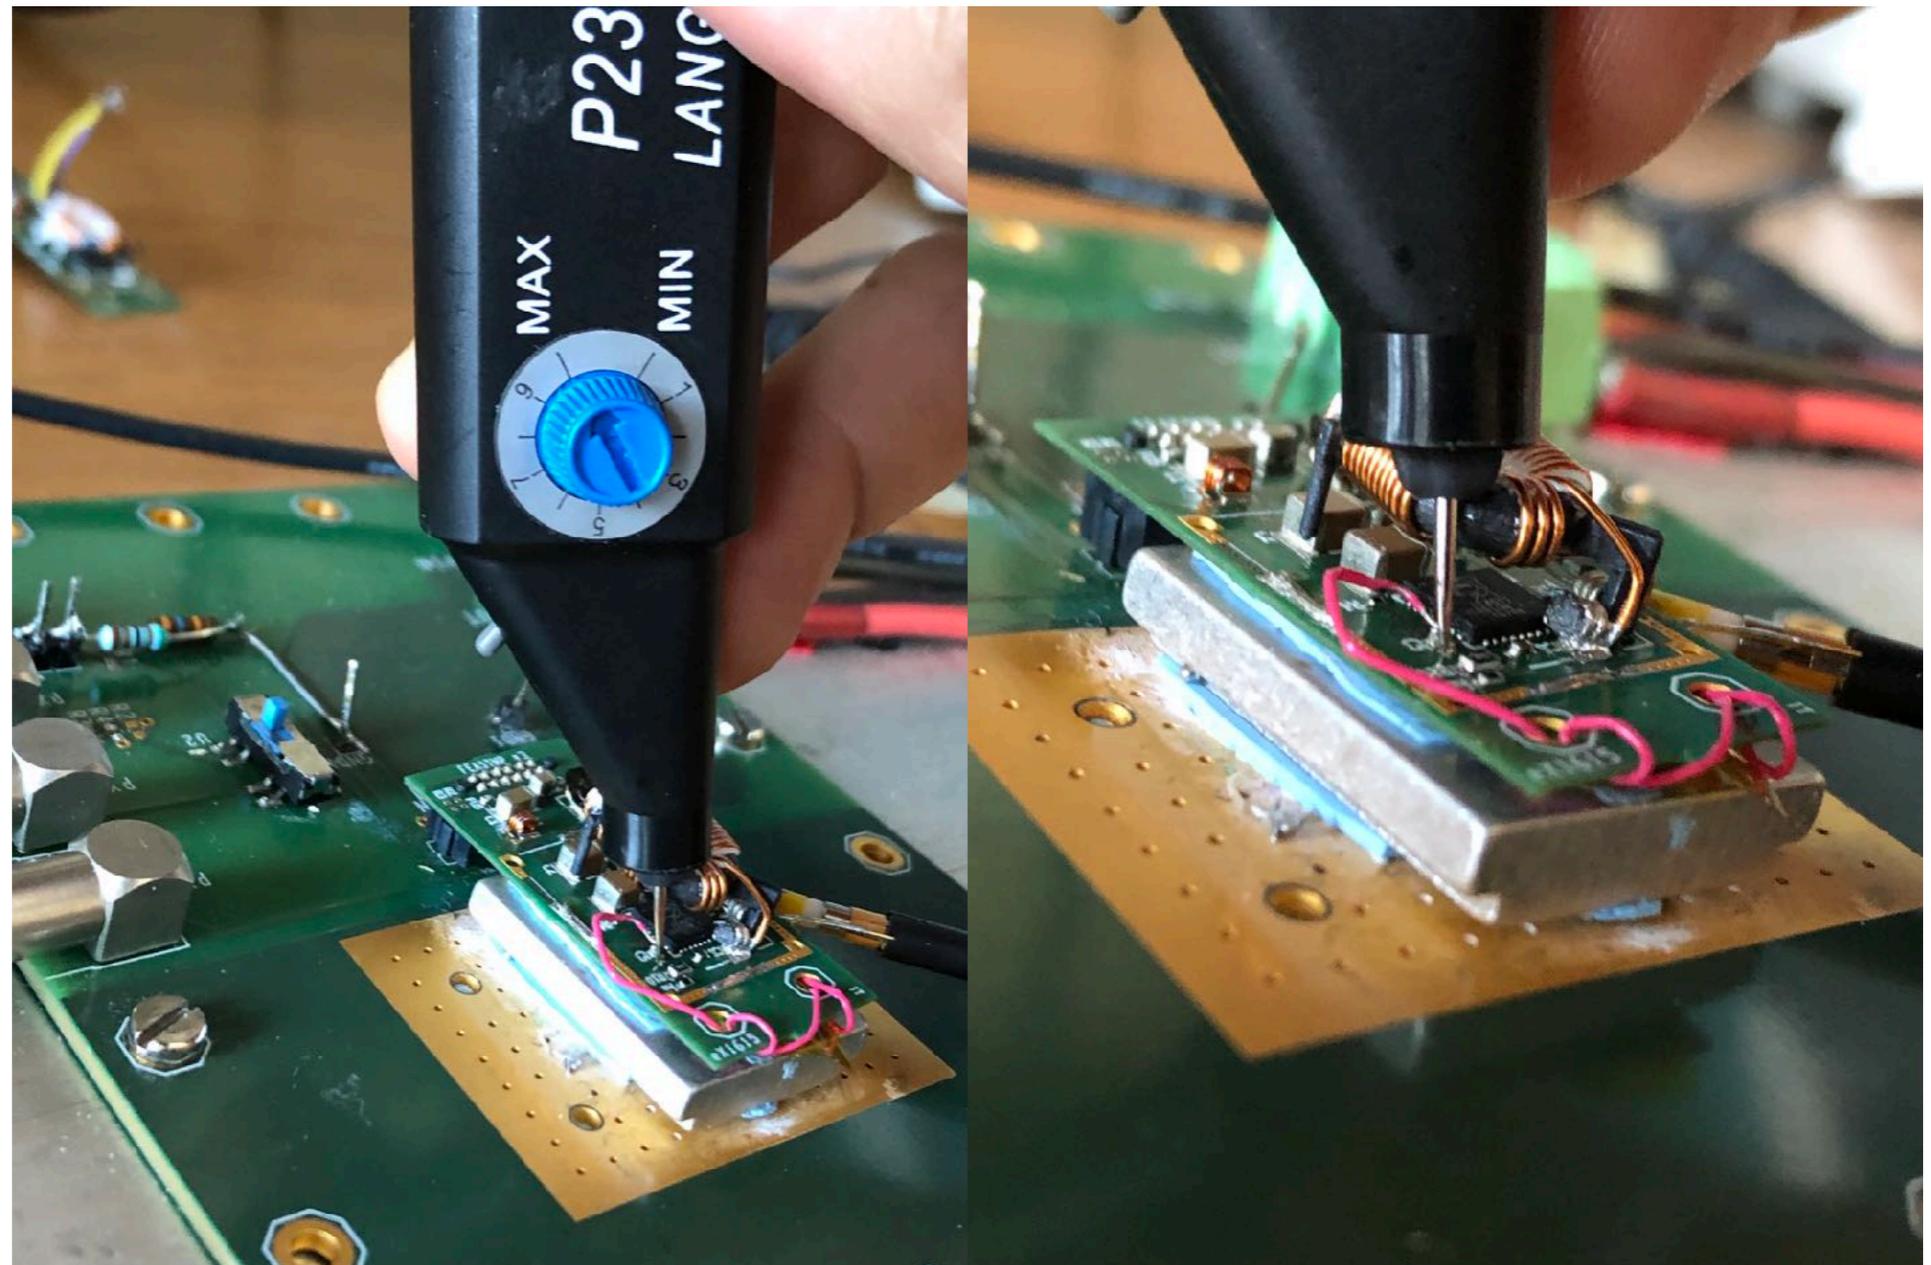
Stress tests with an ESD gun (1.2kV pulses) could produce somewhat similar damage - but the energy injected needs to be really large

An ESD gun is used to inject a discharge to the different pins of the FEAST2 package. To produce any damage, a visible spark has to be produced.

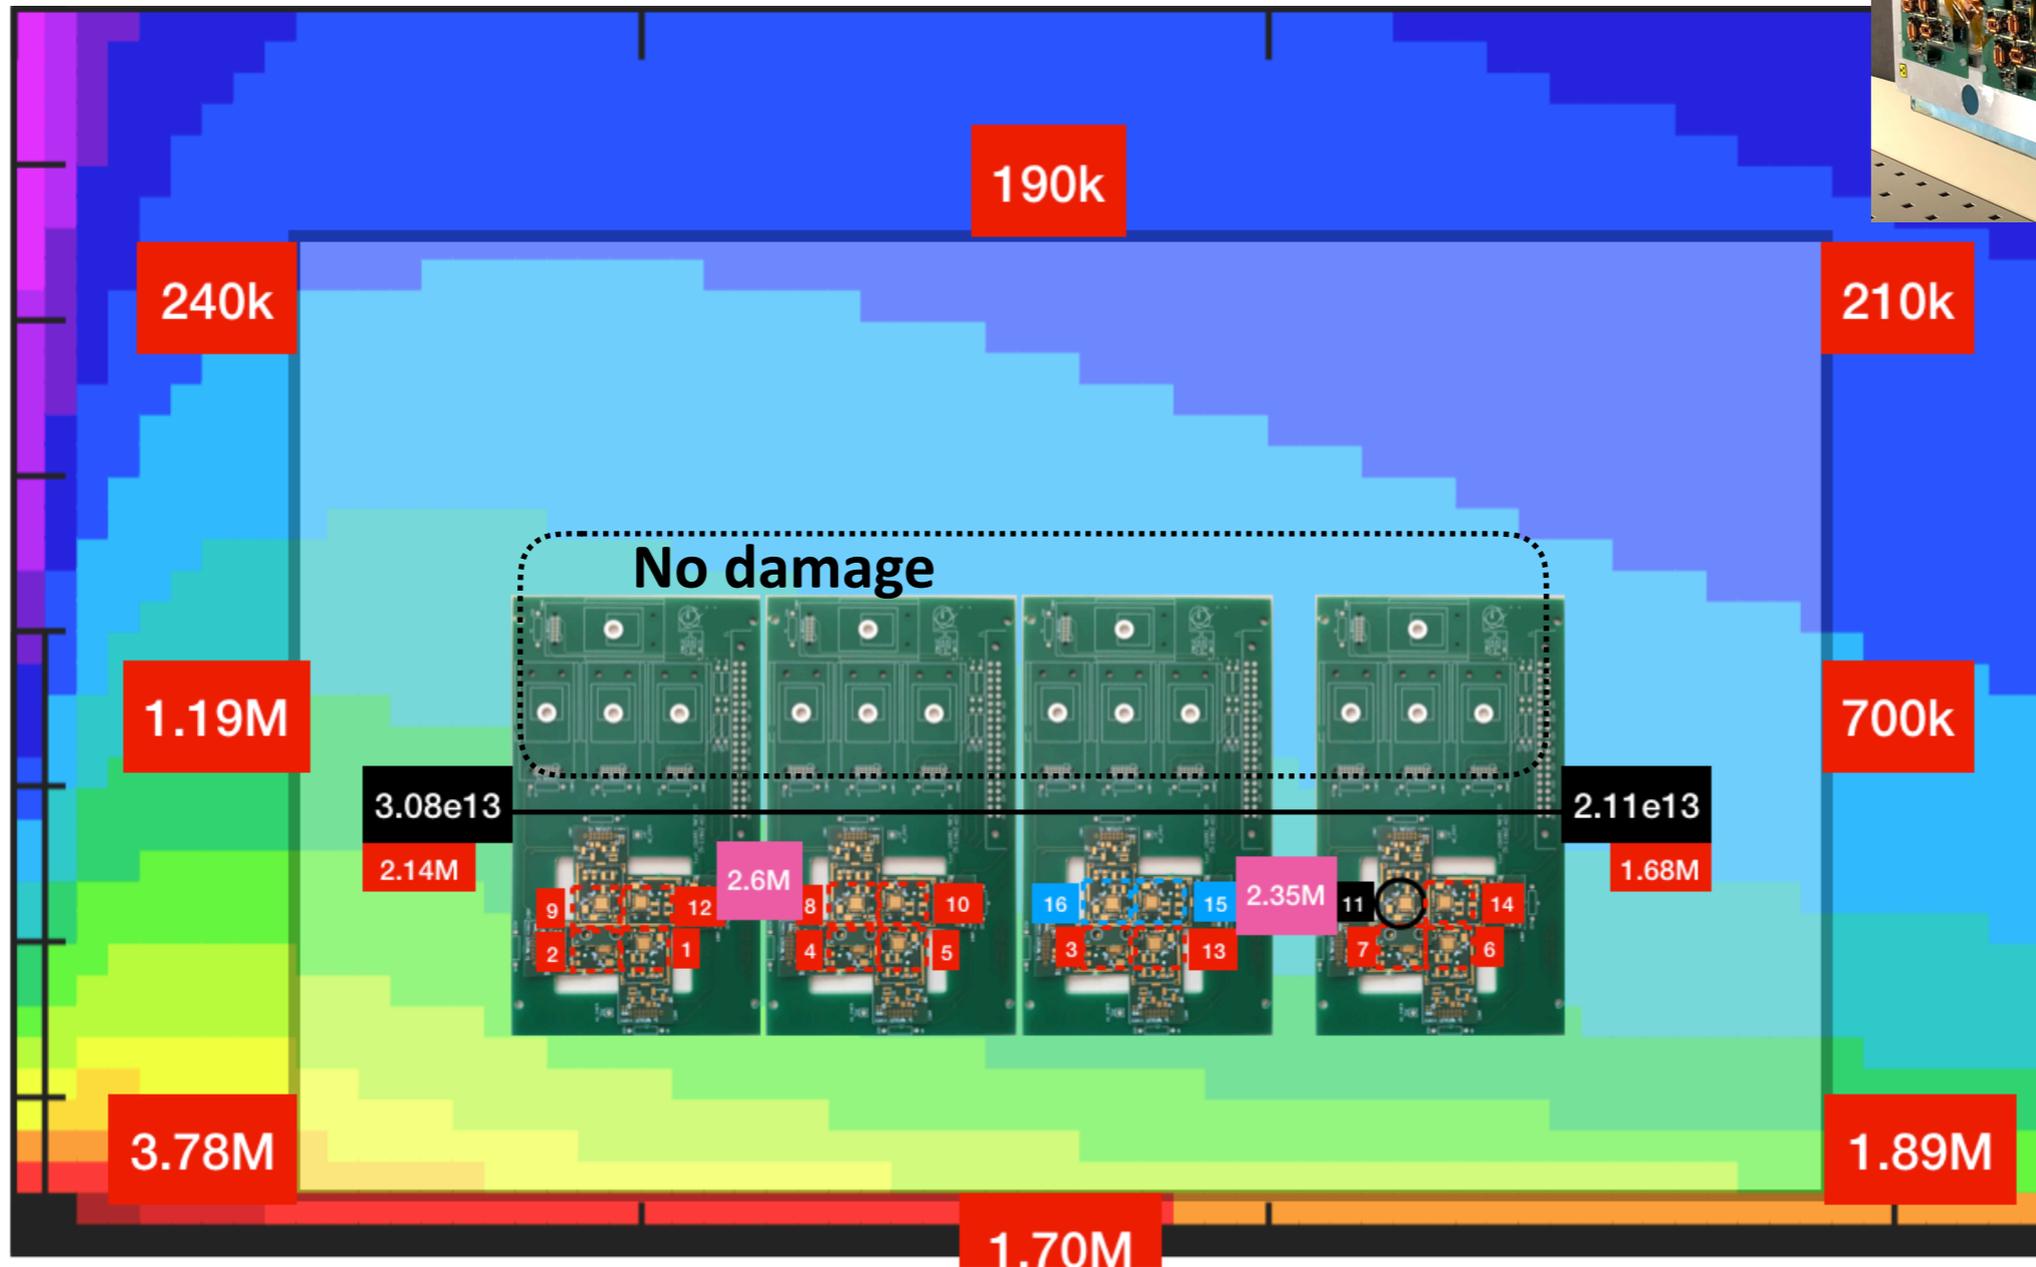
- **Between the damage and the integrated flux**
 - ▶ The first damage occurs after 9 days, then several samples per day
 - ▶ Only samples closer to the beam are damaged
 - ▶ Samples are damaged also after the end of the exposure
- **Between the occurrence of the damage and the disable-enable sequence**
 - ▶ Also true for the “High-Current”

Red = High-Current damage occurred during exposure

Blue = High-Current damage occurred after exposure

Black = failure
