The lonely perpetrator in the DCDC FEAST2 case

How an individual transistor threatened the operation of the CMS pixel detector

F.Faccio, CERN, EP-ESE

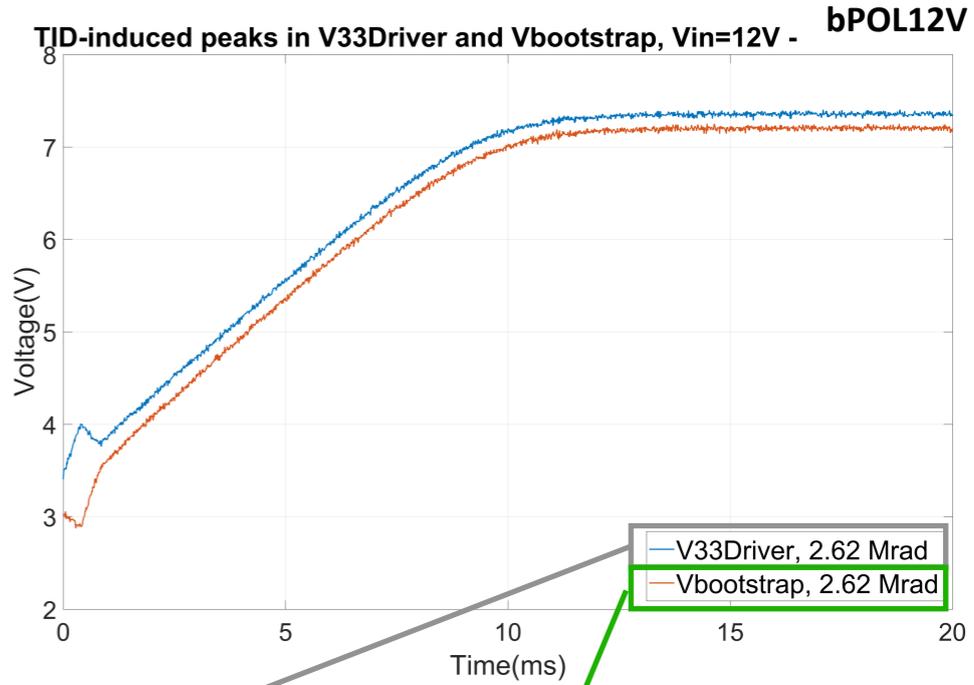
We observed a “voltage peak” on the V33Dr node when FEAST2 is disabled during X-ray exposures. The voltage peak increases with TID

Peaks of up to 8.5V observed during X-ray exposure

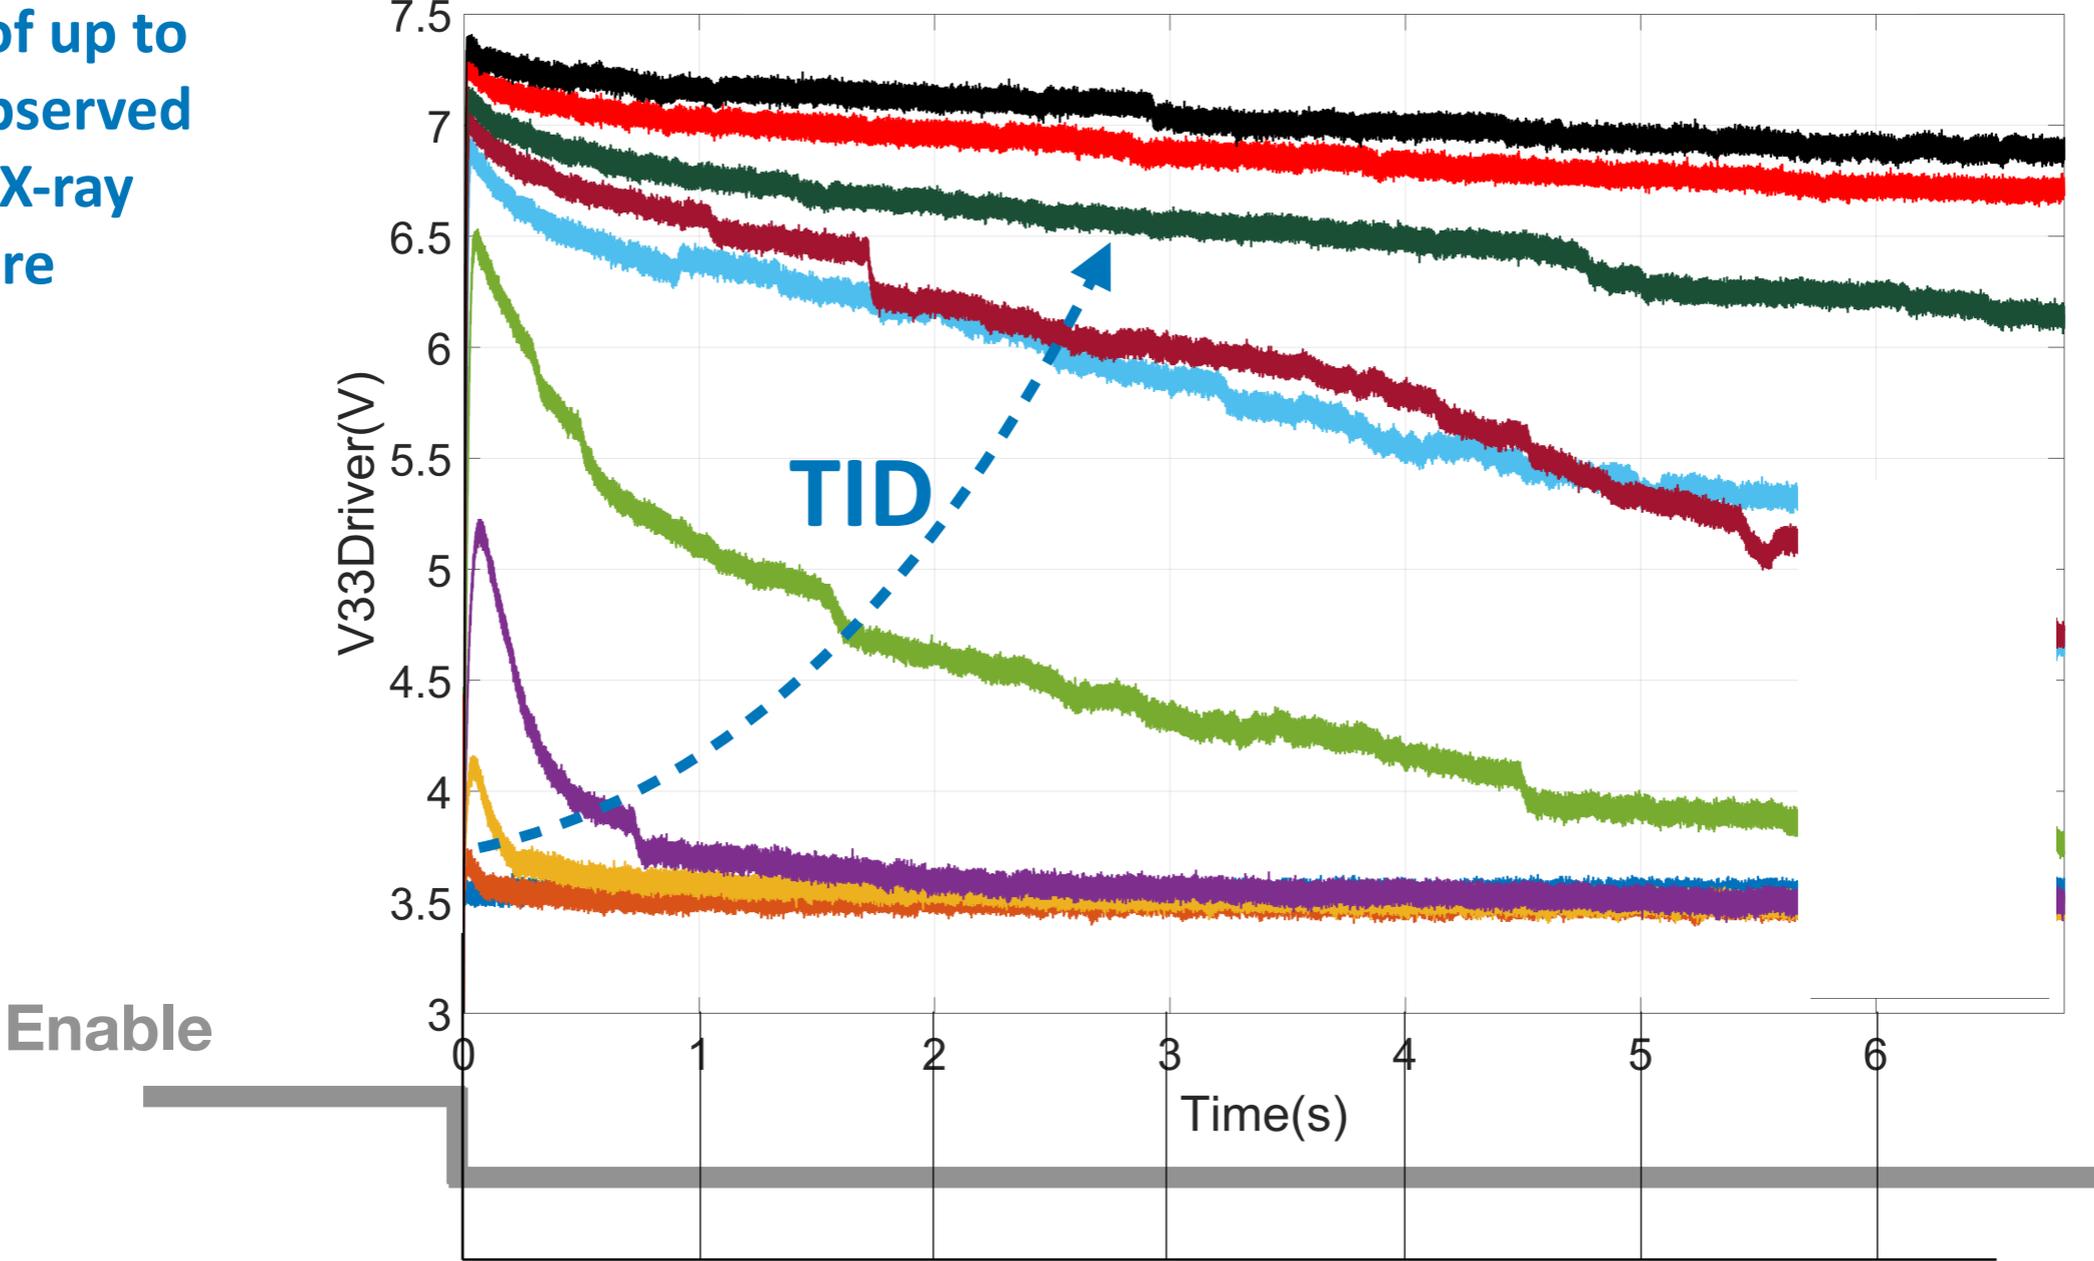
Example waveforms at the V33Dr node

The voltage at the V33Dr node goes well beyond the nominal maximum of 3.3V+10%. This voltage stress might end up damaging a device. We have observed 2 damage mechanisms, and Failure Analysis with emission microscopy and OBIRCH have confirmed the current paths.

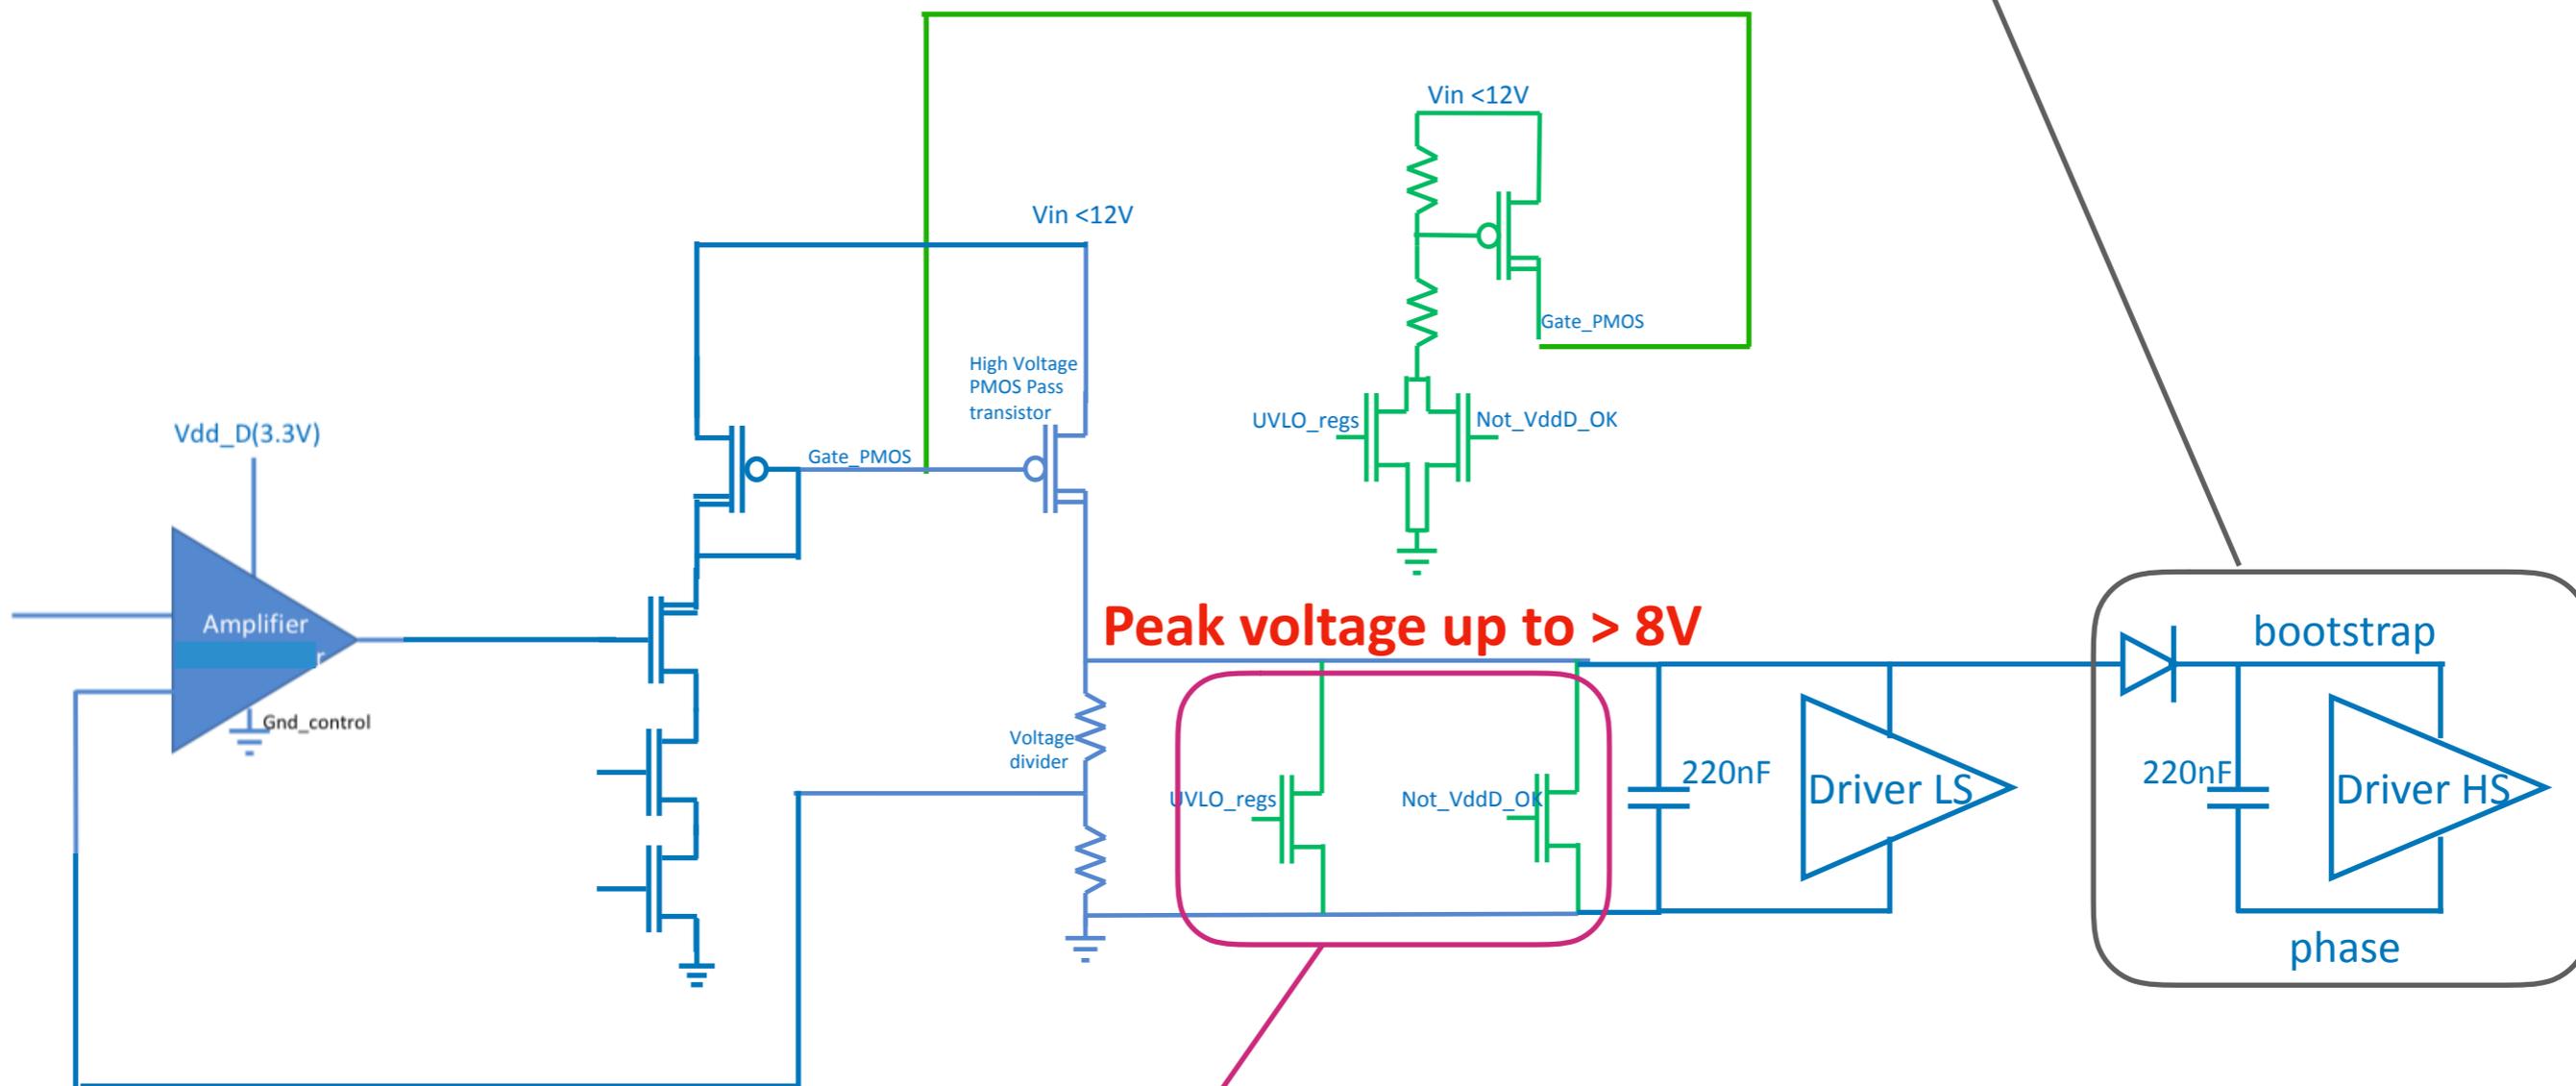
If a device along this path is damaged => increase in regulator current => FEAST2 continues to operate

If a clamp transistor is damaged => linear regulator stuck => FEAST2 failure

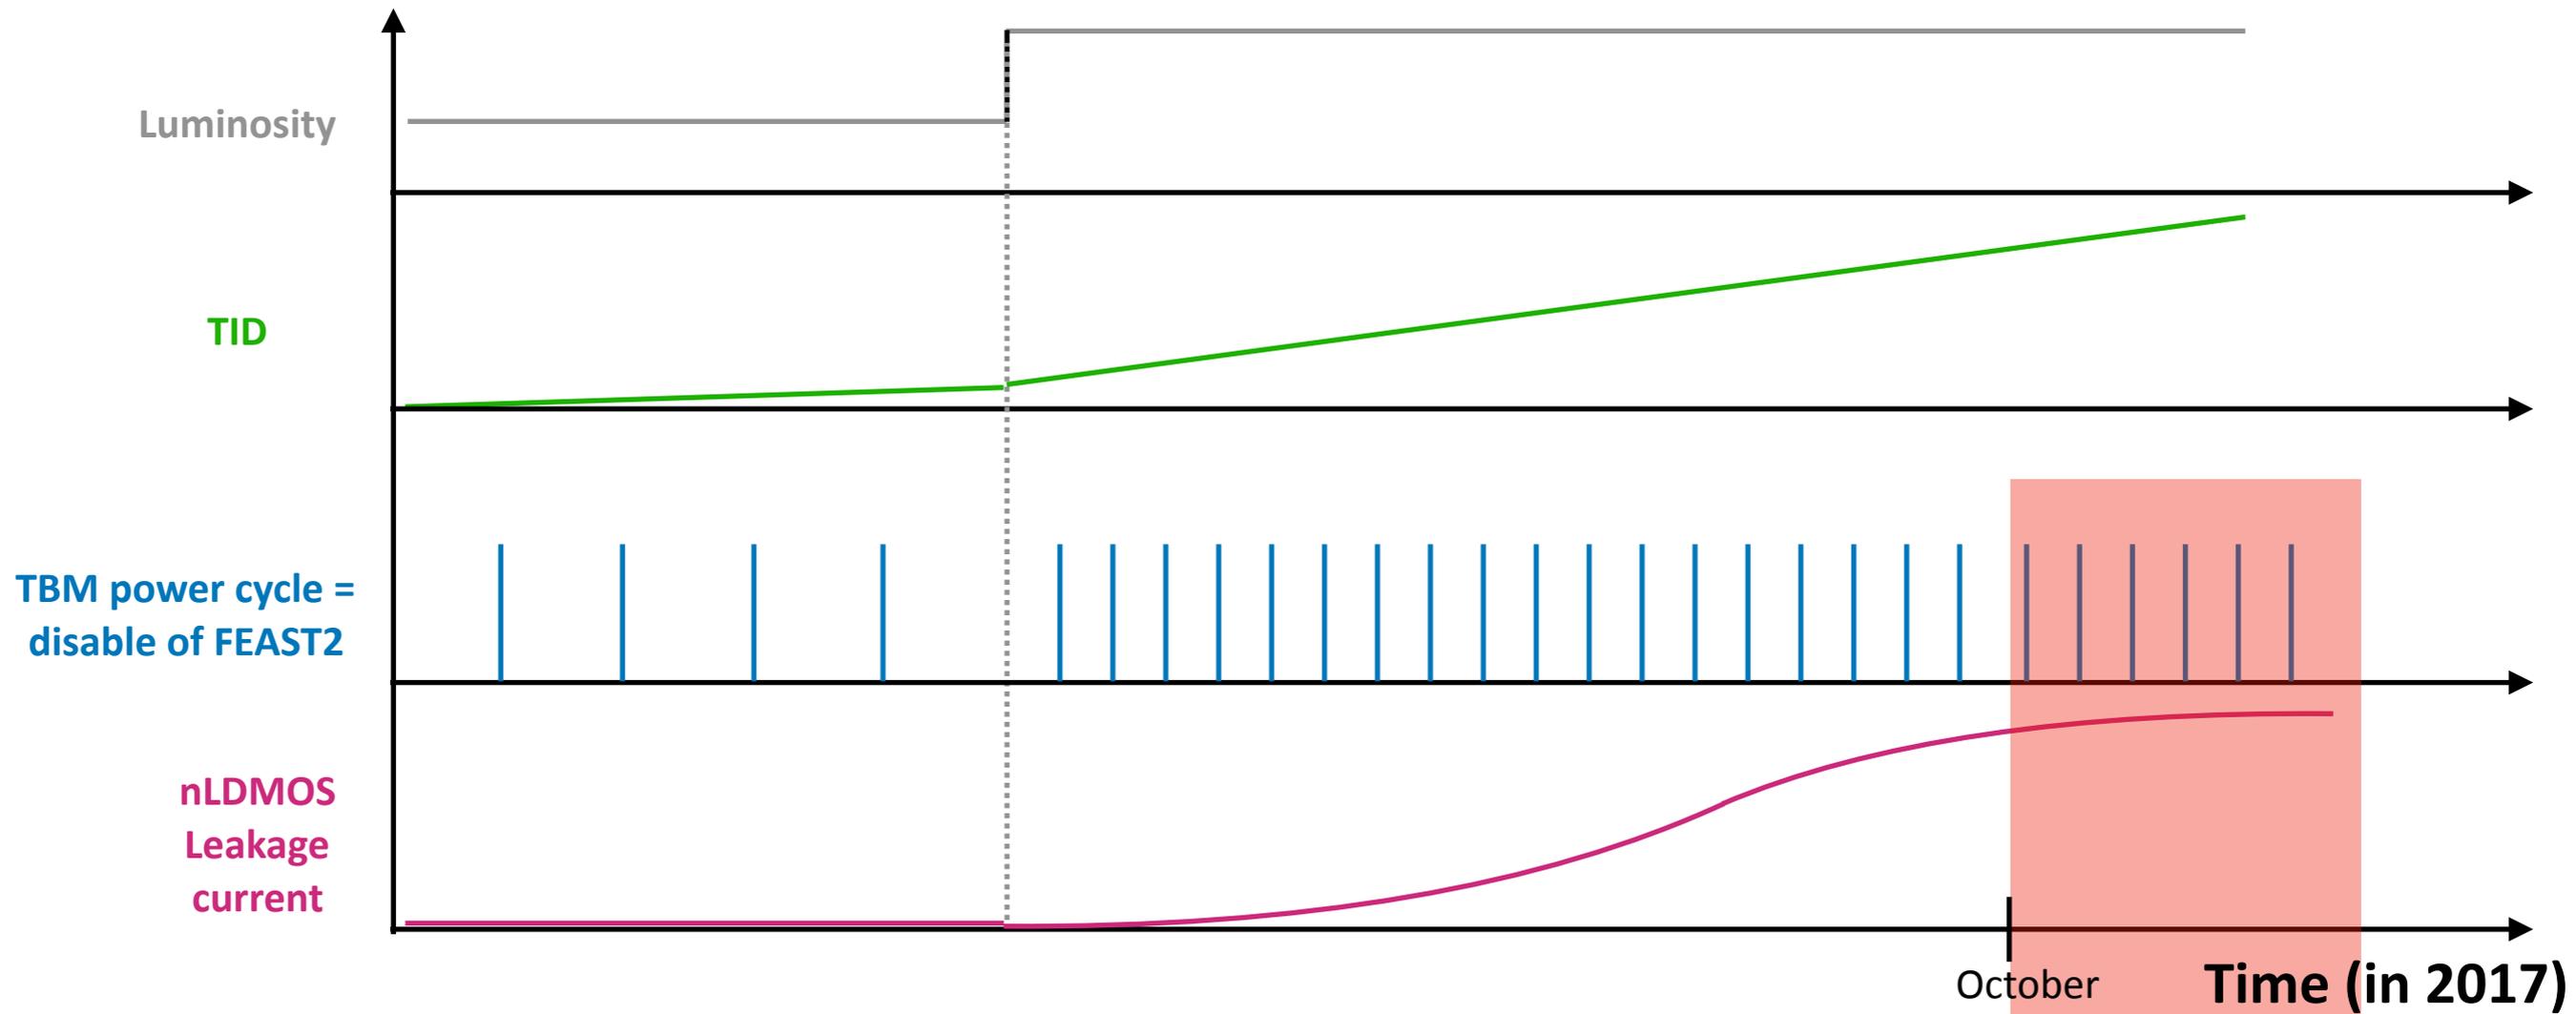
TBM requires a power cycle
=> FEAST2 is disabled while the leakage is large
=> peak voltage at V33Dr
=> damage

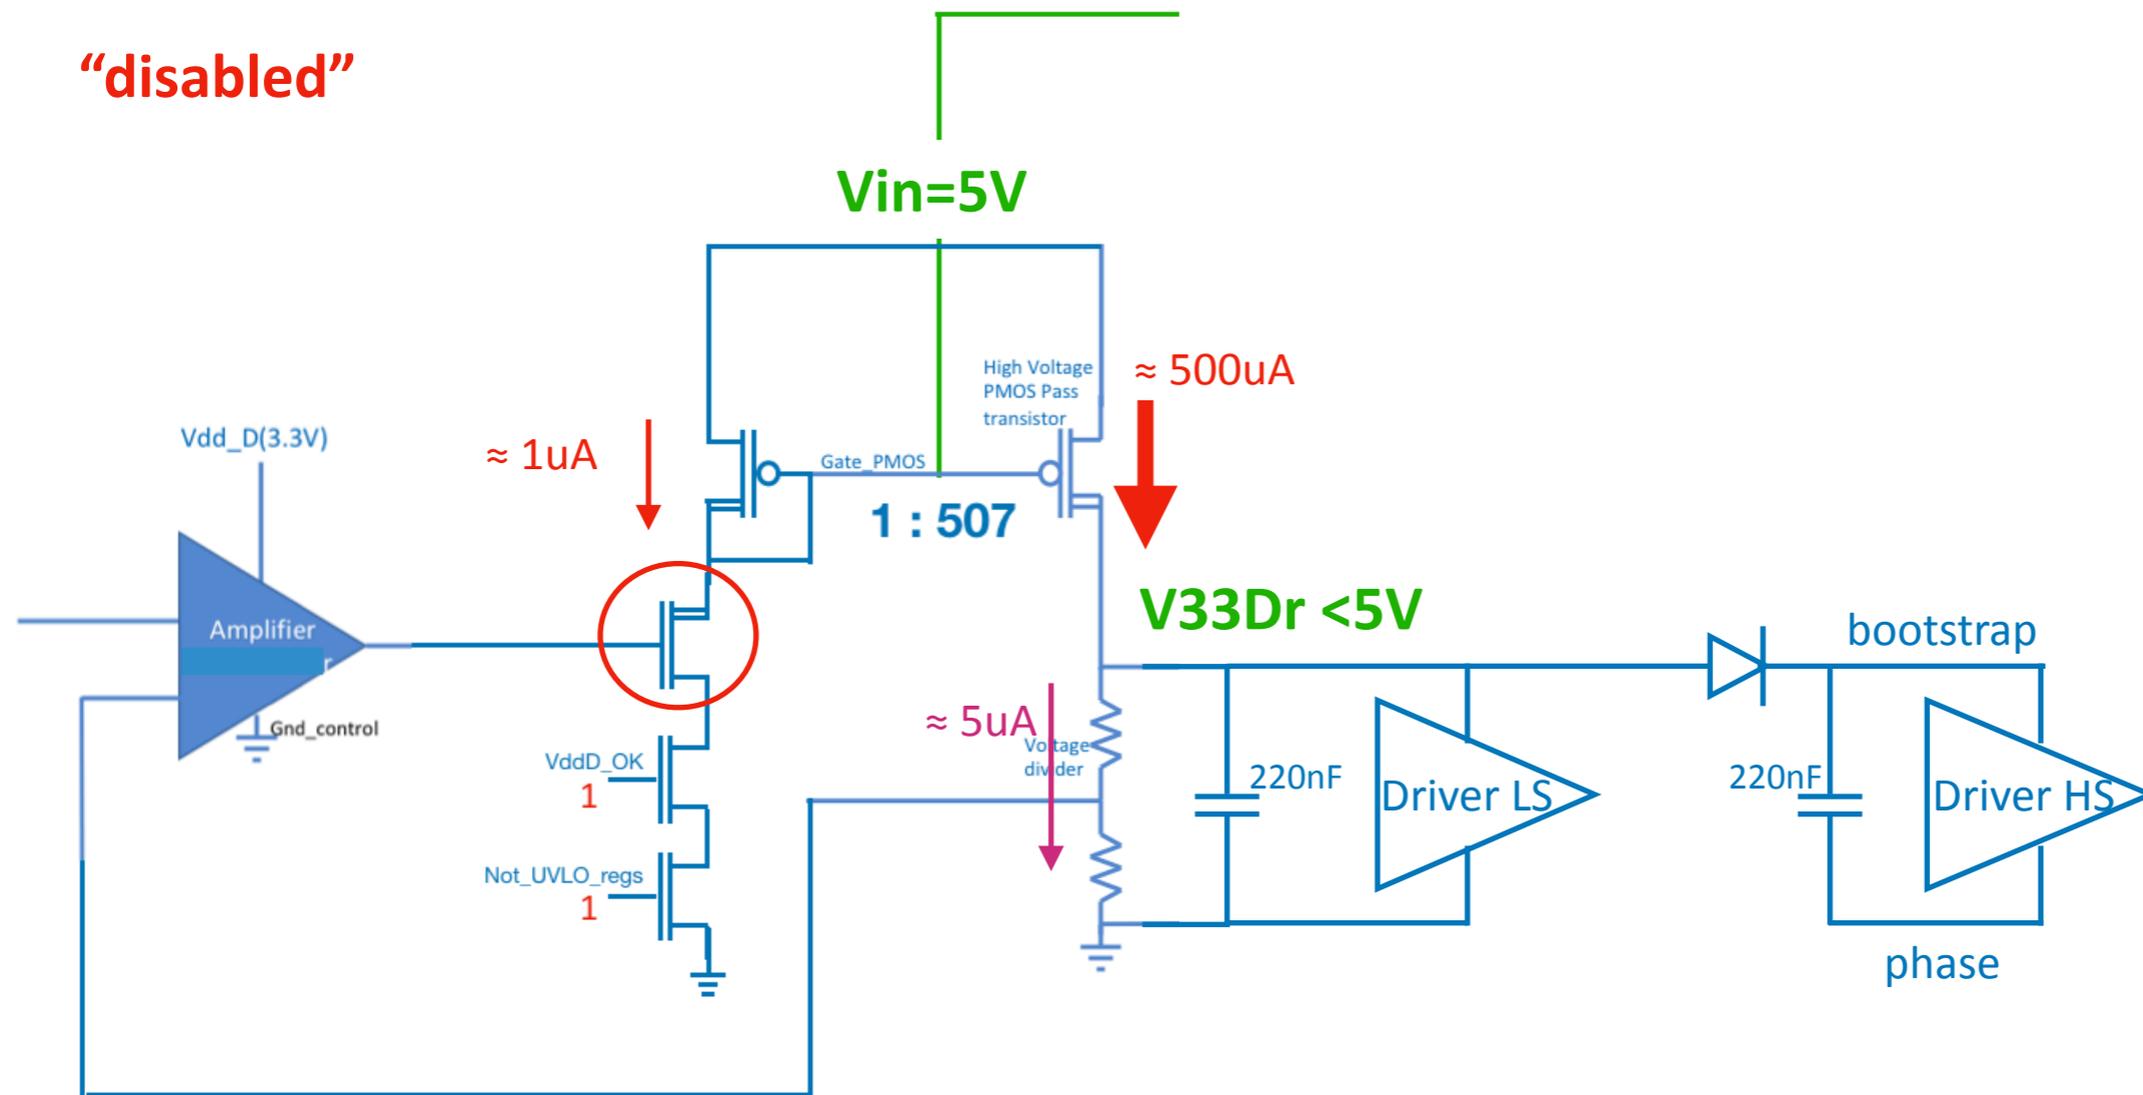
The voltage peak can get close to V_{in} , but not higher

Disable the converter at lower V_{in}

In case of a power cycle (V_{in} down to 0V), the converter is disabled by the UVLO at about 4.4V

This strategy was successfully used during the full 2018 run of the CMS pixel detector, and its efficiency was demonstrated in the second IRRAD run and in X-ray testing

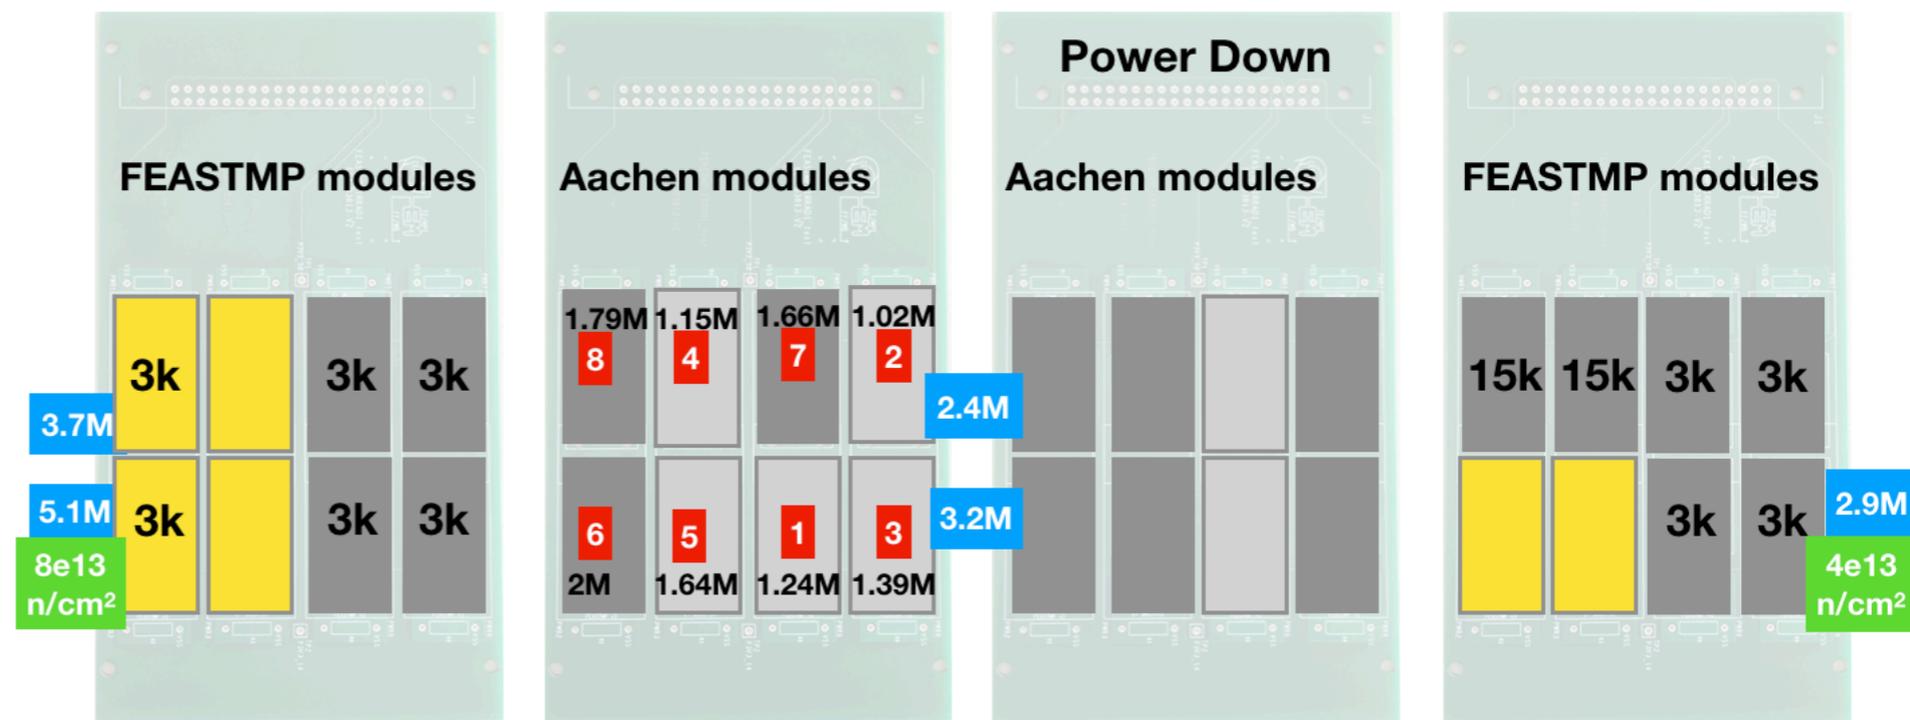
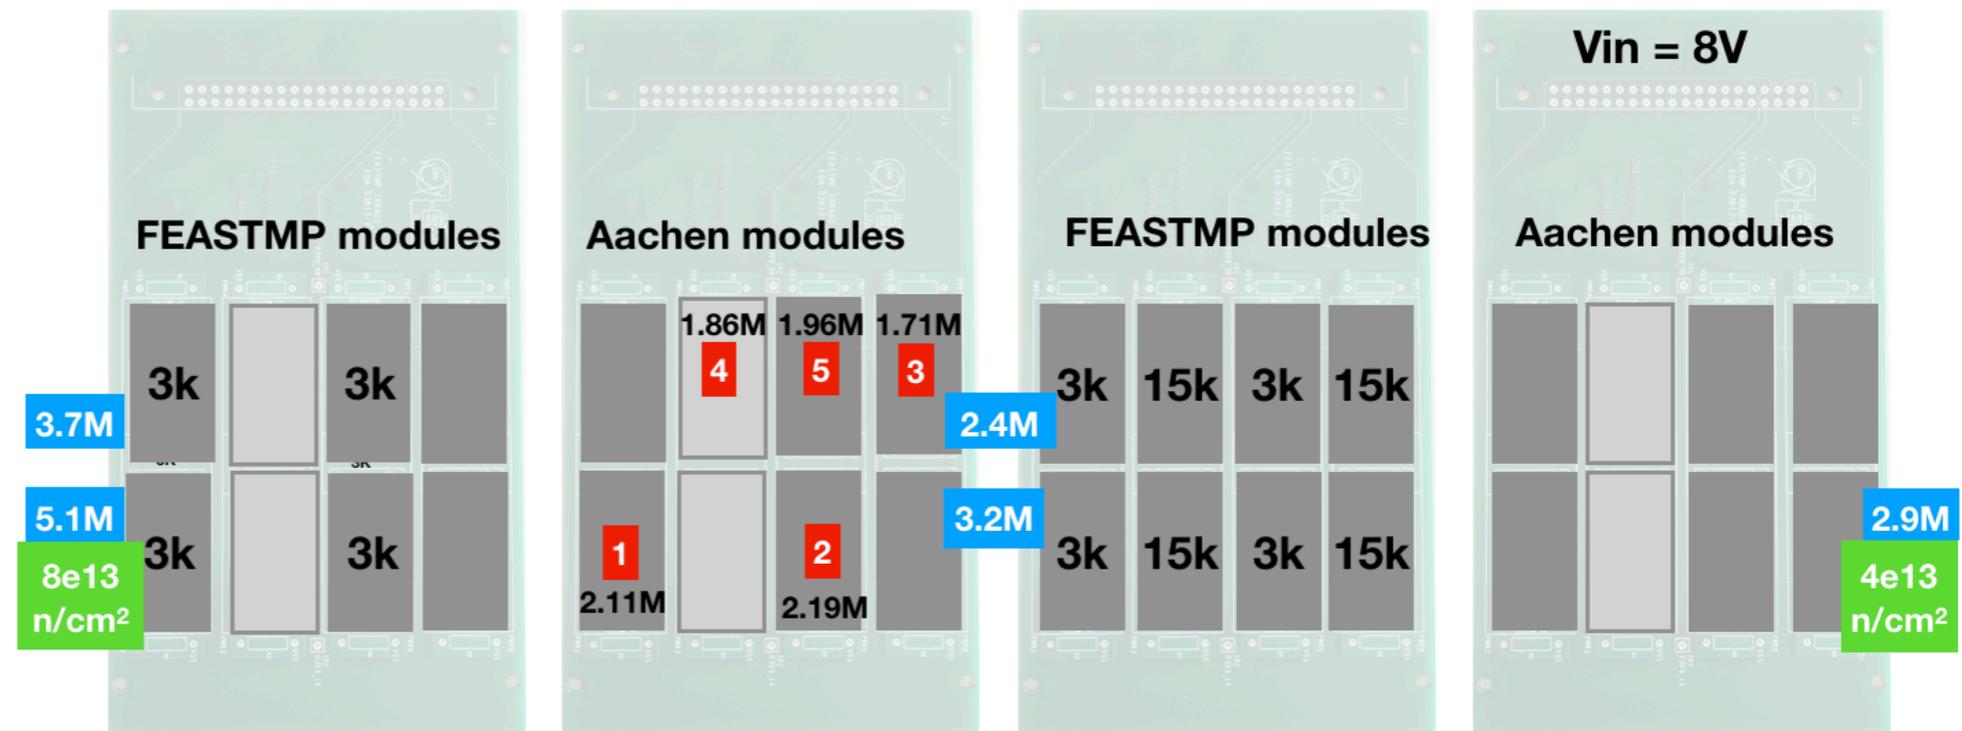
Color code:
 Dark grey = FEAST2.1 new
 Light grey = FEAST2.1 from run1
 Yellow = bPOL12V
 Protection resistor if indicated

Inside the box, T=-25°C

Outside the box, room T

- Worse damage when cold
- Damage earlier if pre-exposed
- No damage

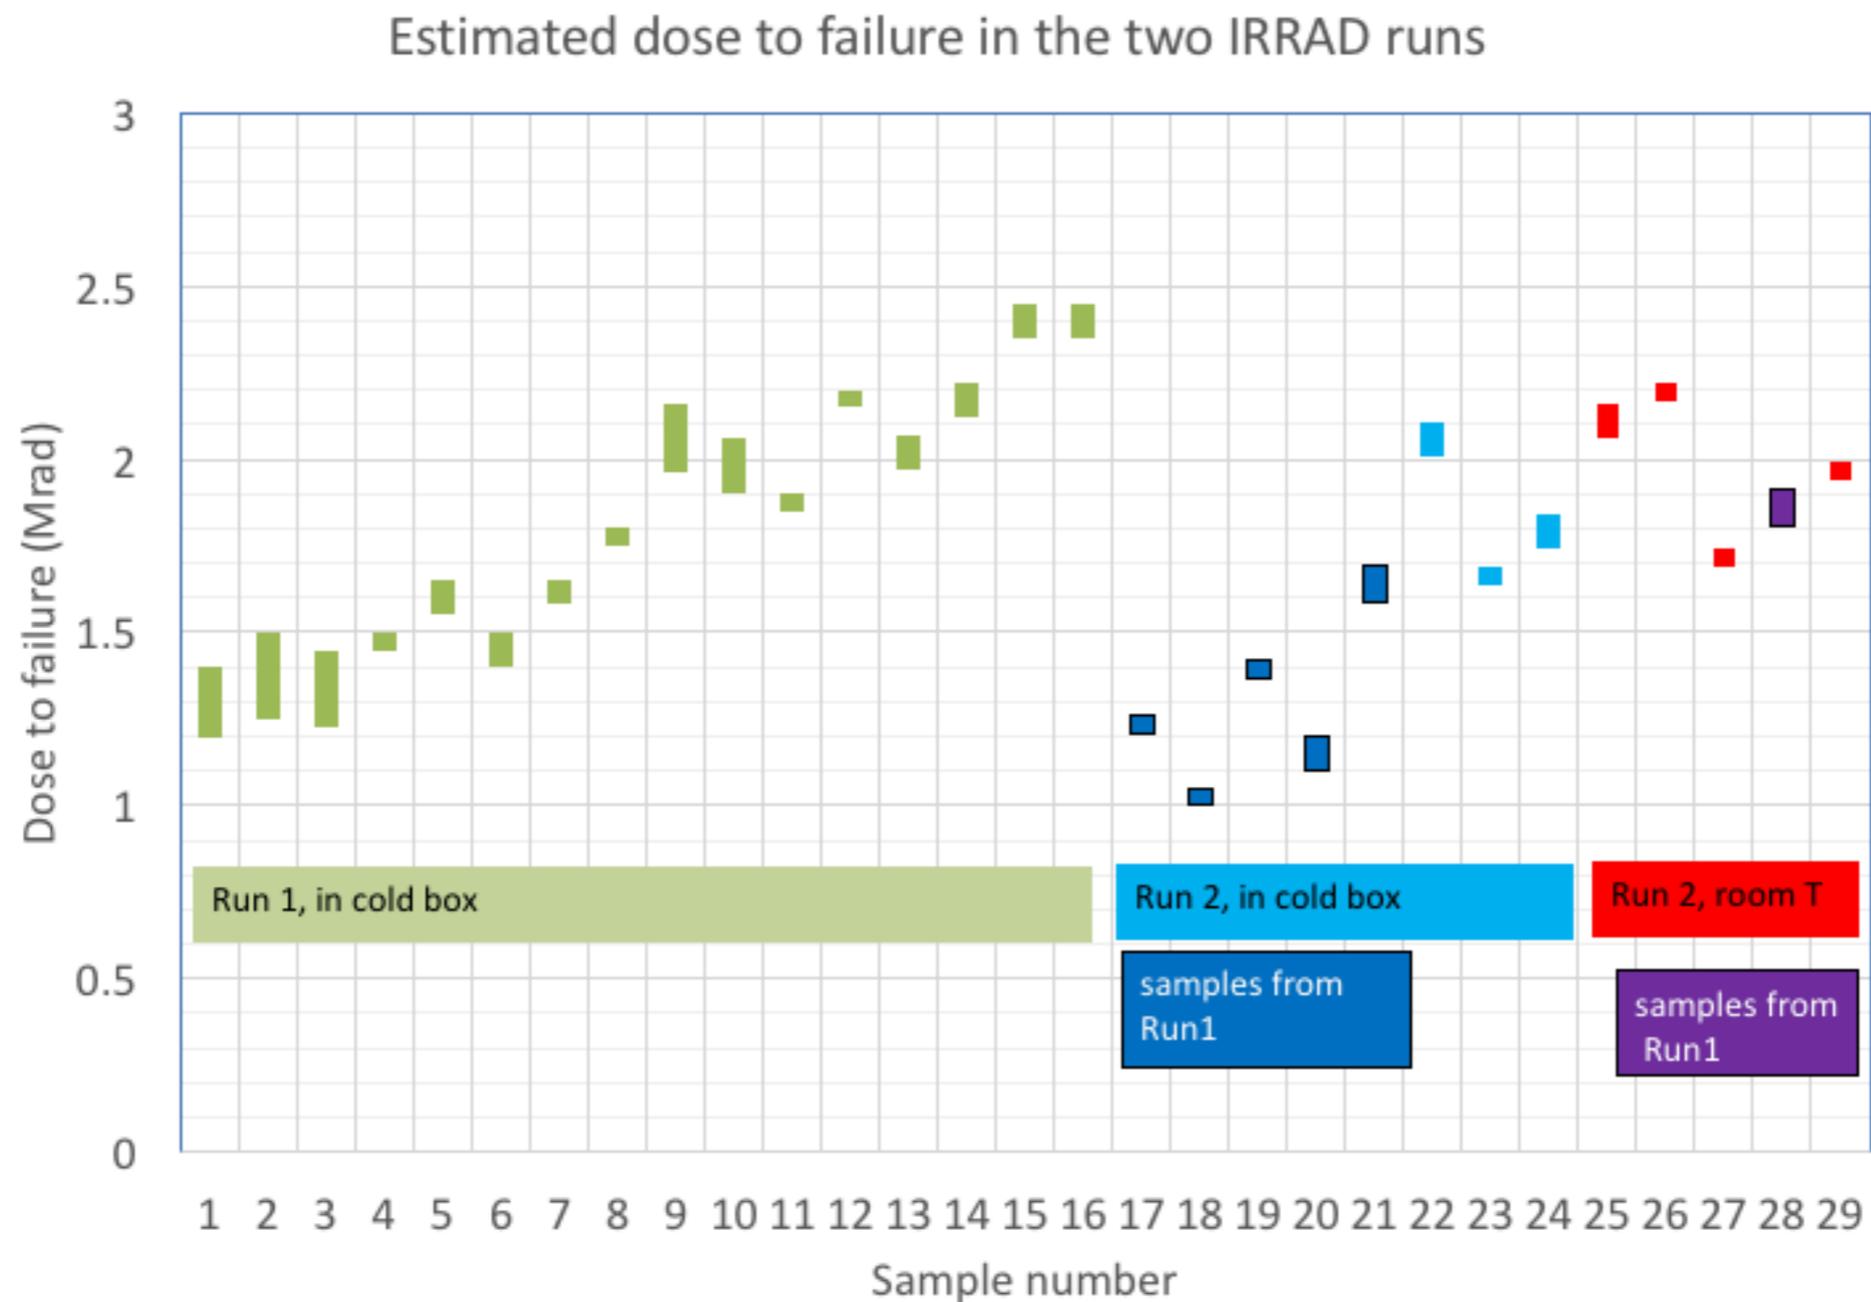
Summary of the best estimate for the dose to failure for the two IRRAD runs

Damage only occurs above 1Mrad in these high-dose-rate (and low-T) experiments
